## Inspection Photos

Location Name: TEP ROCKY MOUNTAIN LLC UNION-66S96W /33NWSE

Location ID: 335237

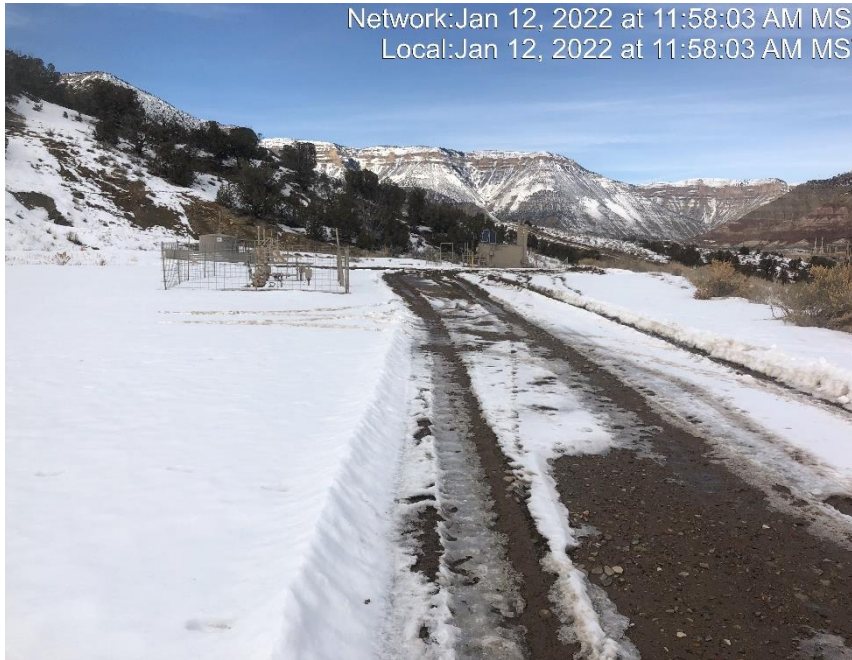
Photo #5659 from entrance to location.

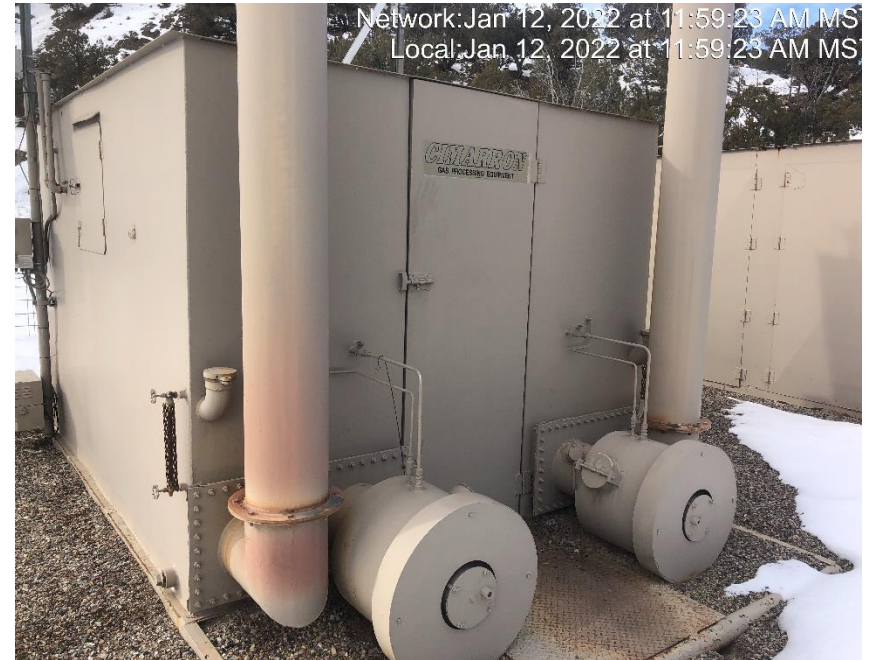
Photo #5660 Storage tanks not labeled.

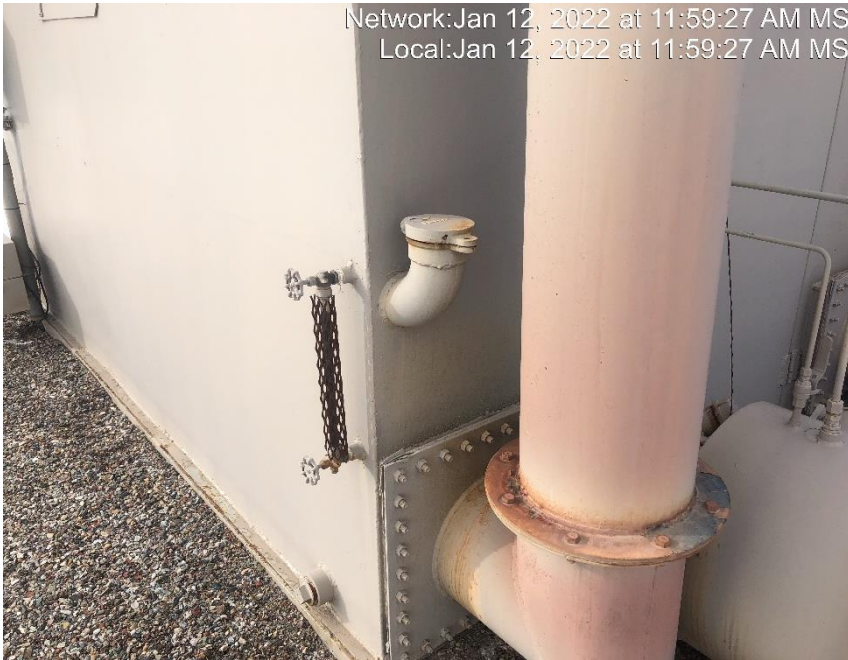
**Photo #5661** Sight glass indicates that the storage tank is full of an unknown fluid.

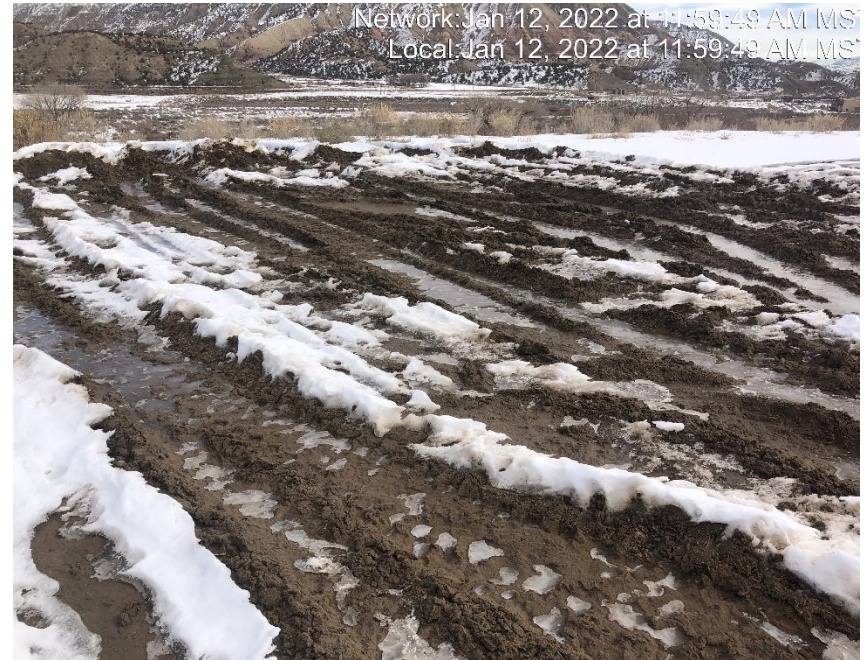
**Photo #5662** Location lacks stabilization.

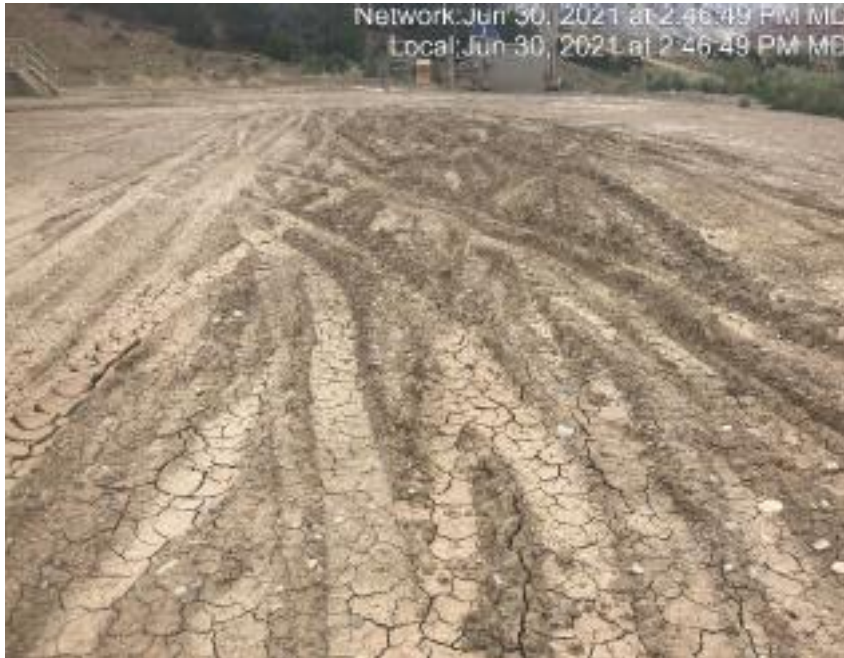
**Photo #4264** form inspection #699803327 conducted on 6/30/21.

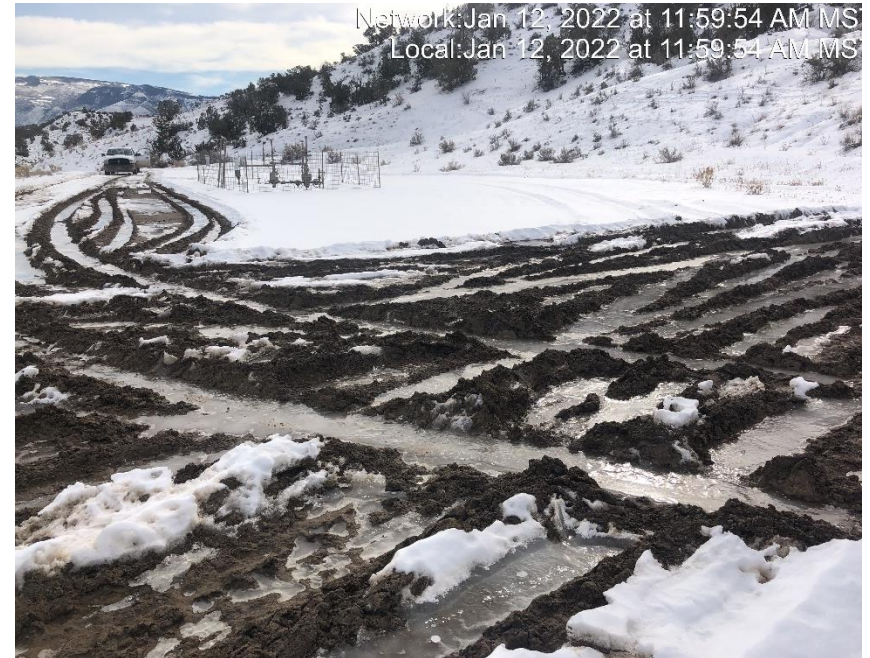
**Photo #5663** Location lacks stabilization.

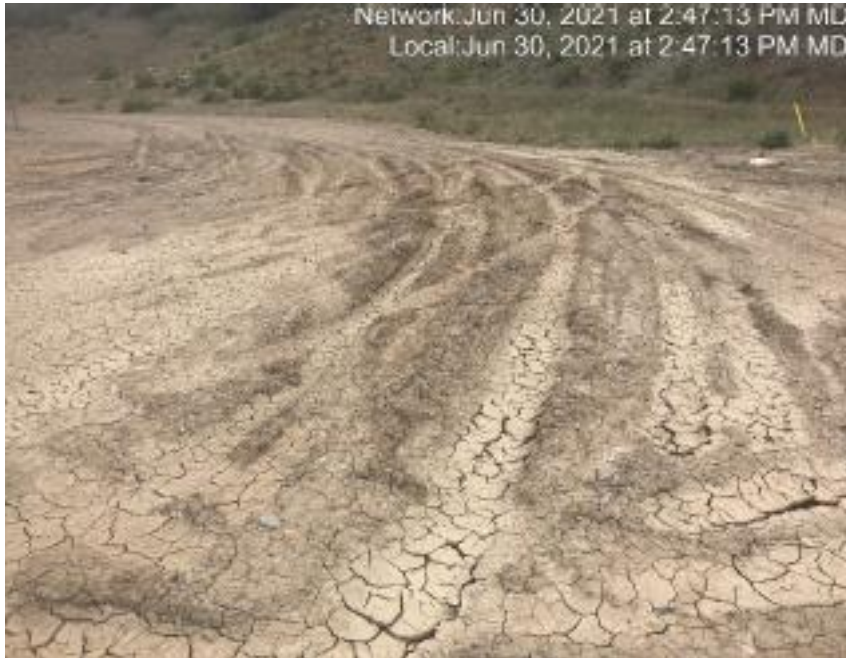
**Photo #4264** form inspection #699803327 conducted on 6/30/21.

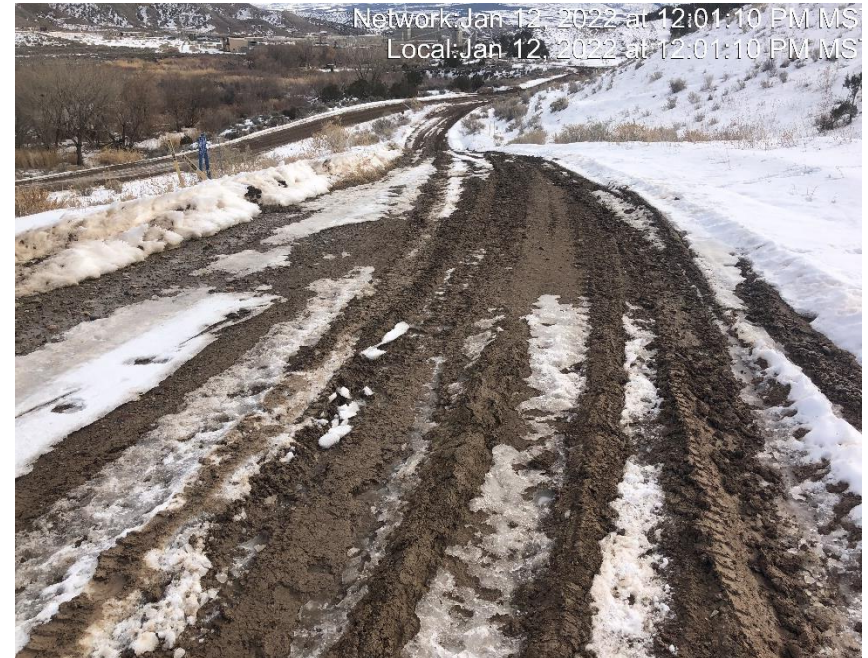
**Photo #5664** Insufficient tracking BMP at entrance to location.
