Inspection Photos

API: 061-06287

Operator: CHEMCO INC

Inspection Date: 1/12/2022

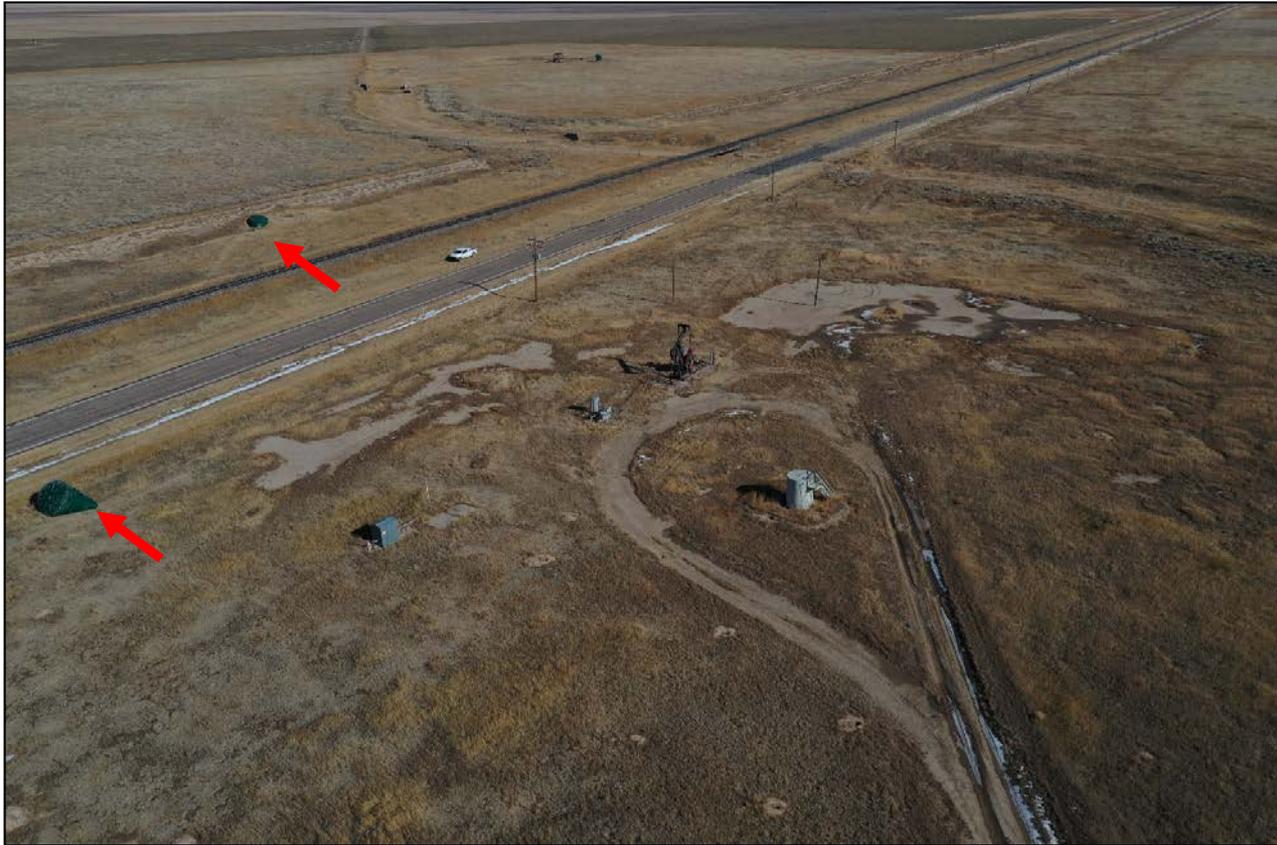
Photo 1. Drone aerial photo facing down toward the well site. There is a green fiberglass tank that has blown to the fence line and across the highway shown at red arrows.

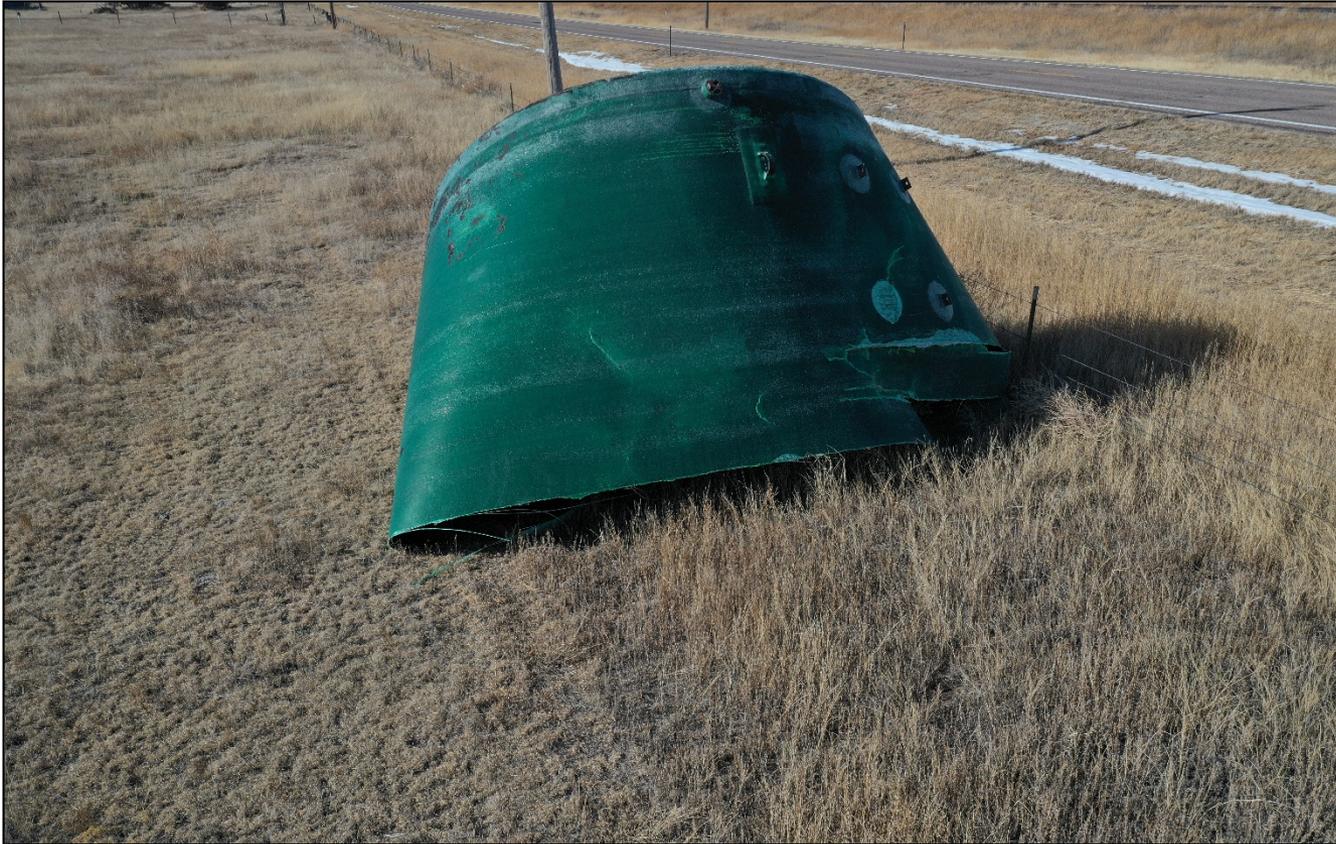
Photo 2. The fiberglass tank has rolled up to the fenceline and the top separated from the tank.

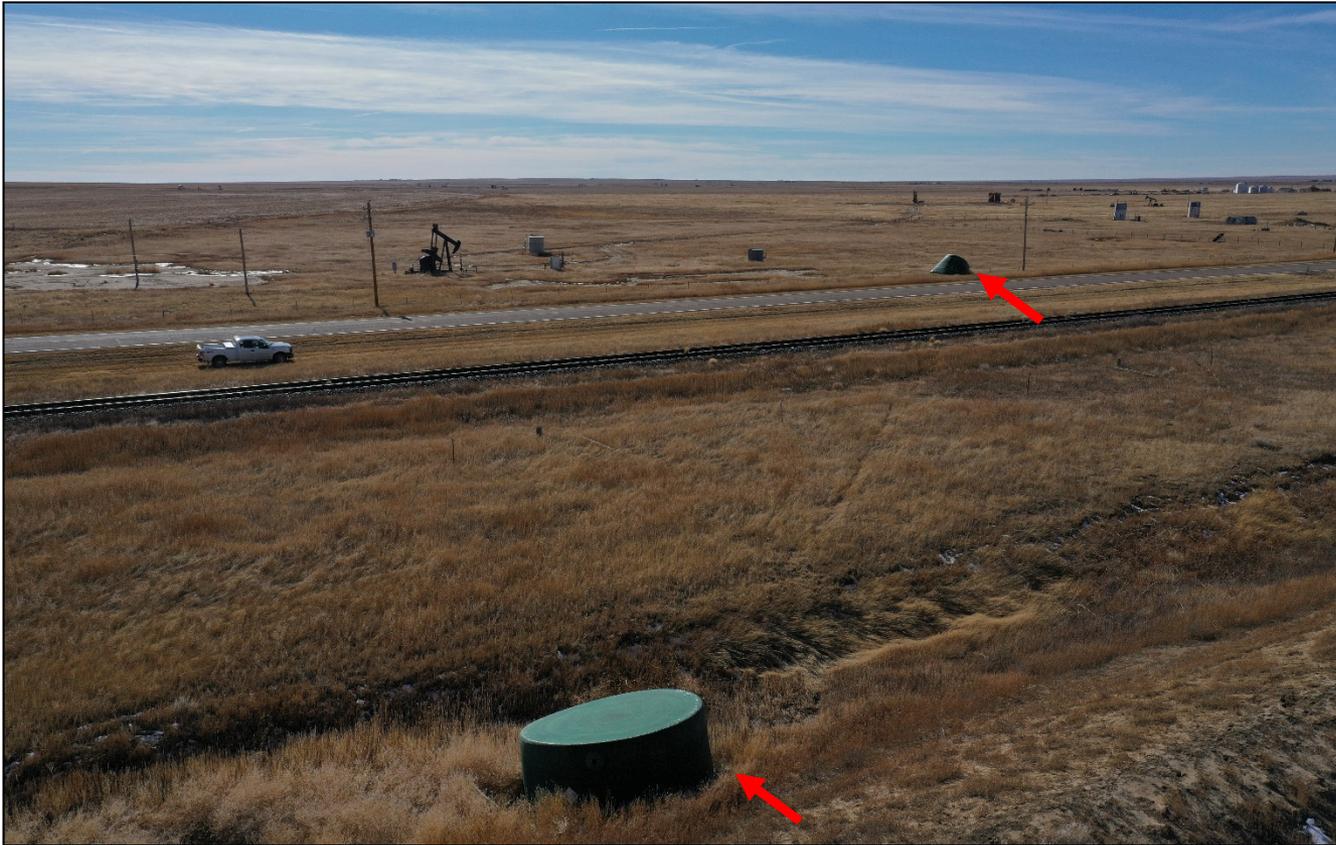
Photo 3. The top of the fiberglass tank blew across the highway.

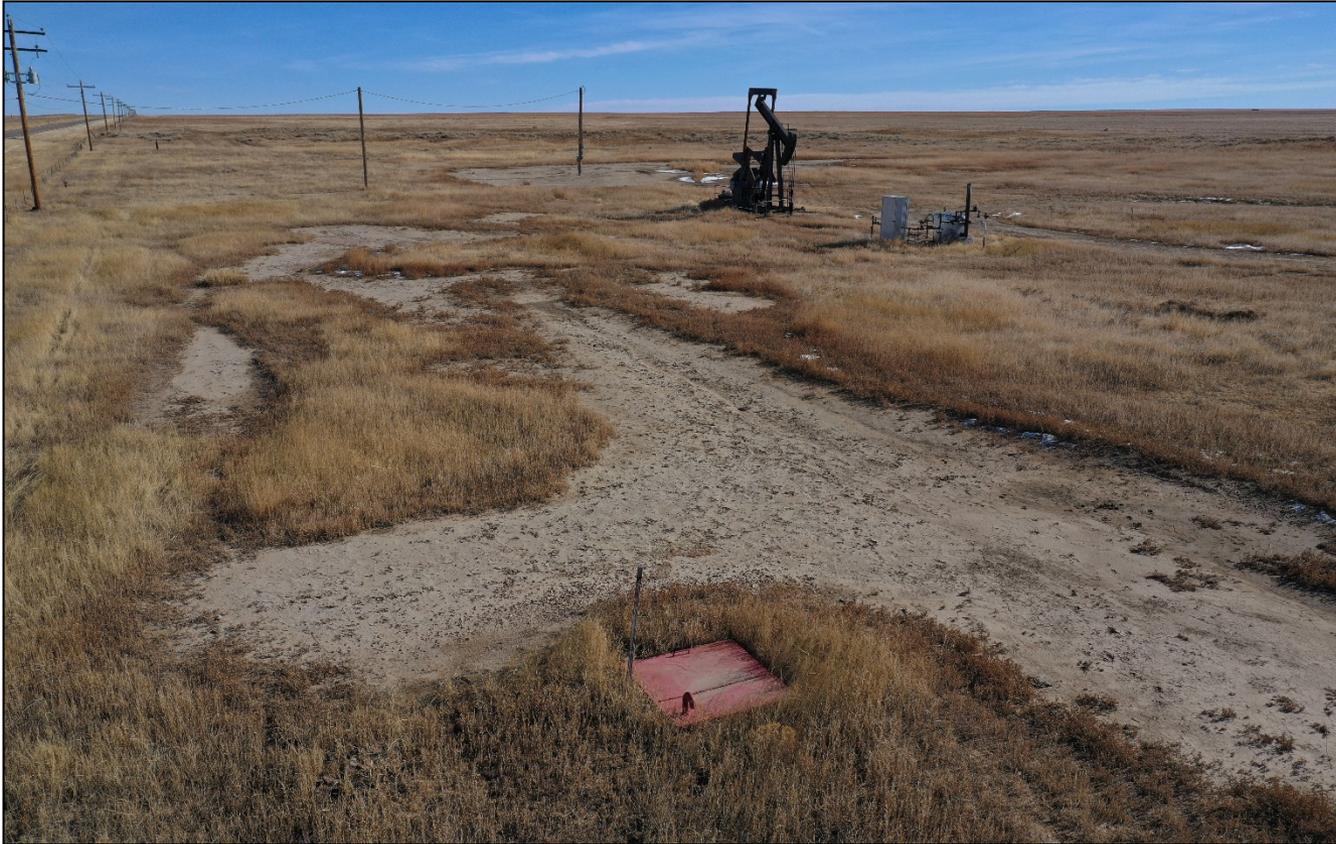
Photo 4. Drone aerial photo facing southeast toward the wellsite. There are areas that are bare of vegetation which appears to be from a former spill.

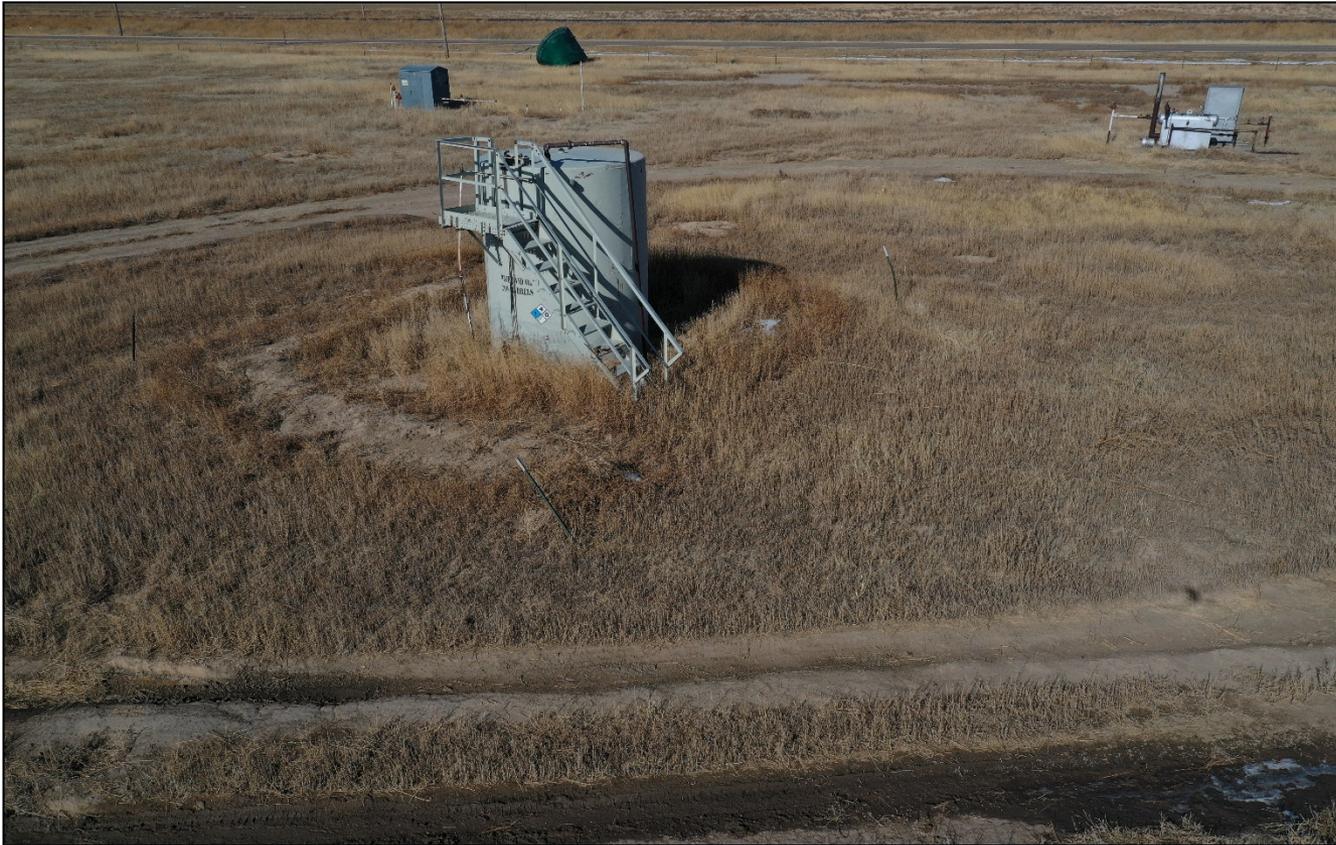
Photo 5. Facing down toward the tank battery. The area inside of the berm needs to be kept free of vegetation. The perimeter fence around the tank needs to be installed to prevent livestock entry.
