Inspection Photos

API: 061-05138

Operator: WESTERN OPERATING COMPANY

Inspection Date: 1/12/2022

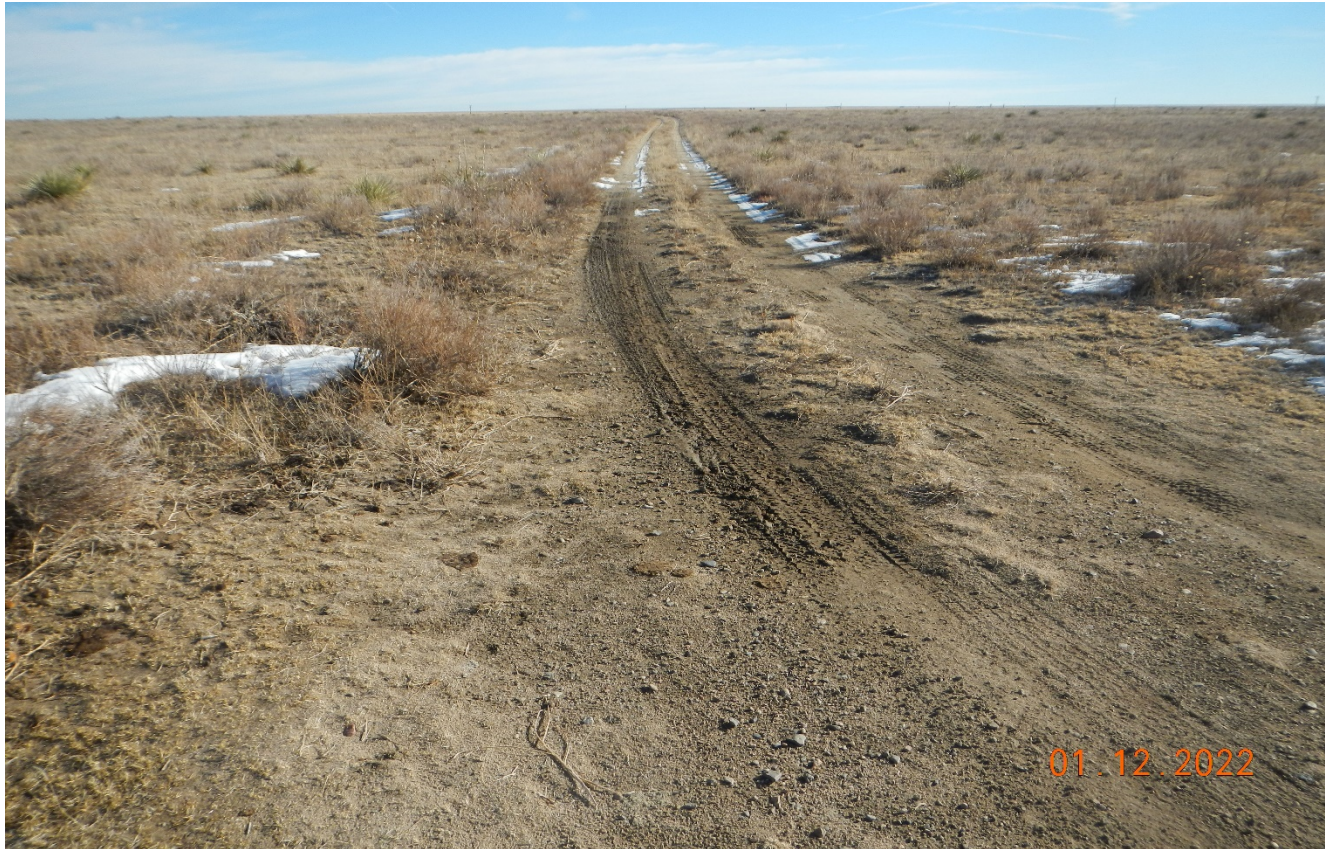
Photo 1. Facing east at the beginning of the access road. The two track road remains with compacted soils. The access road needs to be recontoured and reclaimed.

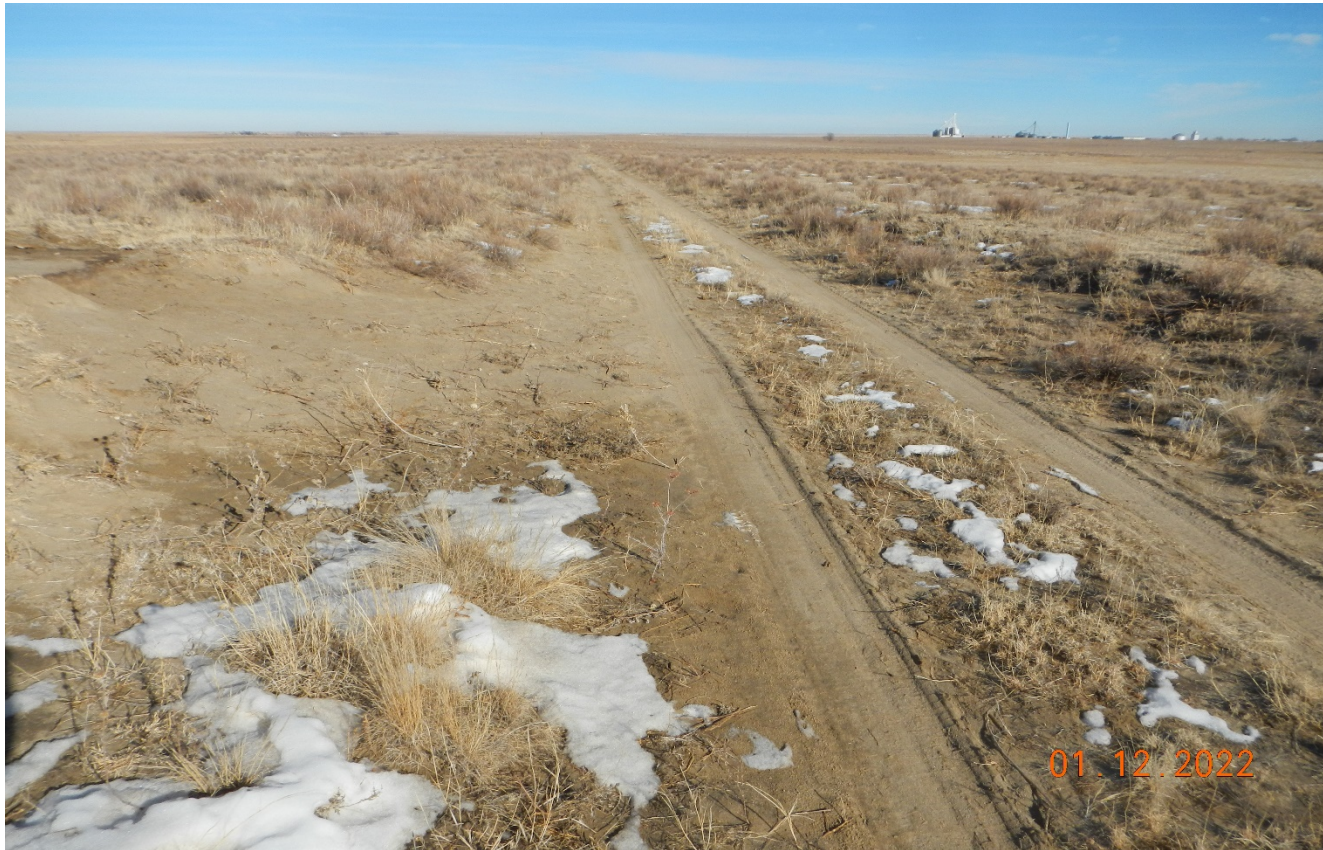
Photo 2. Facing north along the access road which has not been recontoured and reclaimed.

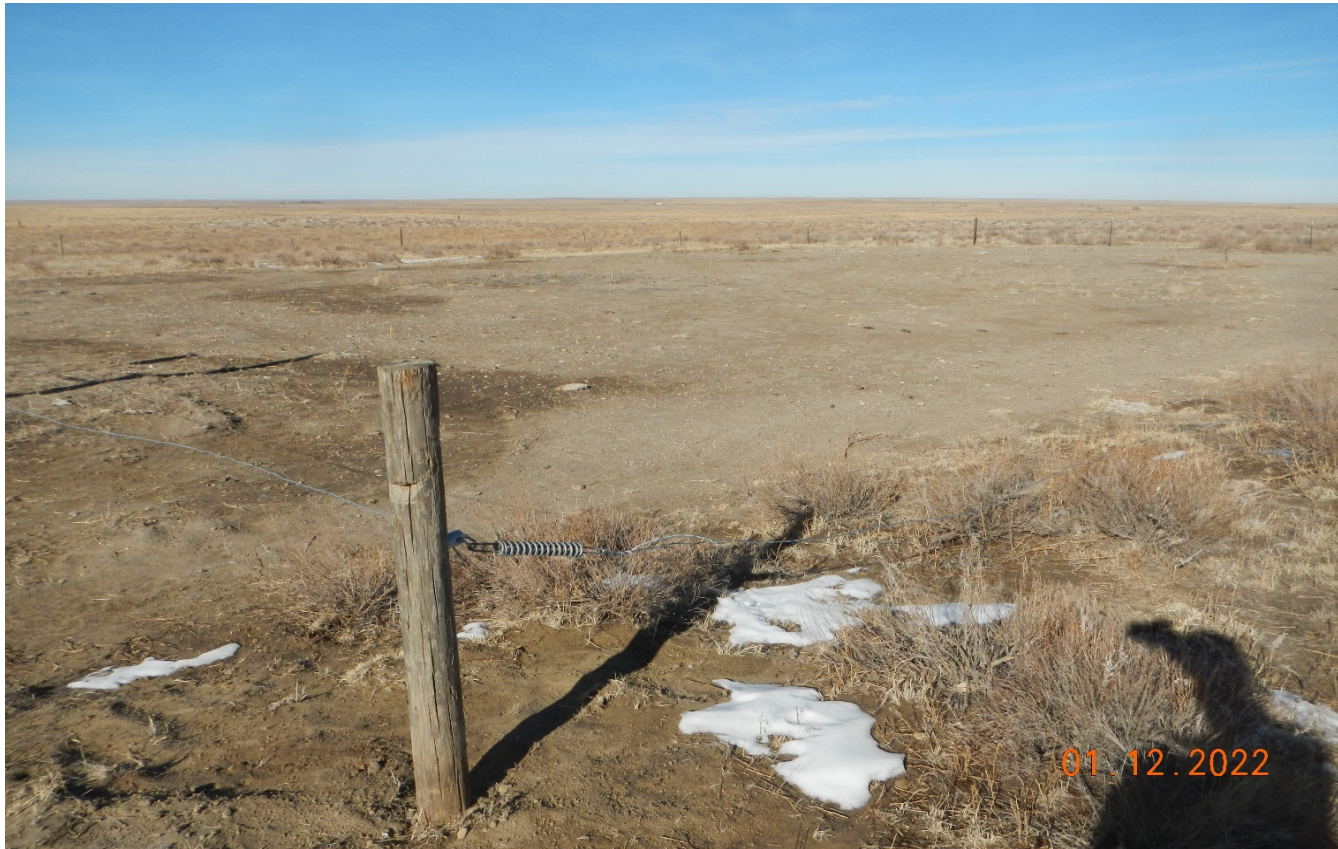
Photo 3. Facing northwest toward the former tank battery site located 300' southwest of the well site. This area has not been reclaimed. An electric fence was installed around this area which is already in disrepair.

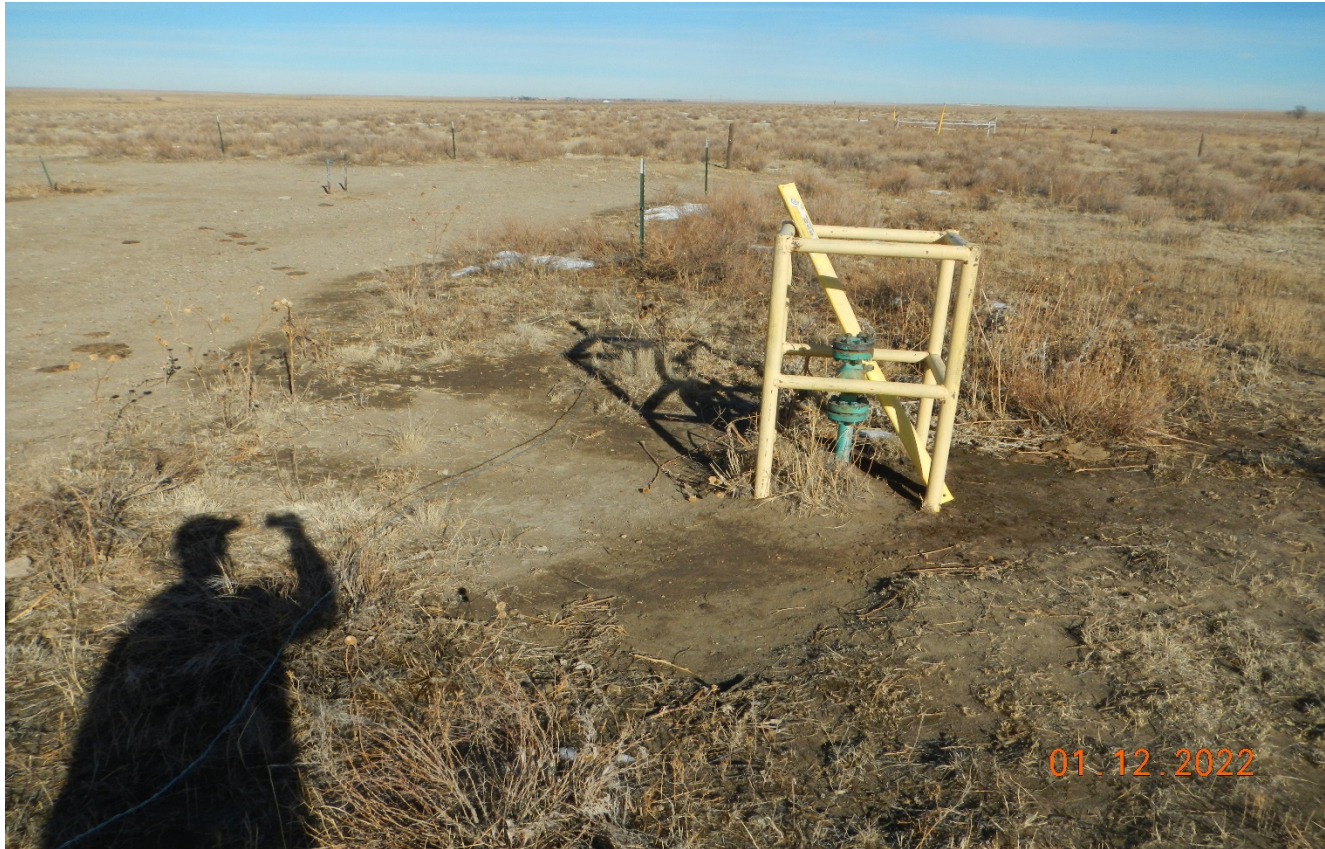
Photo 4. There is a pipe riser that remains at the battery site. All abandoned risers need to be removed.

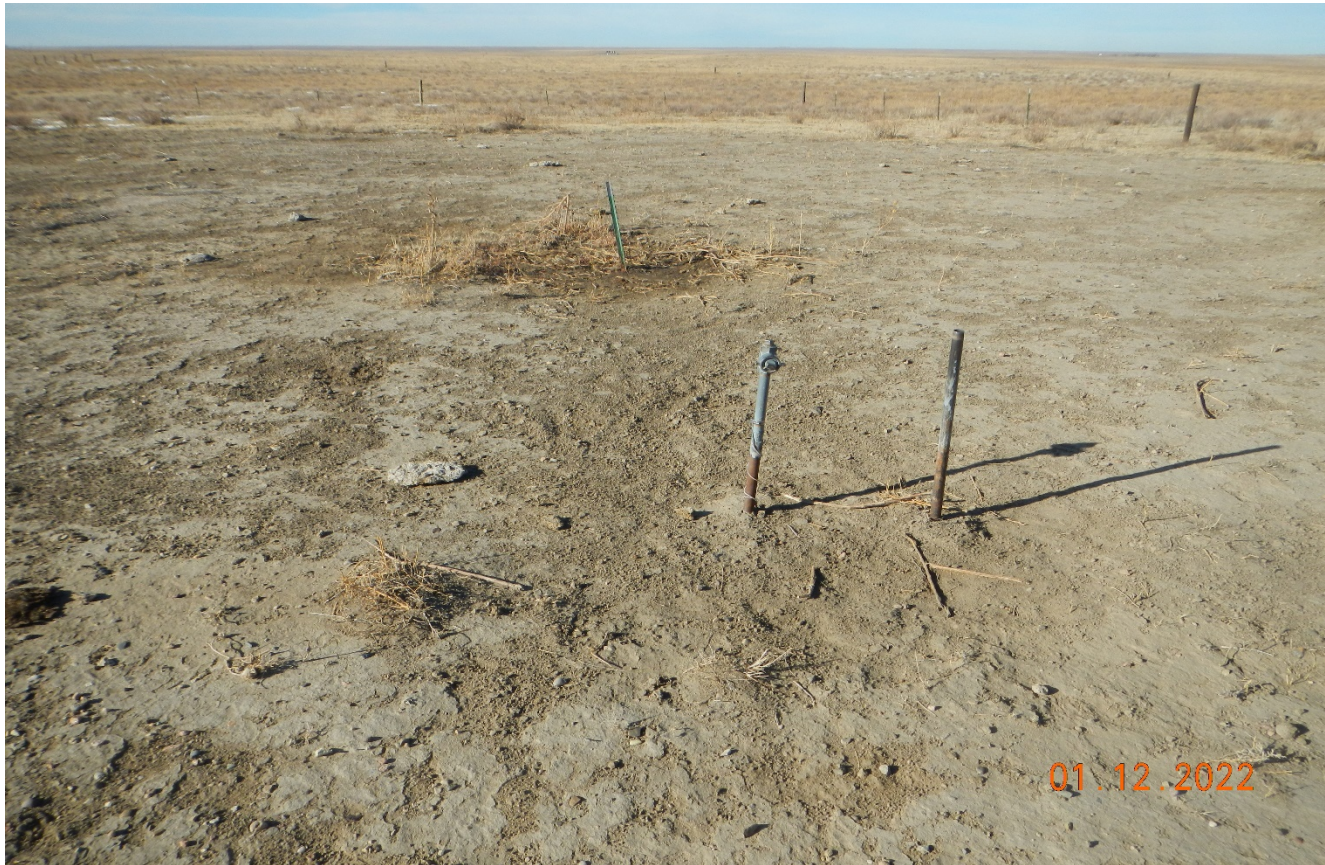
Photo 5. There are two pipes that remain at the battery site that need to be removed.

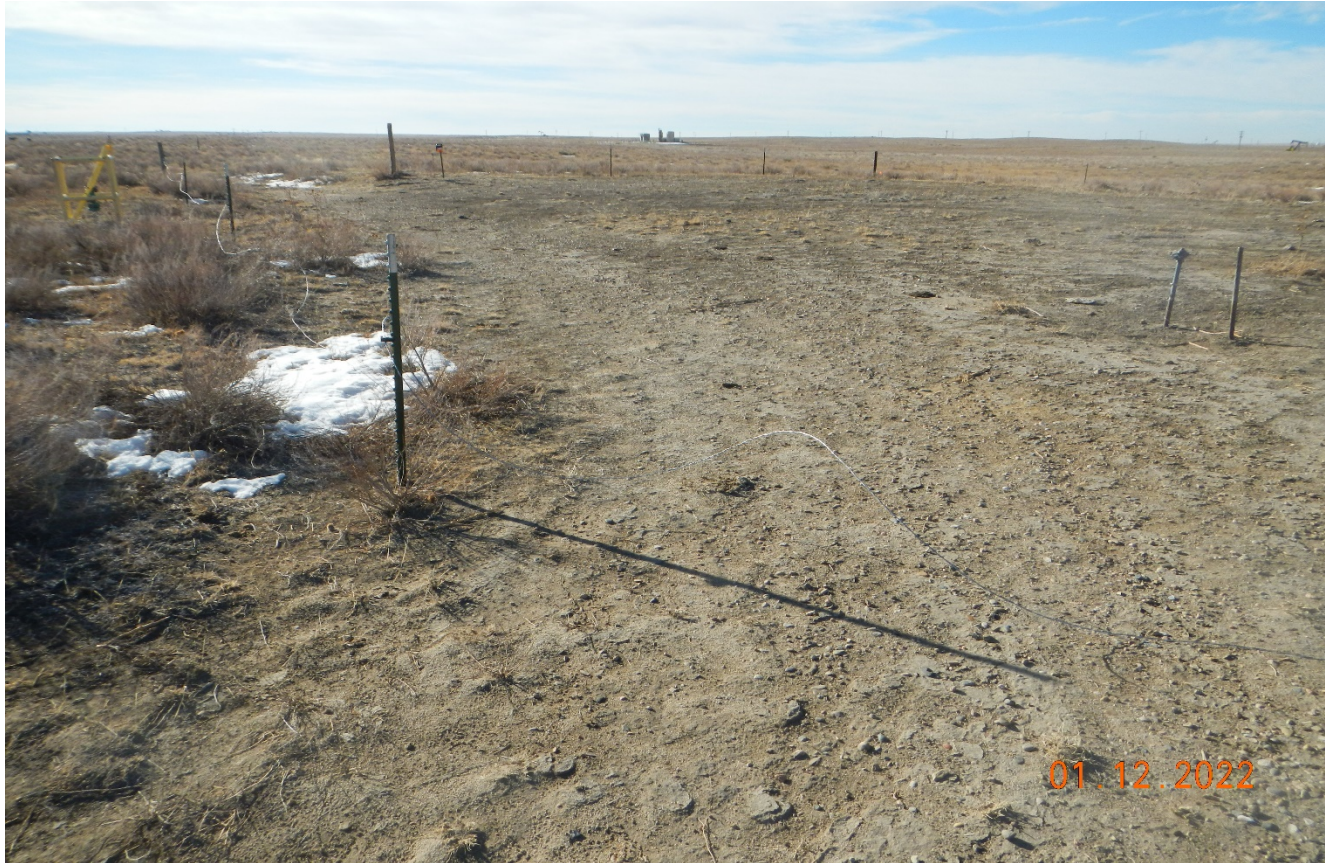
Photo 6. Facing southwest toward the abandoned battery site. This area has not been reclaimed. An electric fence was installed around this area which is already in disrepair.

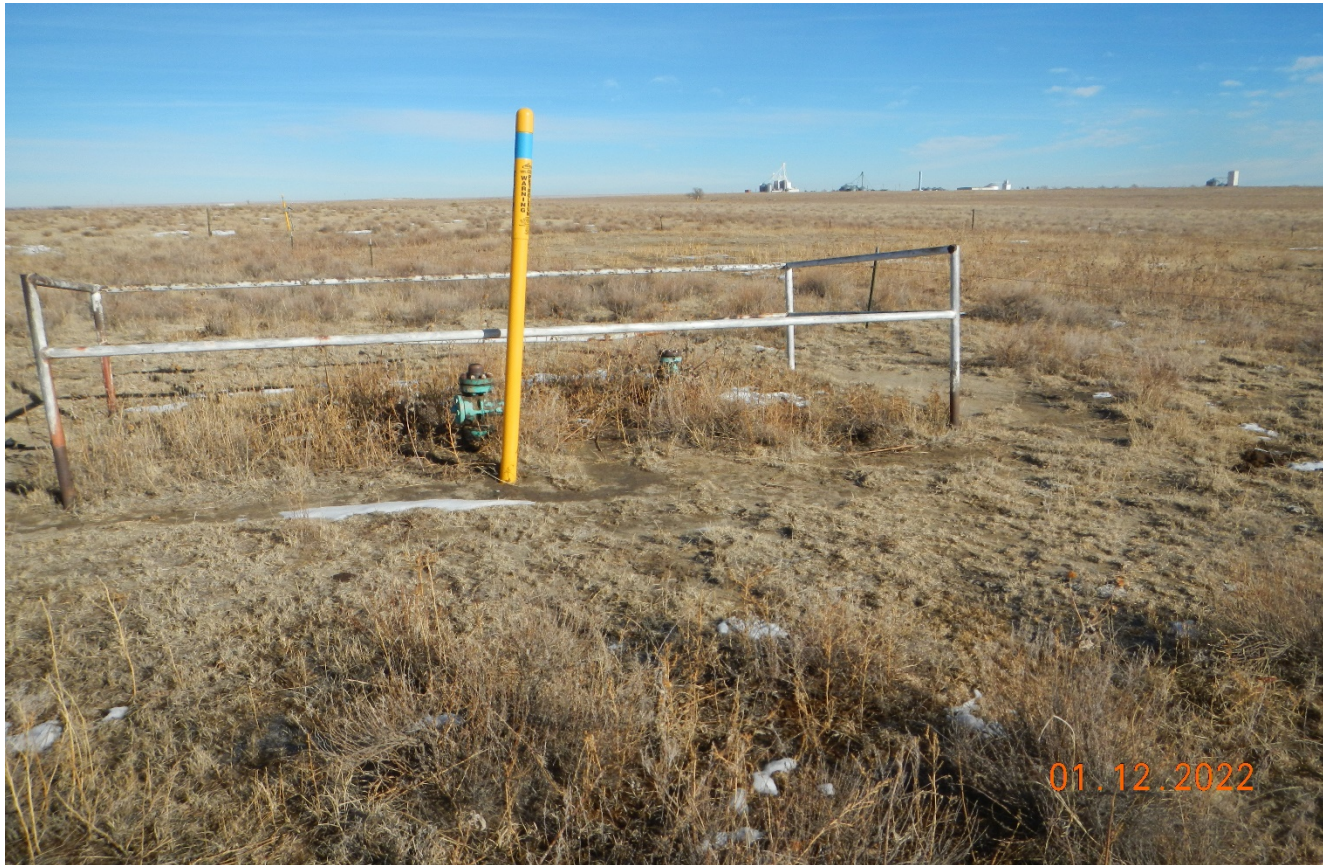
Photo 7. There are additional abandoned risers that remain at the tank battery site. All abandoned risers need to be removed.

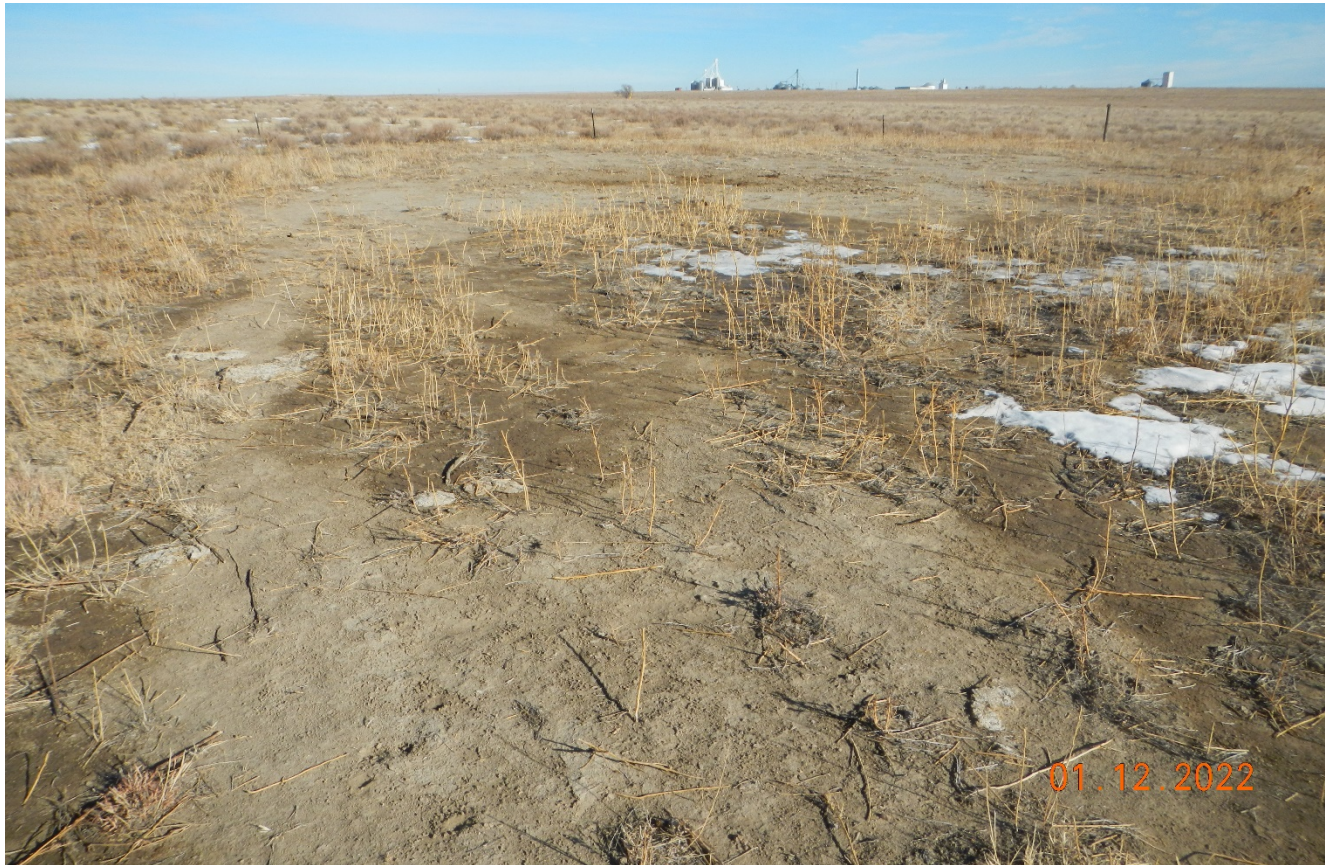
Photo 8. Facing northeast toward the abandoned well site. This area has not been reclaimed. Bare soils that are not stabilized and are susceptible to further erosion.

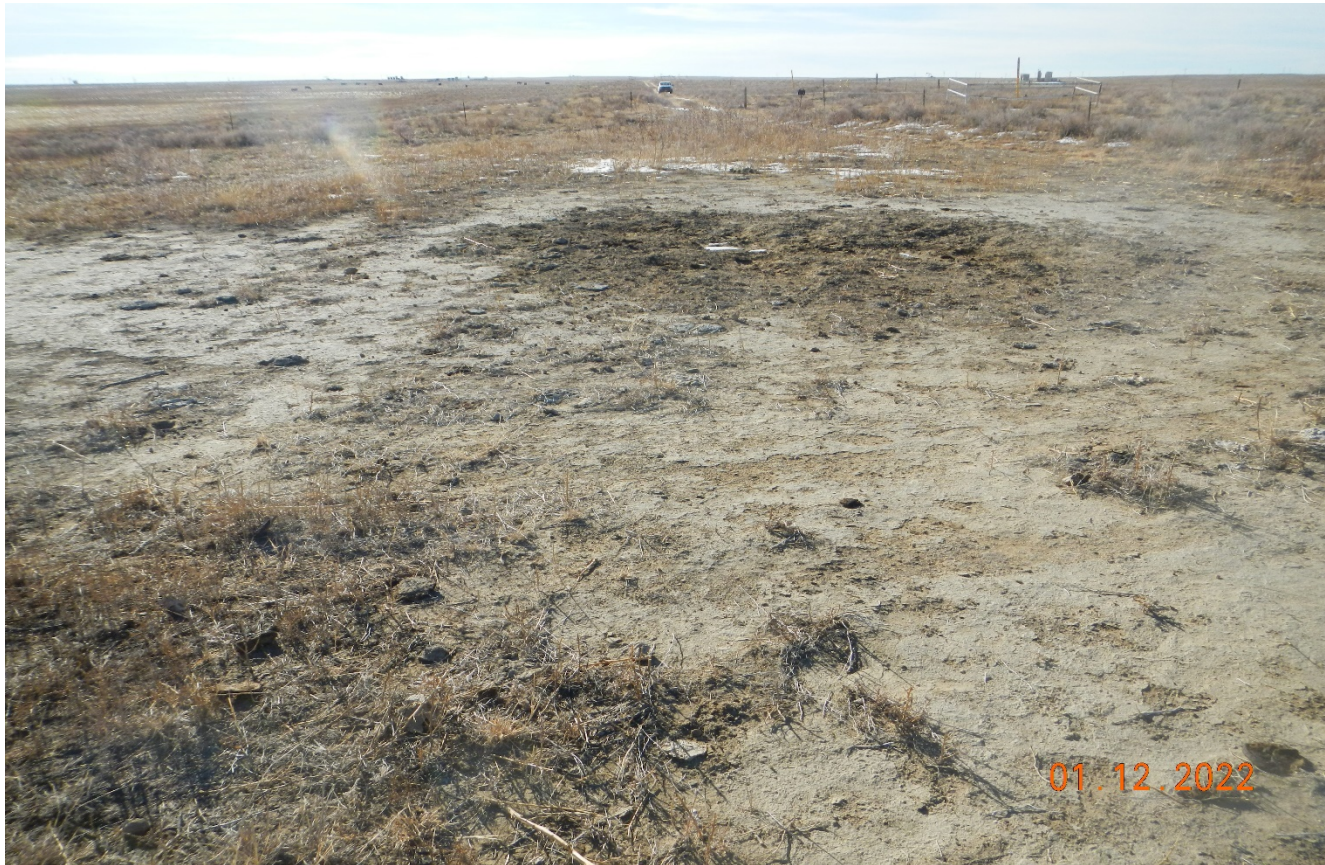
Photo 9. Facing south toward the abandoned well site. This area has not been reclaimed. Bare soils that are not stabilized and are susceptible to further erosion.
