Inspection Photos

API: 061-06041

Operator: WESTERN OPERATING COMPANY

Inspection Date: 1/12/2022

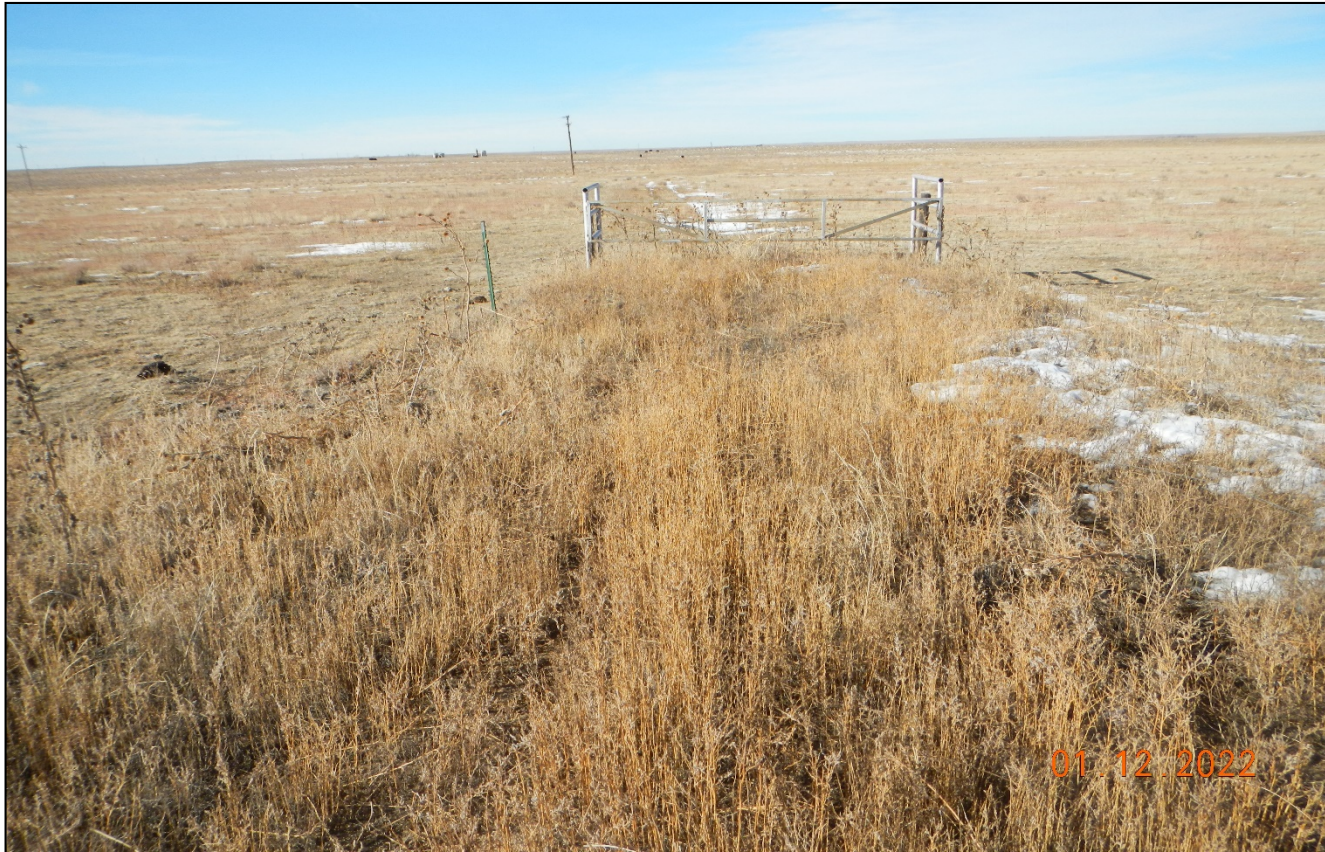
Photo 1. Facing west at the beginning of the access road which consists of undesirable weeds. The cattle guard has not been removed and the road is not reclaimed in this area.

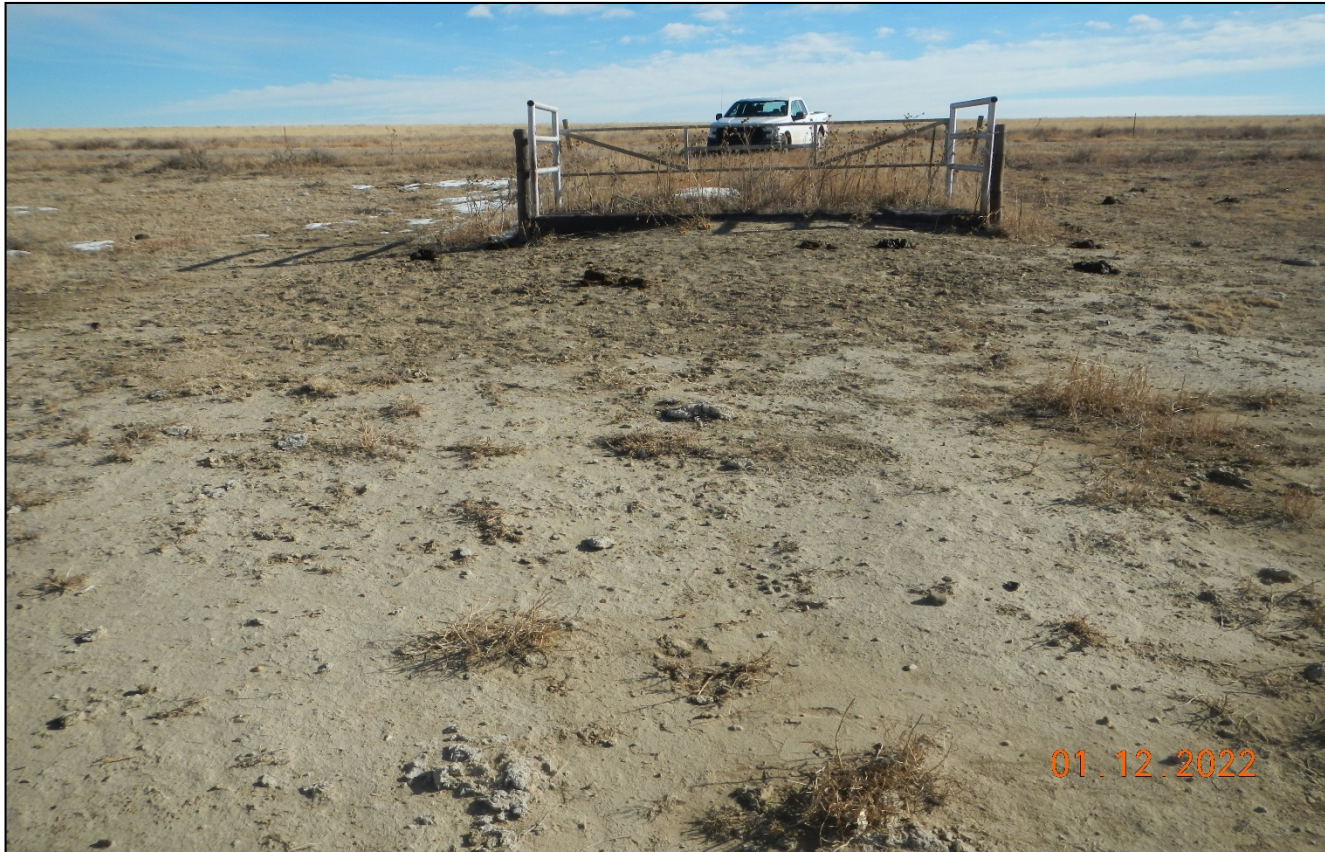
Photo 2. Facing back east toward the cattleguard and access road. The cattleguard must be removed and the access road reclaimed.

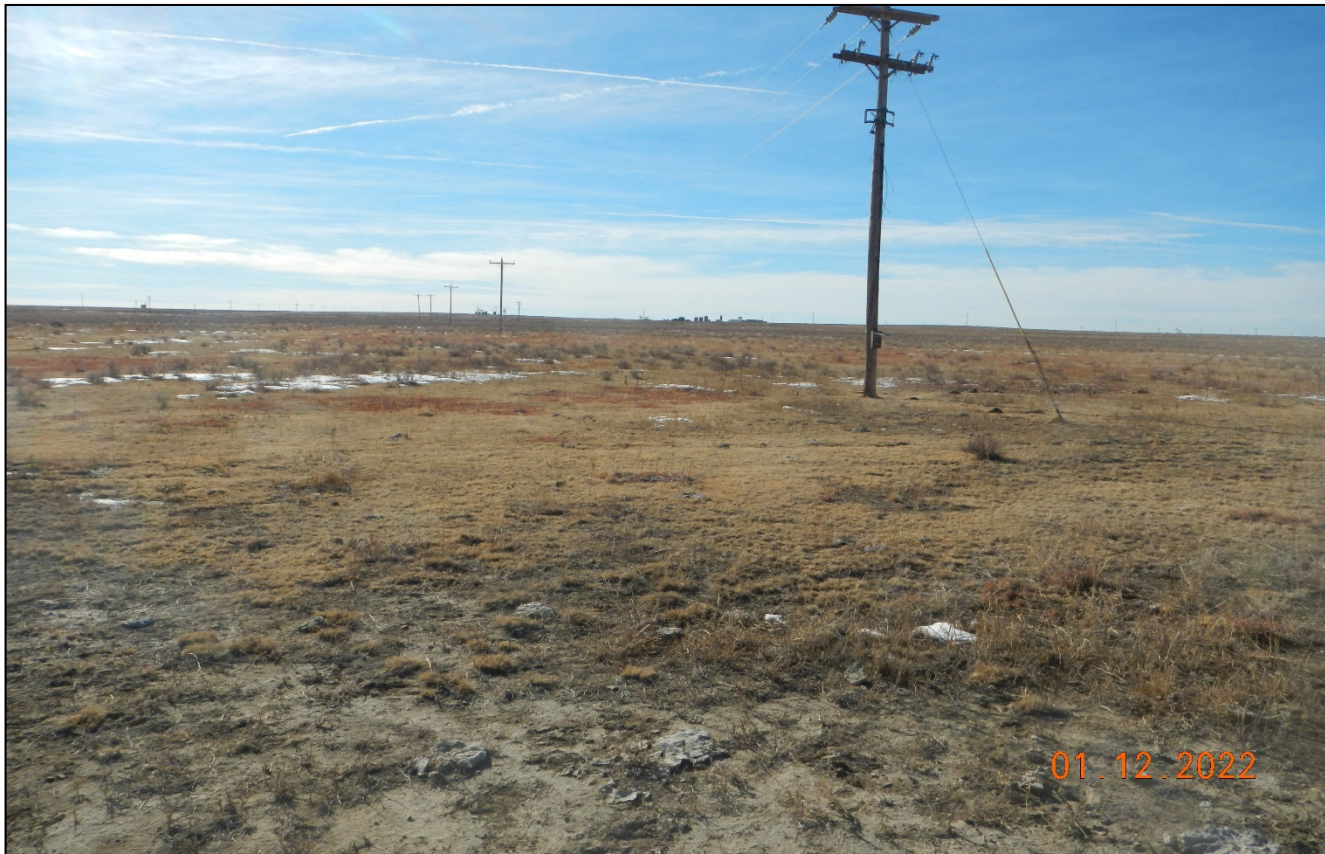
Photo 3. The powerline used for operating the well dead ends at the location and the entire unused portion of the powerline must be removed.

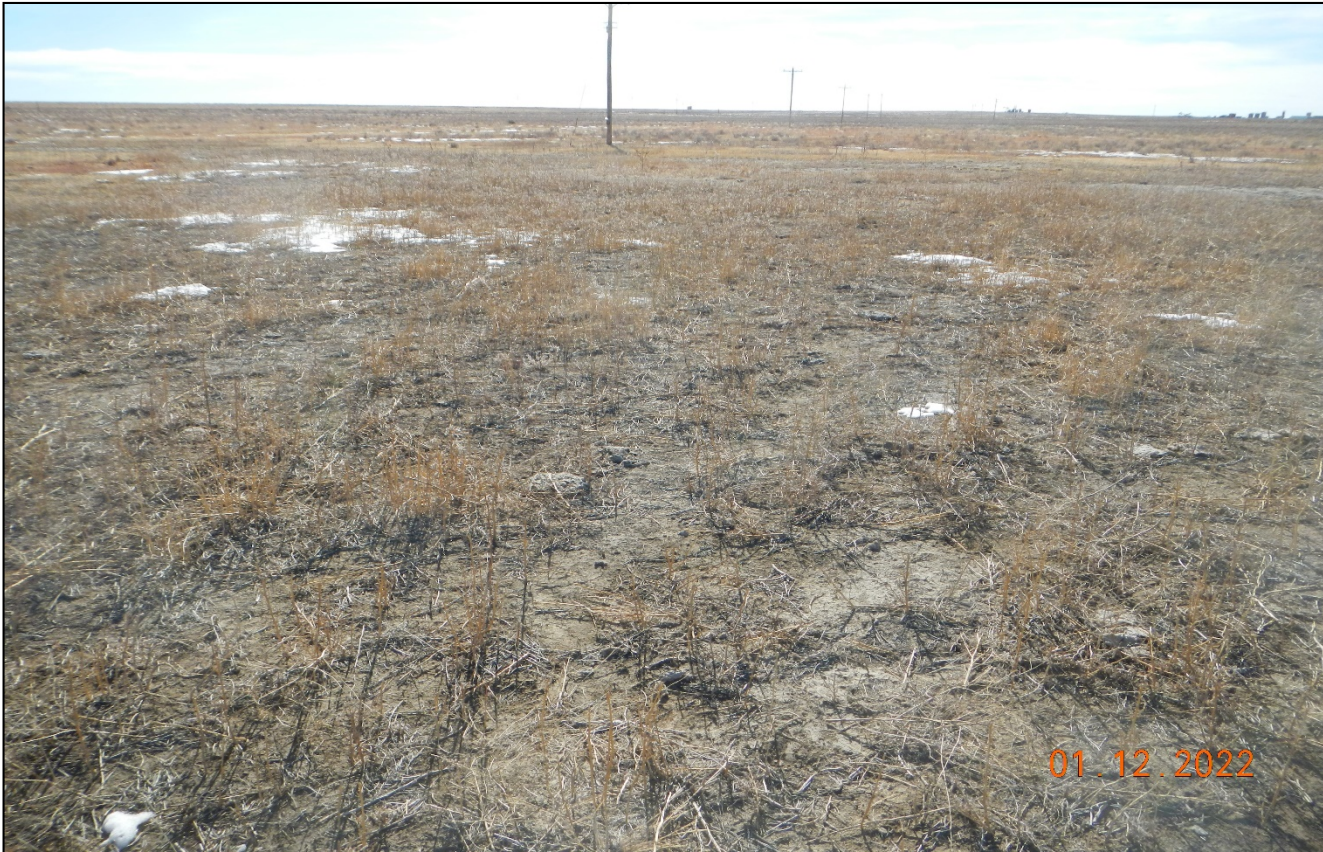
Photo 4. North side of the location facing south. This area of the location is approximately 120'x120' and consist of only undesirable weeds.

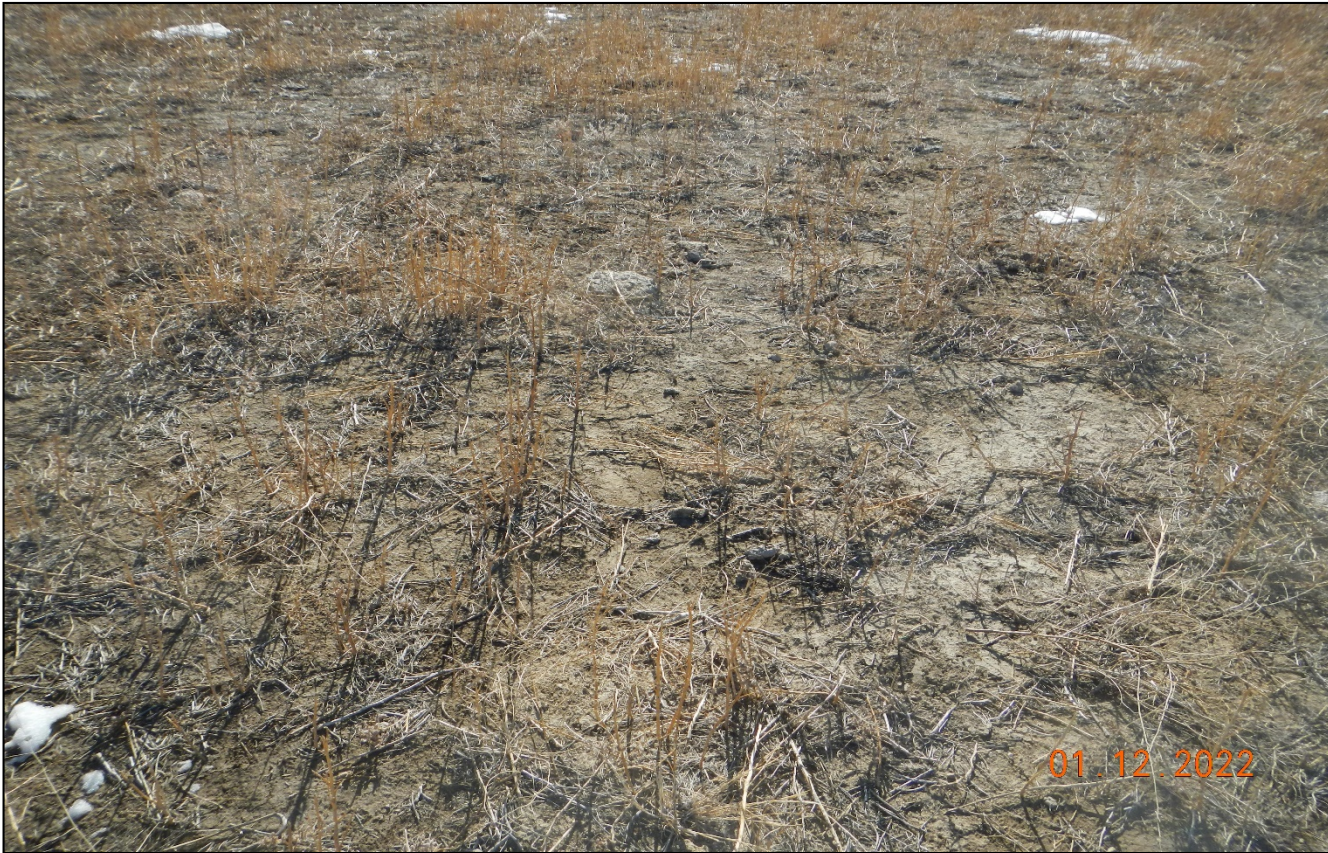
Photo 5. View of groundcover consisting of undesirable weeds (*Kochia* sp.) and no desirable vegetation.

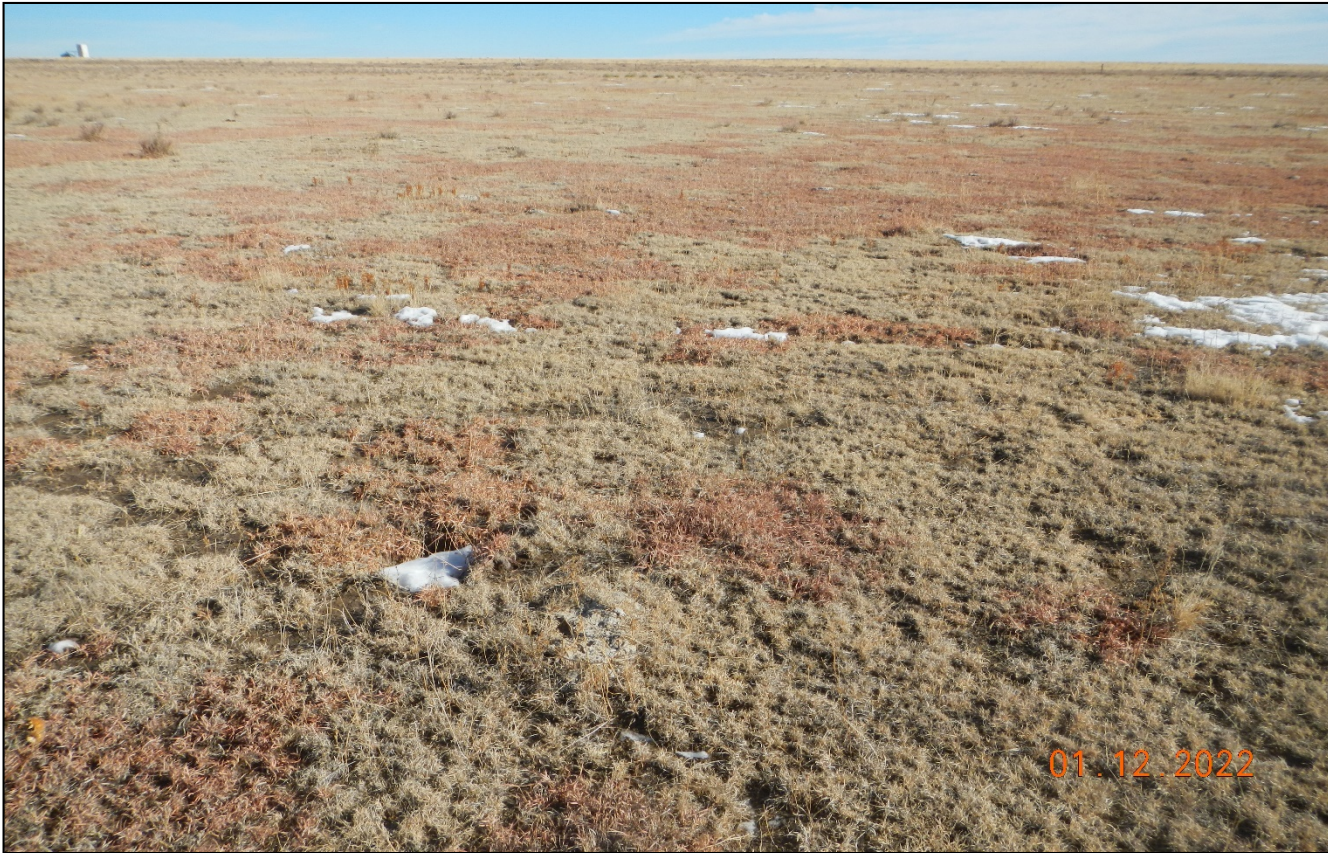
Photo 6. Facing north toward the surrounding undisturbed area which consists of a uniform native vegetation cover.
