**Inspection Photos**  
**Location Name: Firecracker Consolidation**  
**Spill ID: 481413**

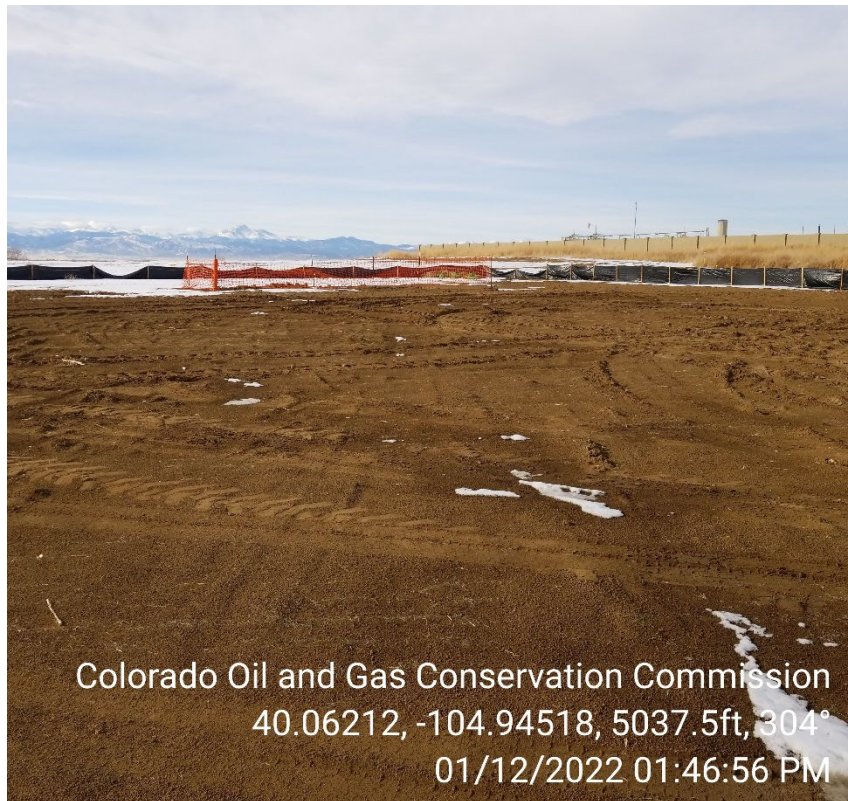
**Photo 1 – Spill area. Fencing present around open excavation.**

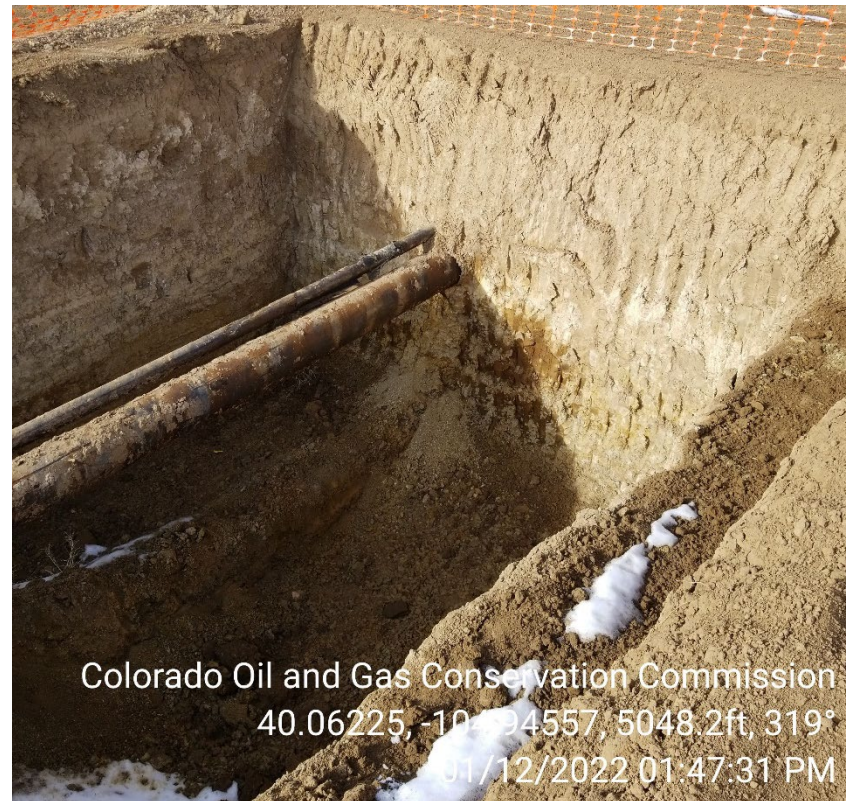
**Photo 2 – Excavation. Impacts remain visible in-situ.**

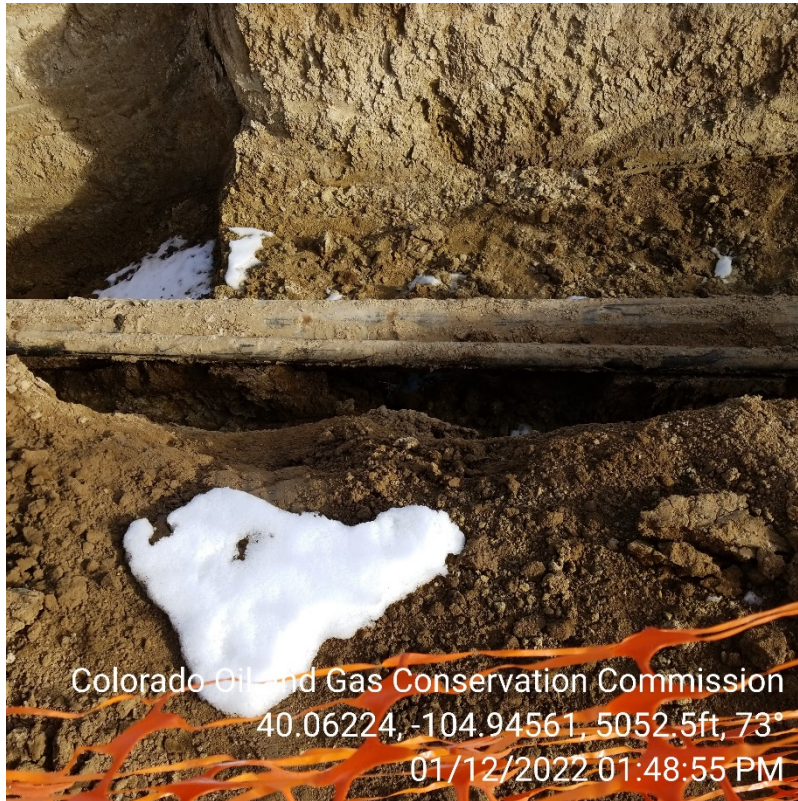
**Photo 3 – Excavation. Location of observed leak.**

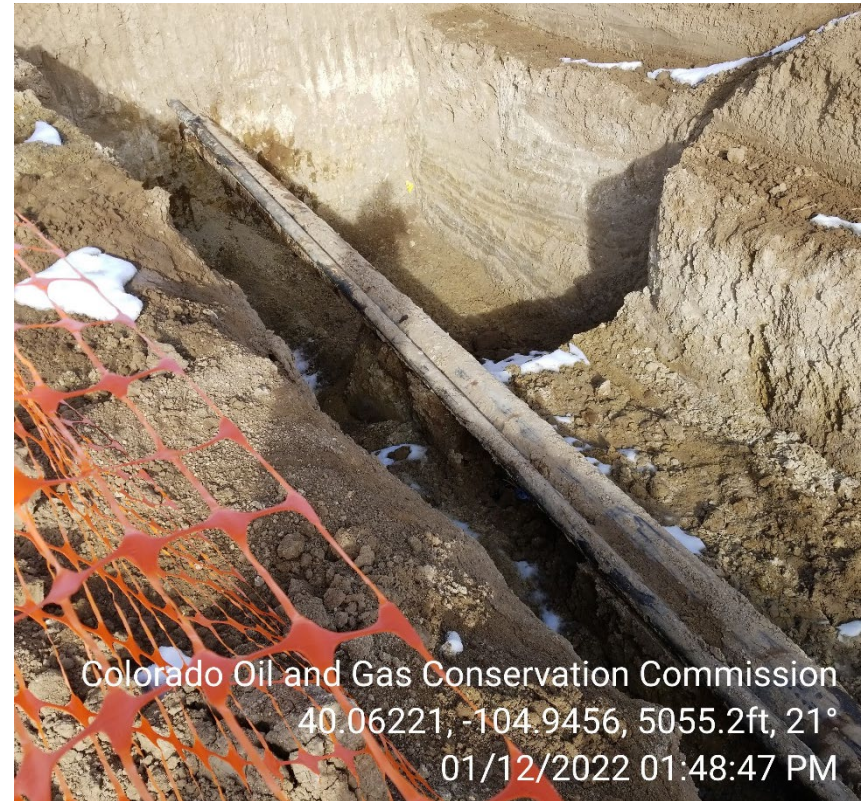
**Photo 4 – Spill excavation. Impacts remain in-situ.**
