Inspection Photos
Operator: Catamount
API: 067-09914
Date: 1/11/2022

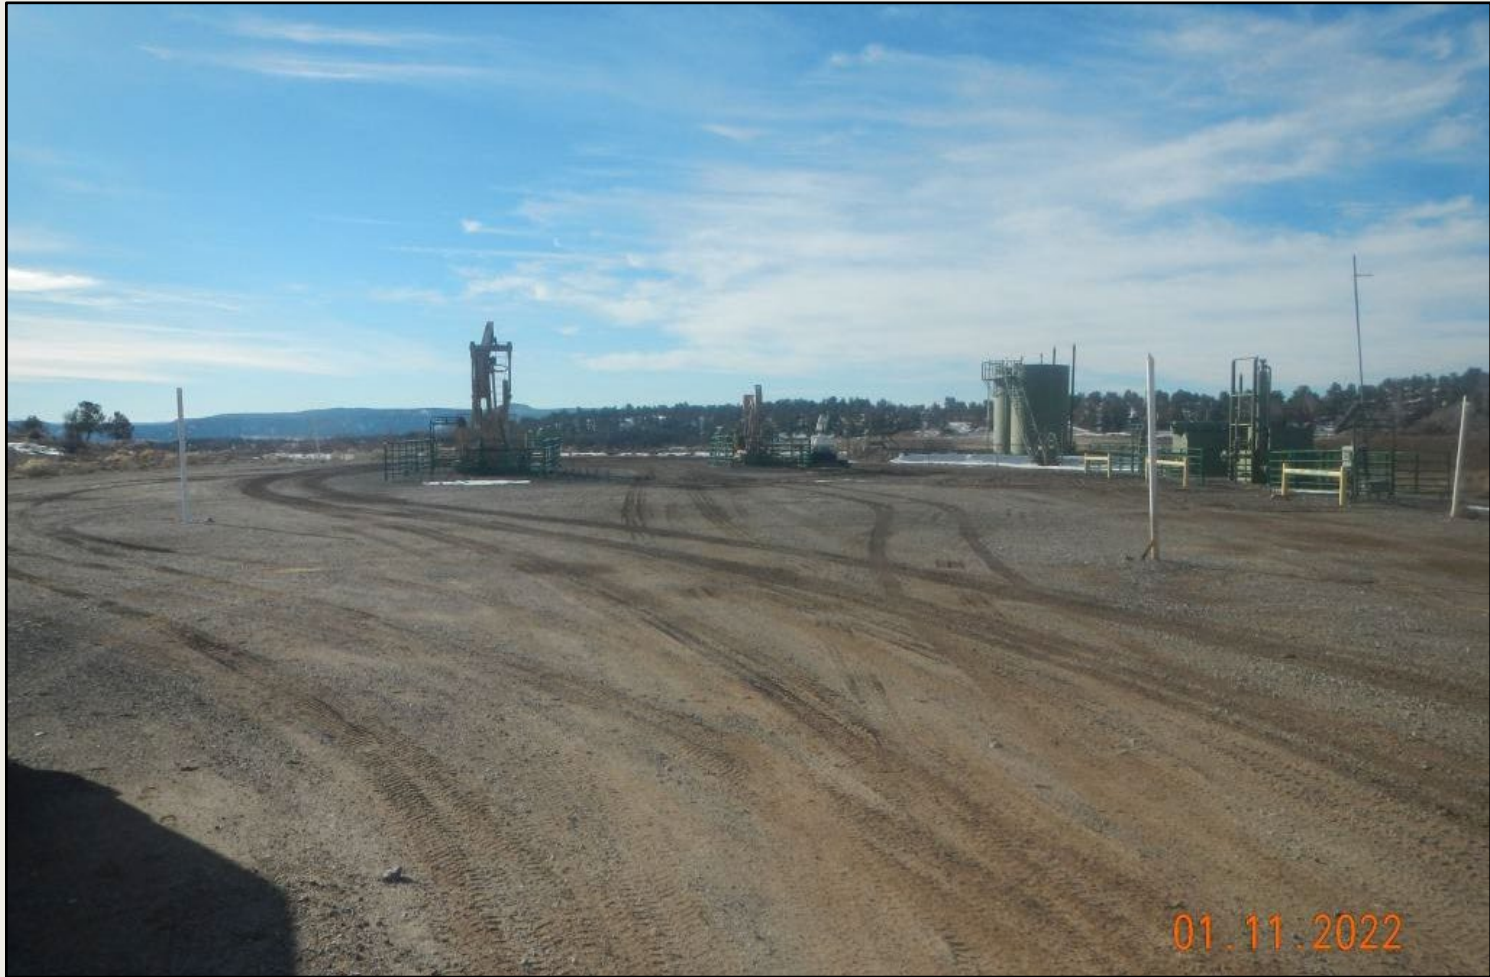
Photo 1. View of project area from the southwestern corner facing center.

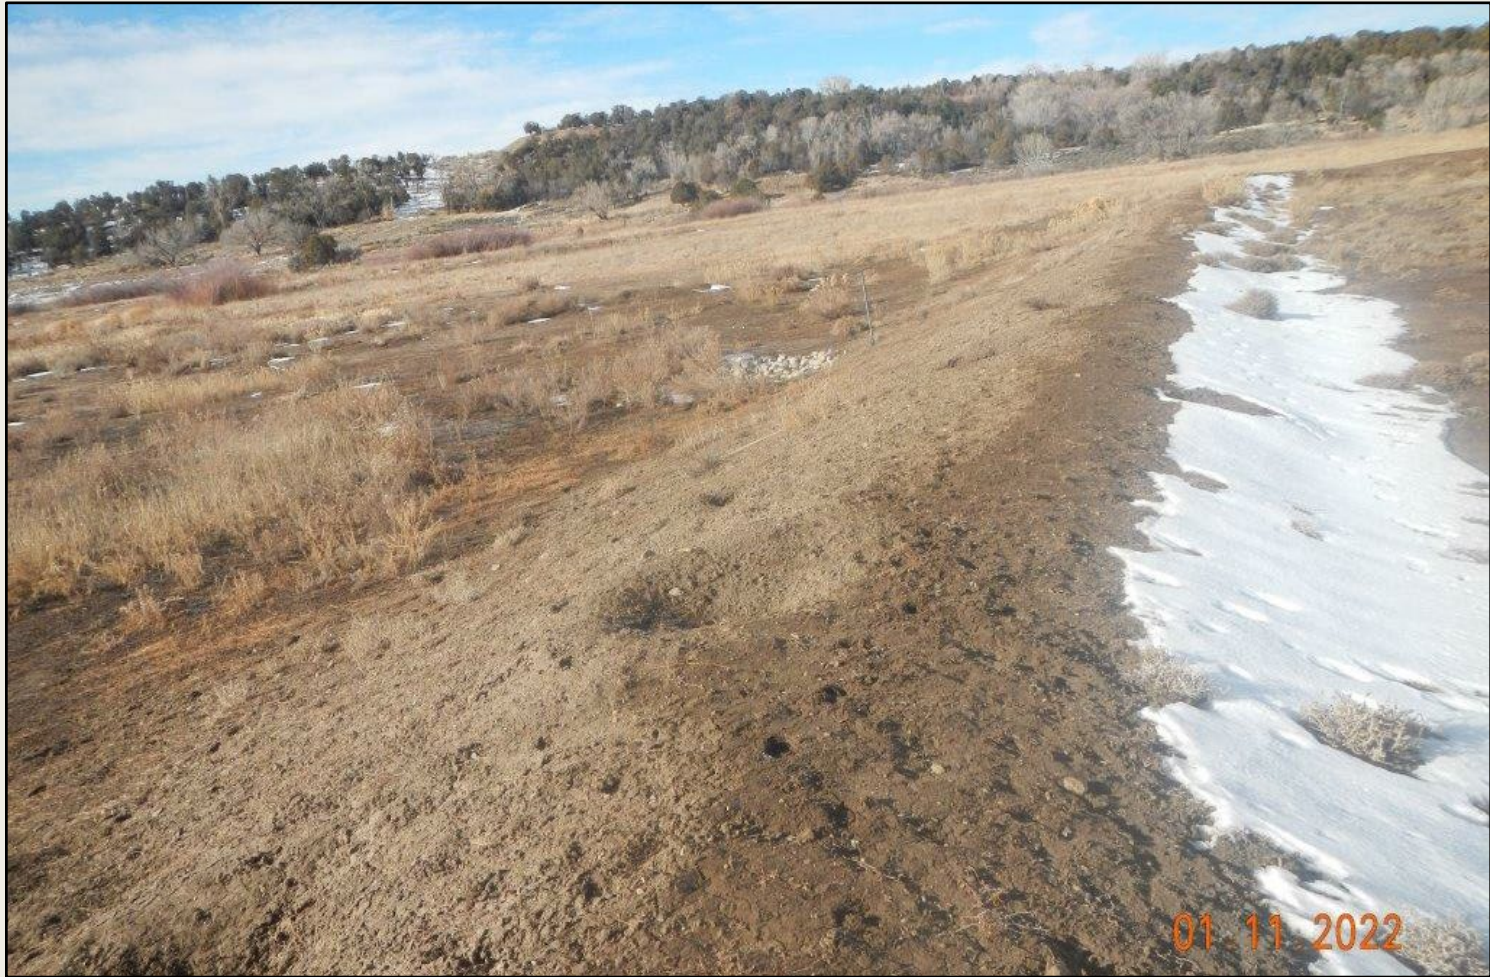
Photo 2. View of the southern project area from the southeastern corner facing westward. Revegetation is progressing in portions of the interim reclamation area, but remain sparse/bare on the southern berm, down-slope from the eastern berm, and on the cut-slopes.

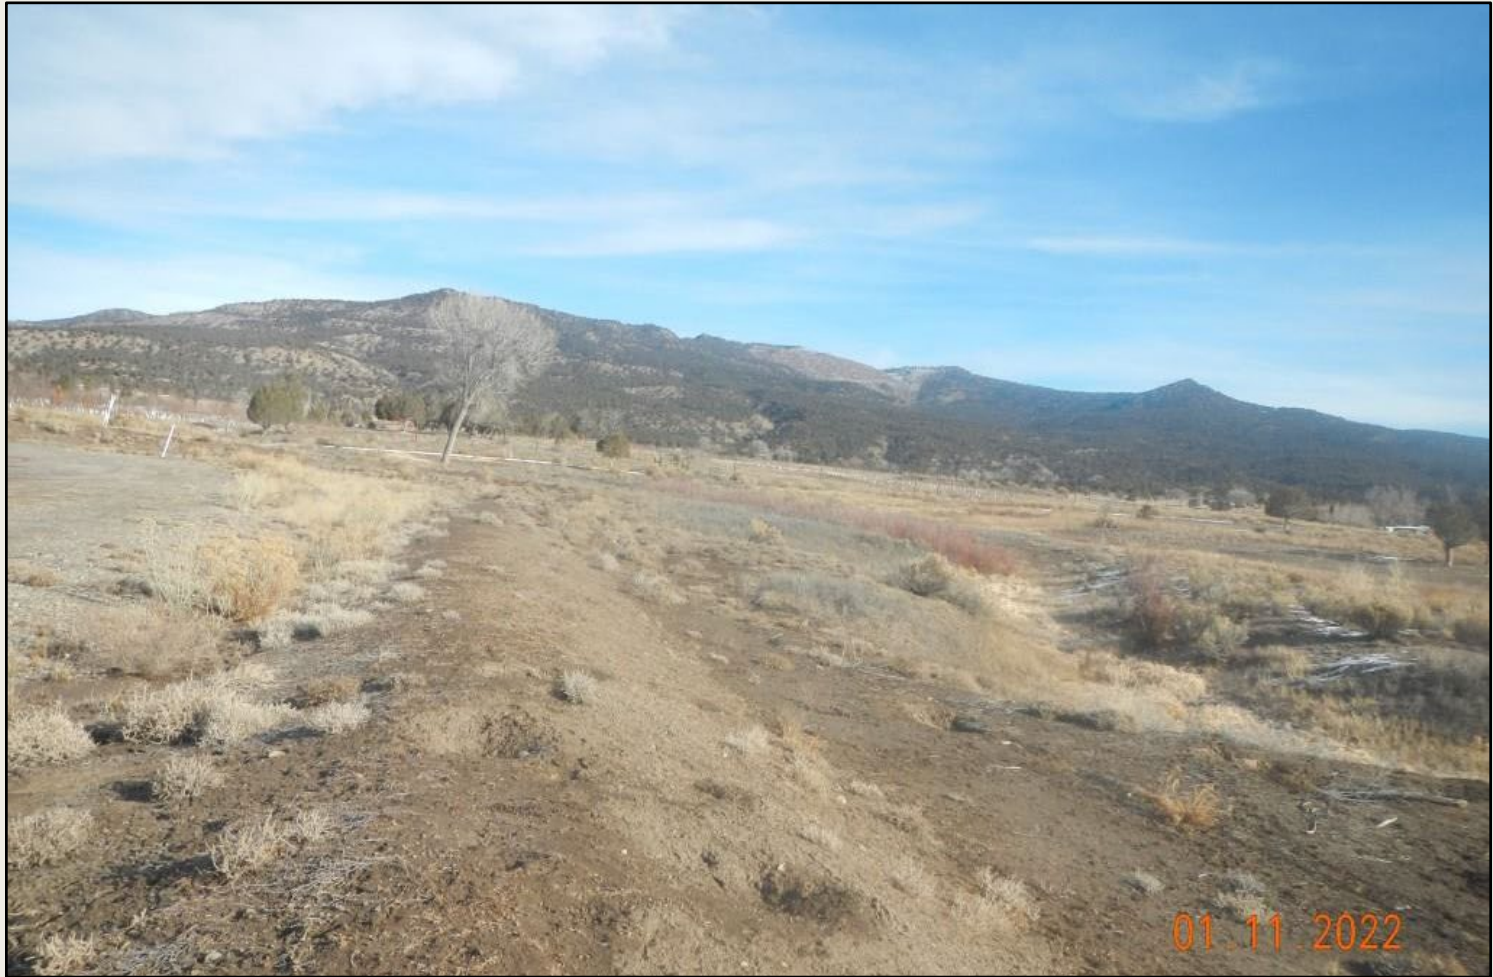
Photo 3. View of the eastern project area from the southeastern corner facing northward.

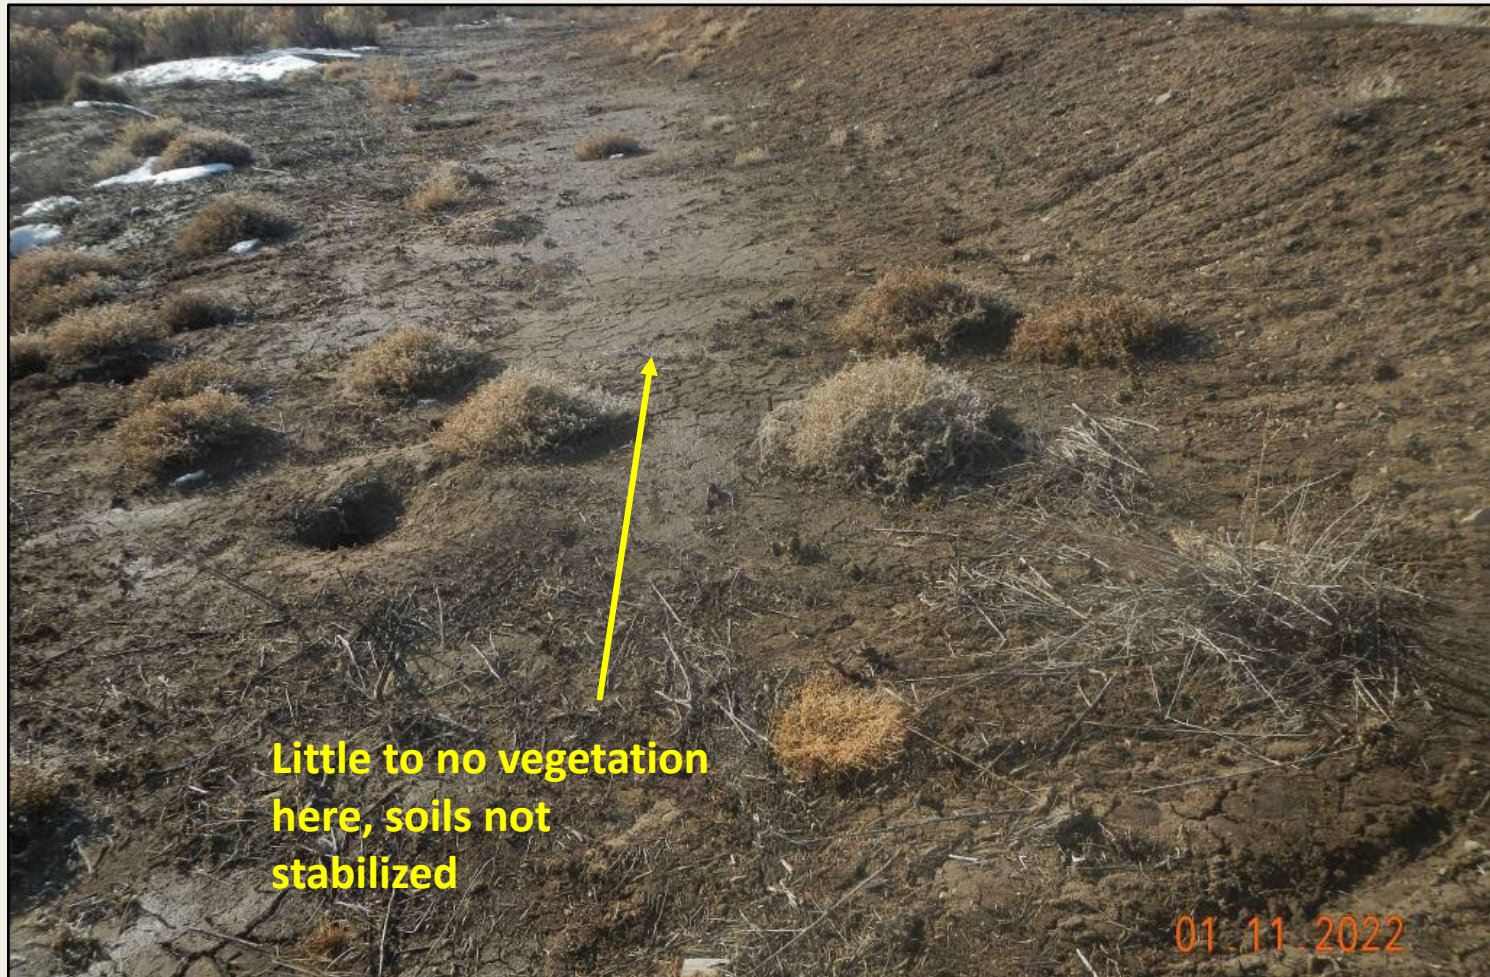
Photo 4. View of eastern berms and area down-slope from berms where little desirable vegetation is present, bare soils are not stabilized.

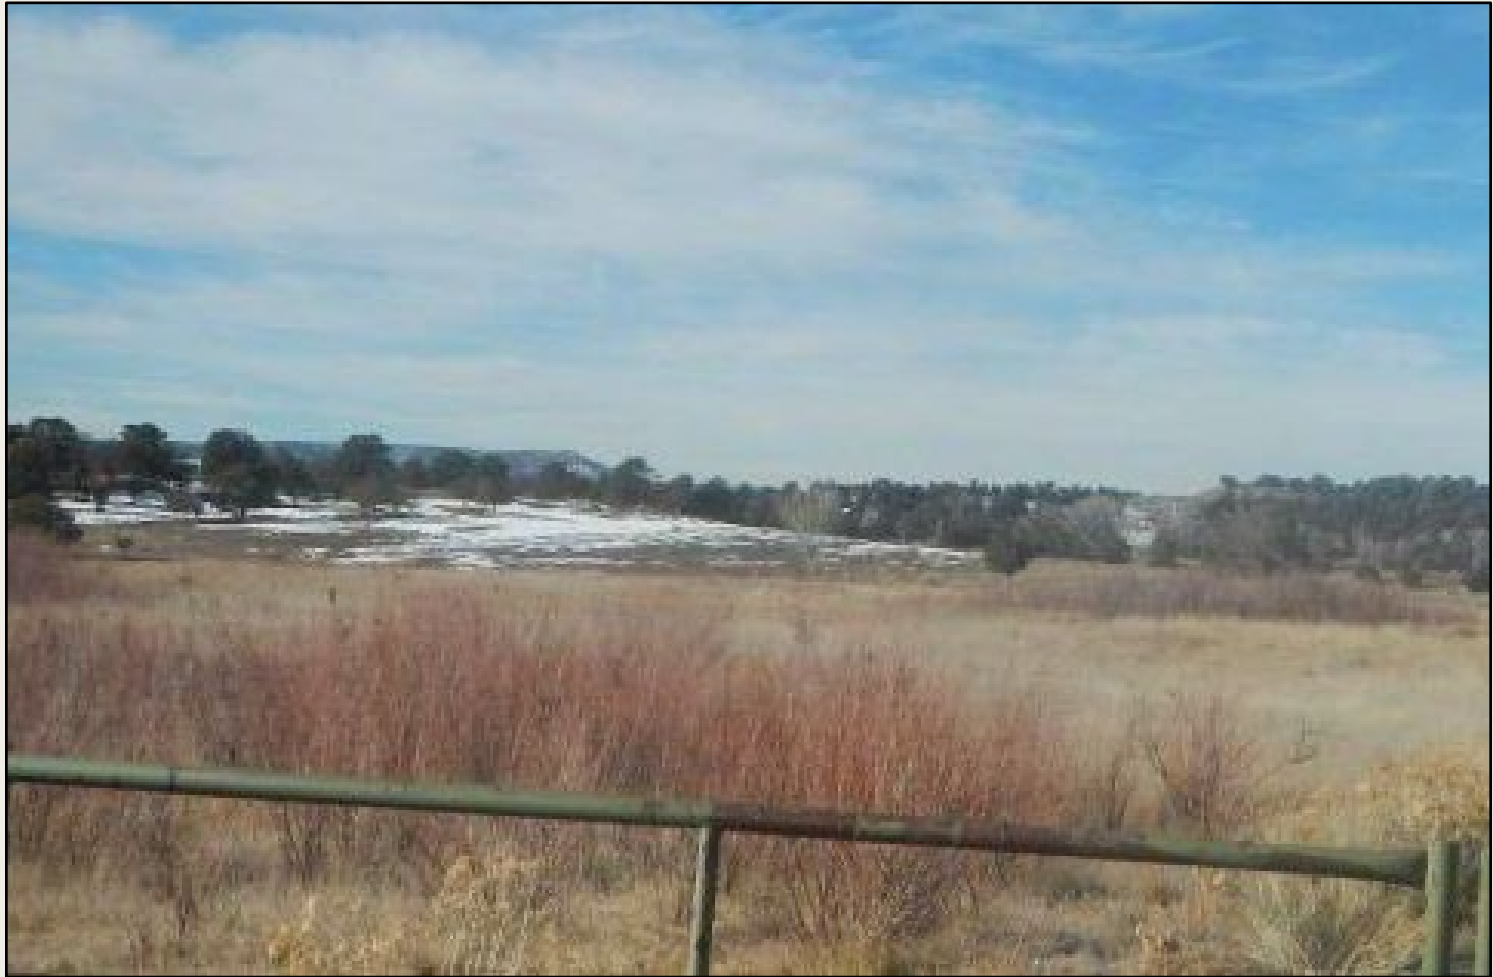
Photo 5. View of reference area, comprised of irrigated grass field with thickspike wheatgrass, smooth brome, willows, and rabbitbrush.
