Inspection Photos  
Operator: Simcoe  
API: 007-06326  
Date: 1/11/2022

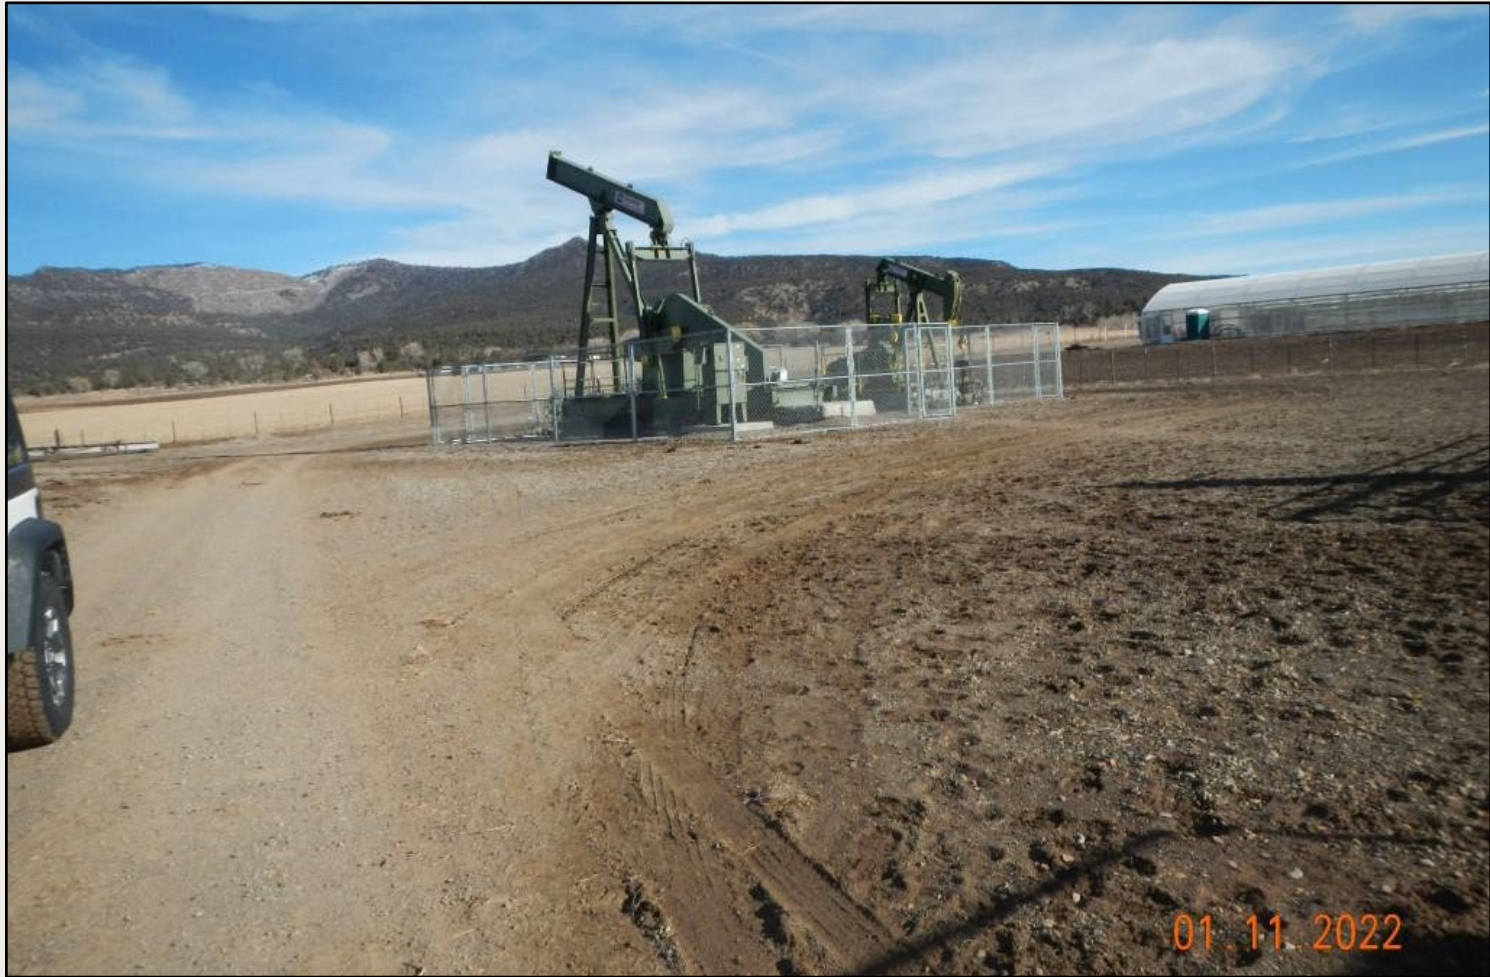
Photo 1. View of project area from the well pad entrance facing center.

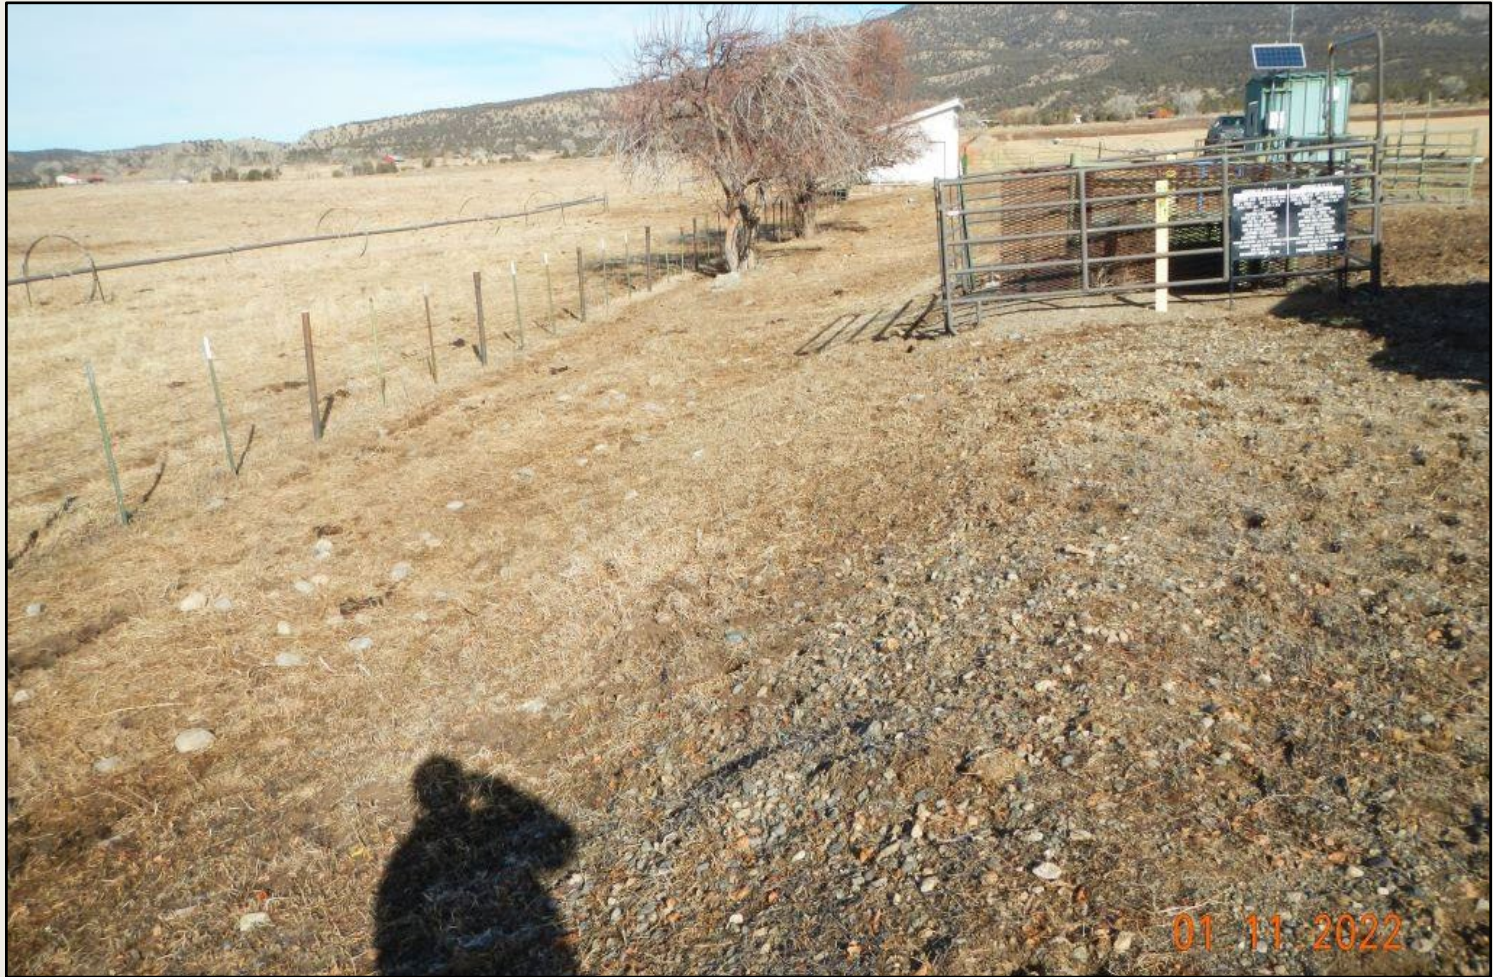
Photo 2. View of the western fill slope from the southwestern corner facing northward. Revegetation appears to be progressing, largely in a grazed vegetative condition at this time.

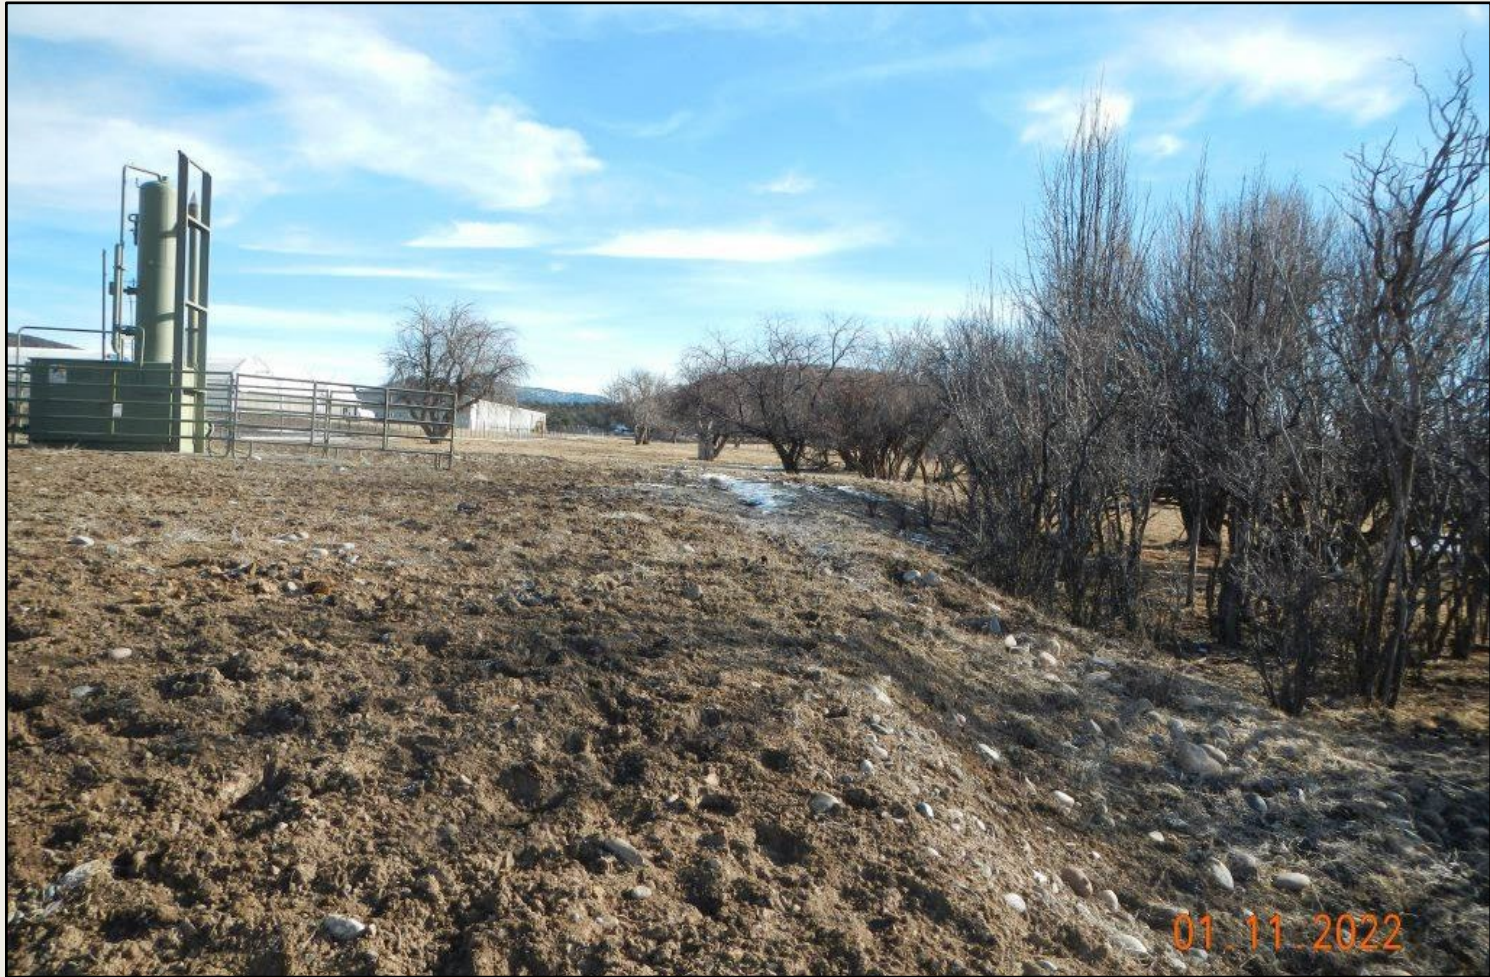
Photo 3. View of the southern project area from the southwestern corner facing eastward.

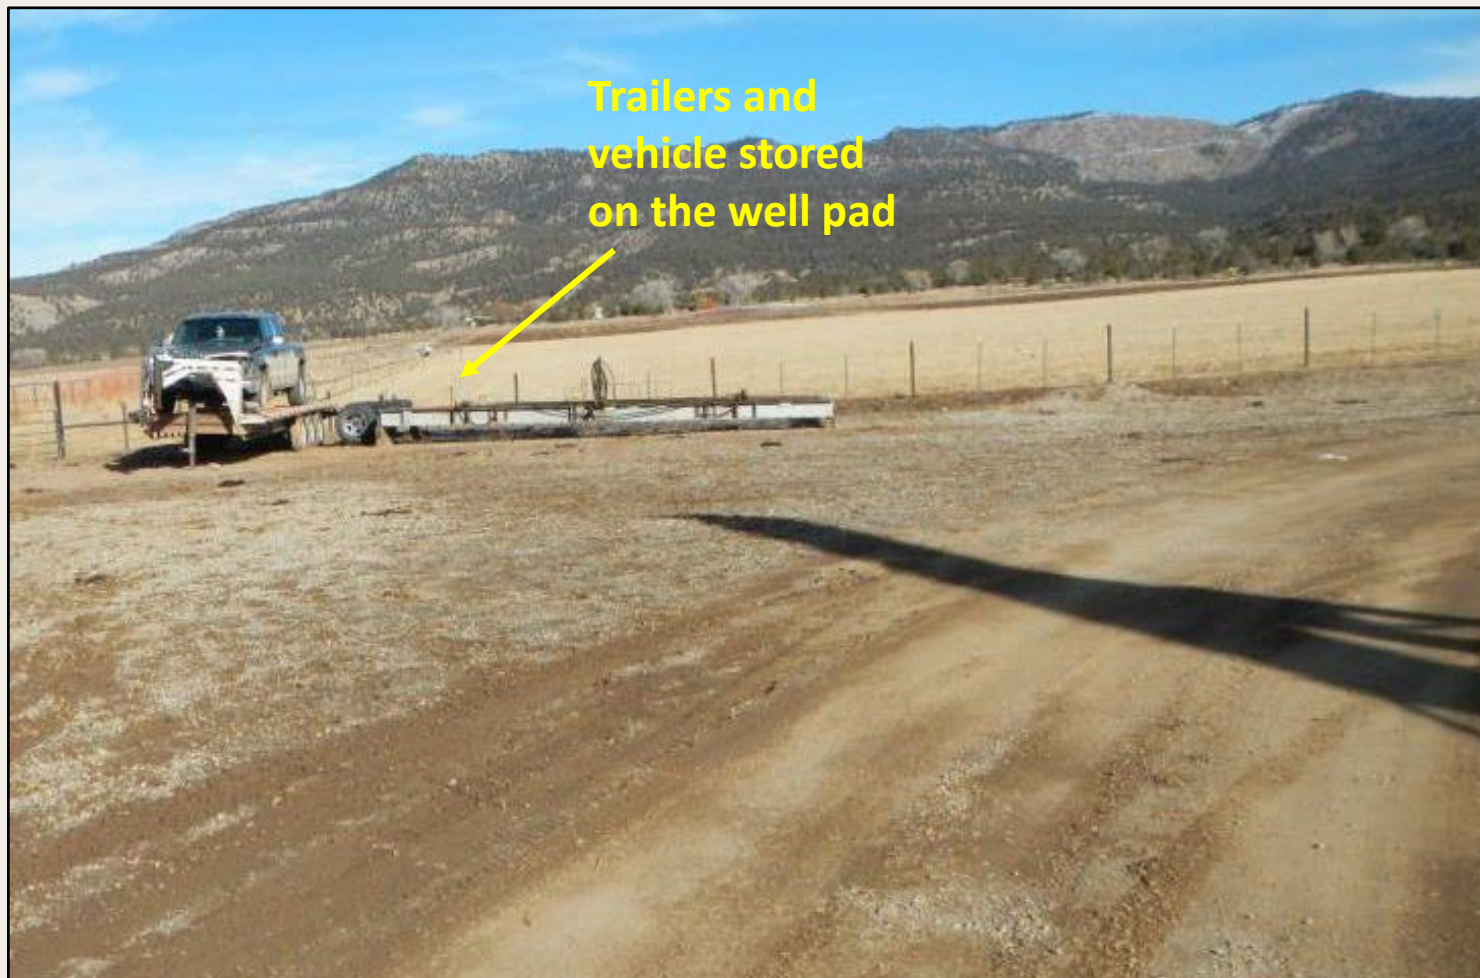
Photo 4. View of trailers and car stored within the northwestern project area. This portion of the project area needs interim reclamation if not needed for production operations.

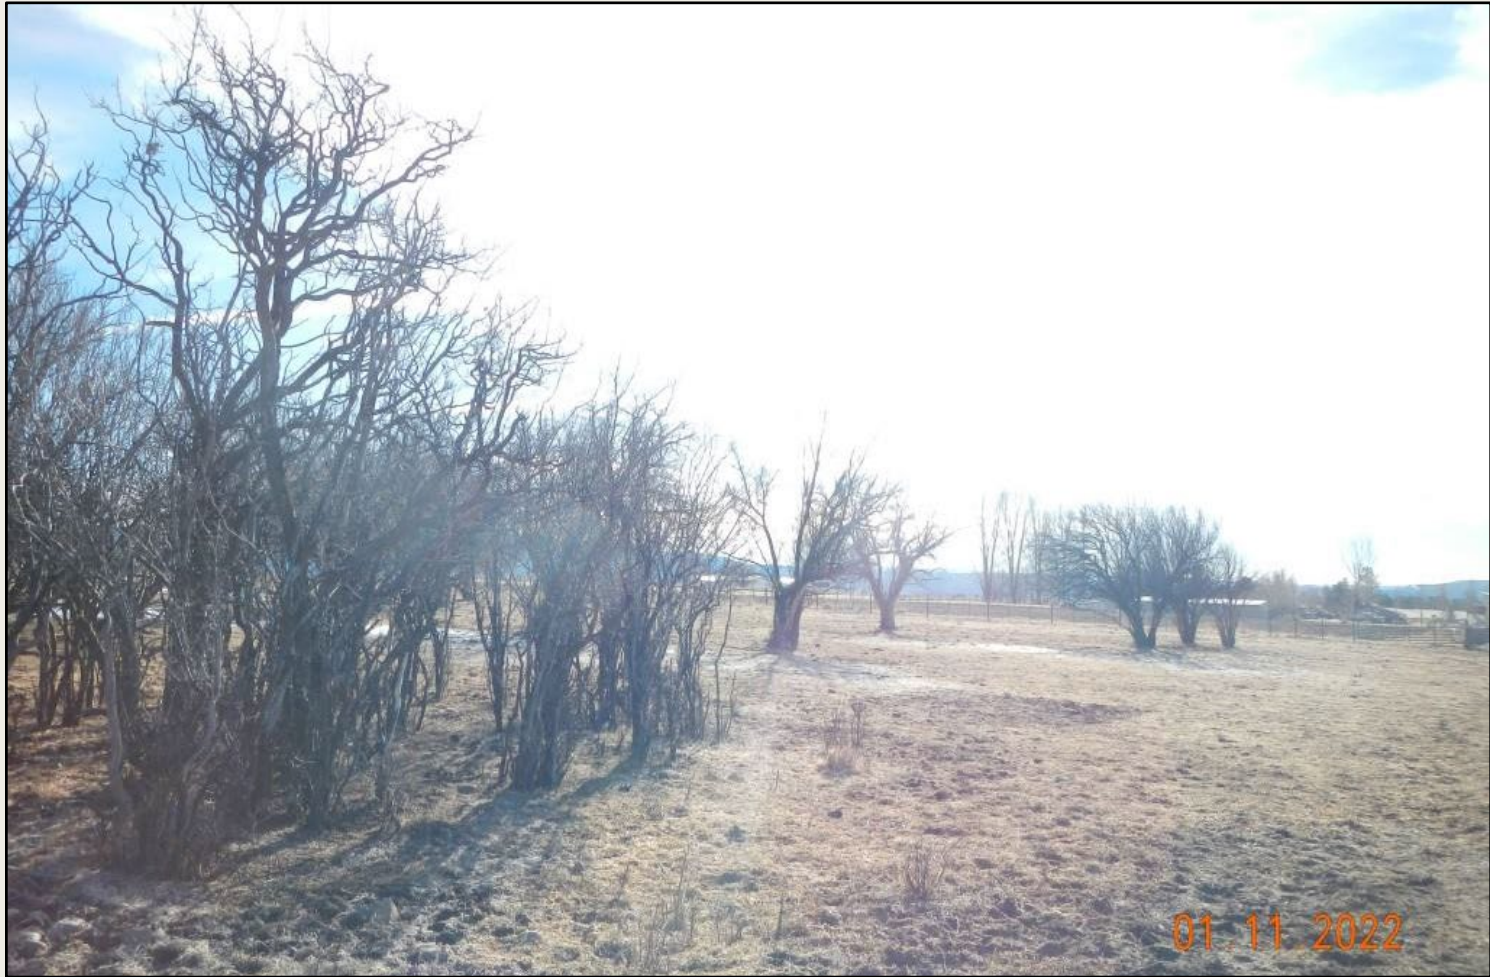
Photo 5. View of reference area, comprised of apple trees and irrigated grasses, in a grazed vegetative condition.
