Inspection Photos  
Operator: Simcoe  
API: 007-06221  
Date: 1/11/2022

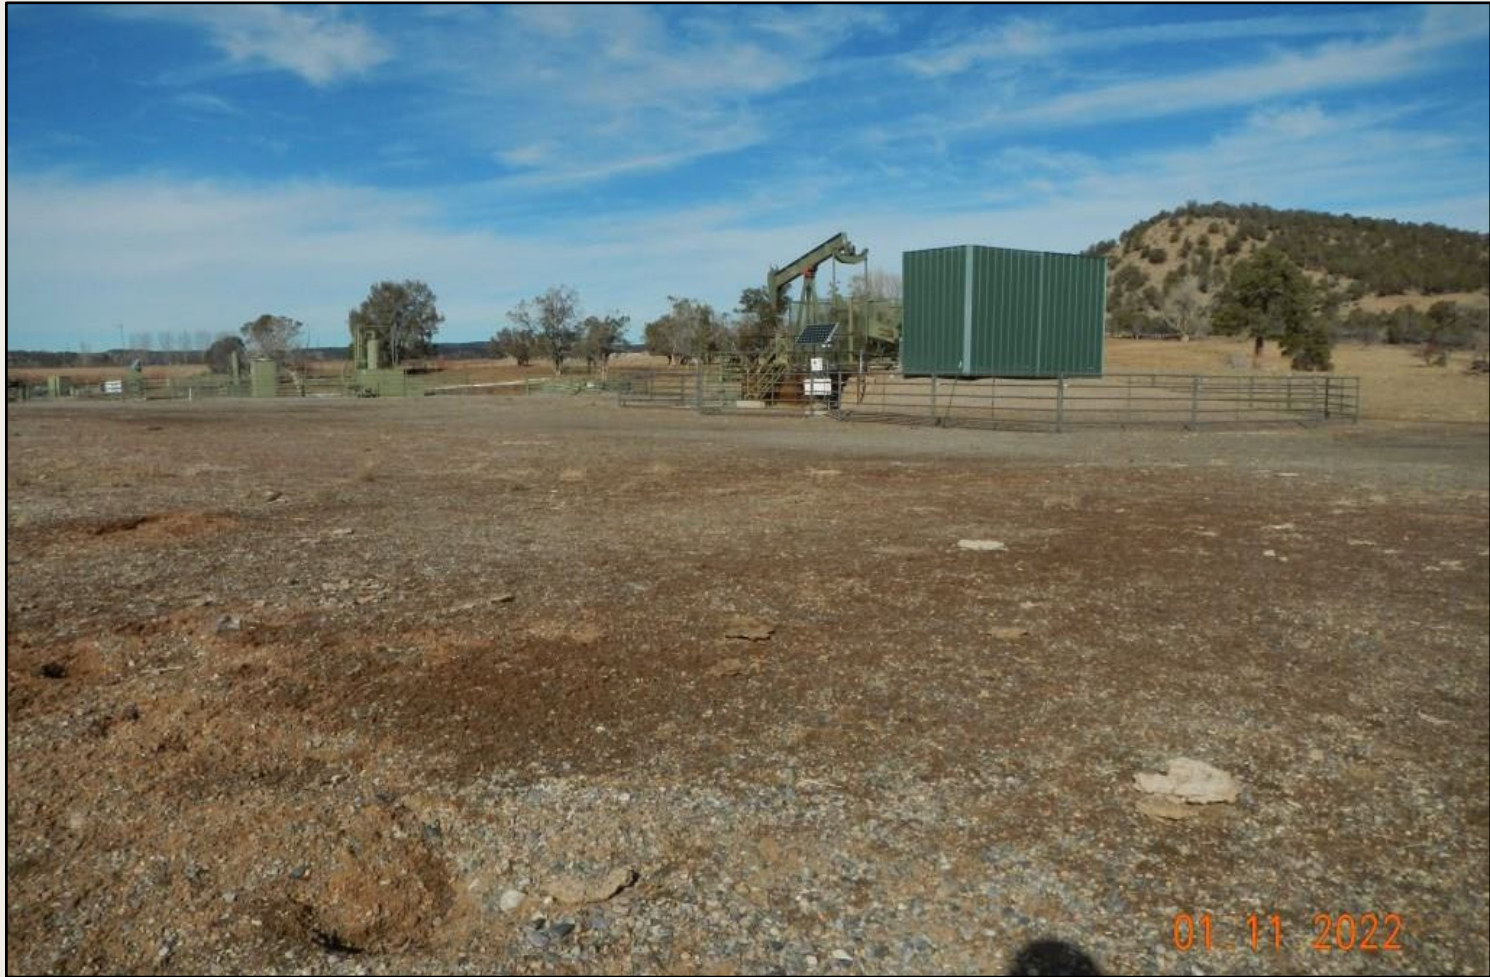
Photo 1. View of project area from the southeastern corner facing center.

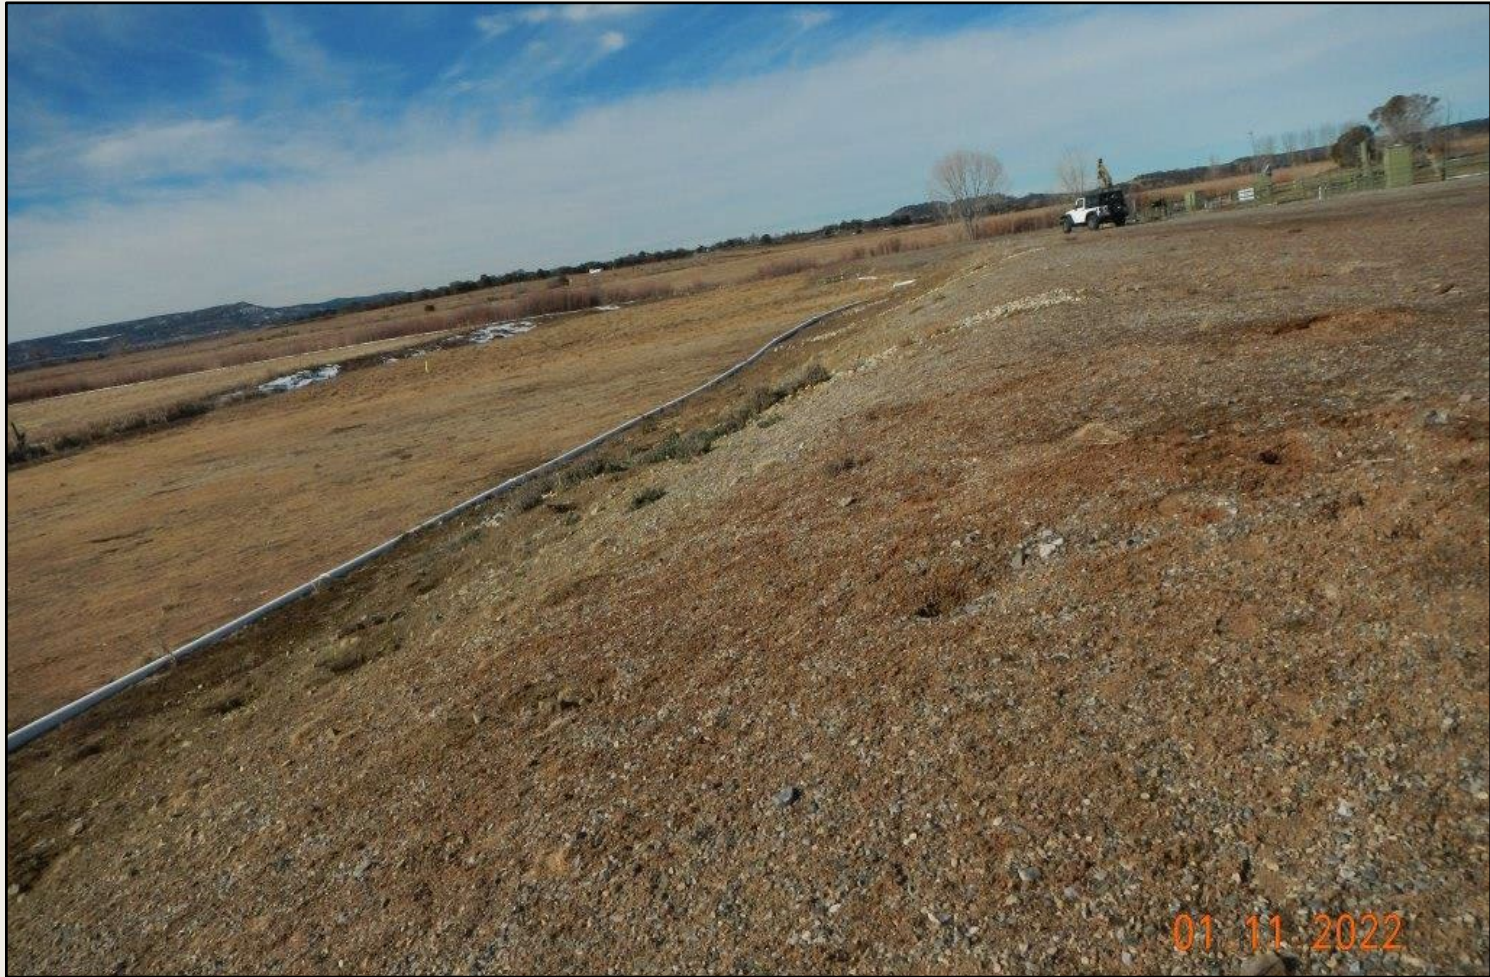
Photo 2. View of the southern fill slope from the southeastern corner facing westward. Revegetation appears to be progressing, largely in a grazed vegetative condition at this time, needs to be assessed during the active growing season.

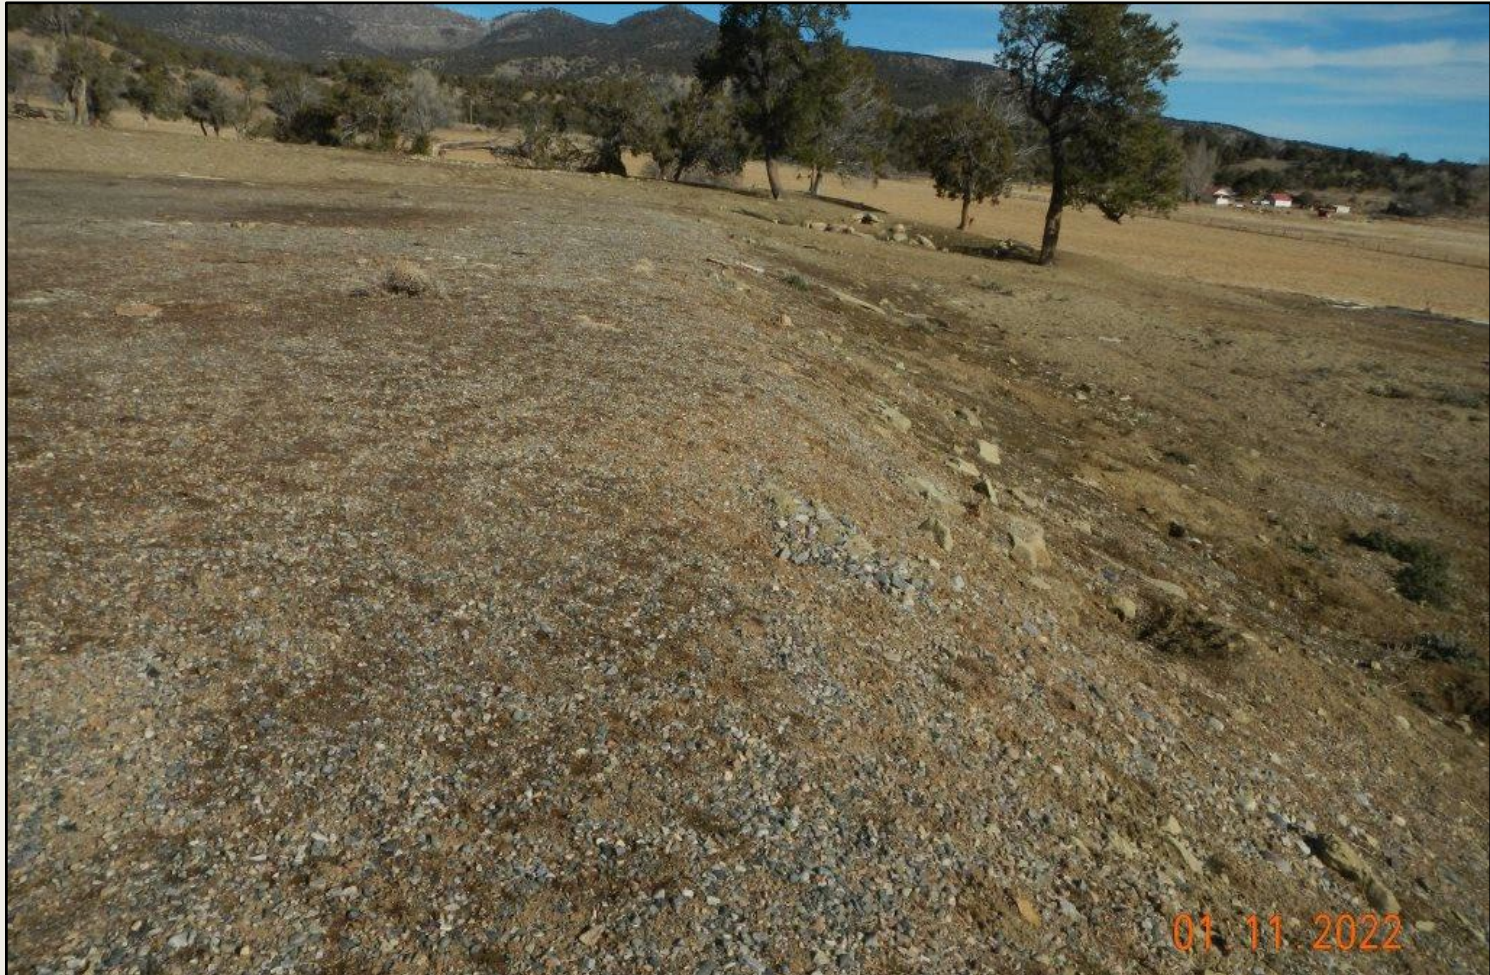
Photo 3. View of the eastern project area from the southeastern project area from the southeastern corner facing northward.

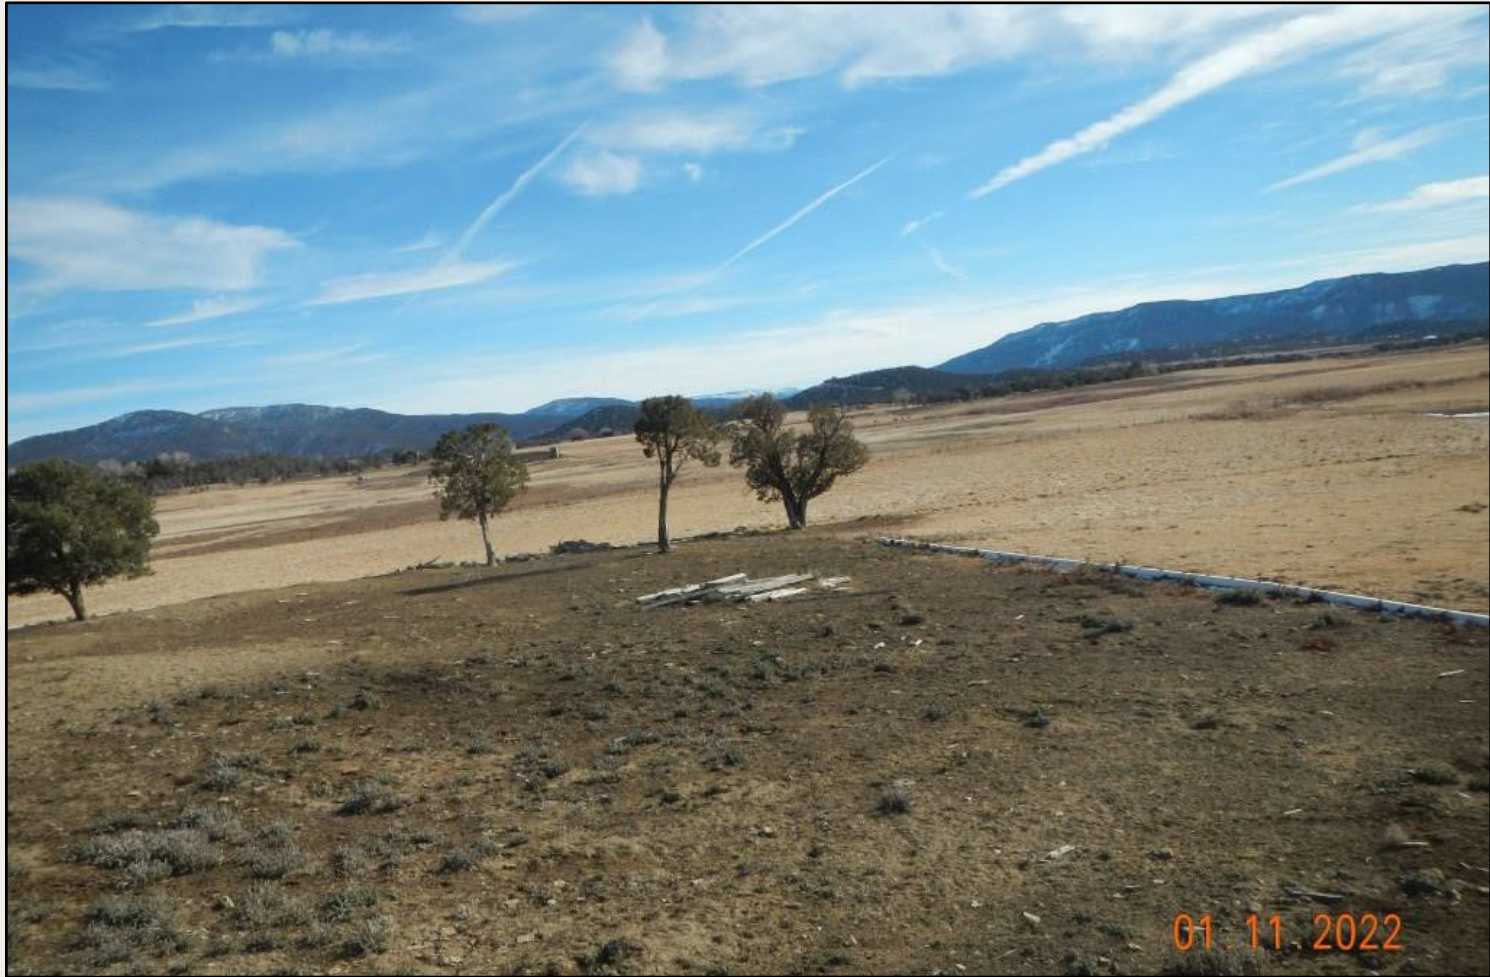
Photo 4. View of reference area, comprised of irrigated and non-irrigated grass field with scattered pinyon and juniper trees, western wheatgrass and blue grama observed in the understory.
