Inspection Photos
Operator: Simcoe
API: 007-06149
Date: 1/11/2022

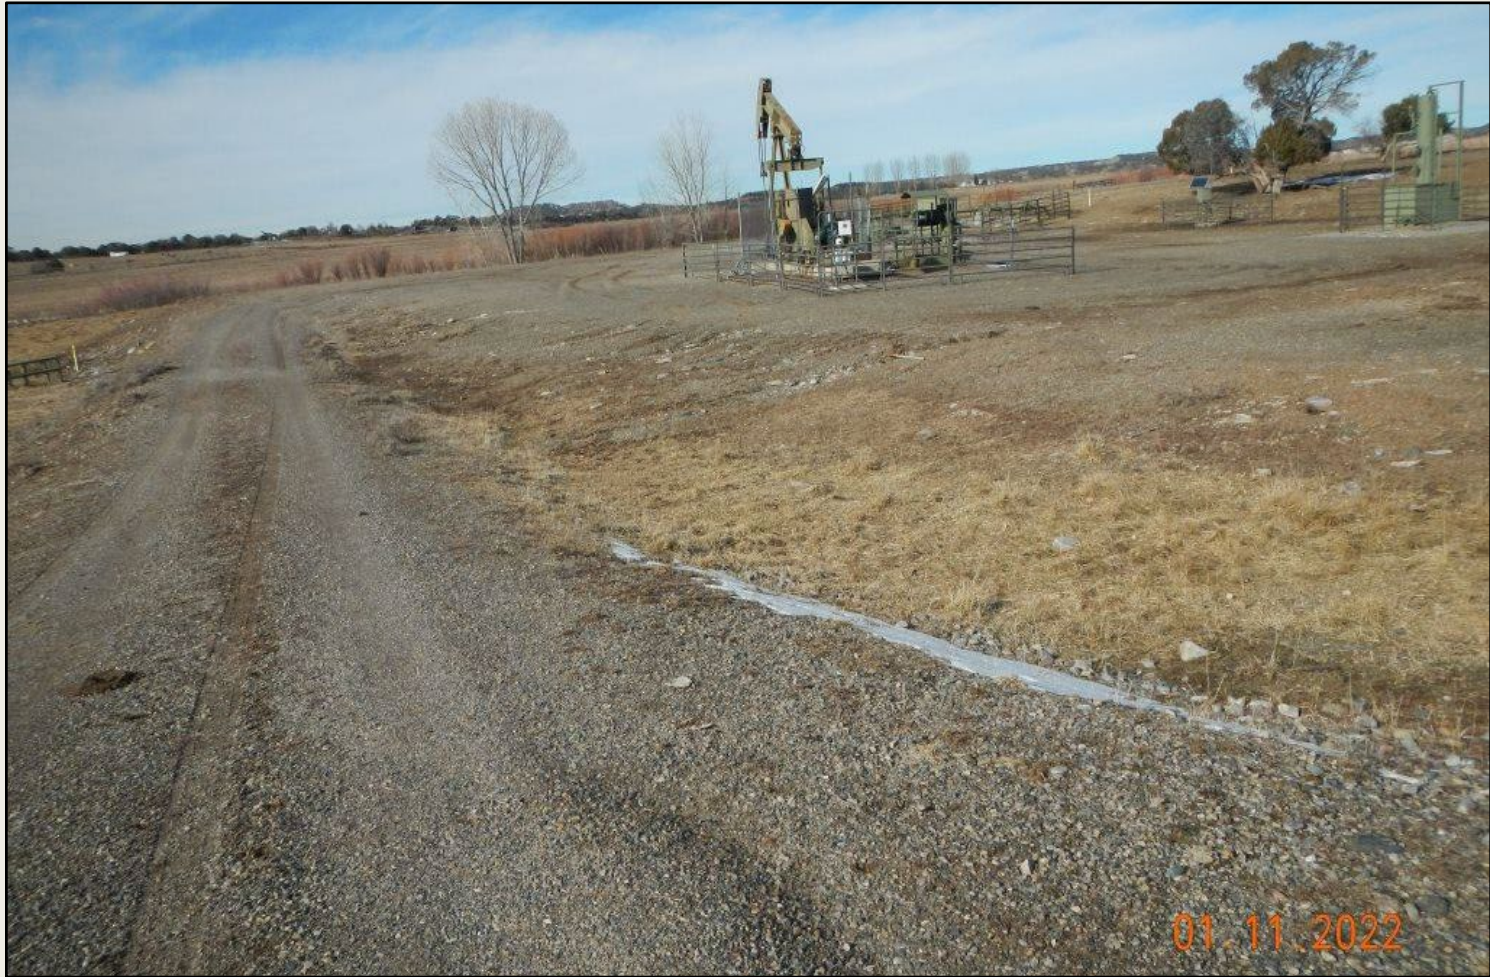
Photo 1. View of project area from the southeastern corner facing center.

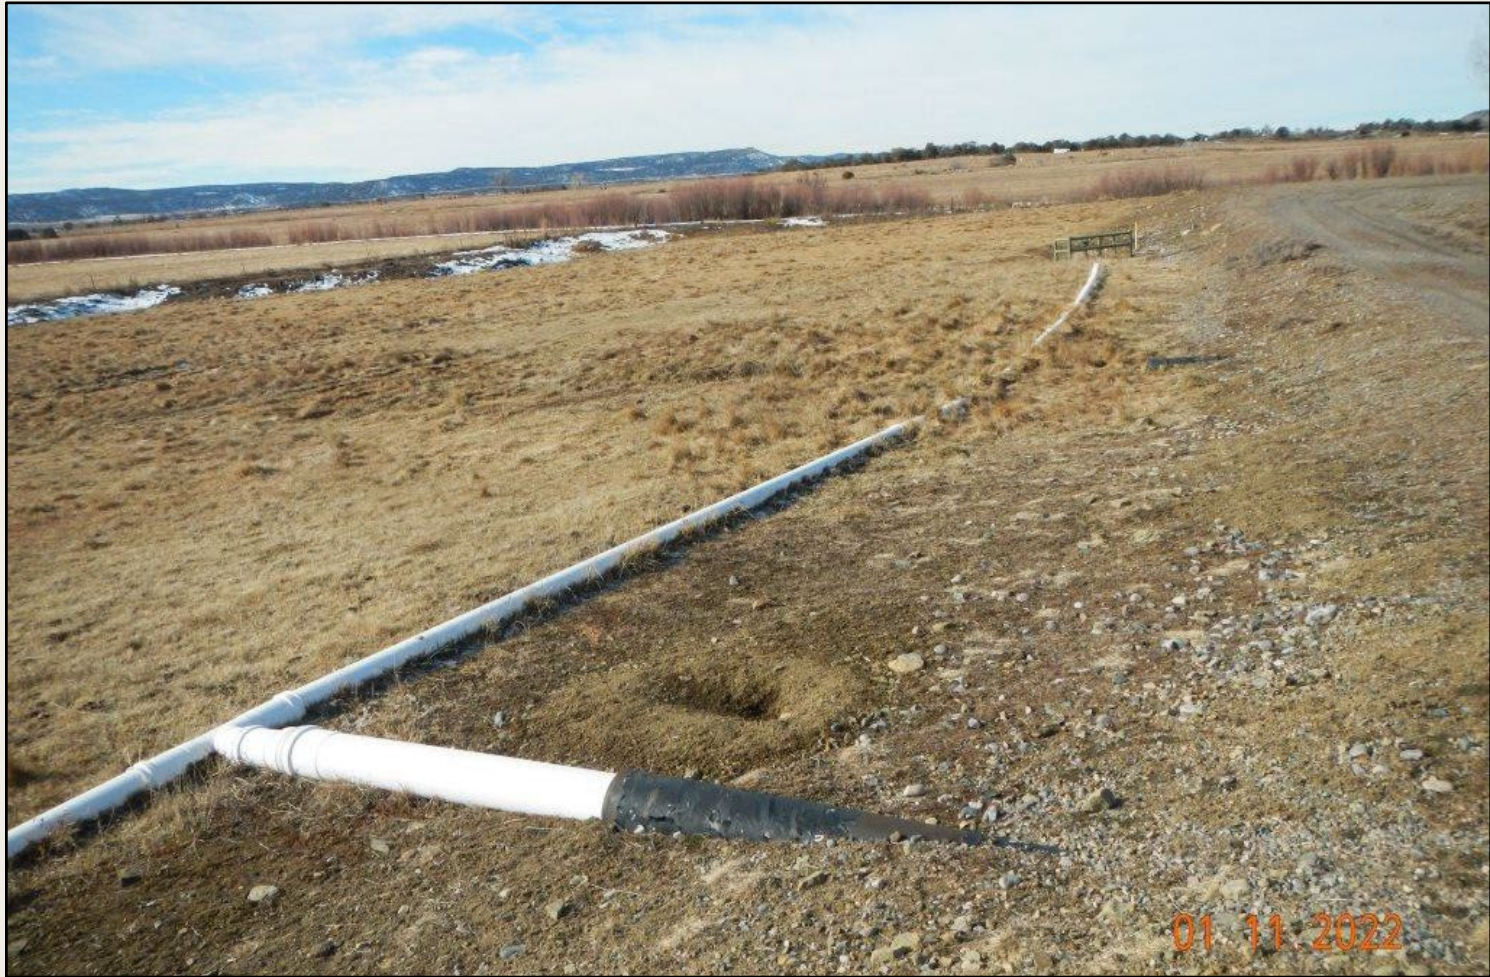
Photo 2. View of the southern fill slope from the southeastern corner facing westward. Revegetation appears to be progressing, largely in a grazed vegetative condition at this time, needs to be assessed during the active growing season. Western wheatgrass and blue grama are observable.

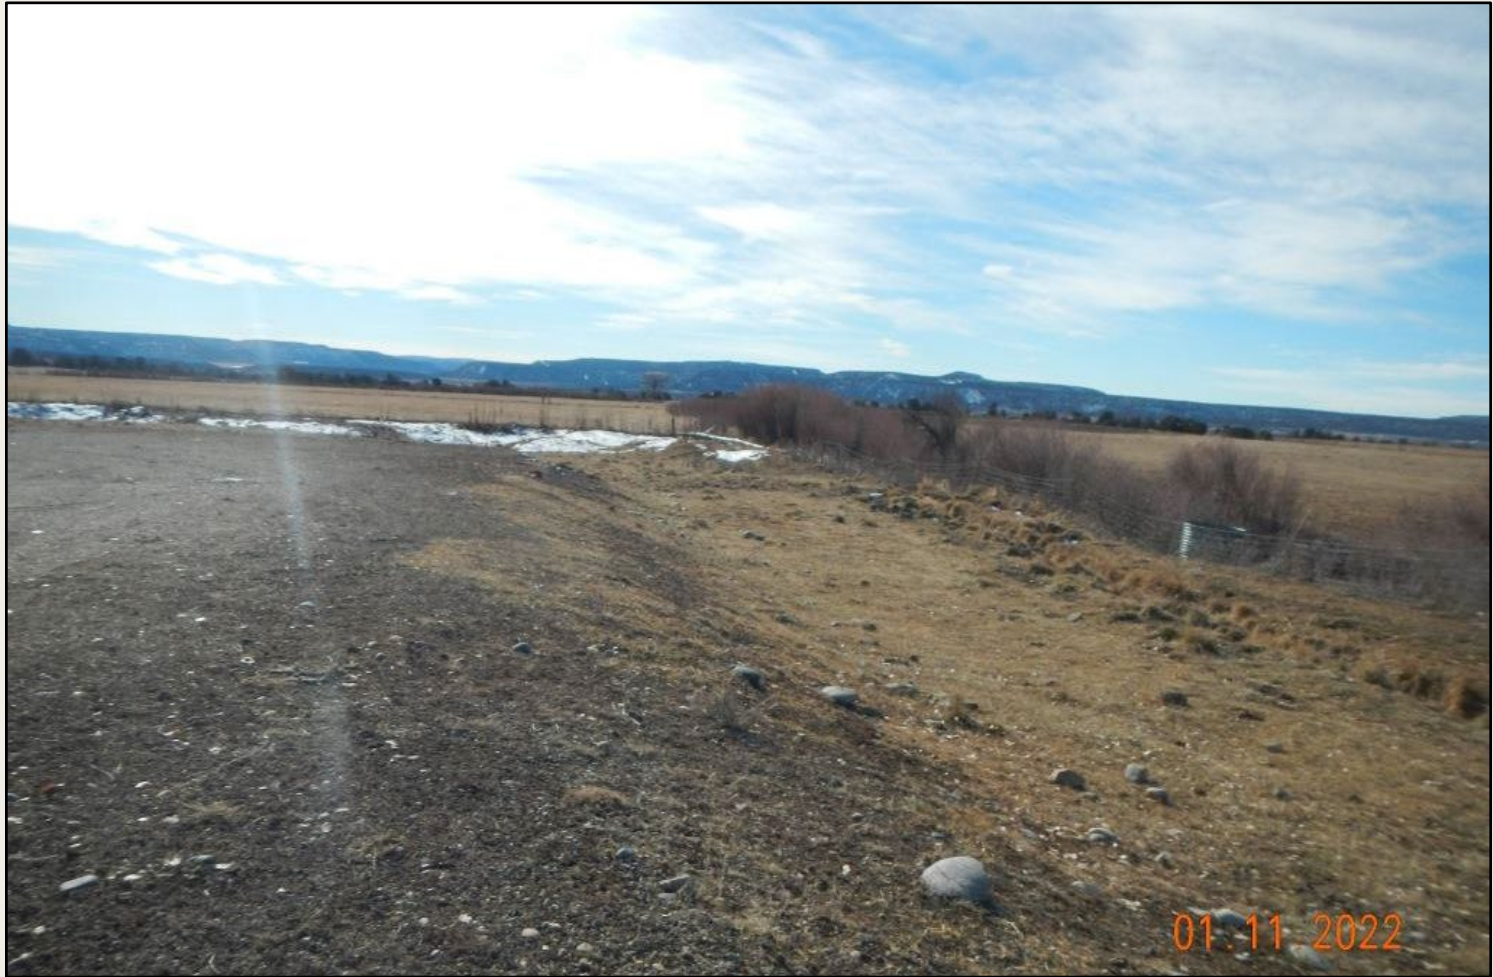
Photo 3. View of the western project area from the northwestern corner facing southward.
