Inspection Photos
Operator: Simcoe
API: 007-06086
Date: 1/11/2022

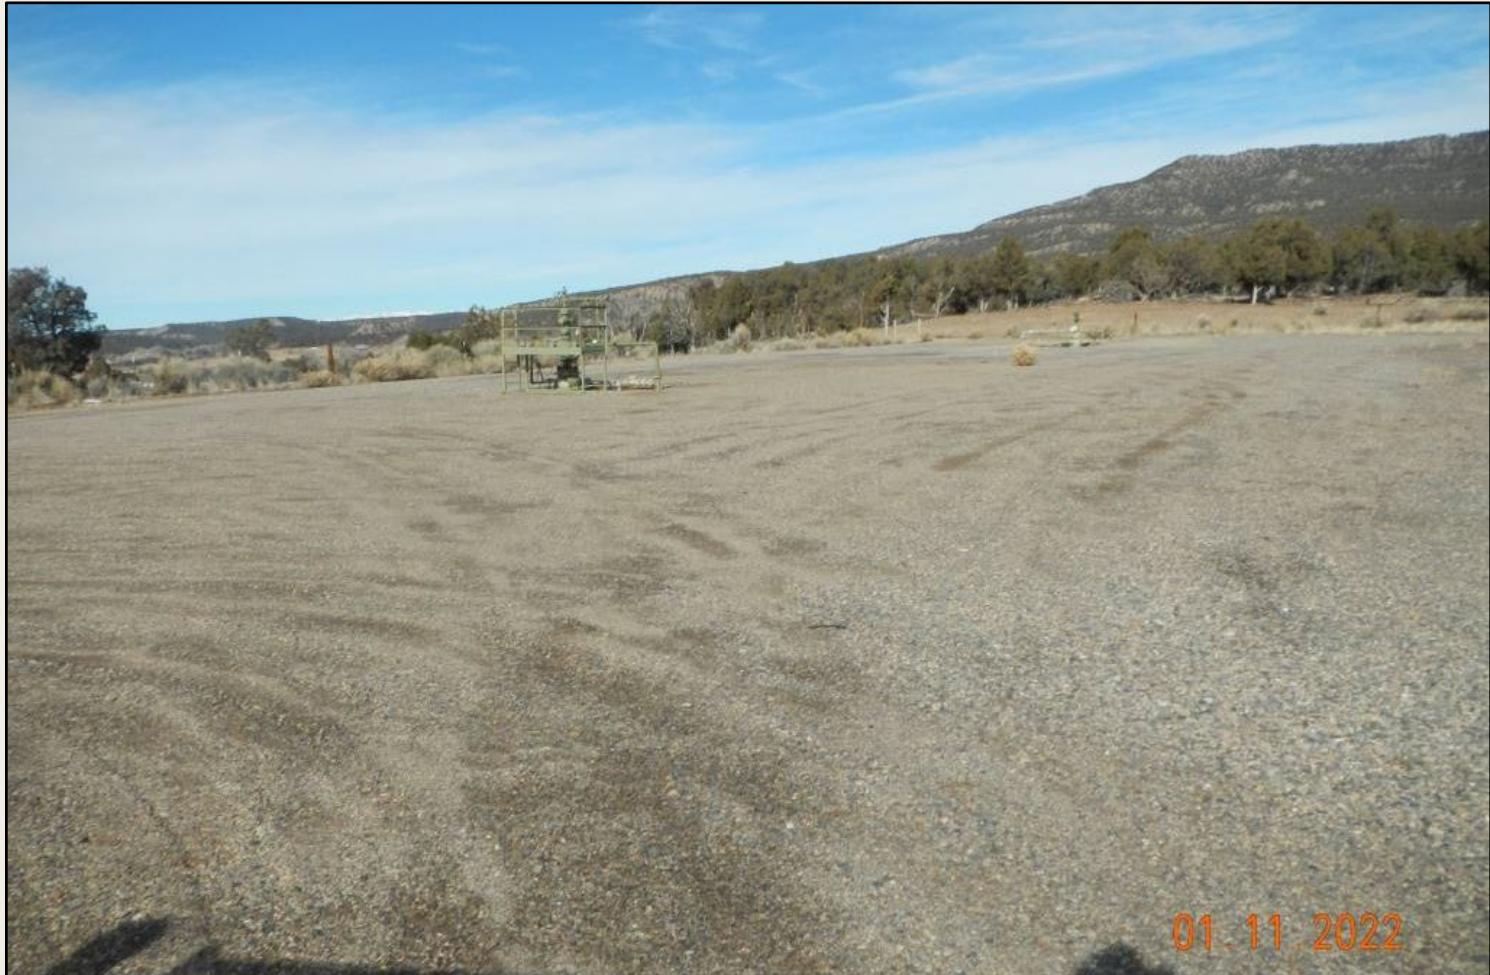
Photo 1. View of project area from the well pad entrance facing center.

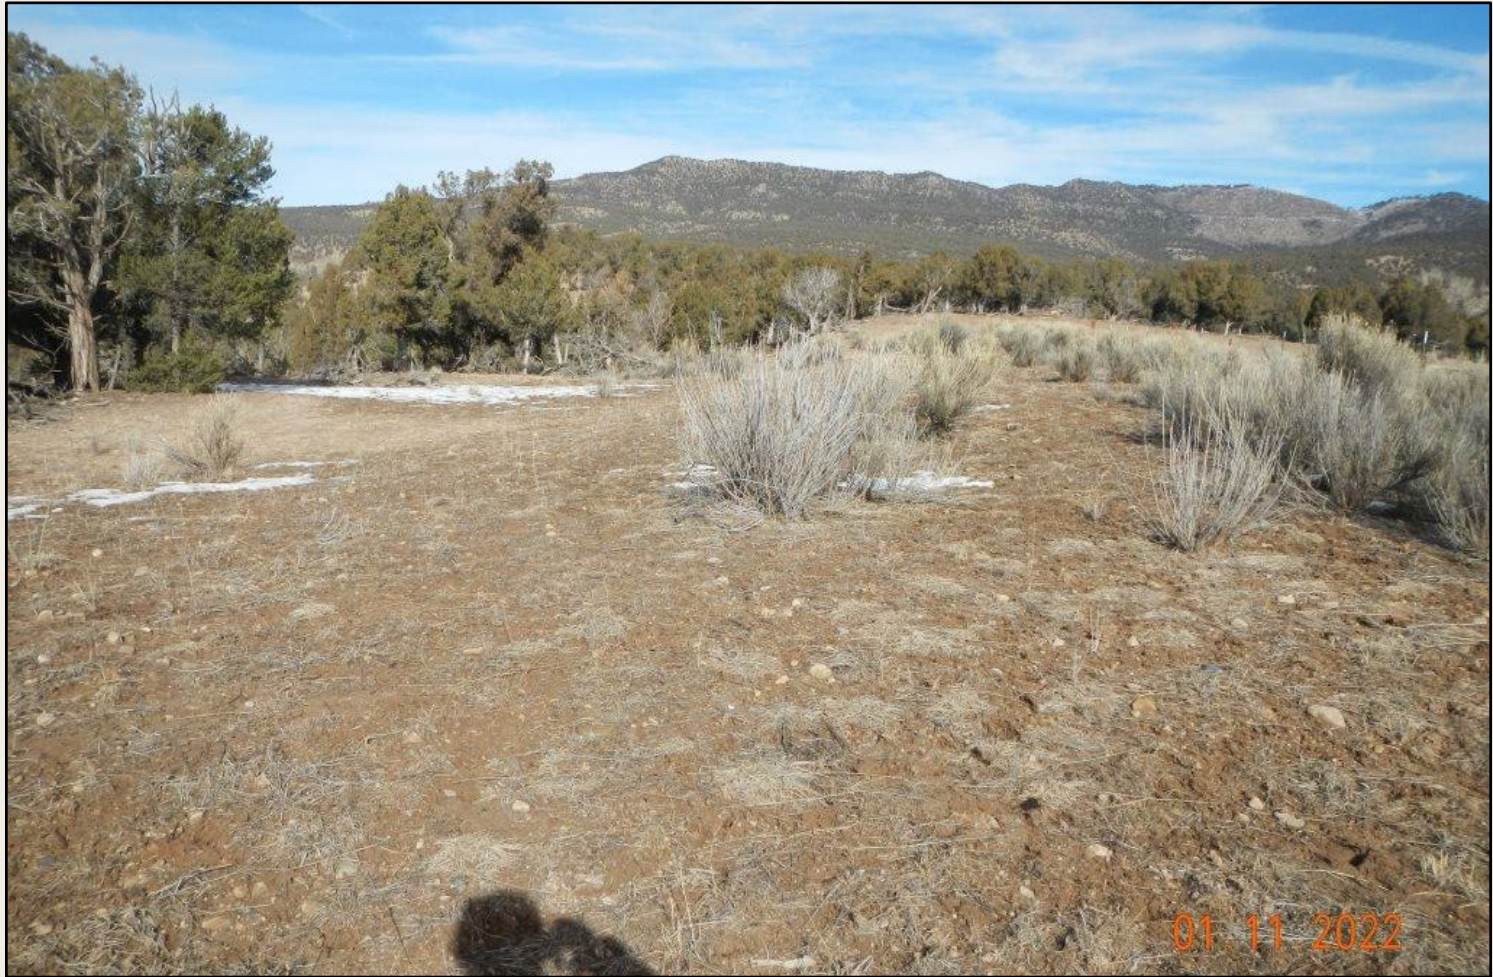
Photo 2. View of the western fill slope from the southwestern corner facing northward. Revegetation appears to be progressing with blue grama, rubber rabbitbrush, western wheatgrass, and crested wheatgrass.

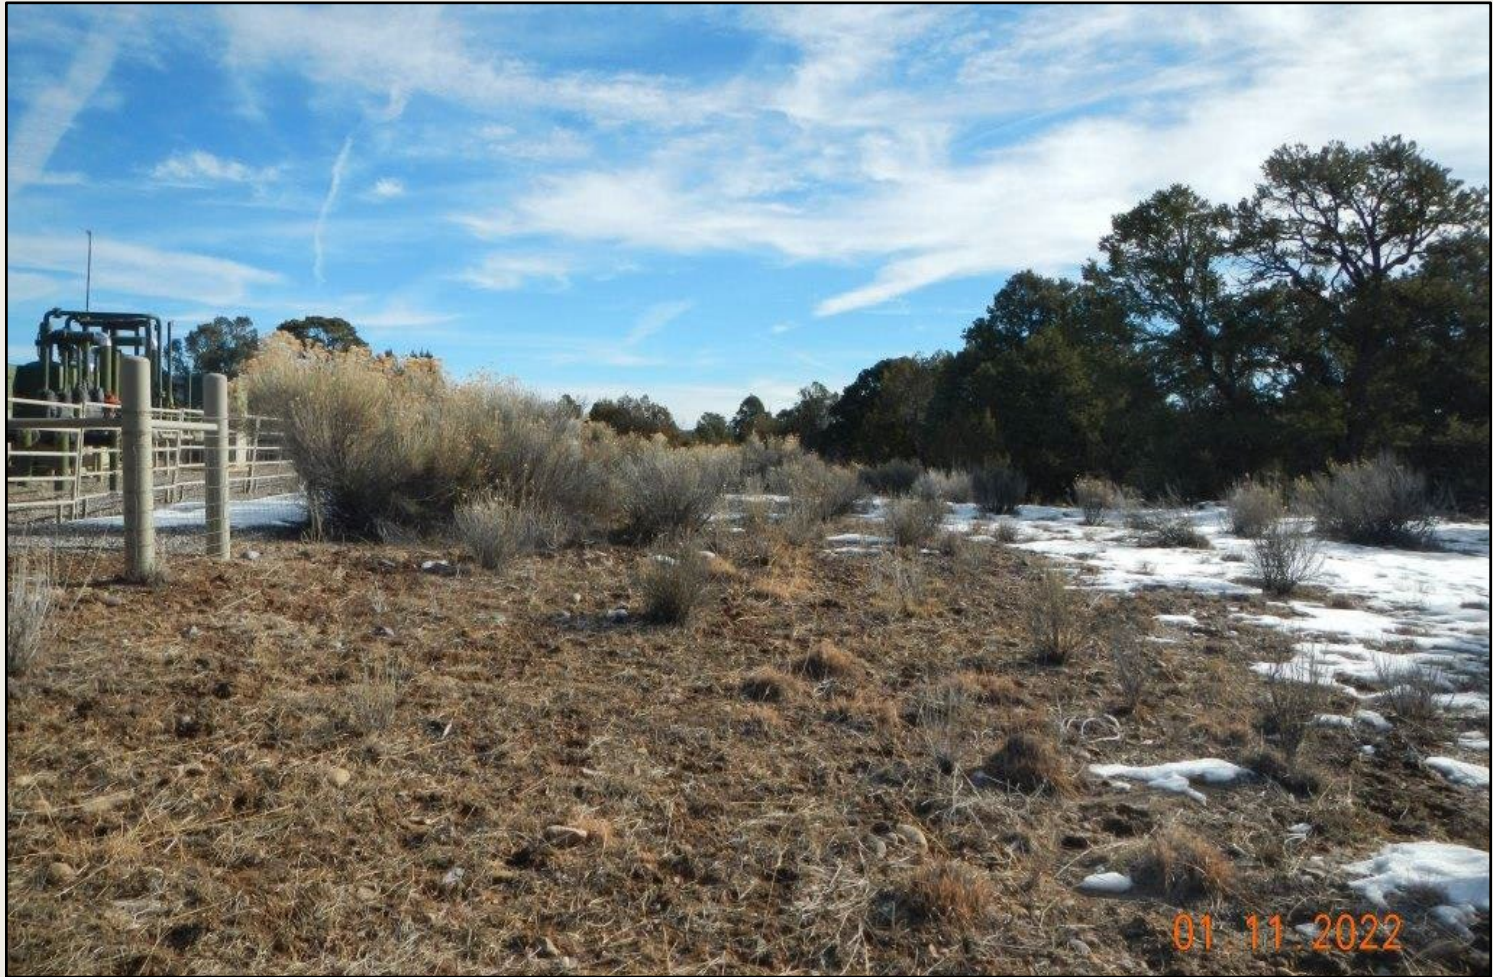
Photo 3. View of the southern project area from the southwestern corner facing eastward.

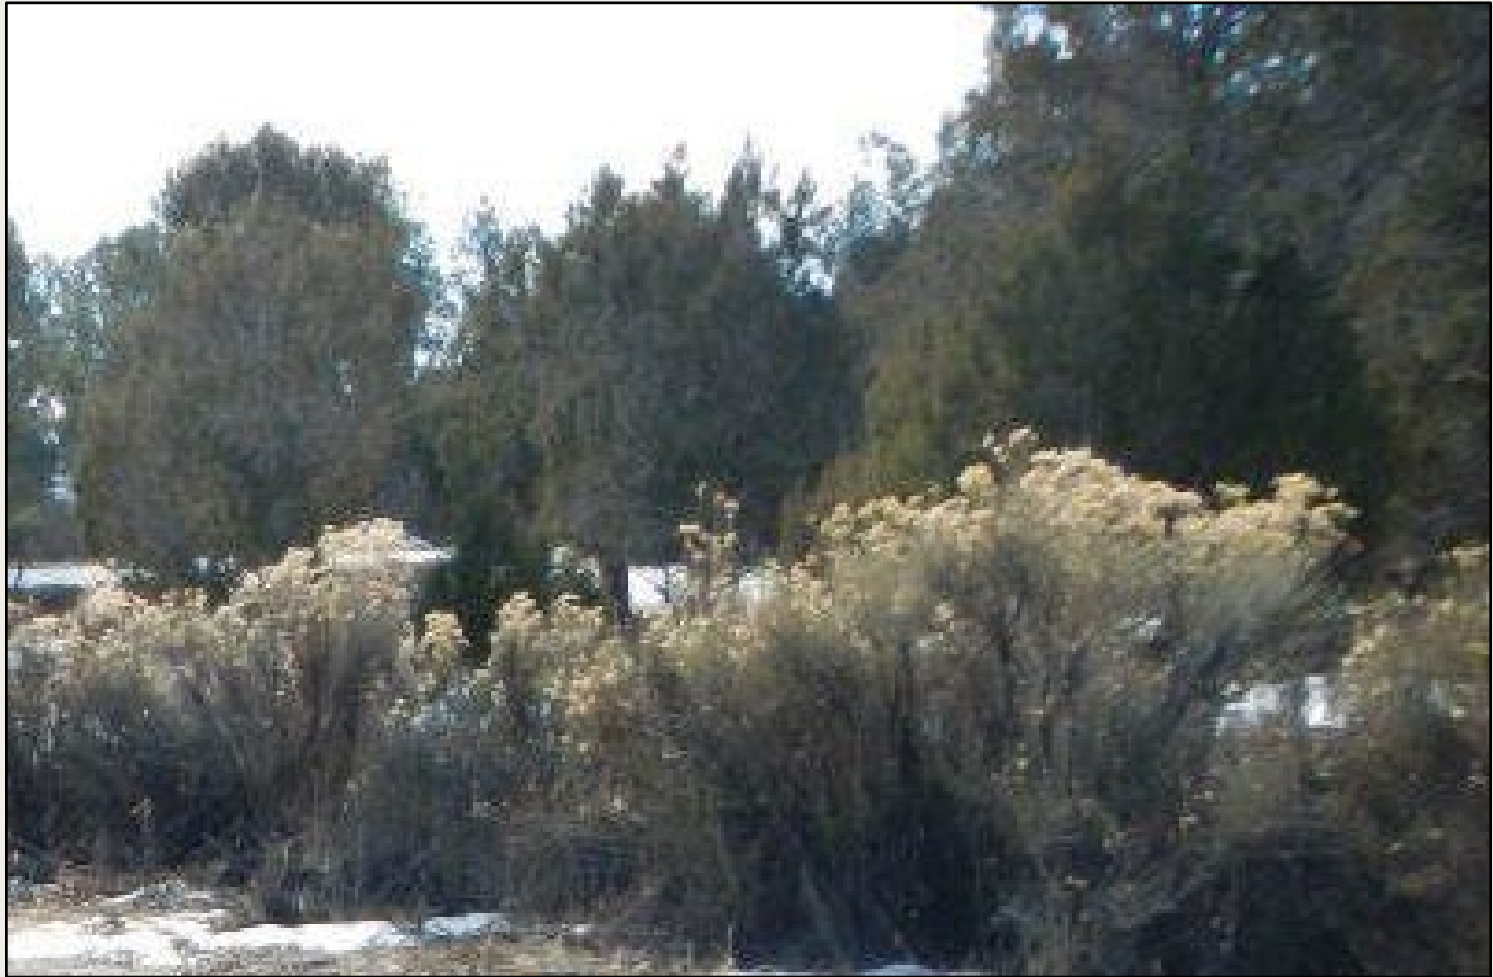
Photo 4. View of reference area, comprised of irrigated and non-irrigated grass field with scattered pinyon and juniper trees, western wheatgrass and blue grama observed in the understory.
