Inspection Photos  
Operator: Morningstar  
API: 007-06185  
Date: 1/11/2022

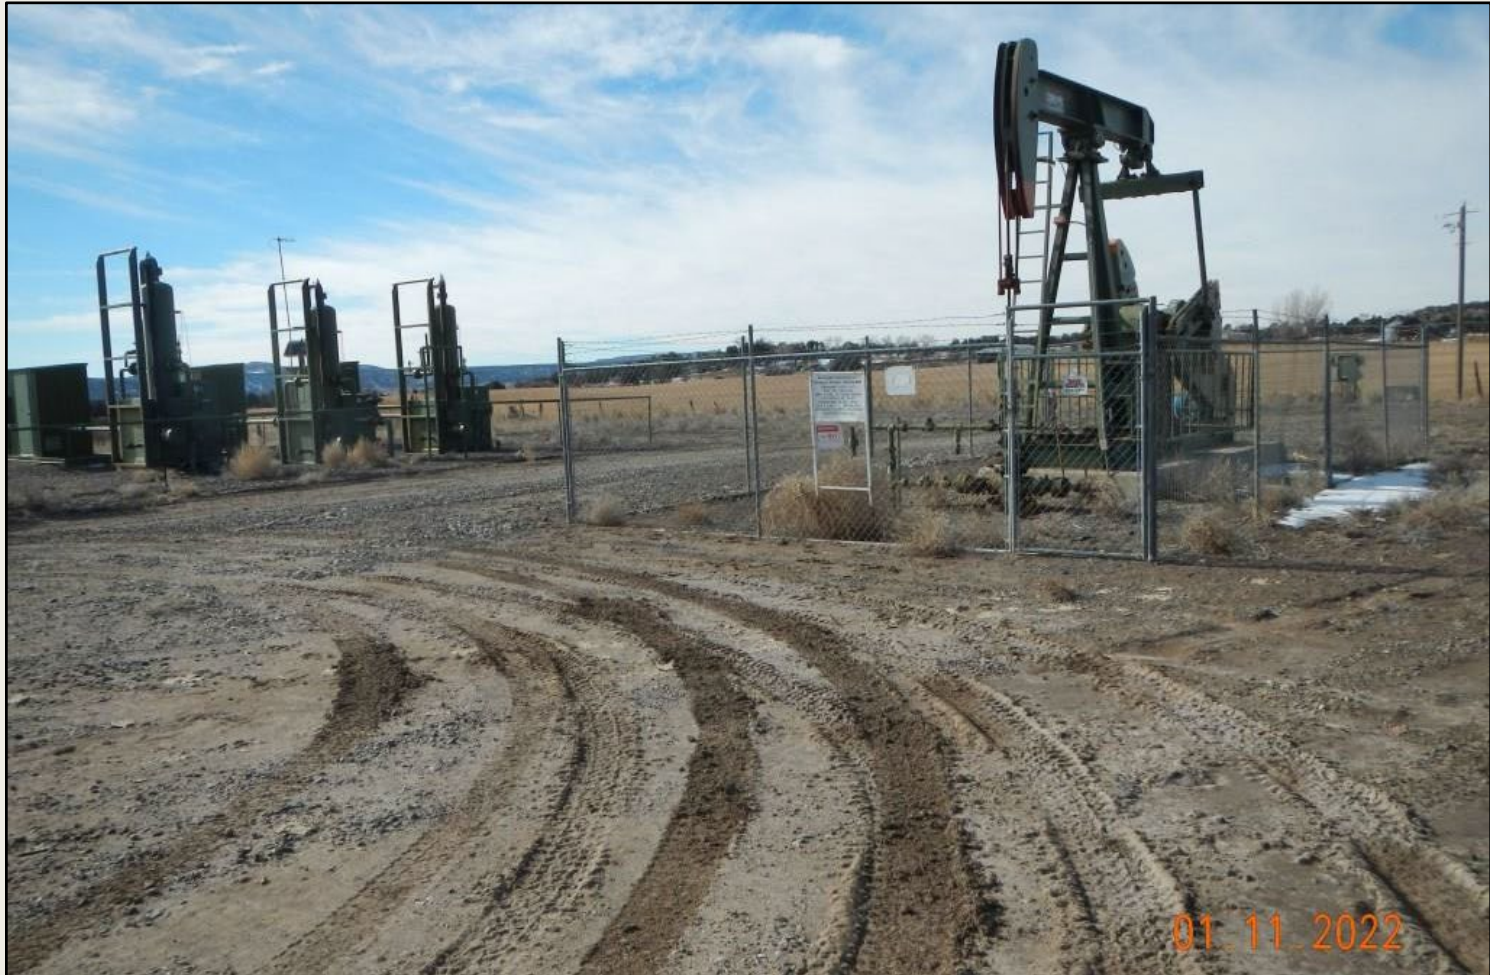
Photo 1. View of project area from the northeastern corner facing center.

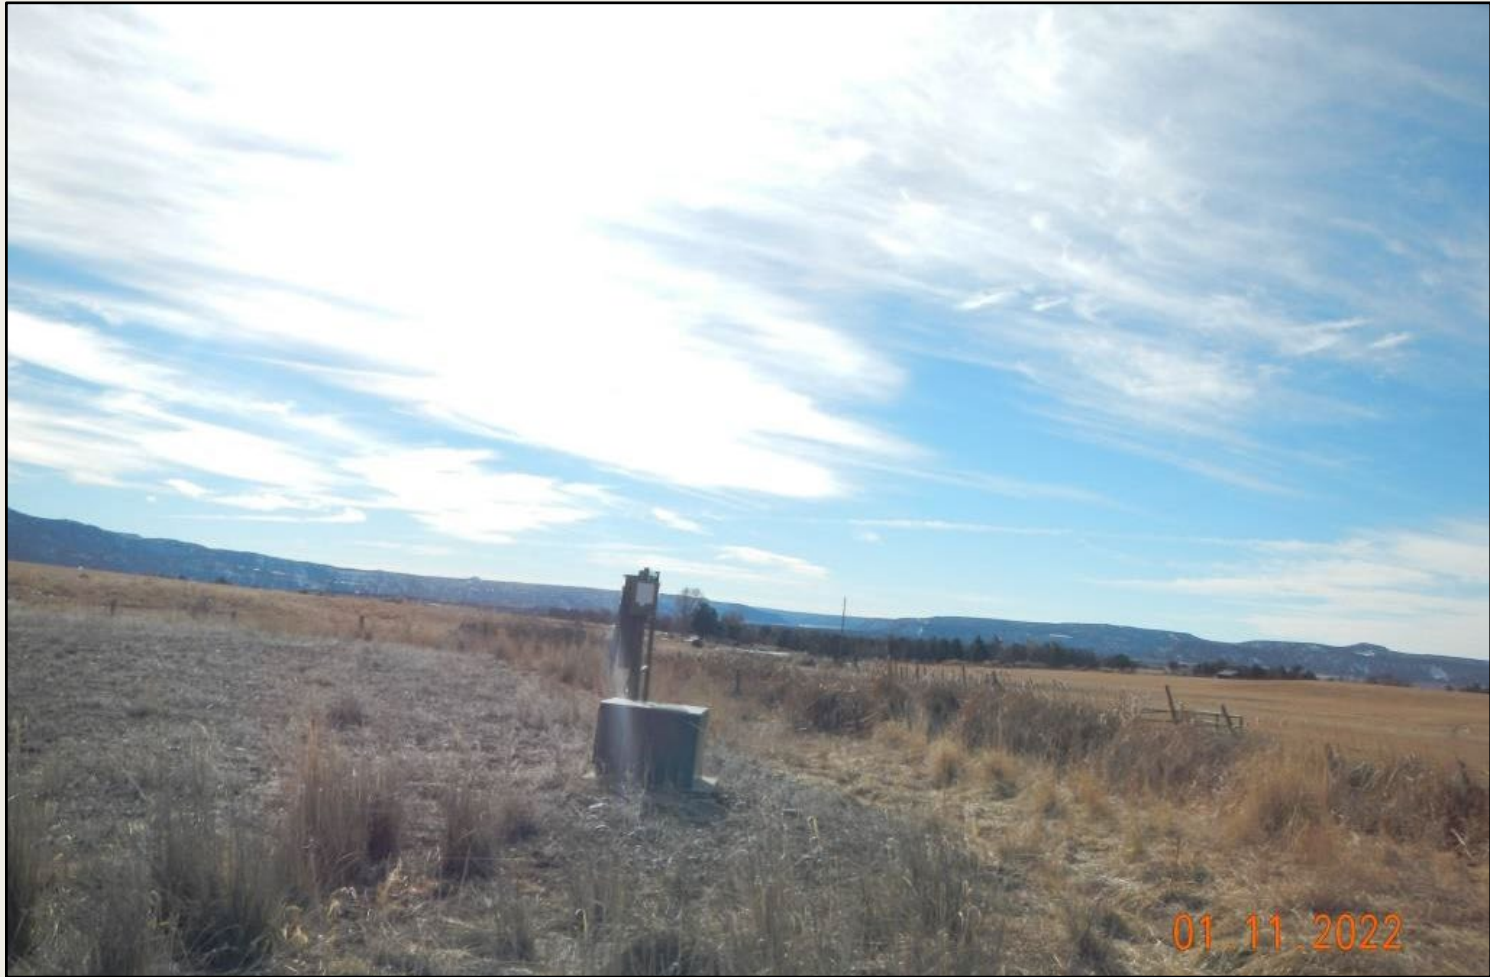
Photo 2. View of the western project area from the northwestern corner facing southward. Revegetation appears to be progressing with mixed wheatgrass such as intermediate wheatgrass and western wheatgrass.

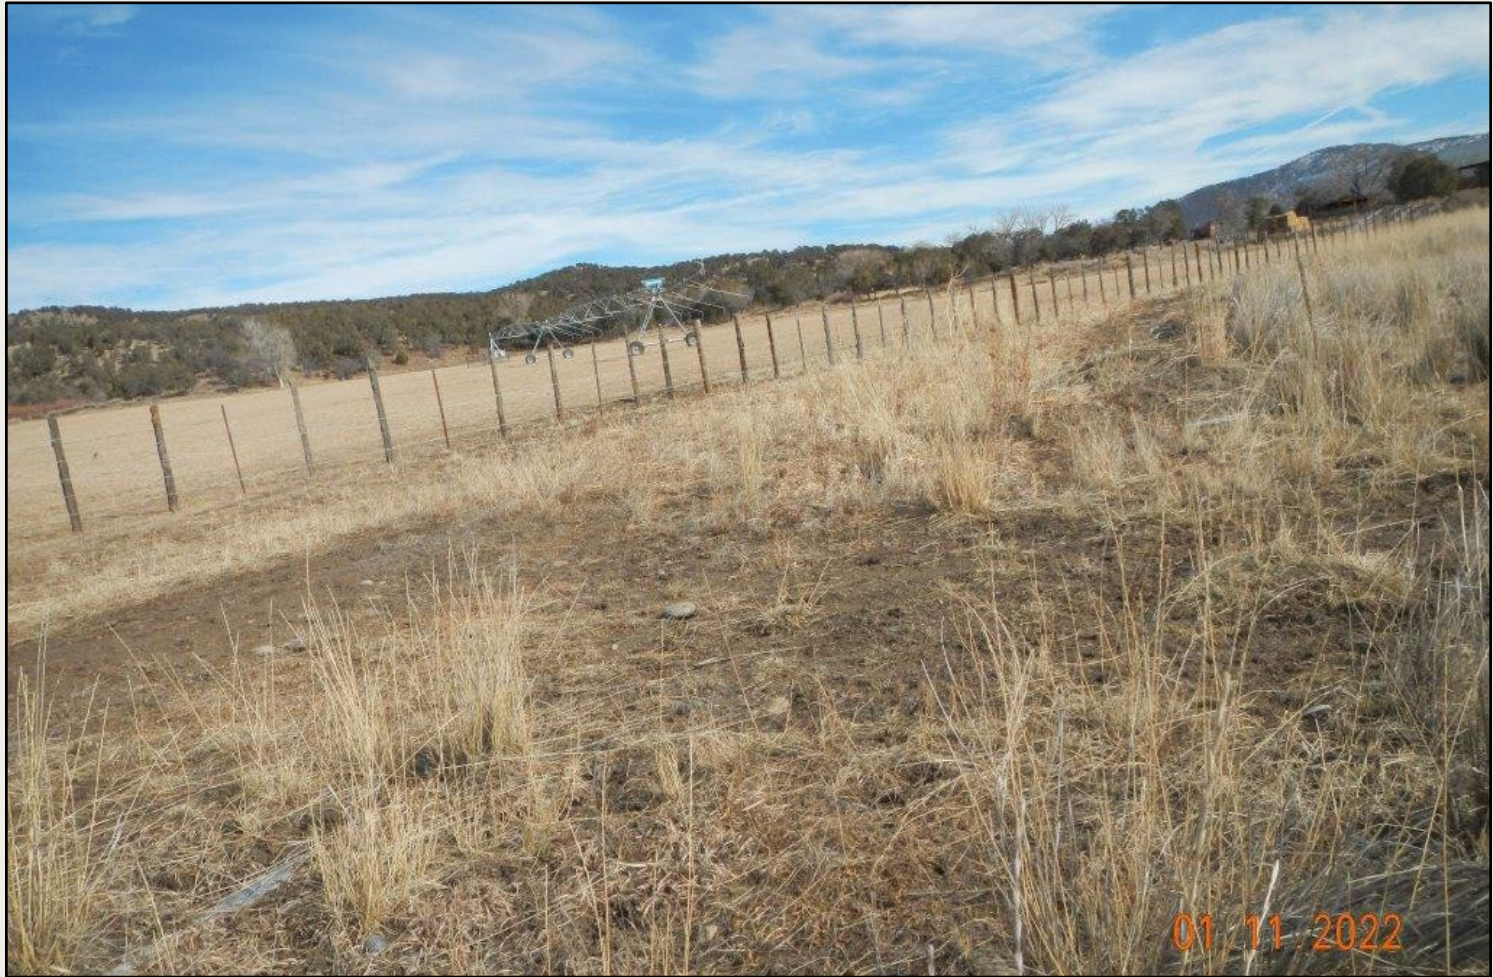
Photo 3. View of the northern project area from the northwestern corner facing eastward.

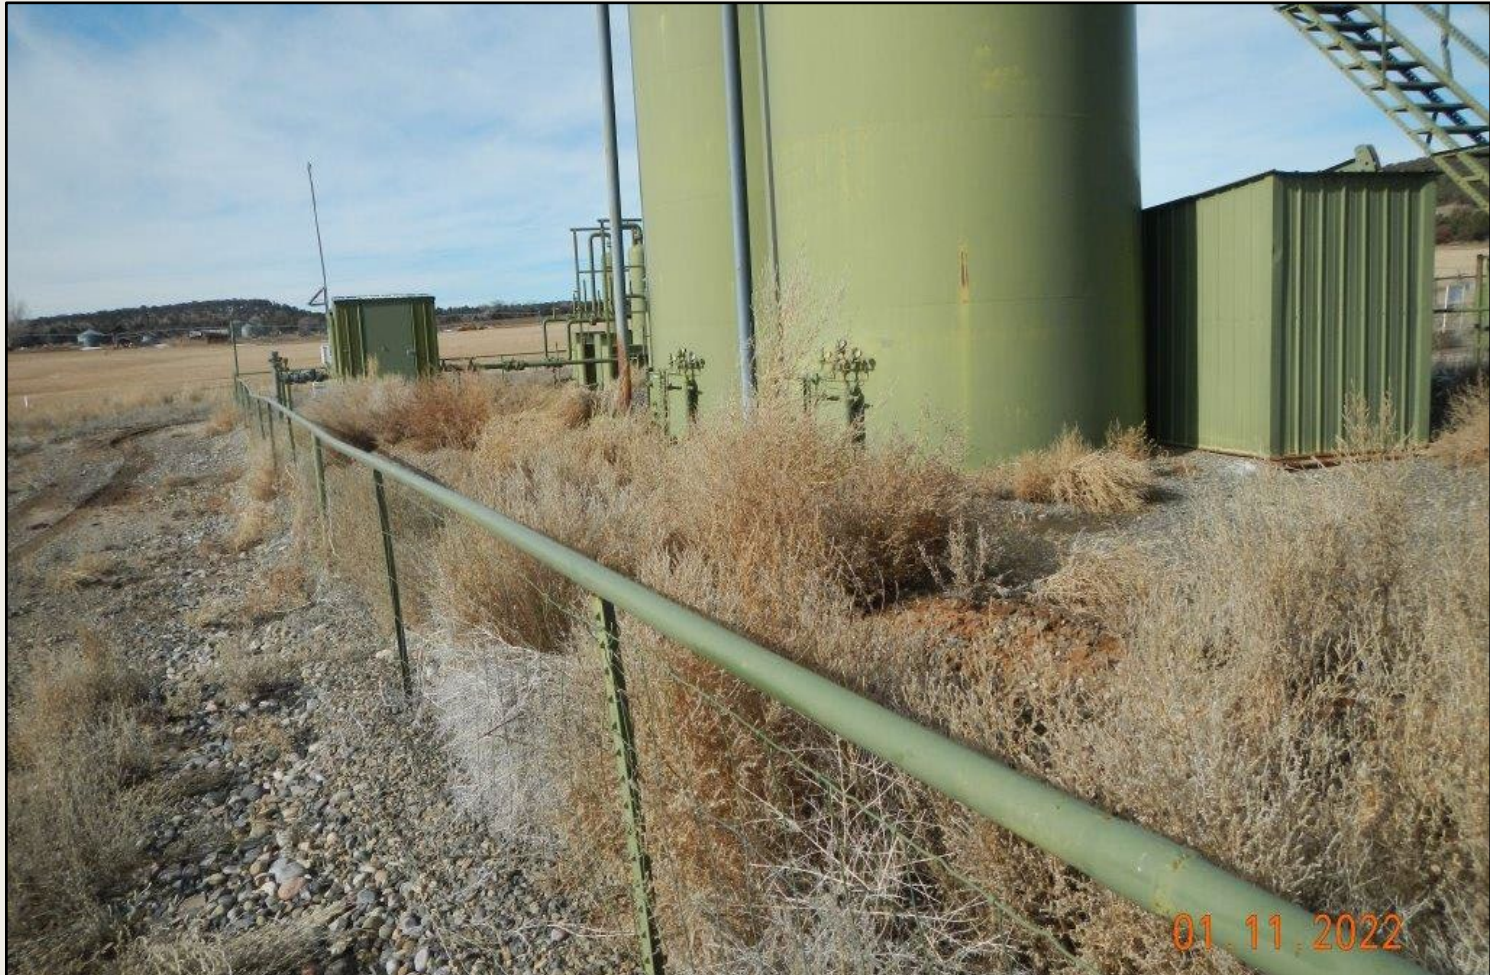
Photo 4. View of kochia debris within tan battery berms. Kochia debris observed throughout the project area and needs to be removed.

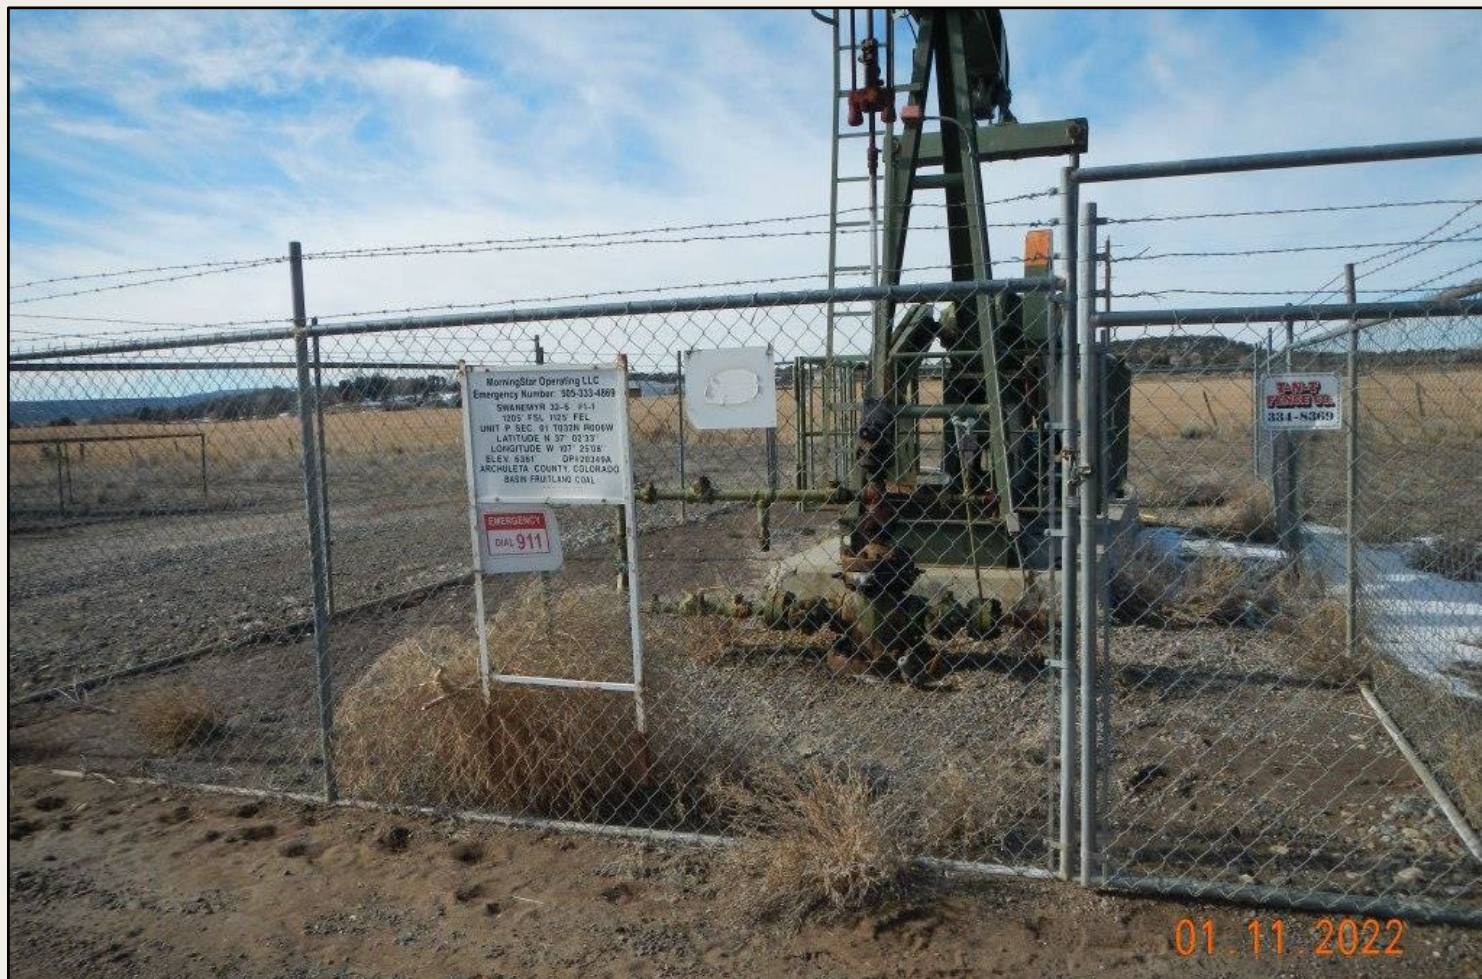
Photo 5. View of kochia debris around the wellhead.

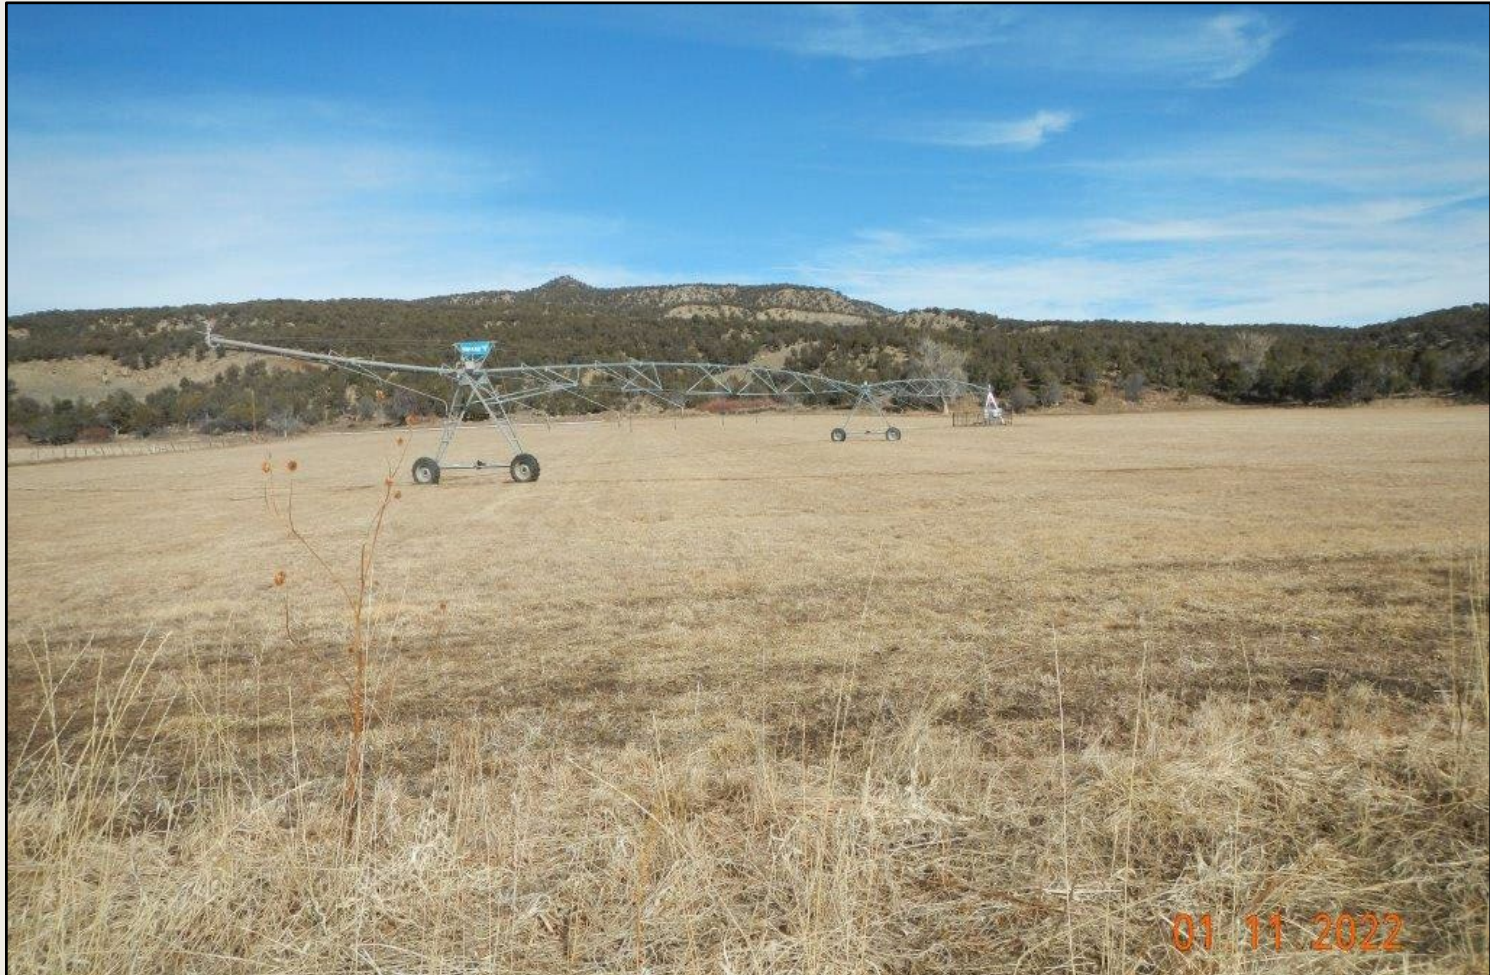
Photo 6. View of reference area, comprised of irrigated crop field, grasses are mowed and appear to be comprised of mixed wheatgrasses.
