Inspection Photos
Operator: Morningstar
API: 007-06212
Date: 1/11/2022

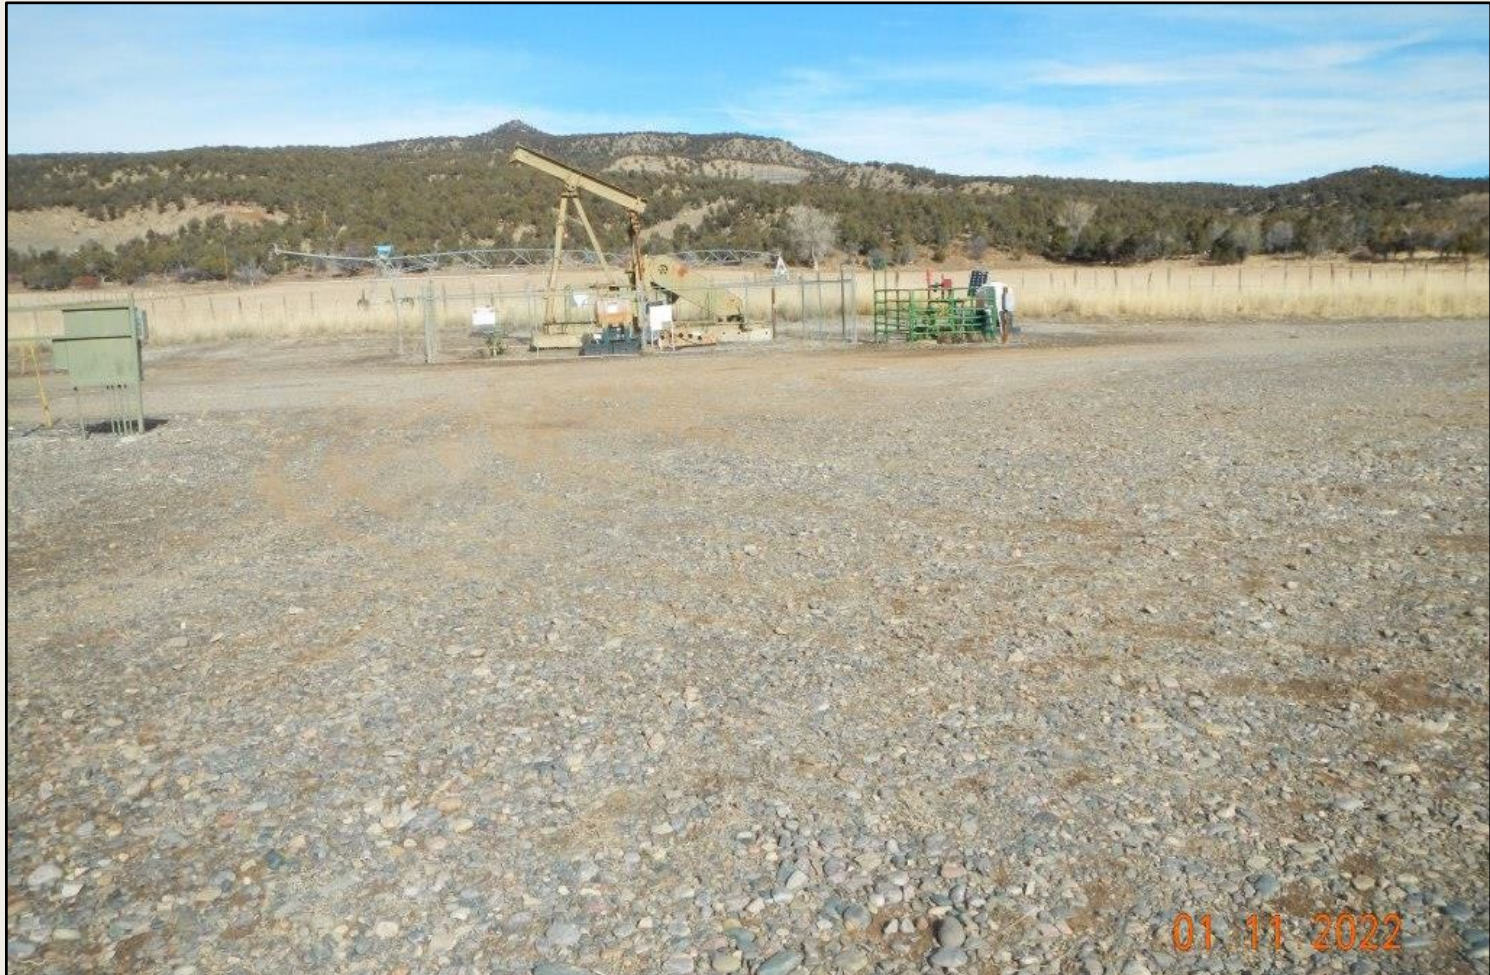
Photo 1. View of project area from the southwestern corner facing center.

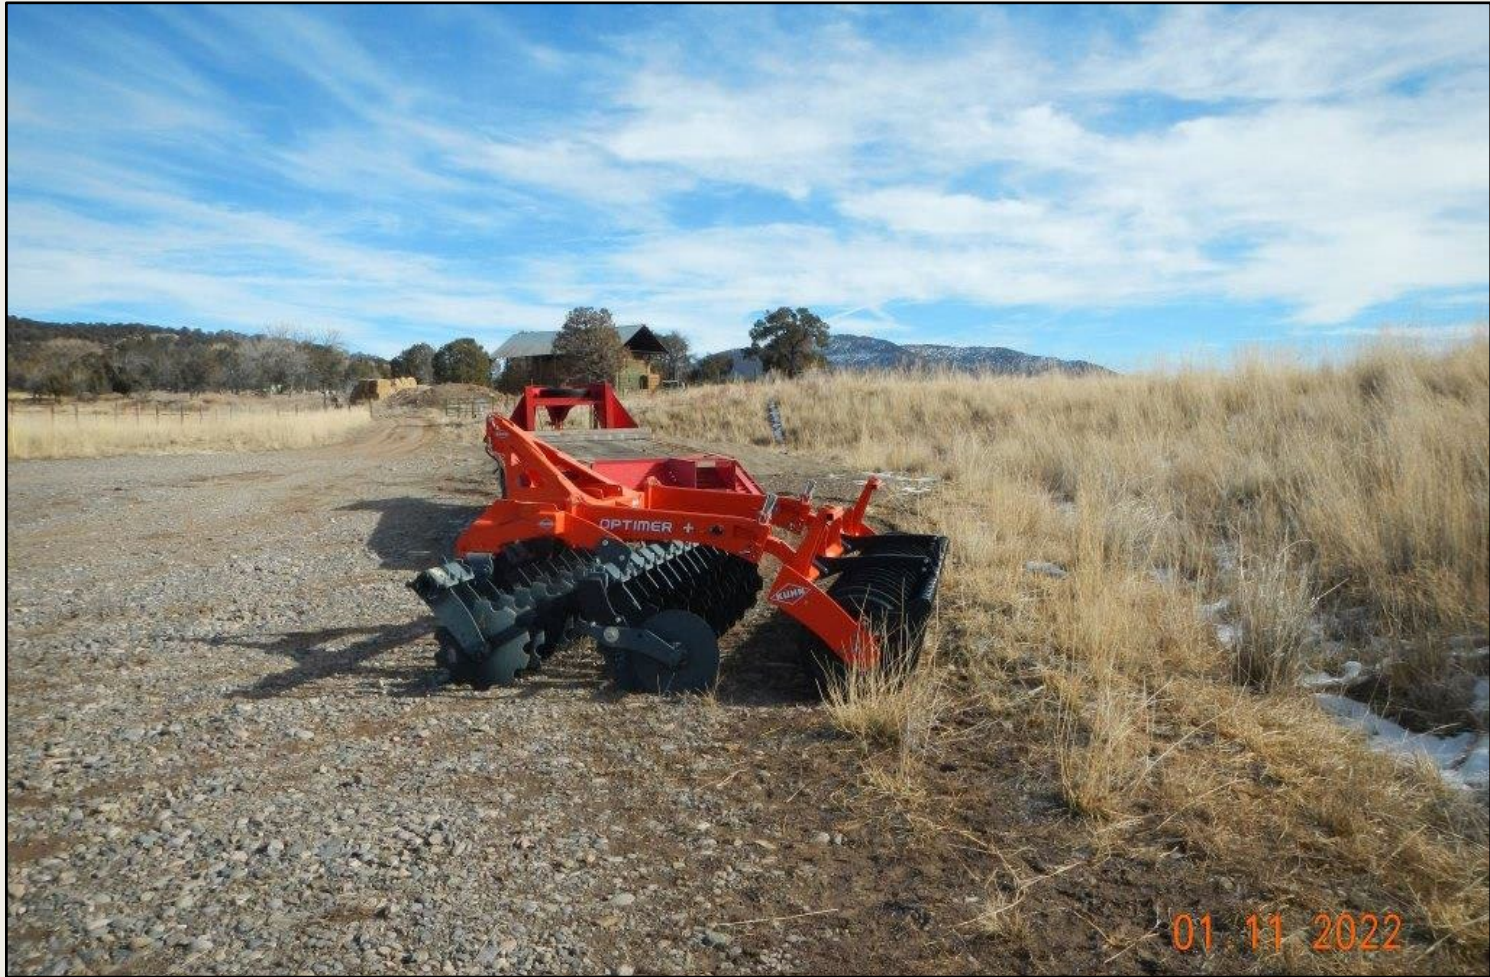
Photo 2. View of the southern project area from the southwestern corner facing eastward. Revegetation appears to be progressing with mixed wheatgrass such as intermediate wheatgrass and western wheatgrass. Unused equipment stored within the southern project area. Interim reclamation needs to be conducted within areas not needed for production operations.

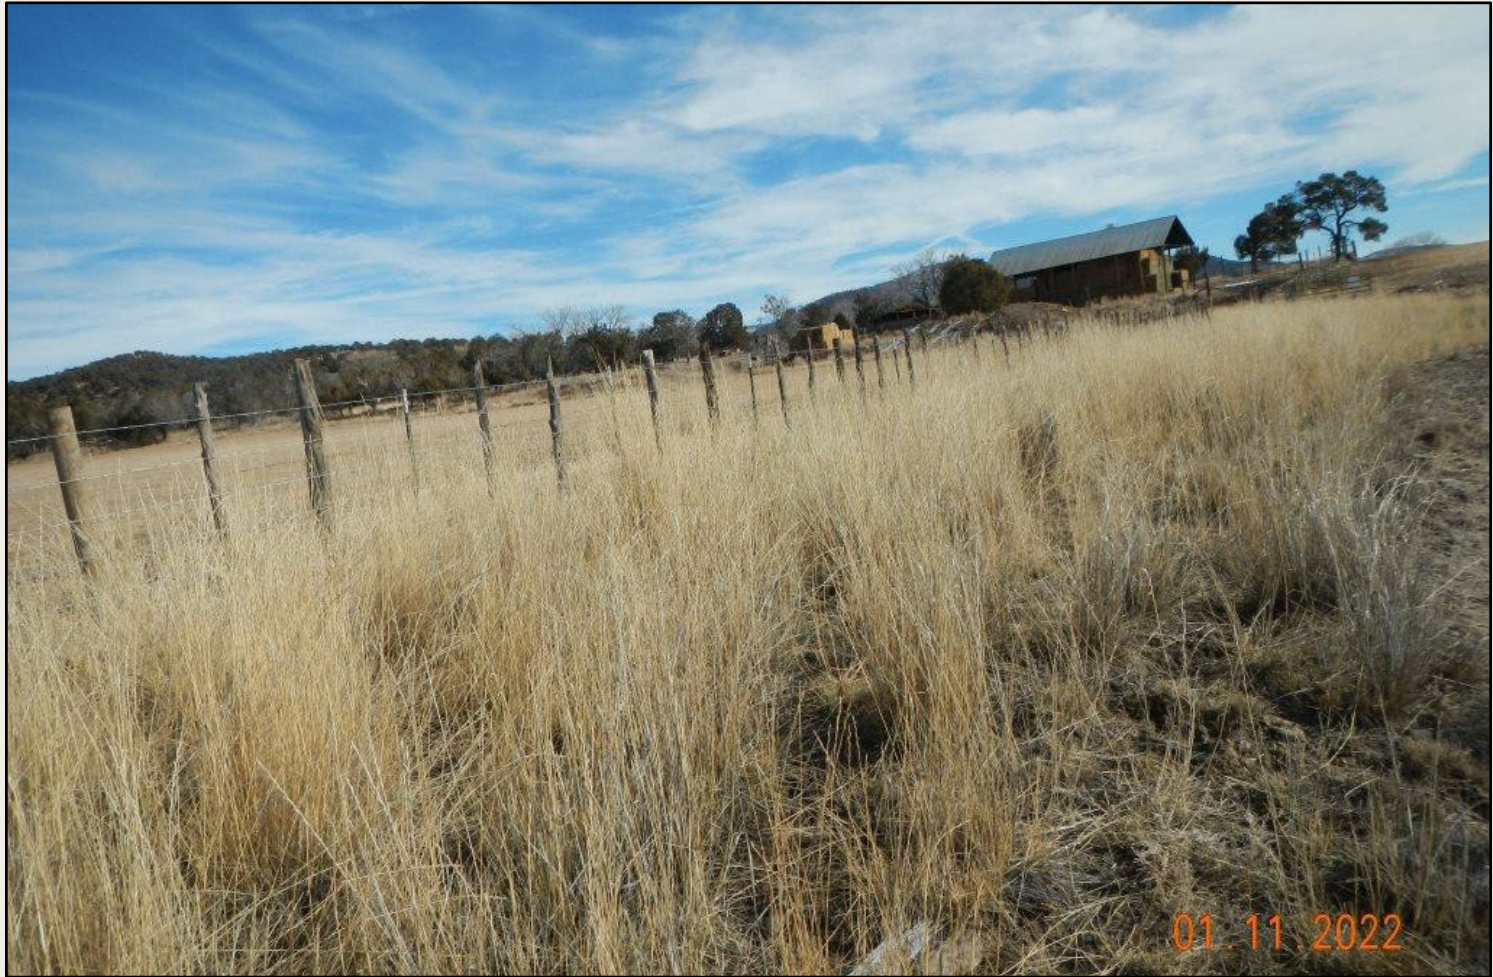
Photo 3. View of the northern project area from the northwestern corner facing eastward.

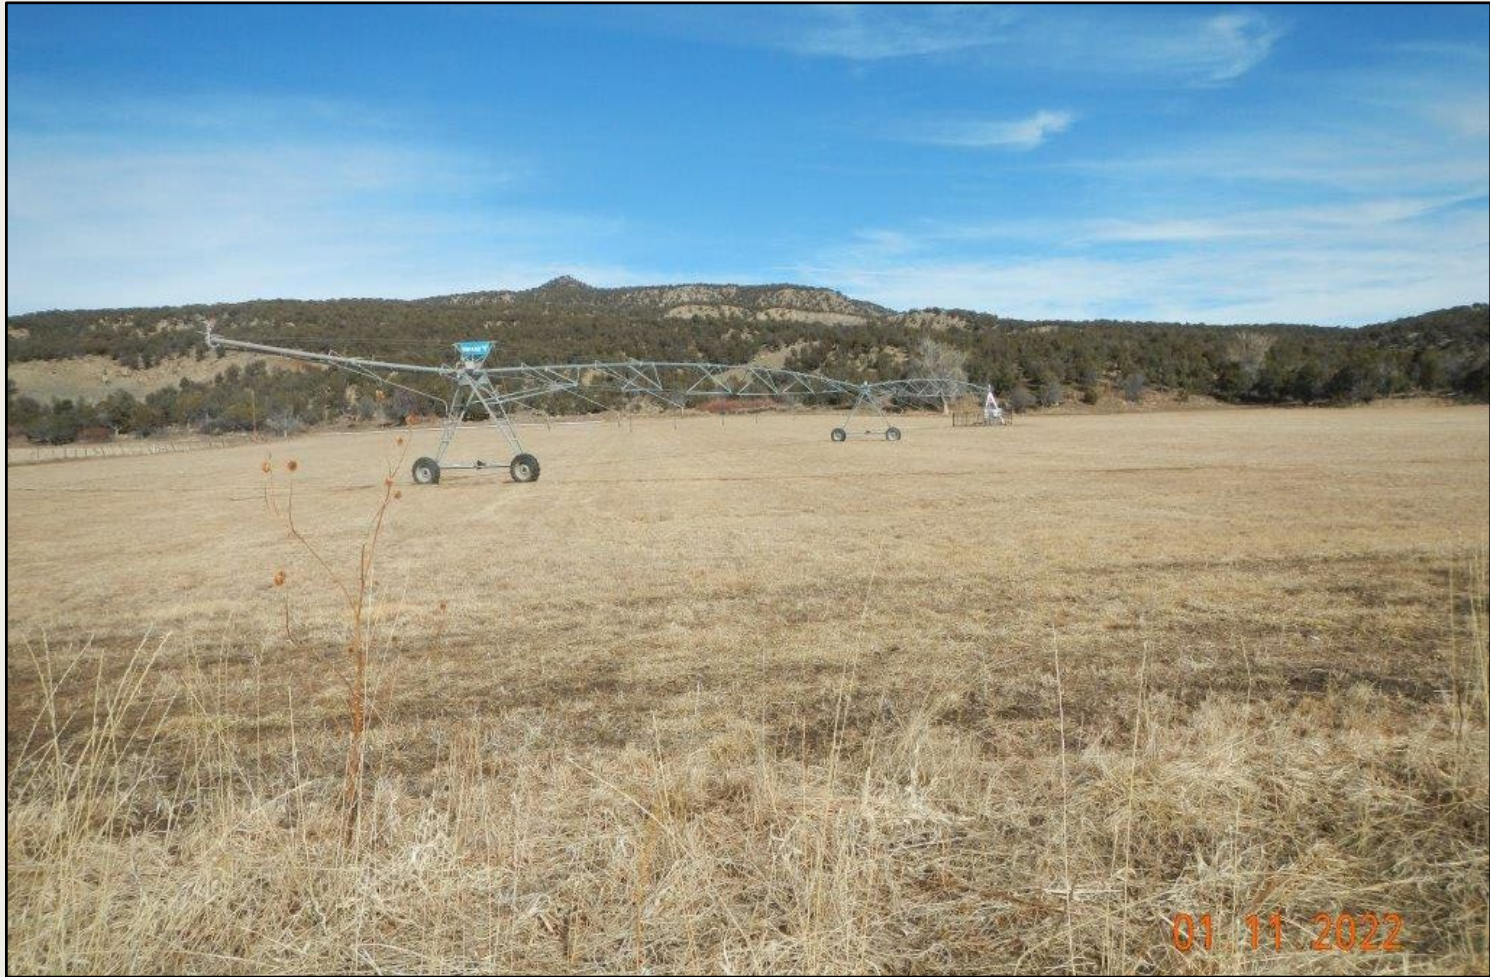
Photo 4. View of reference area, comprised of irrigated crop field, grasses are mowed and appear to be comprised of mixed wheatgrasses.
