KP Kauffman - COGCC Inspection Photos
Location: Firecracker Consolidation Release
Spill ID #481413 Date 01/13/2022

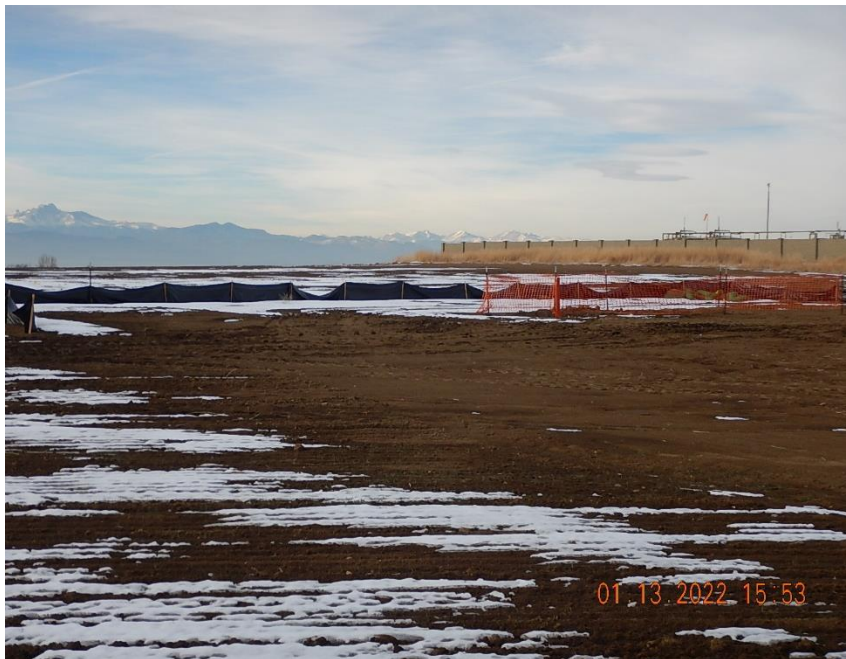
Firecracker consolidated flowline spill release area; view NW.

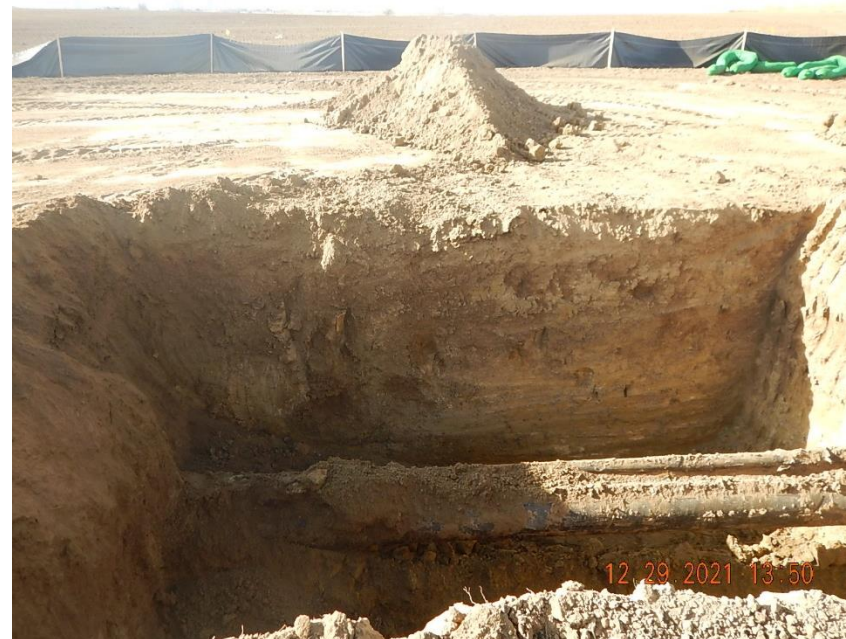
View of flowlines exposed in excavation at Firecracker release: (1) 10" carbon steel Firecracker consolidation flowline; (1) 2" carbon steel off location gas flowline.

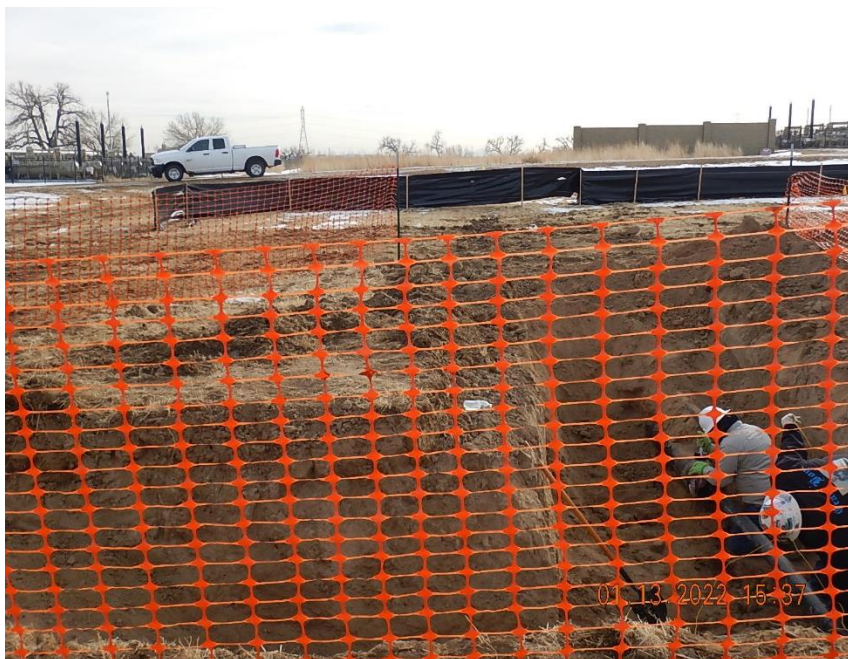
View from north bell hole excavation to south toward the Firecracker release point; KPK field personnel in process of completing flowline repairs.

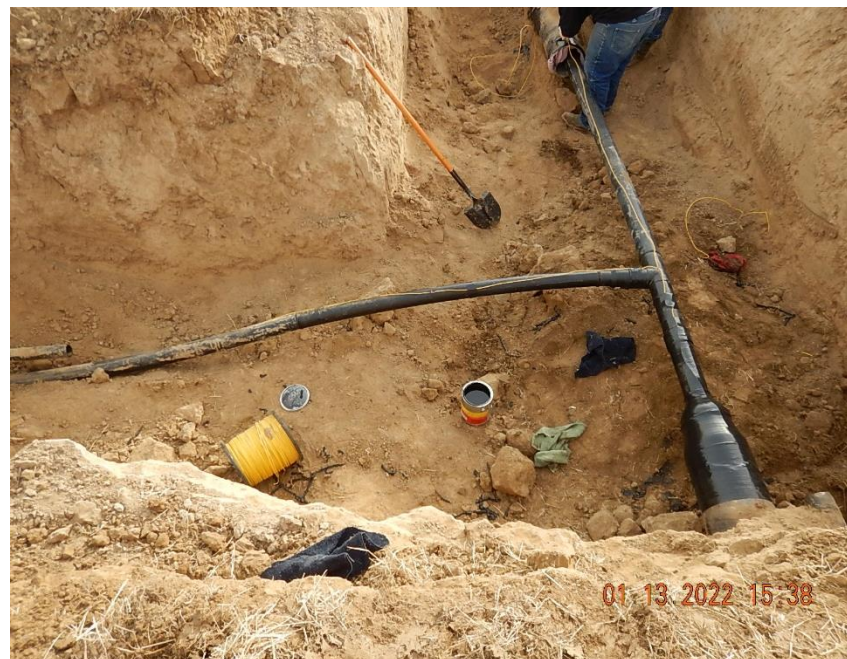
Flowline repairs being completed in north bell hole excavation. 10" CS pipe to 4" HDPE pipe transition; 3" HDPE flowline tie in from Foreman Unit #2 well. Tracer wire being installed at time of inspection.

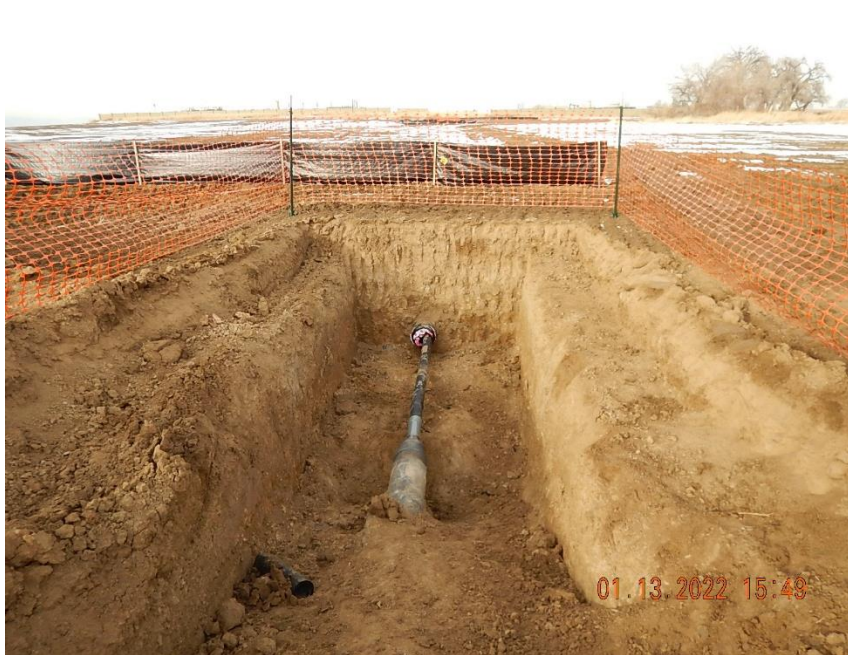
View from south bell hole excavation to north toward the Firecracker release point; flowline repairs in progress.

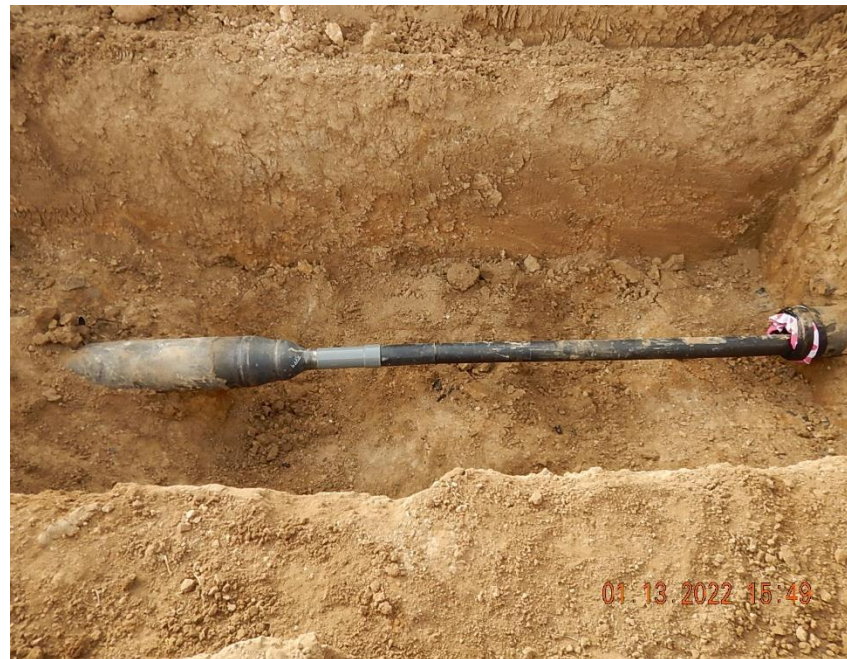
Flowline repairs being completed at south bell hole excavation. 10" OD CS pipe to 4" OD HDPE pipe transition. Approximately 1245' linear feet of 4" HDPE pipe sliplined through existing 10" firecracker consolidation flowline (across failure point at spill ID #481413).
