**Inspection Photos**  
**Location Name: Ignacio Gas Plant**  
**Facility ID: 412668**

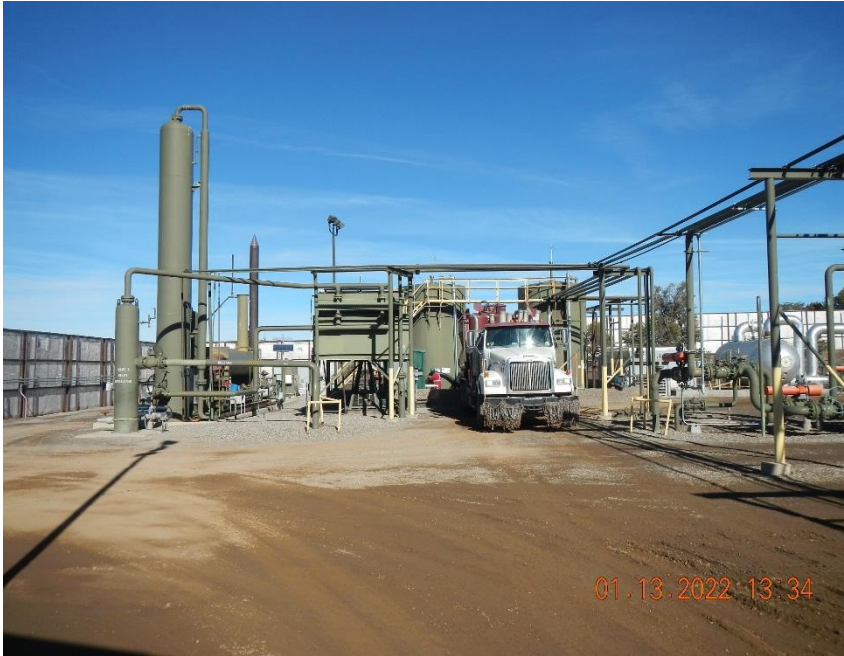
**Hydrovac truck on site removing impacted material.**

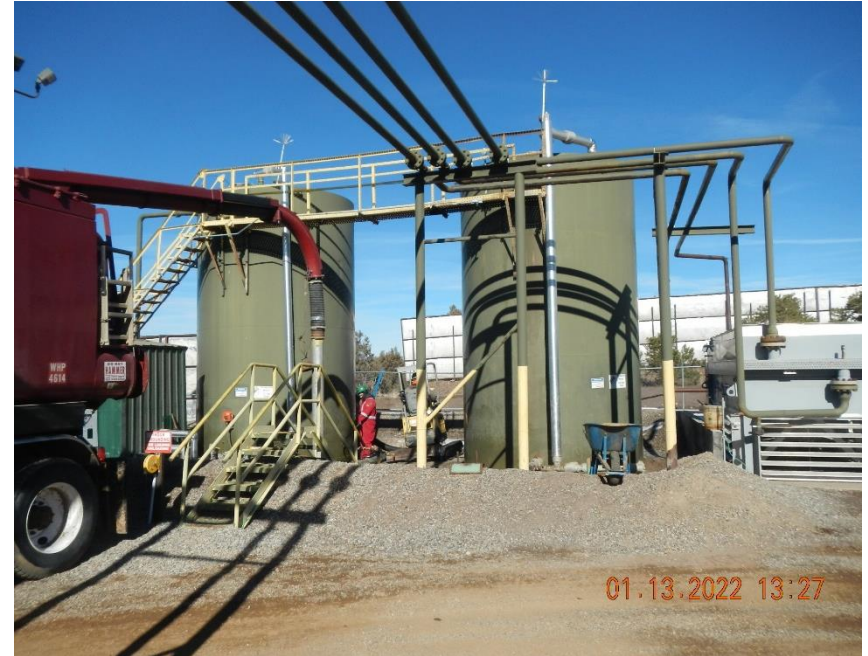
**Personnel removing impacted material from within secondary containment berm.**

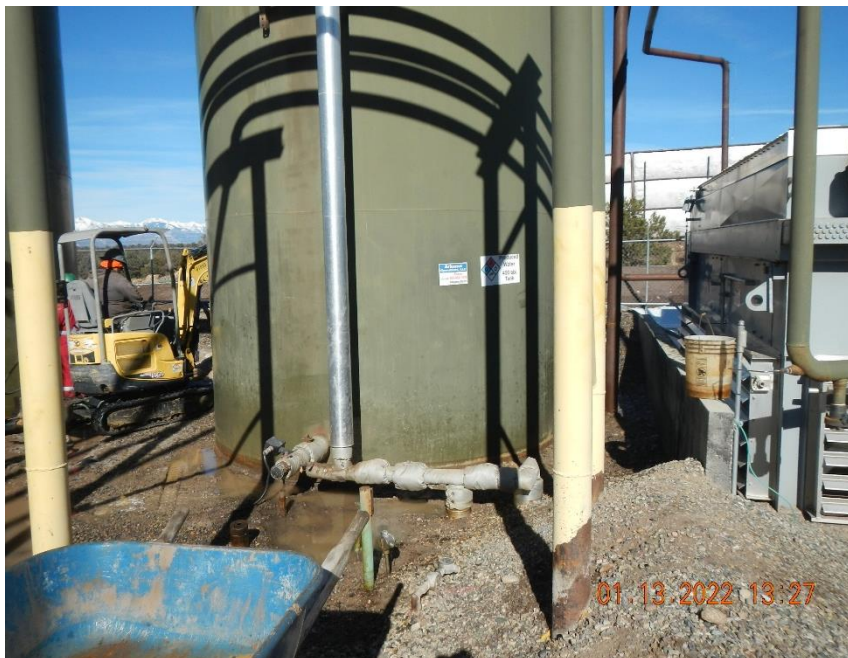
**400 bbl. AST where spill/release originated.**

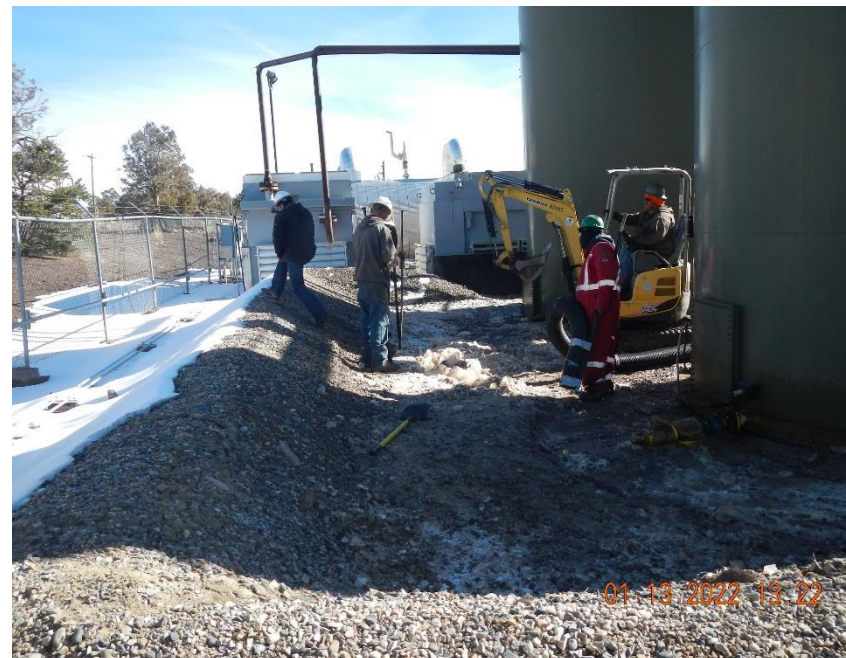
**Personnel removing ice from within secondary containment berm.**

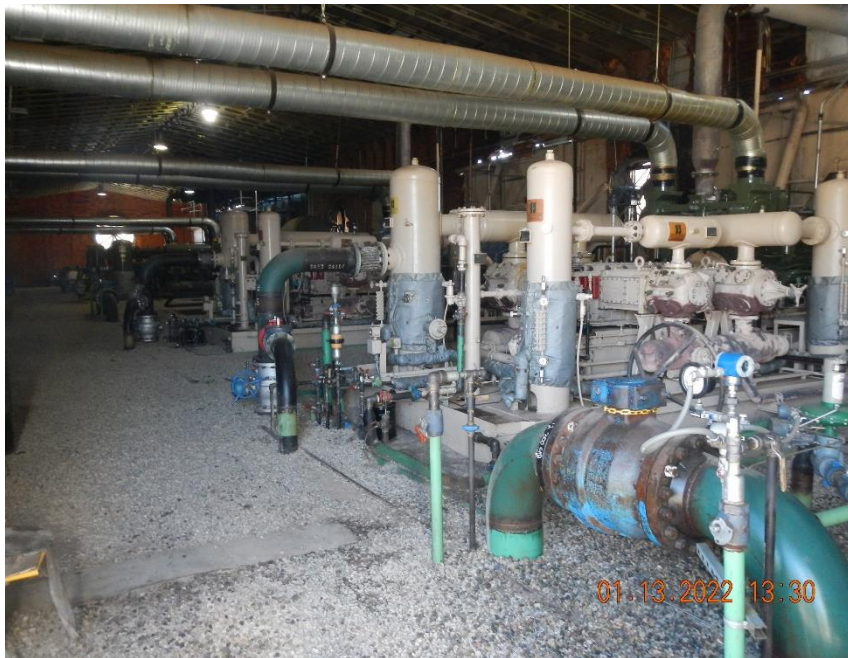
**Compressors within steel building.**

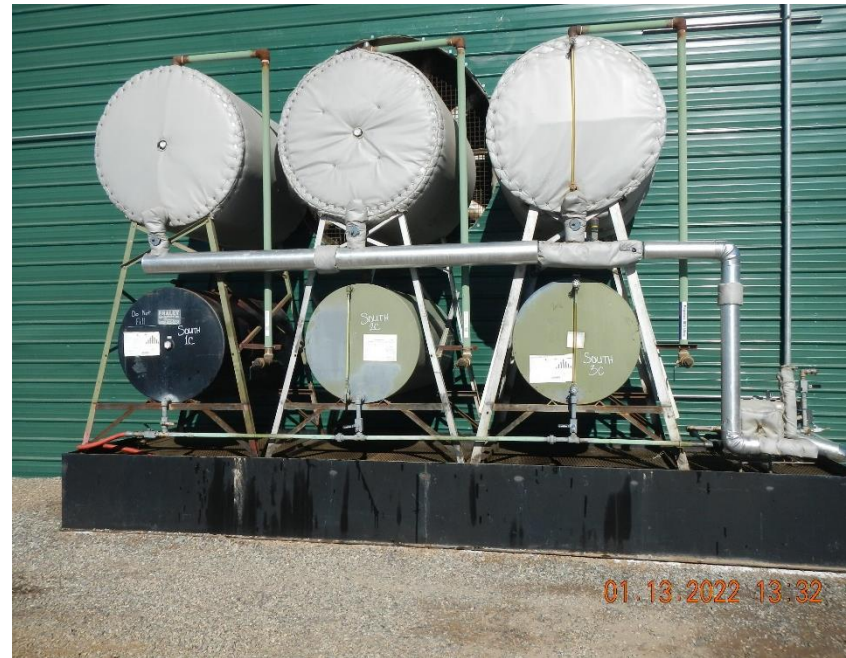
**Secondary containment for lube oil containers.**
