Inspection Photos
Location Name: Mollie Corynne 33-7-2 #2A
API: 05-067-08800

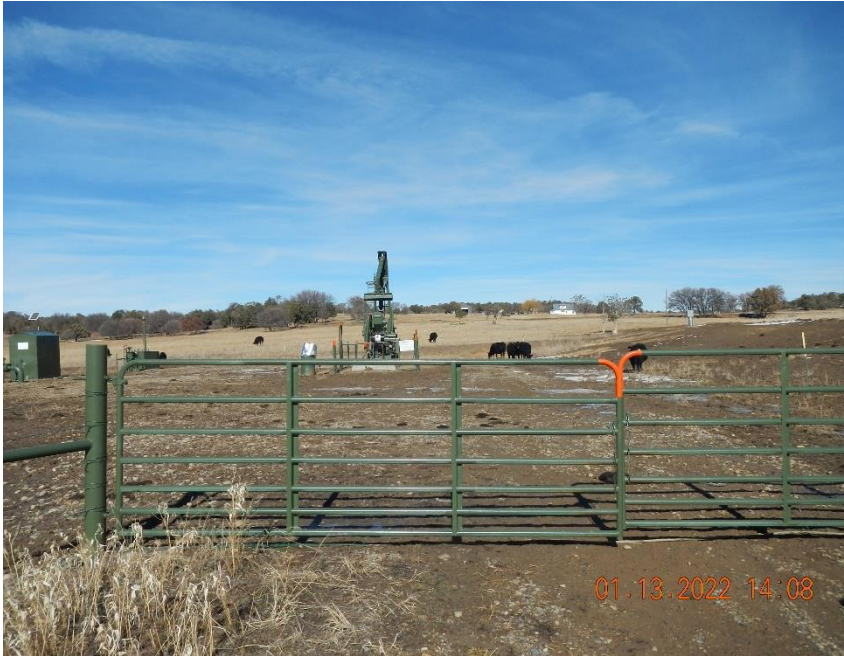
Mollie Corynne 33-7-2 #2A location photo.

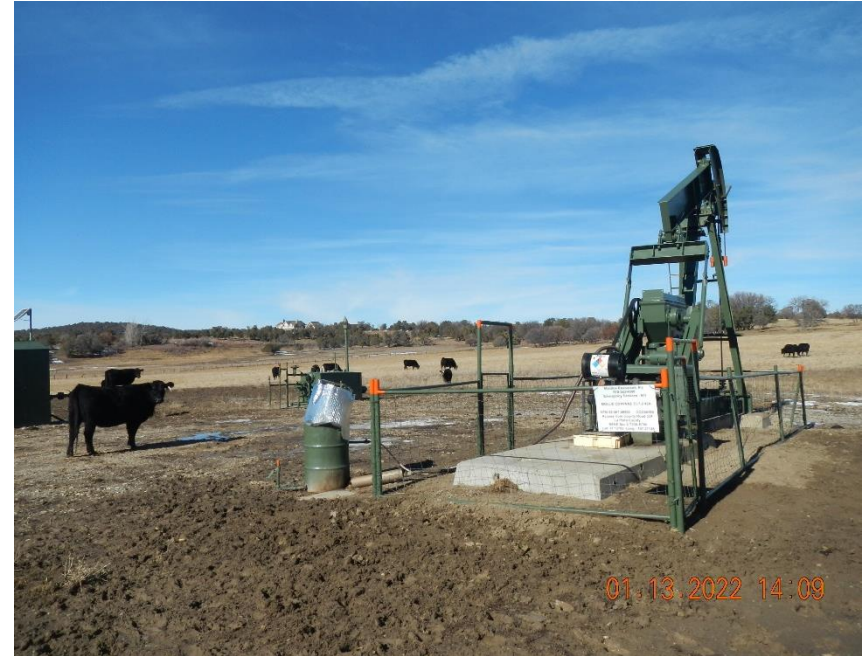
Mollie Corynne 33-7-2 #2A equipment overview.

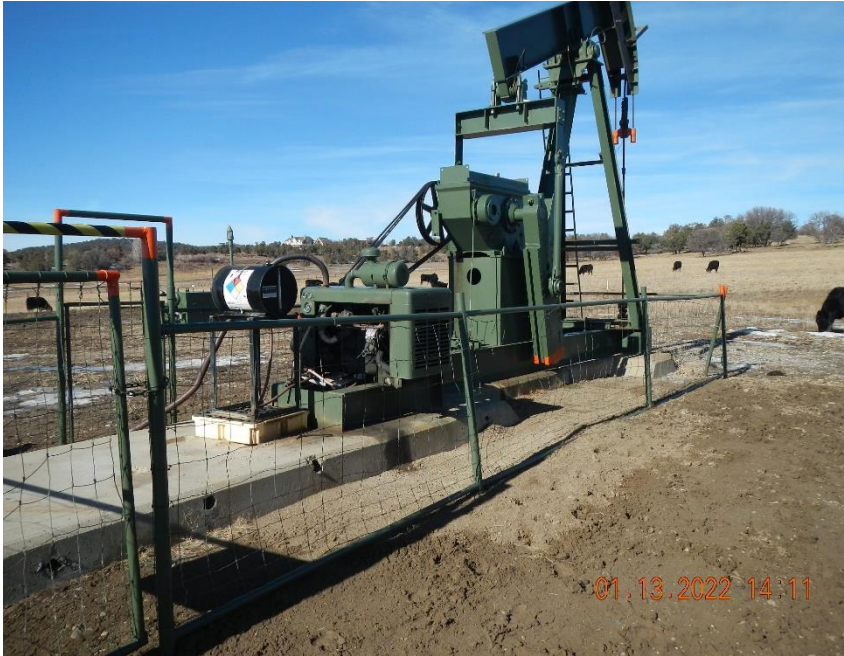
Staining beneath the prime mover on the concrete pad and adjacent soil.

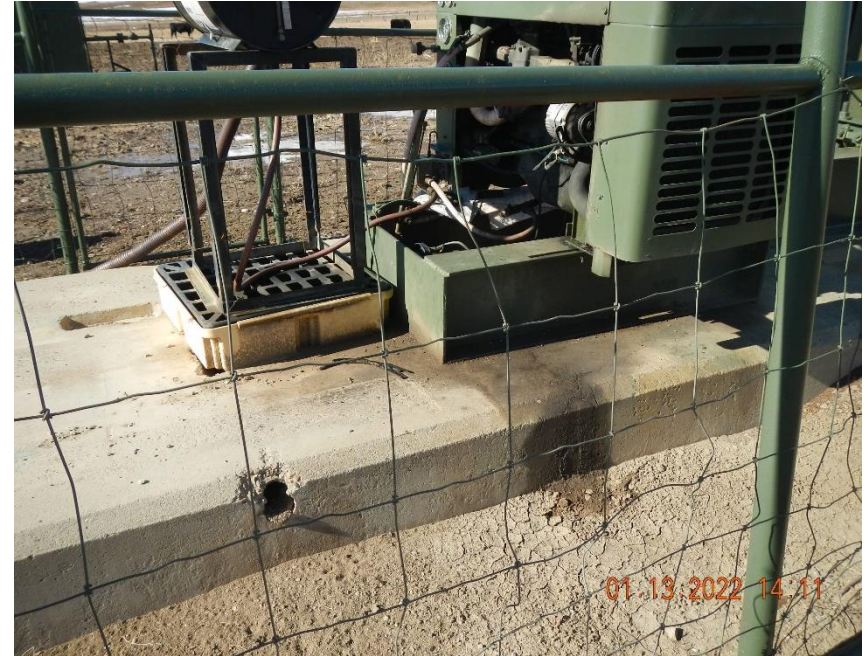
Staining beneath prime mover.

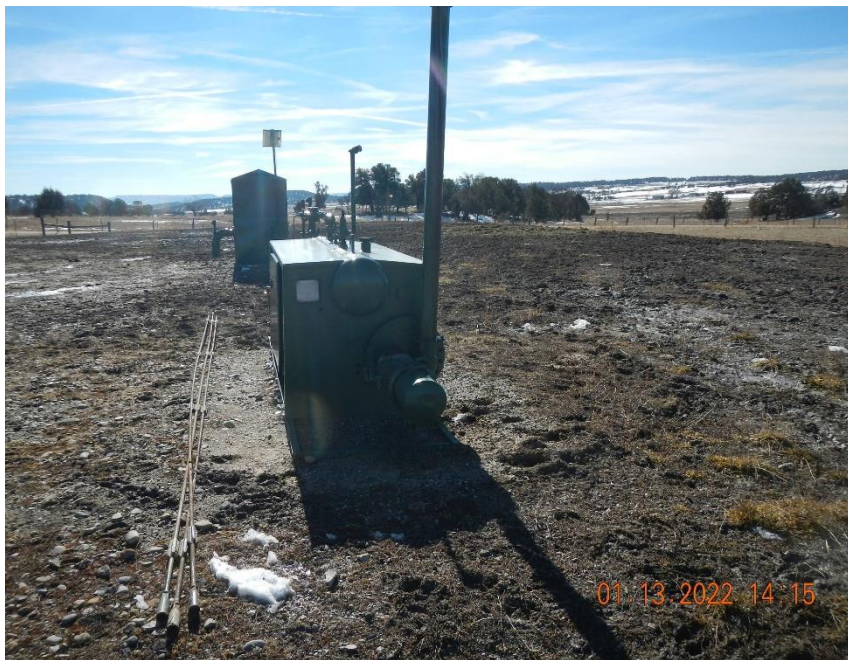
Unused equipment near separator.

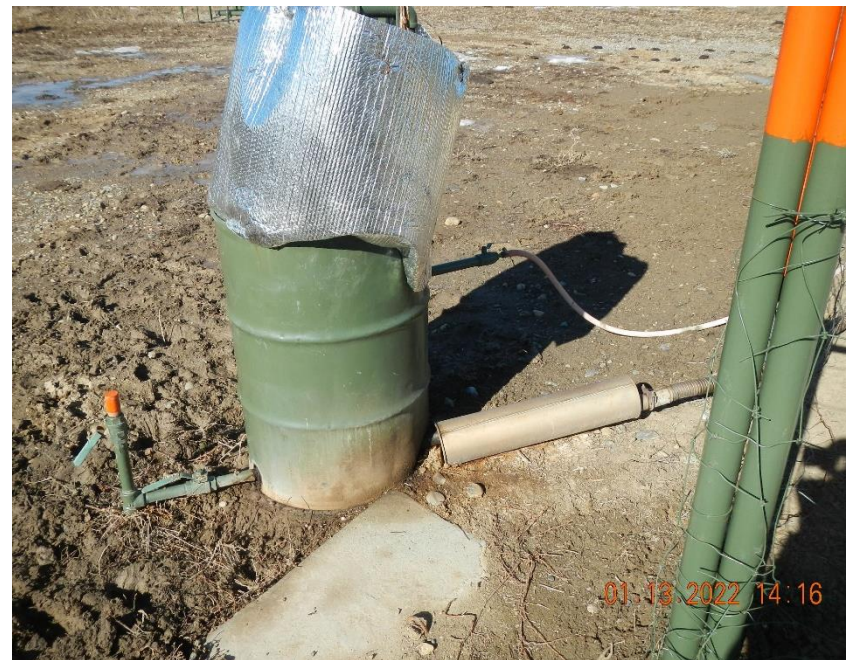
Drop out tank for supply gas. Prime mover exhaust ported into drum.
