Inspection Photos
Operator: Simcoe
API: 067-06818
Date: 1/14/2022

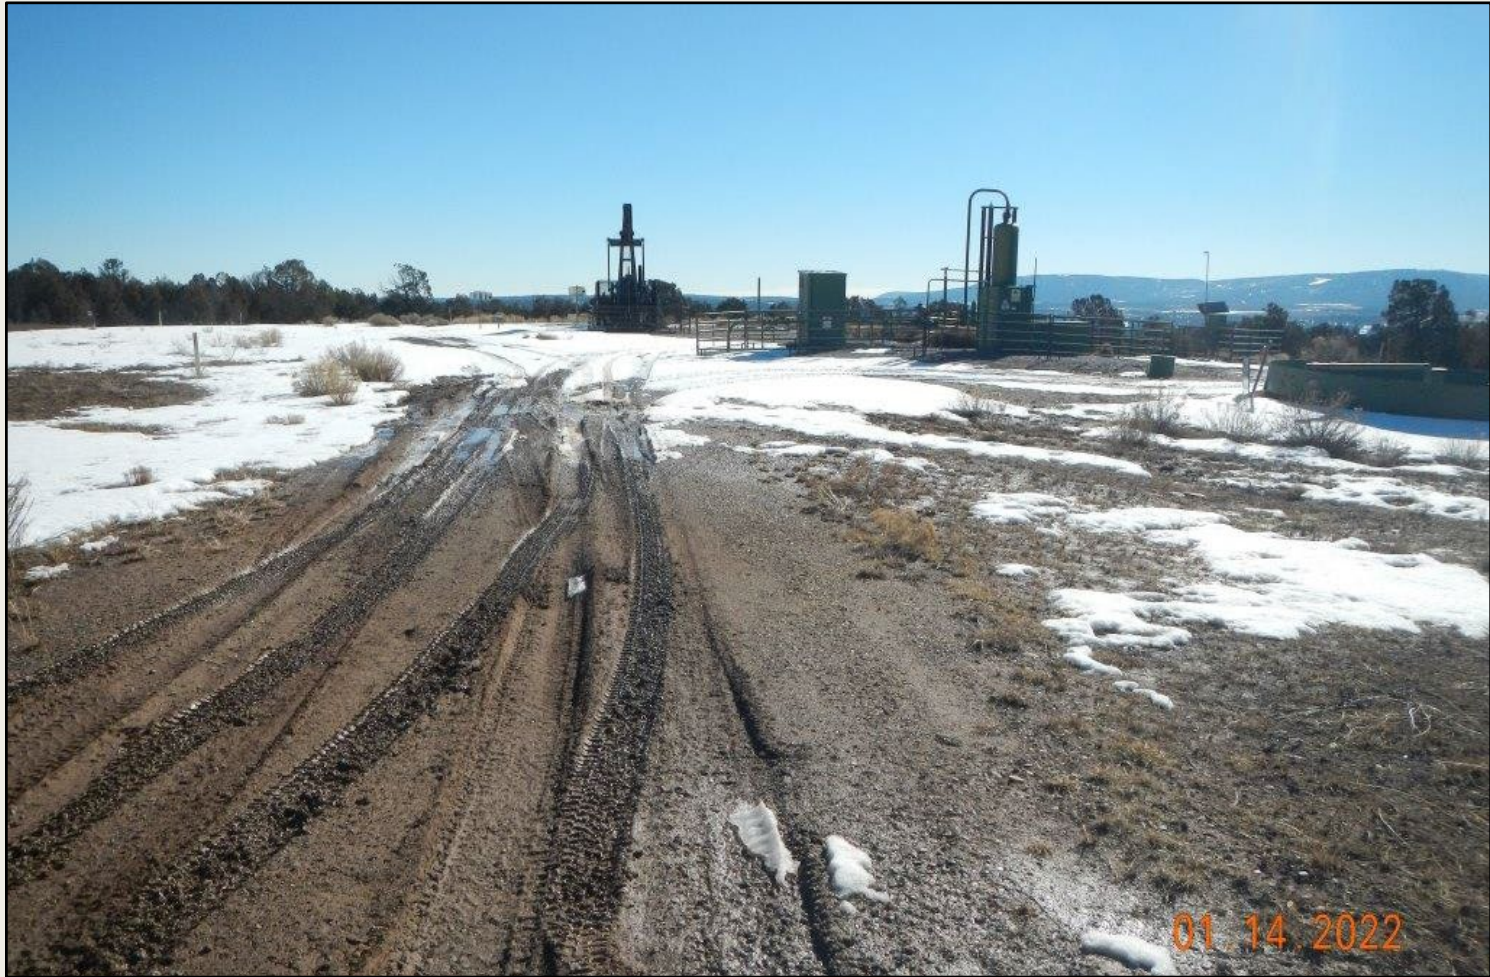
Photo 1. View of project area from the well pad entrance facing center.

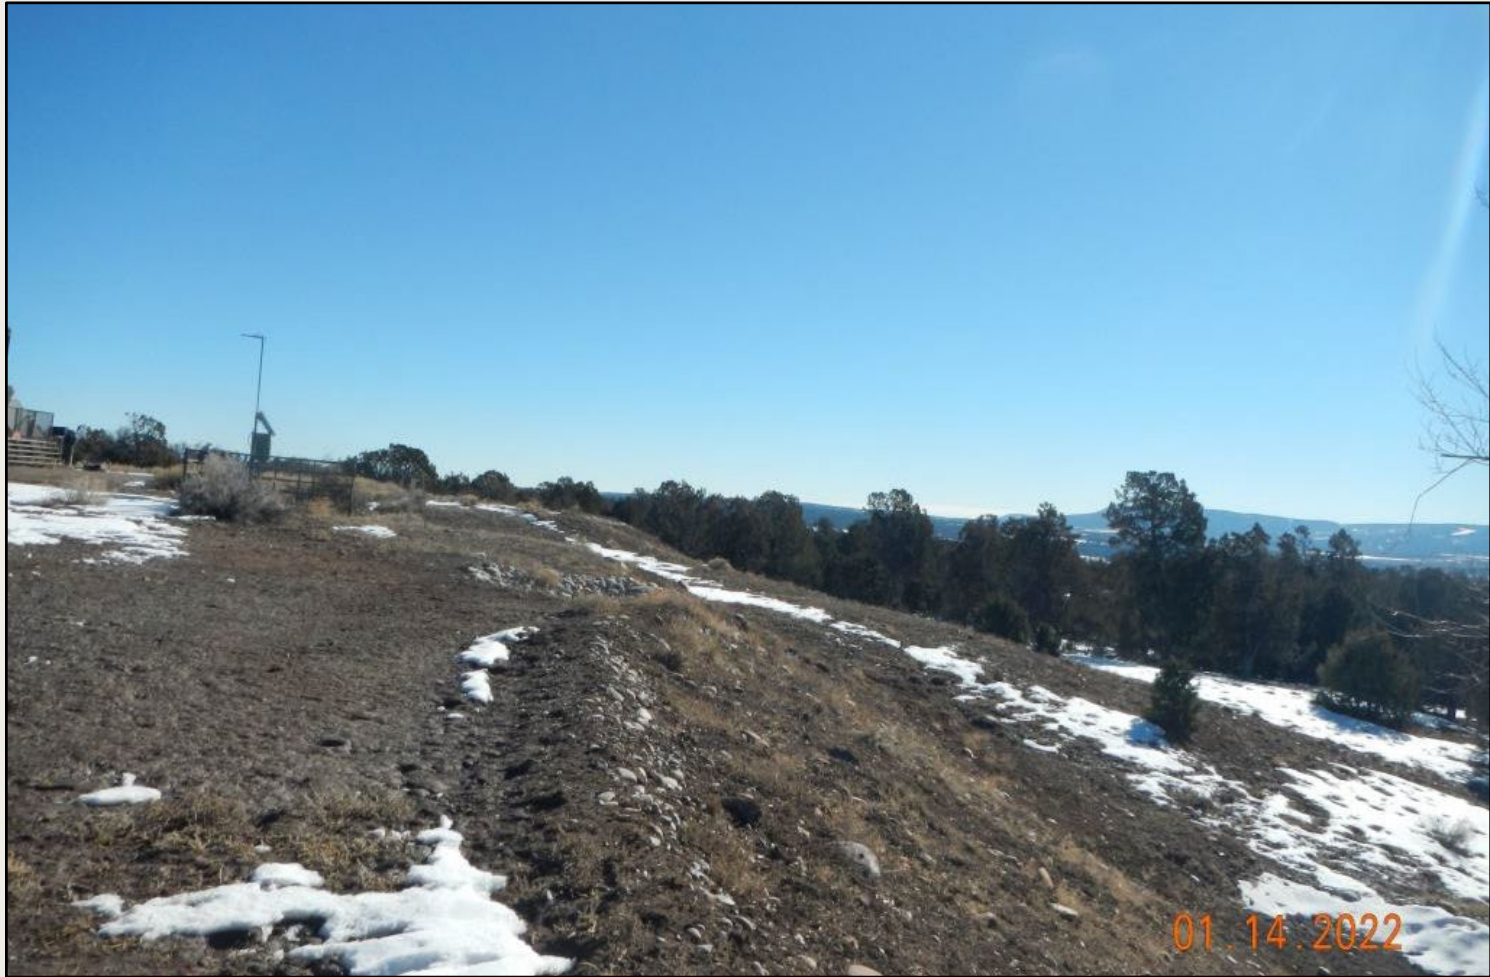
Photo 2. View of the western project area from the northwestern corner facing southward. Revegetation appears to be progressing in portions with western wheatgrass and sand dropseed.

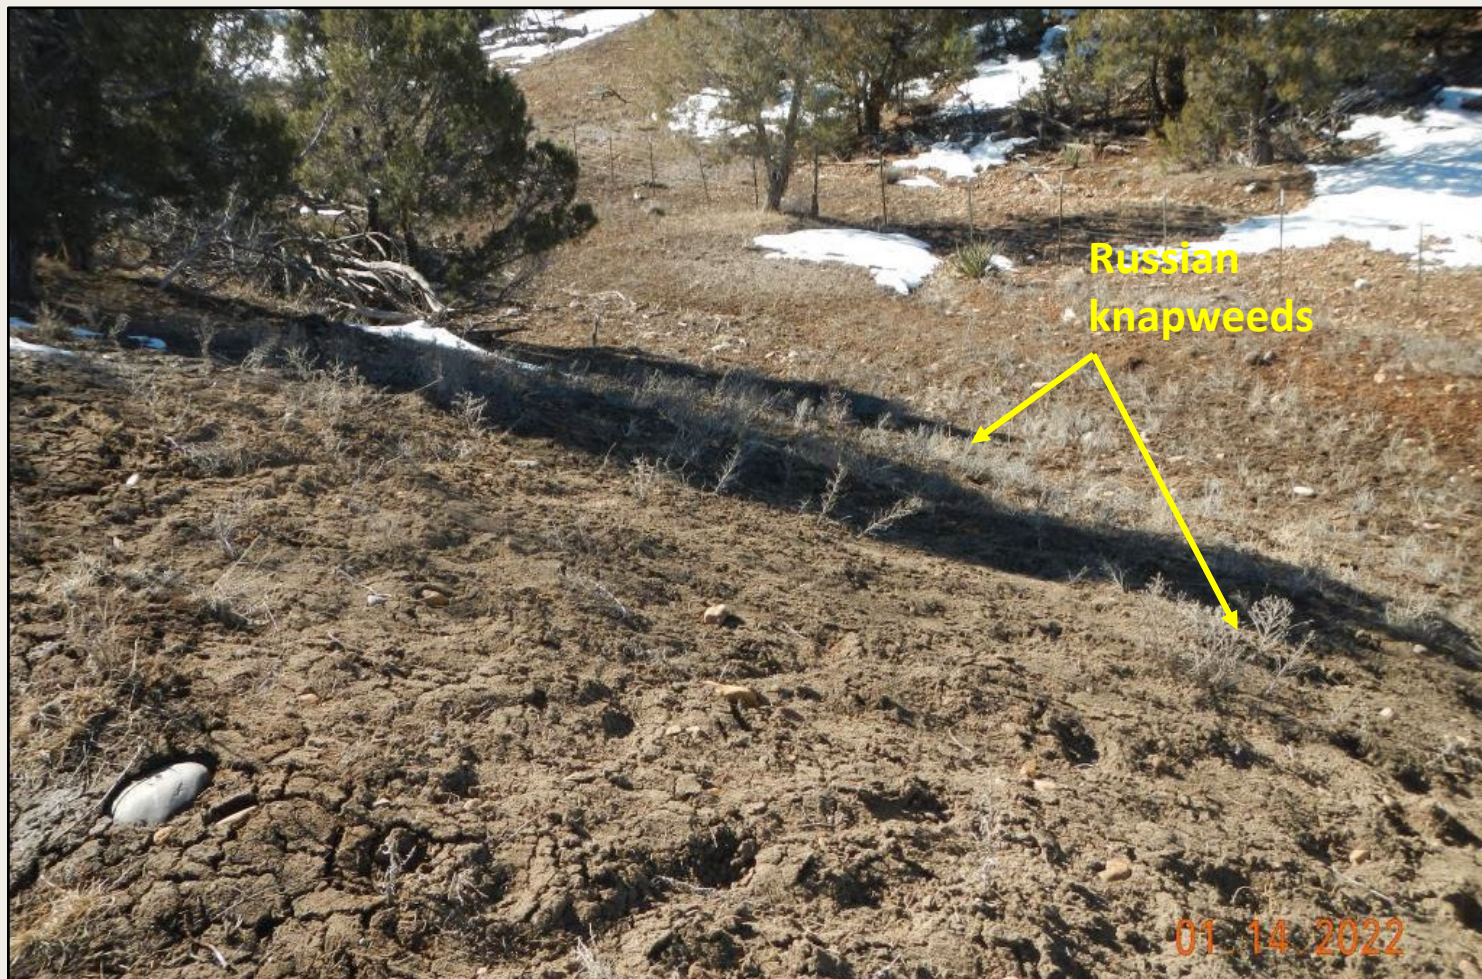
Photo 3. View of the northwestern fill slope facing down-slope. Little desirable vegetation. Russian knapweed is present.
