Inspection Photos
Operator: Simcoe
API: 067-08331
Date: 1/14/2022

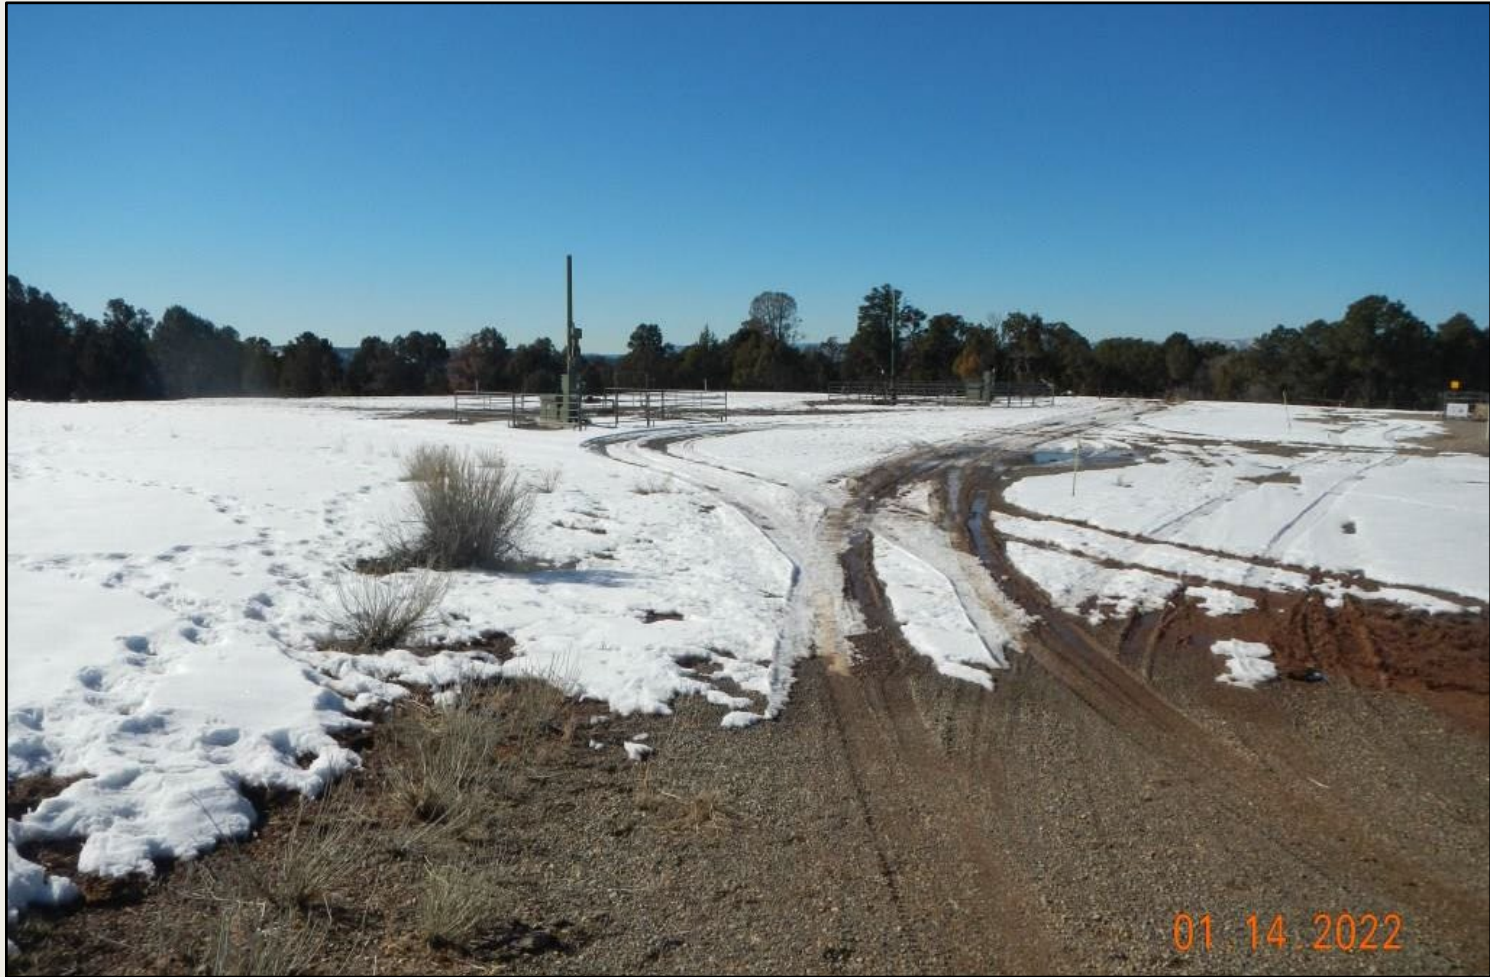
Photo 1. View of project area from the well pad entrance facing center.

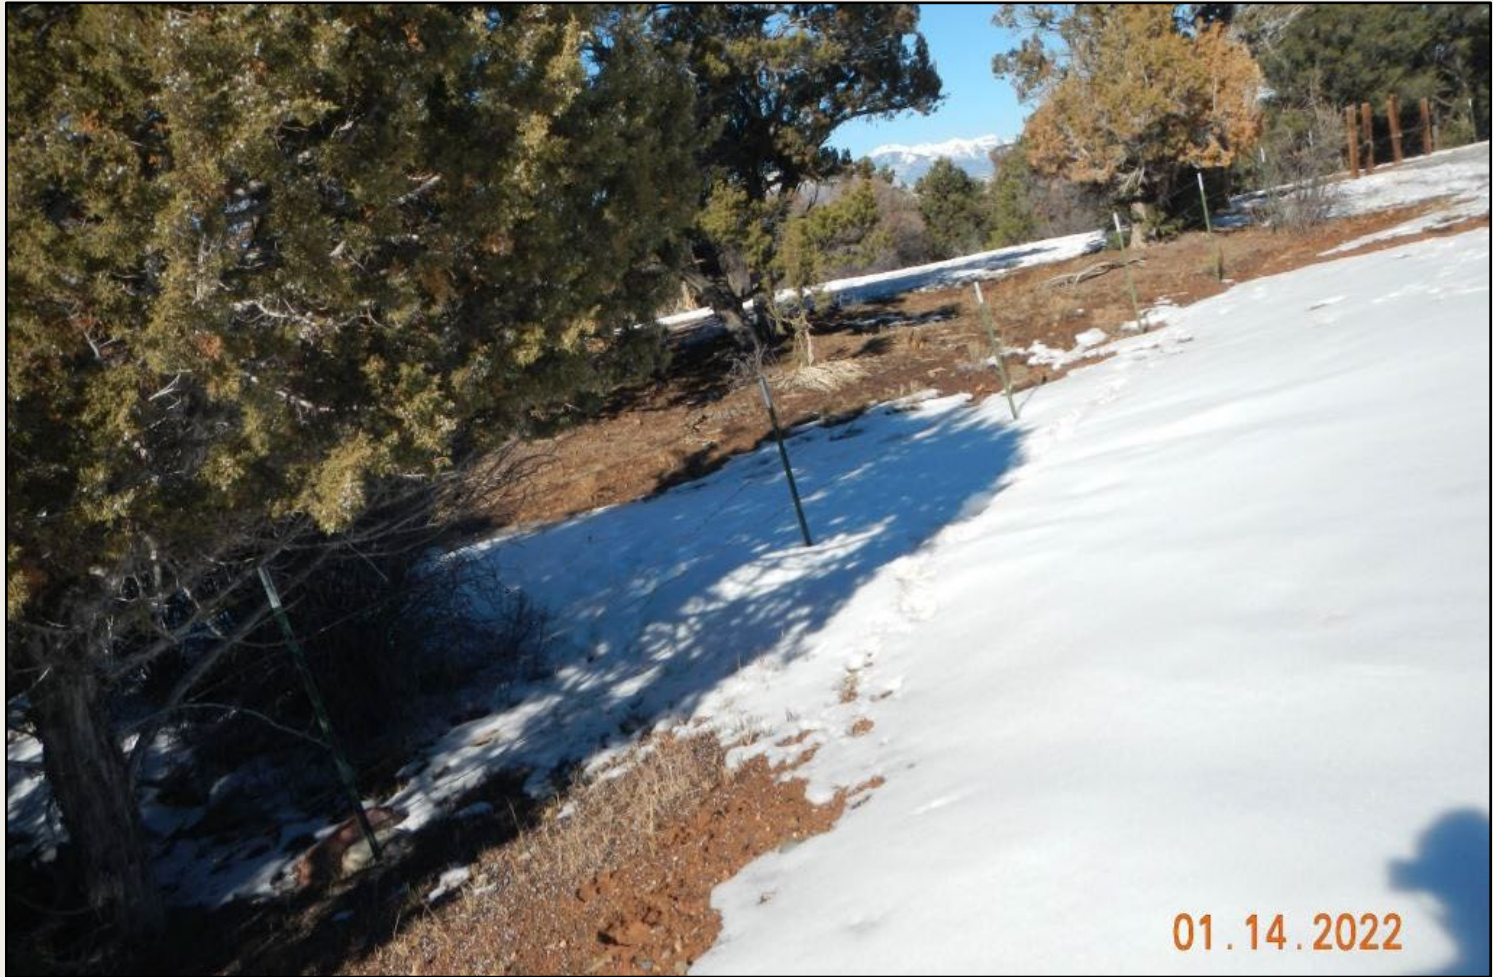
Photo 2. View of the western project area from the northwestern corner facing southward. Revegetation appears to be progressing in portions with western wheatgrass and sand dropseed.

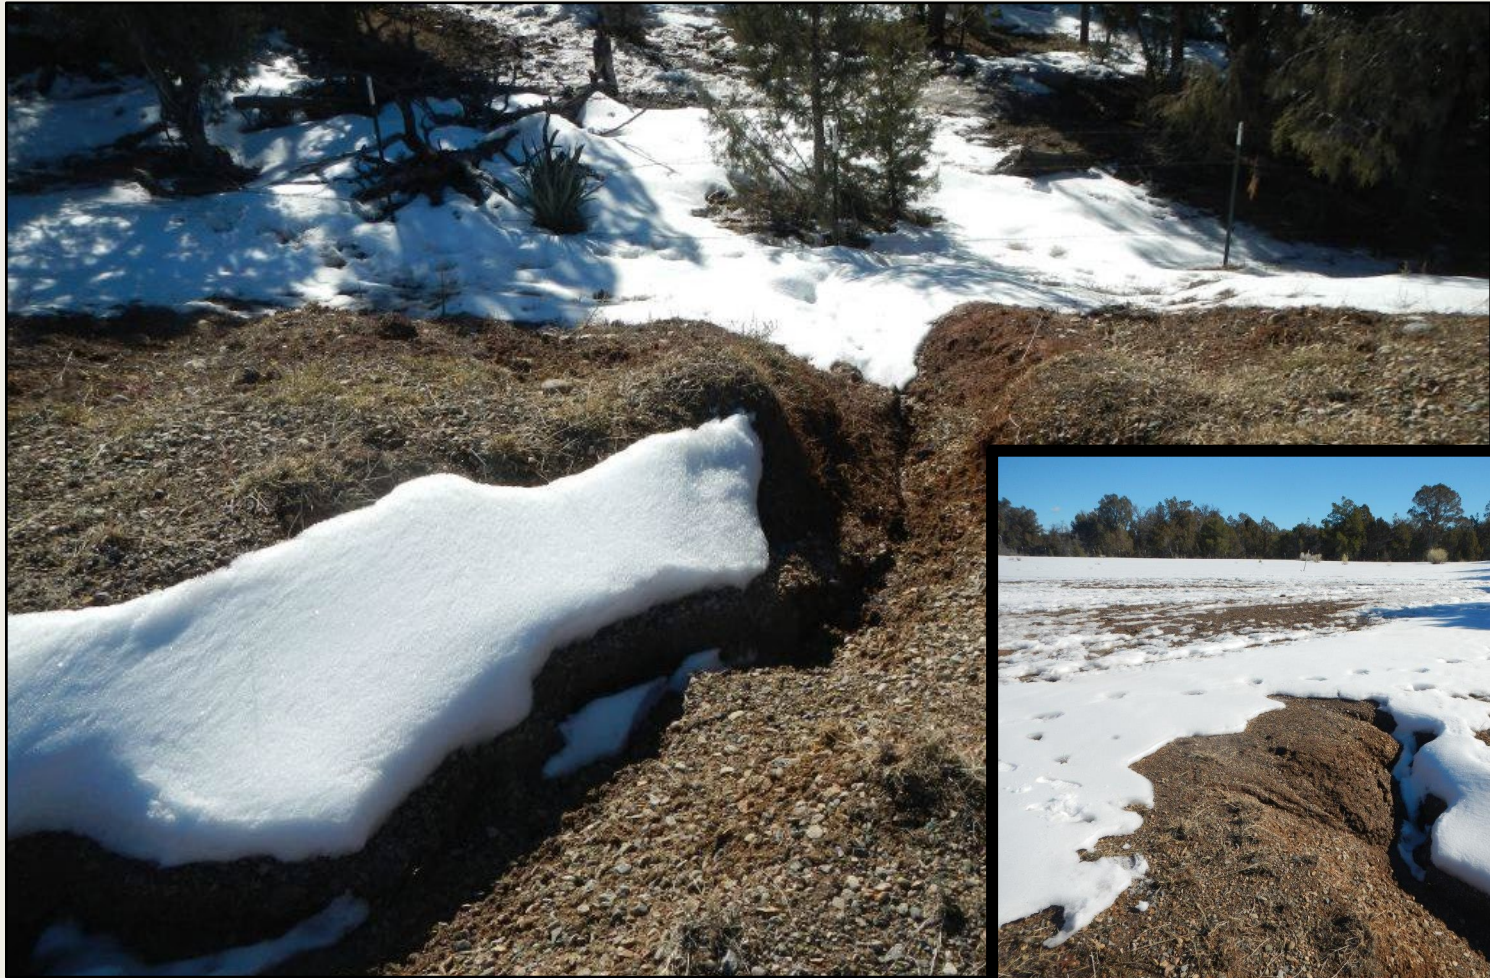
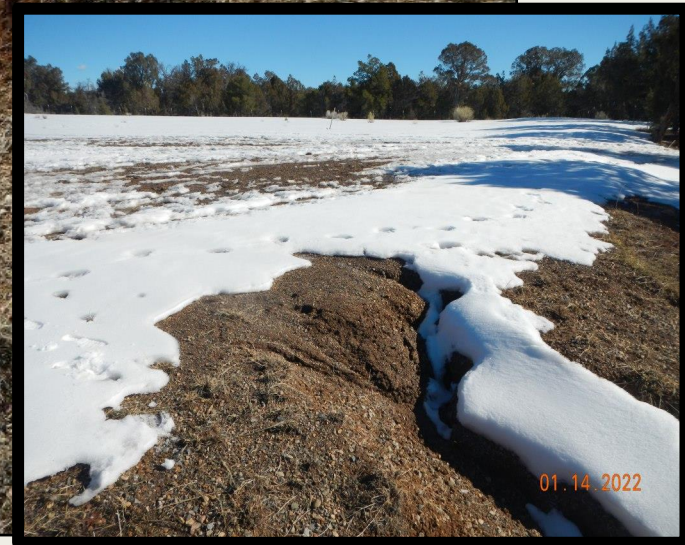
Photo 3. View of erosional channeling approximately 2ft wide and deep observed within the southern project area. Inset shows area where concentrated stormwater flows off of the southern fill slope.

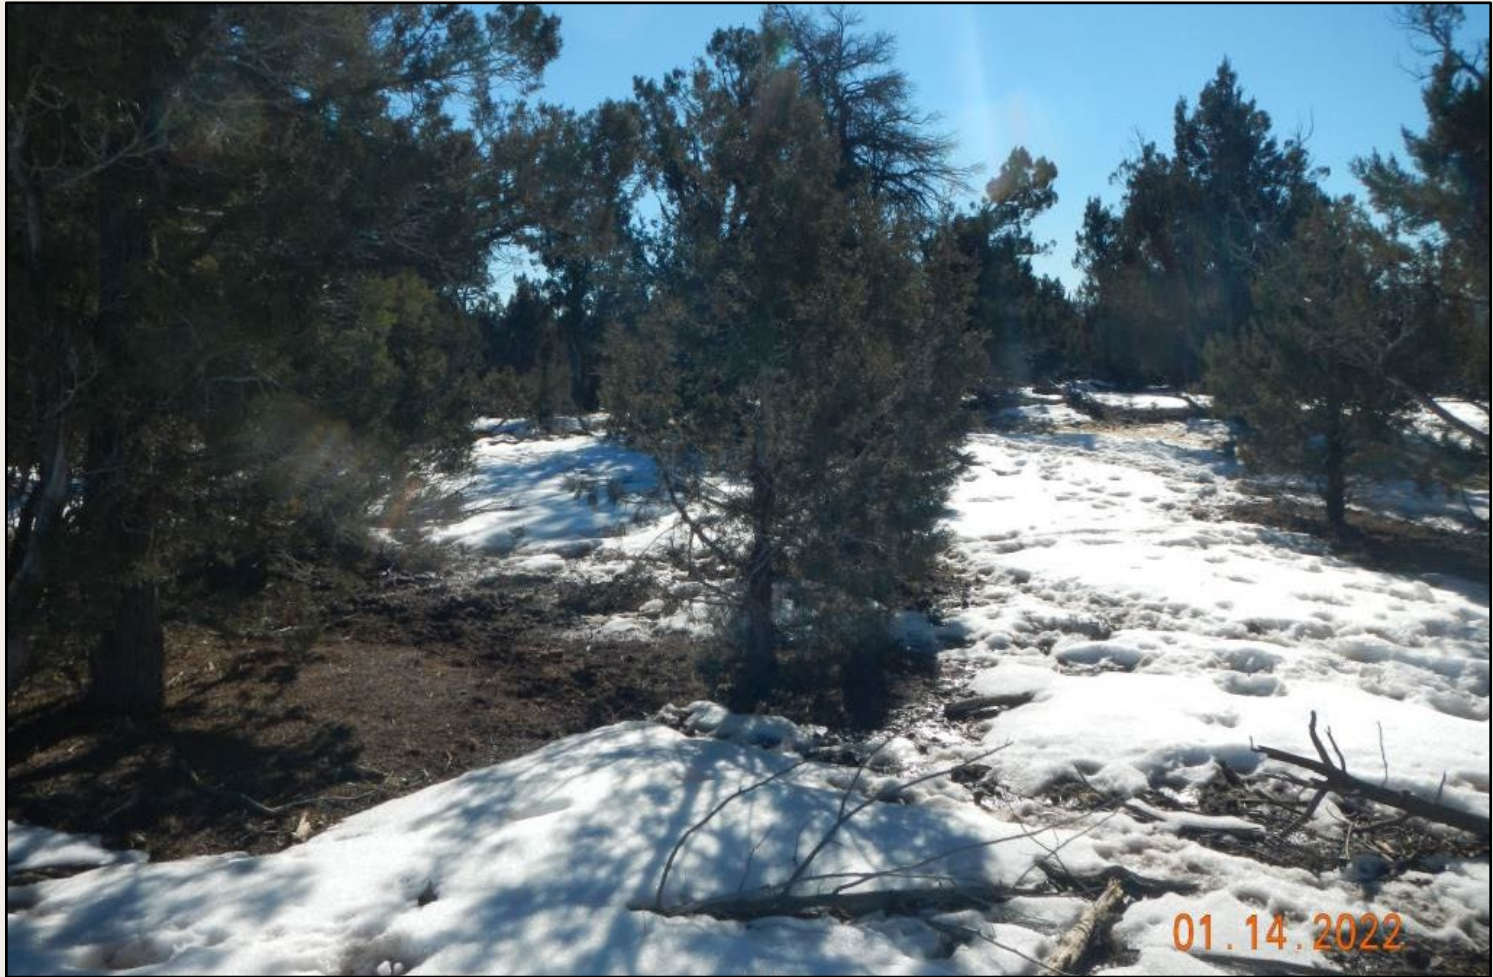
Photo 4. View of reference area comprised of pinyon and juniper woodland with sagebrush, squirreltail, penstemon, and pricklypear in the understory.
