Inspection Photos

Location Name: TEP ROCKY MOUNTAIN LLC DOE /2-W-27

Location ID: 335233

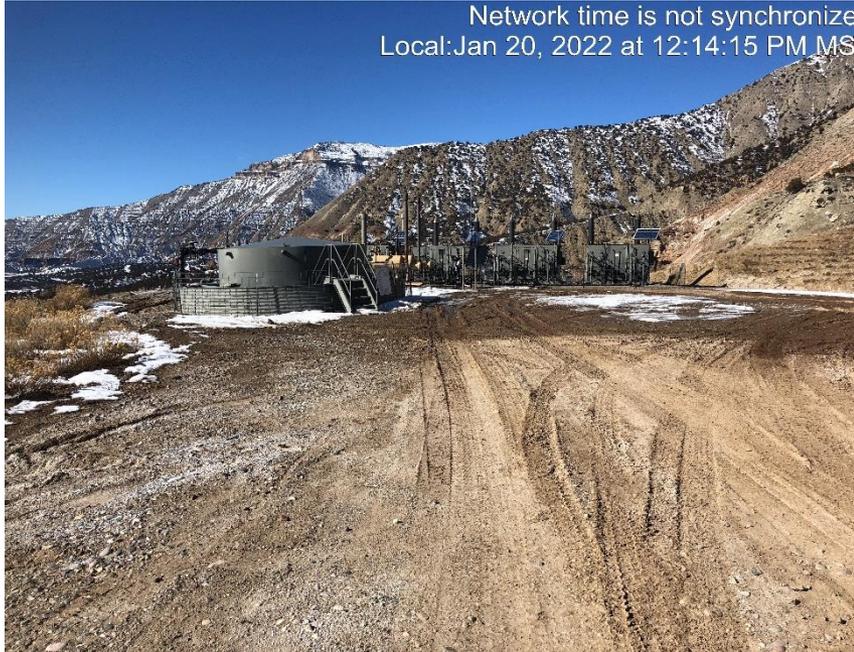
Photo #5730 from entrance to location.

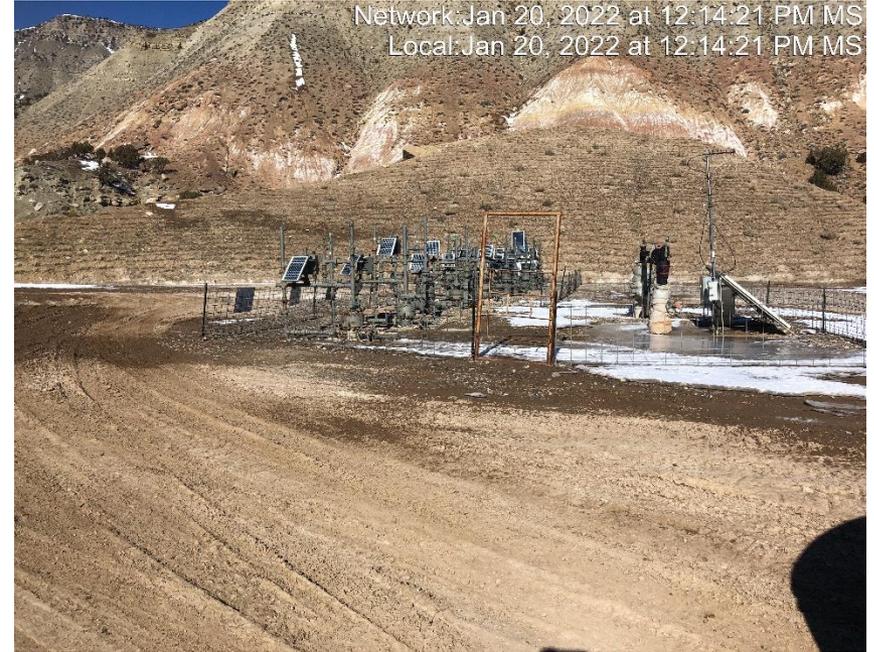
Photo #5731 from entrance to location.

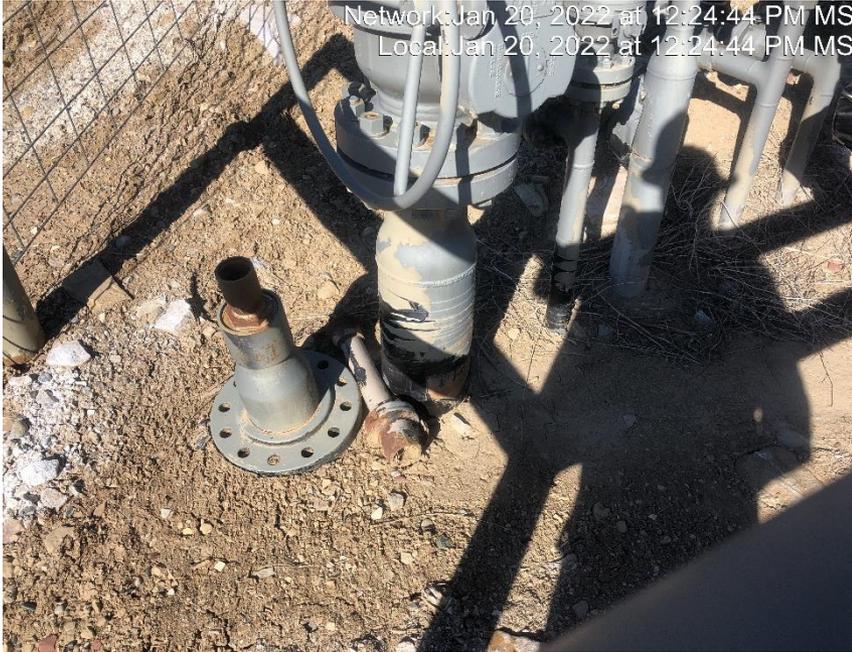
Photo #5733 Unused equipment.

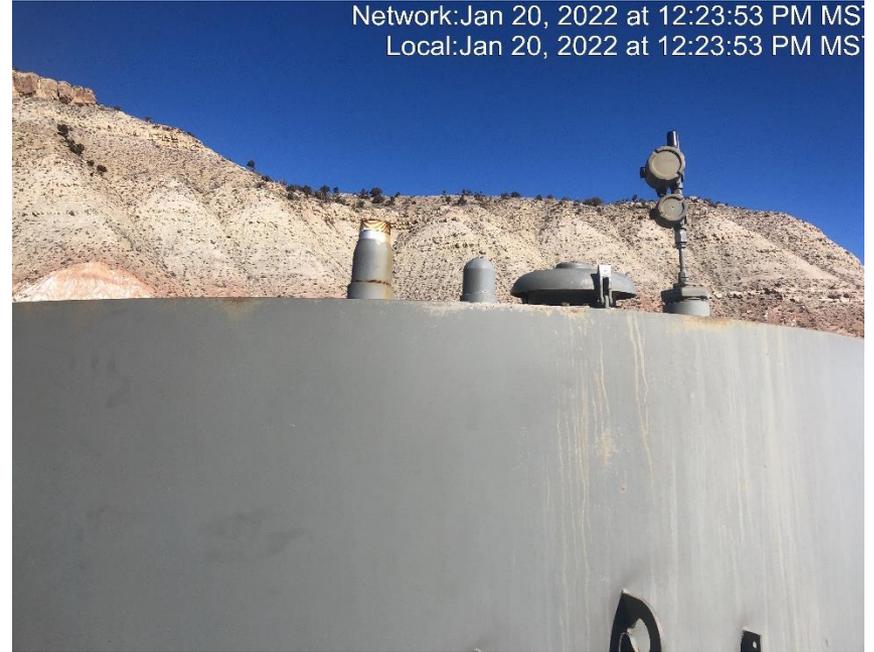
Photo #5732 Vent pipe on tank open ended.

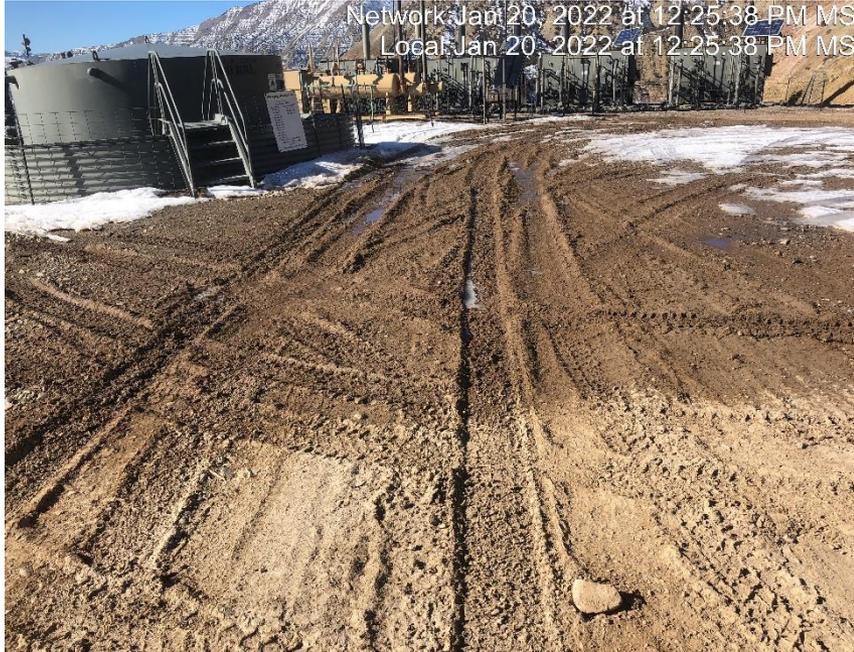
Photo #5734 Location lacks stabilization.

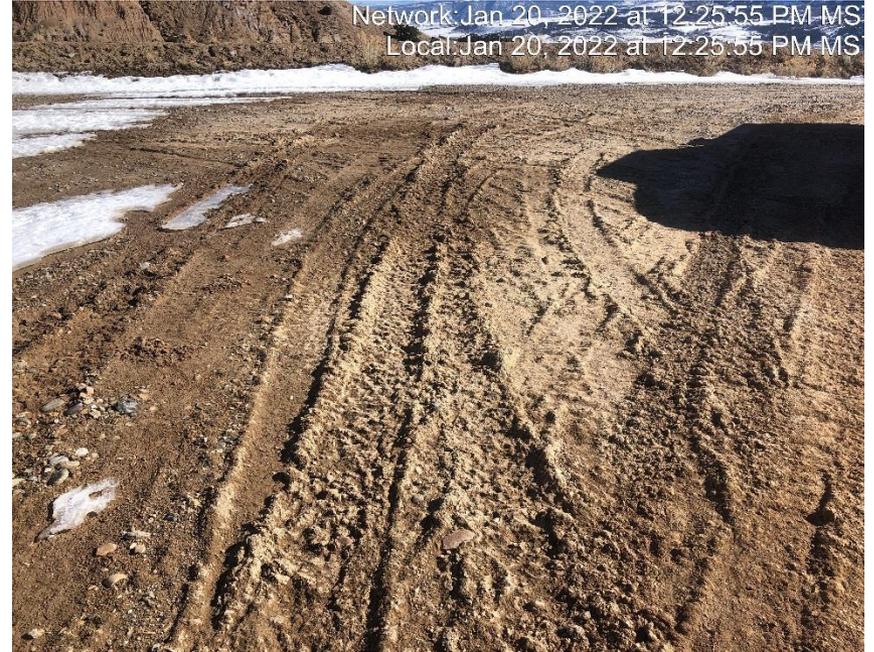
Photo #5735 Location lacks stabilization.

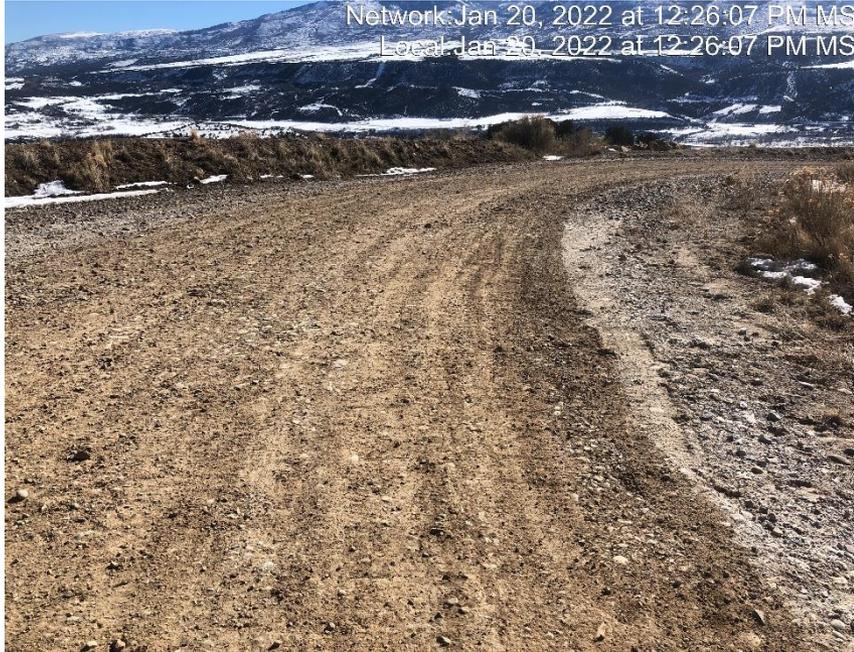
Photo #5736 Insufficient tracking BMP at entrance to location.
