Inspection Photos

Location Name: TEP ROCKY MOUNTAIN LLC FEDERAL /PA 543-27

Location ID: 335418

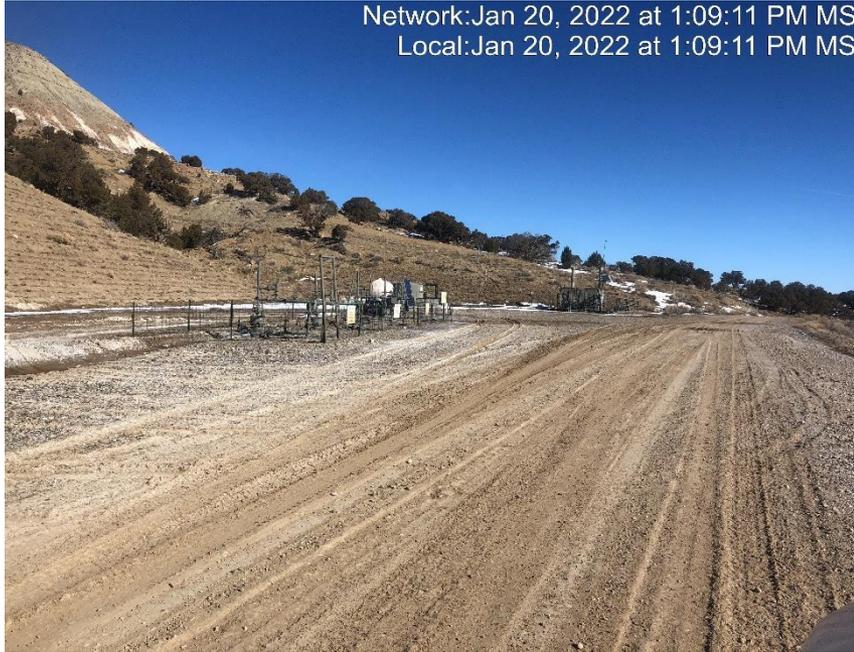
Photo #5737 from entrance to location.

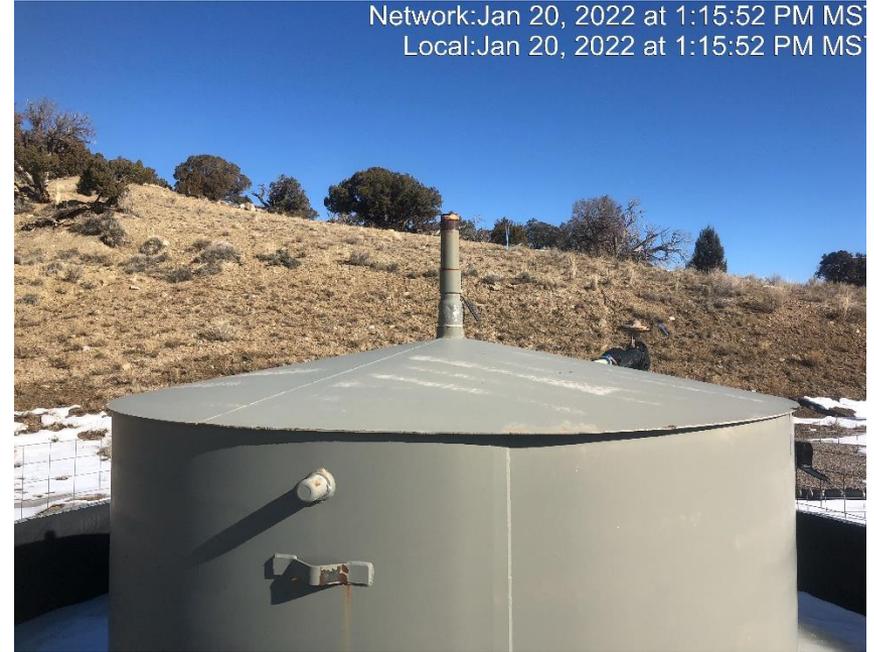
Photo #5738 Vent pipe on tank open ended.

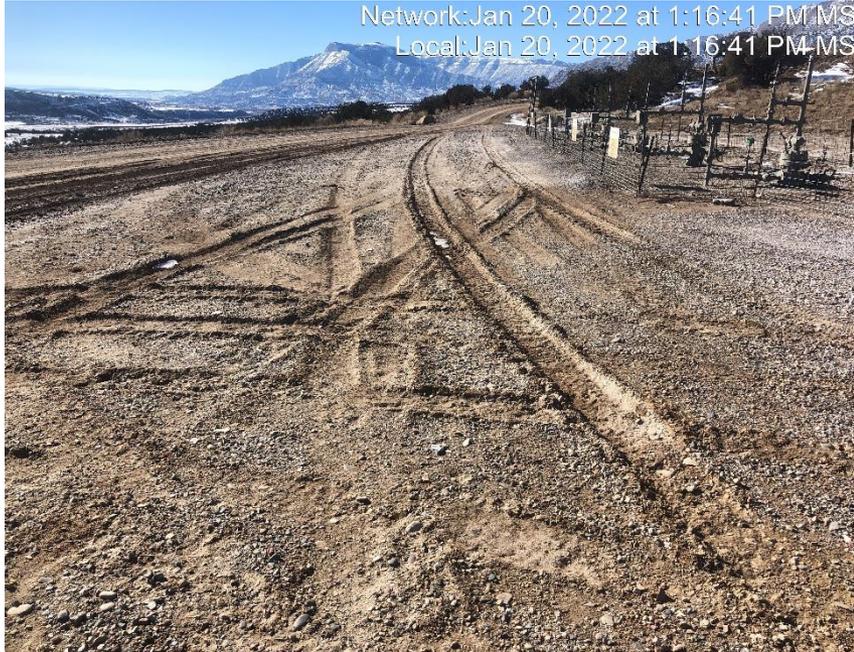
Photo #5740 Location lacks stabilization.

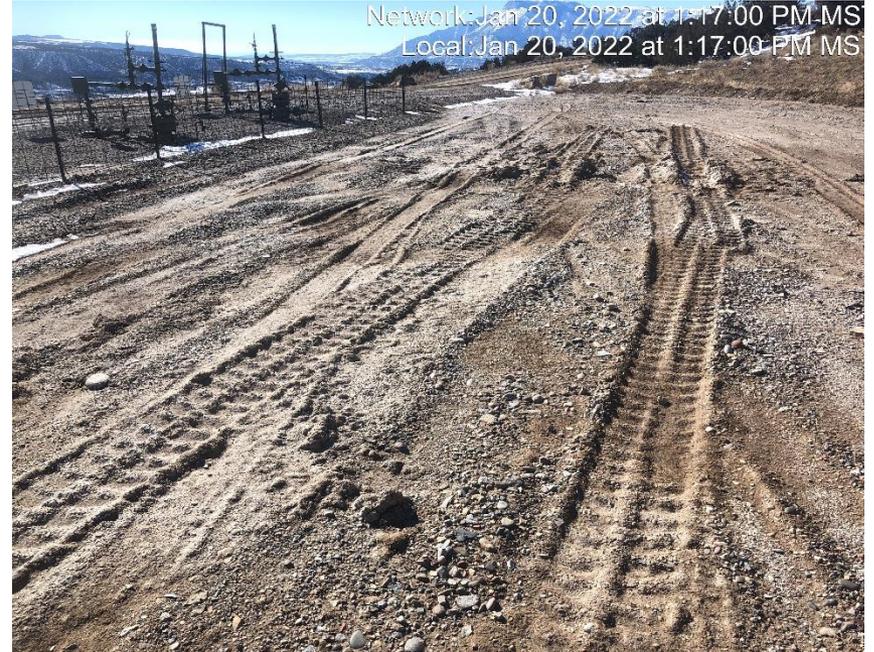
Photo #5741 Location lacks stabilization.

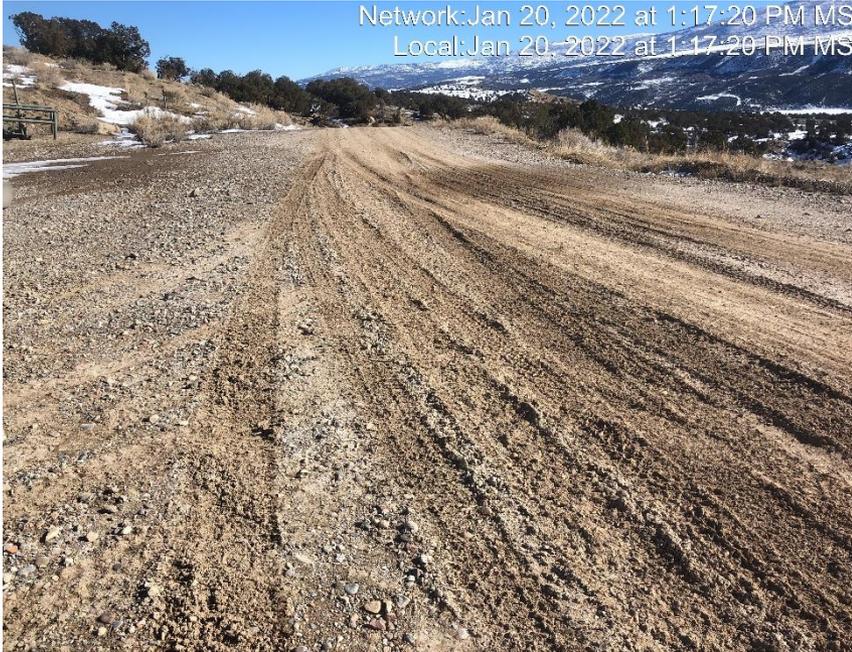
Photo #5742 Insufficient tracking BMP at entrance to location.
