Inspection Photos
Operator: Simcoe
API: 067-08423
Date: 1/19/2022

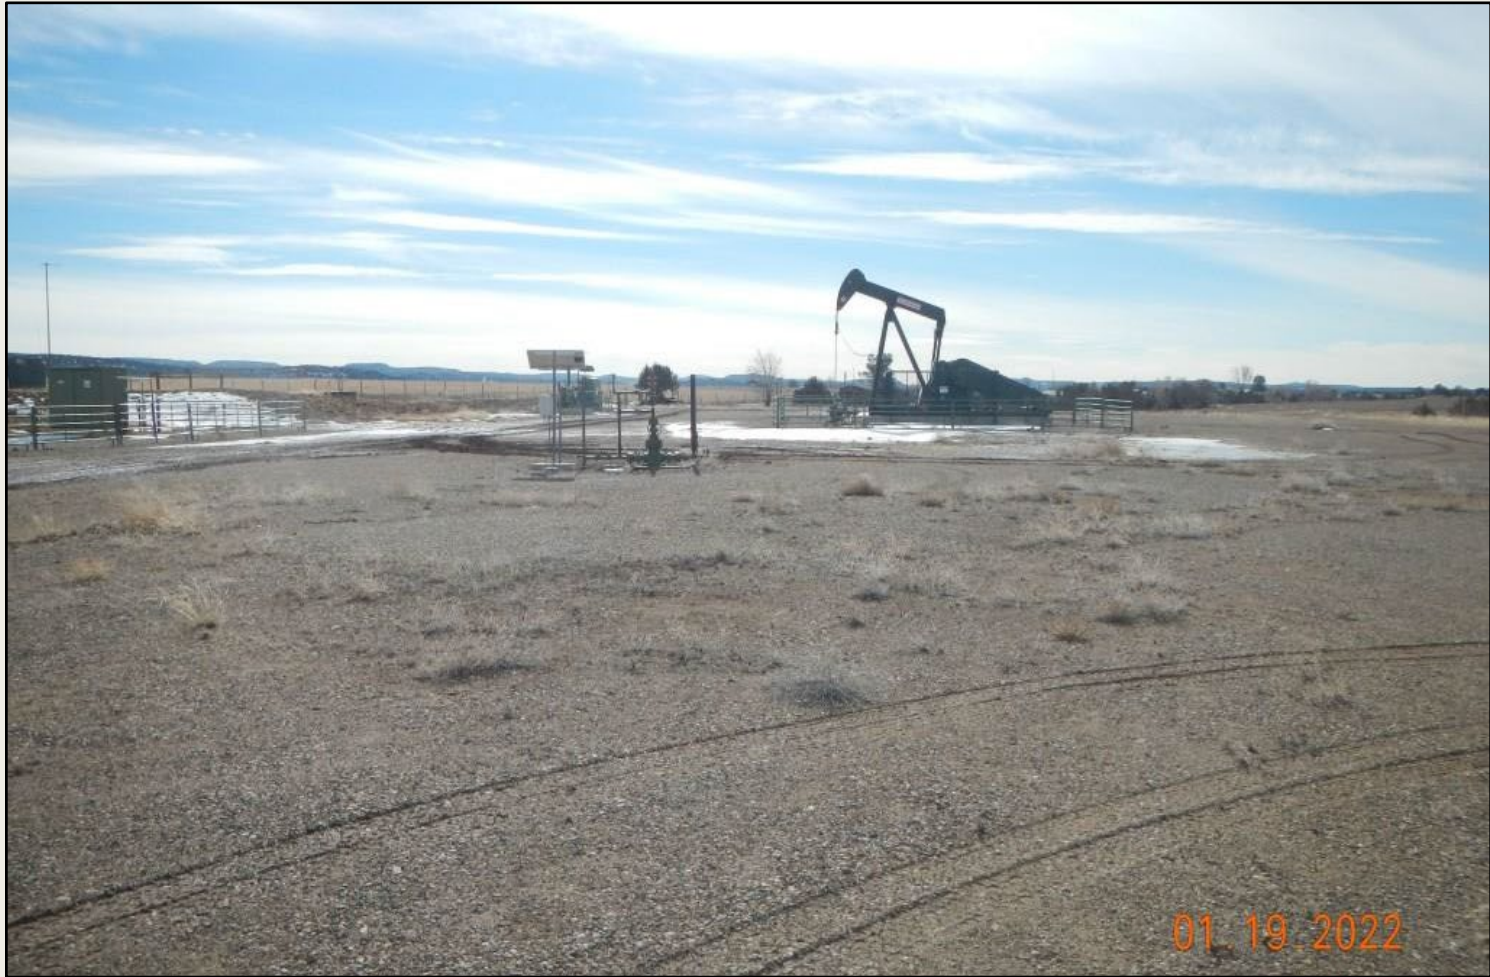
Photo 1. View of project area from the well pad entrance facing center.

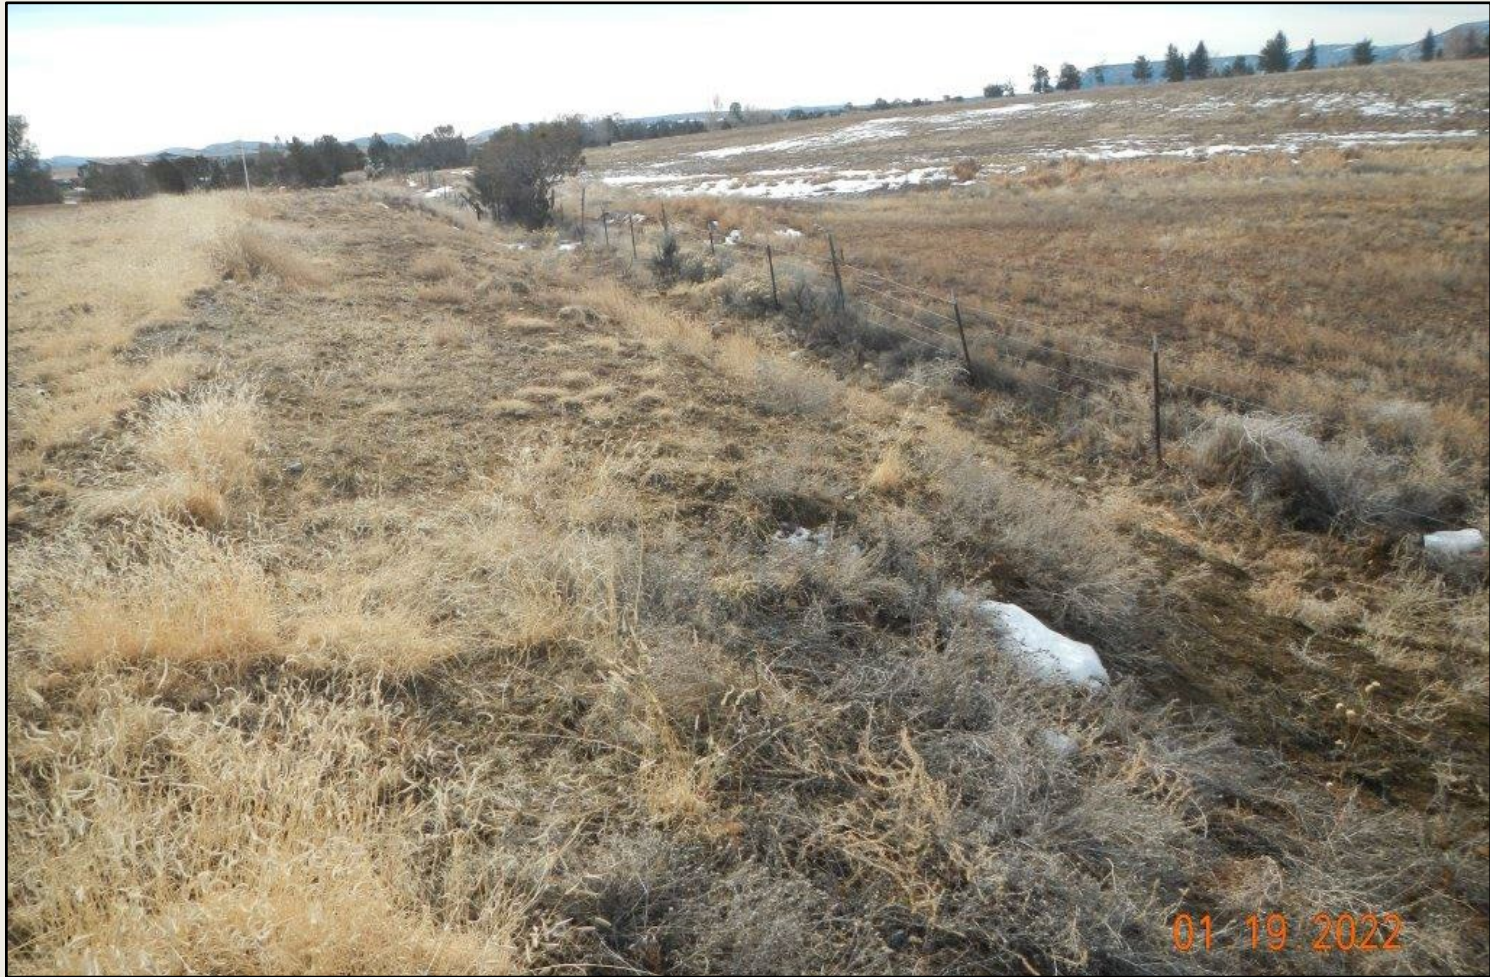
Photo 2. View of the western project area from the northwestern corner facing southward. Revegetation is progressing with blue grama, western wheatgrass, and sand dropseed.

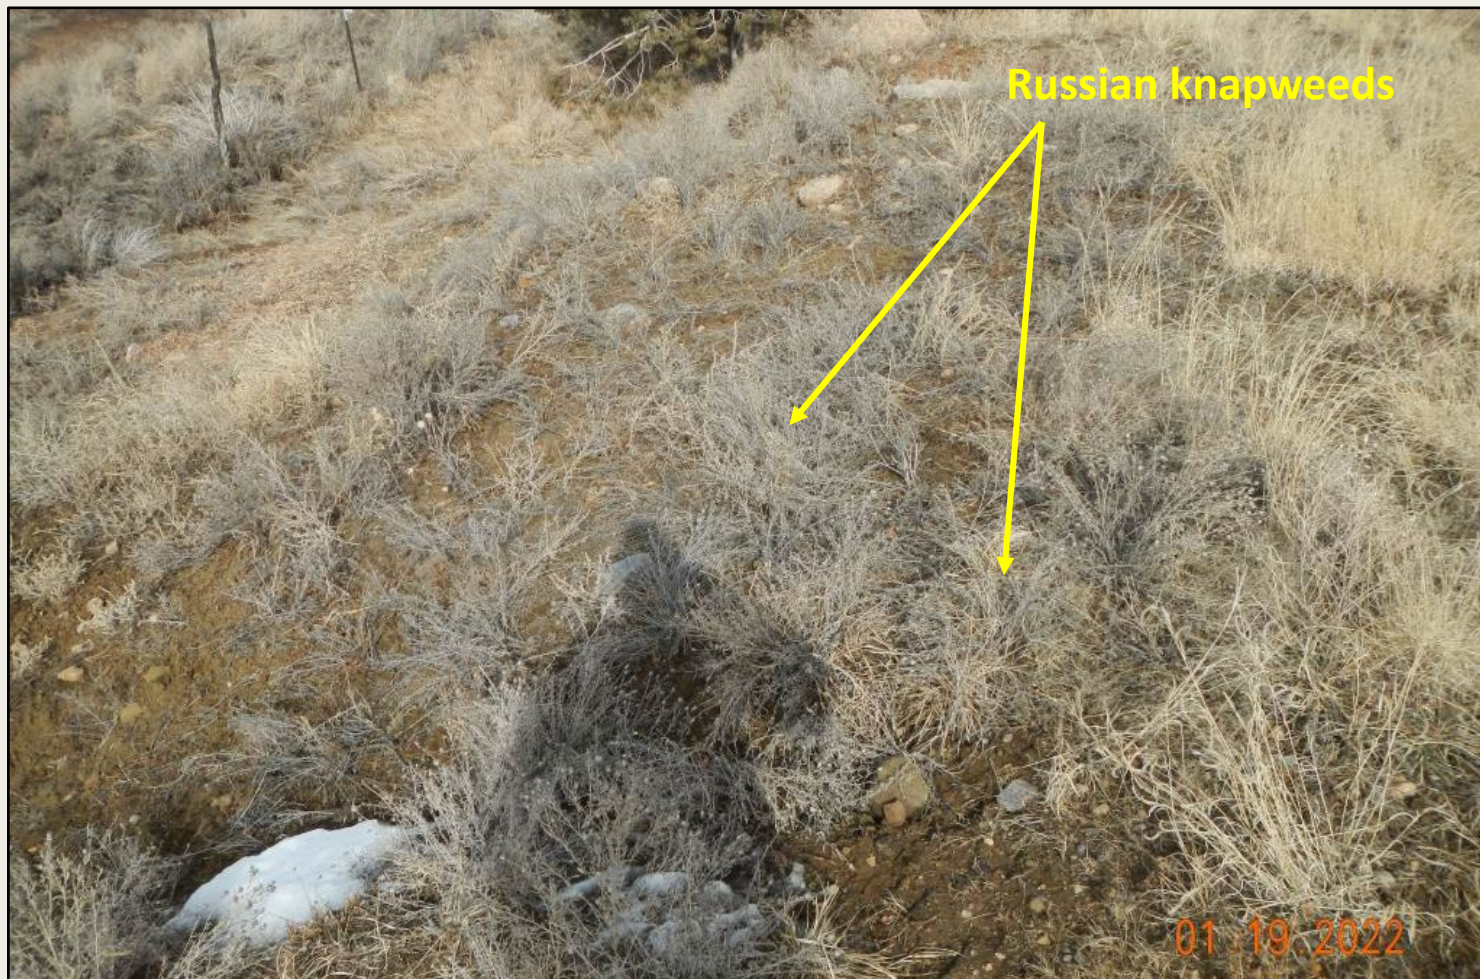
Photo 3. View of dense Russian knapweeds within the western project area. Approximately 500 observed. Scattered spotted knapweeds are also present.

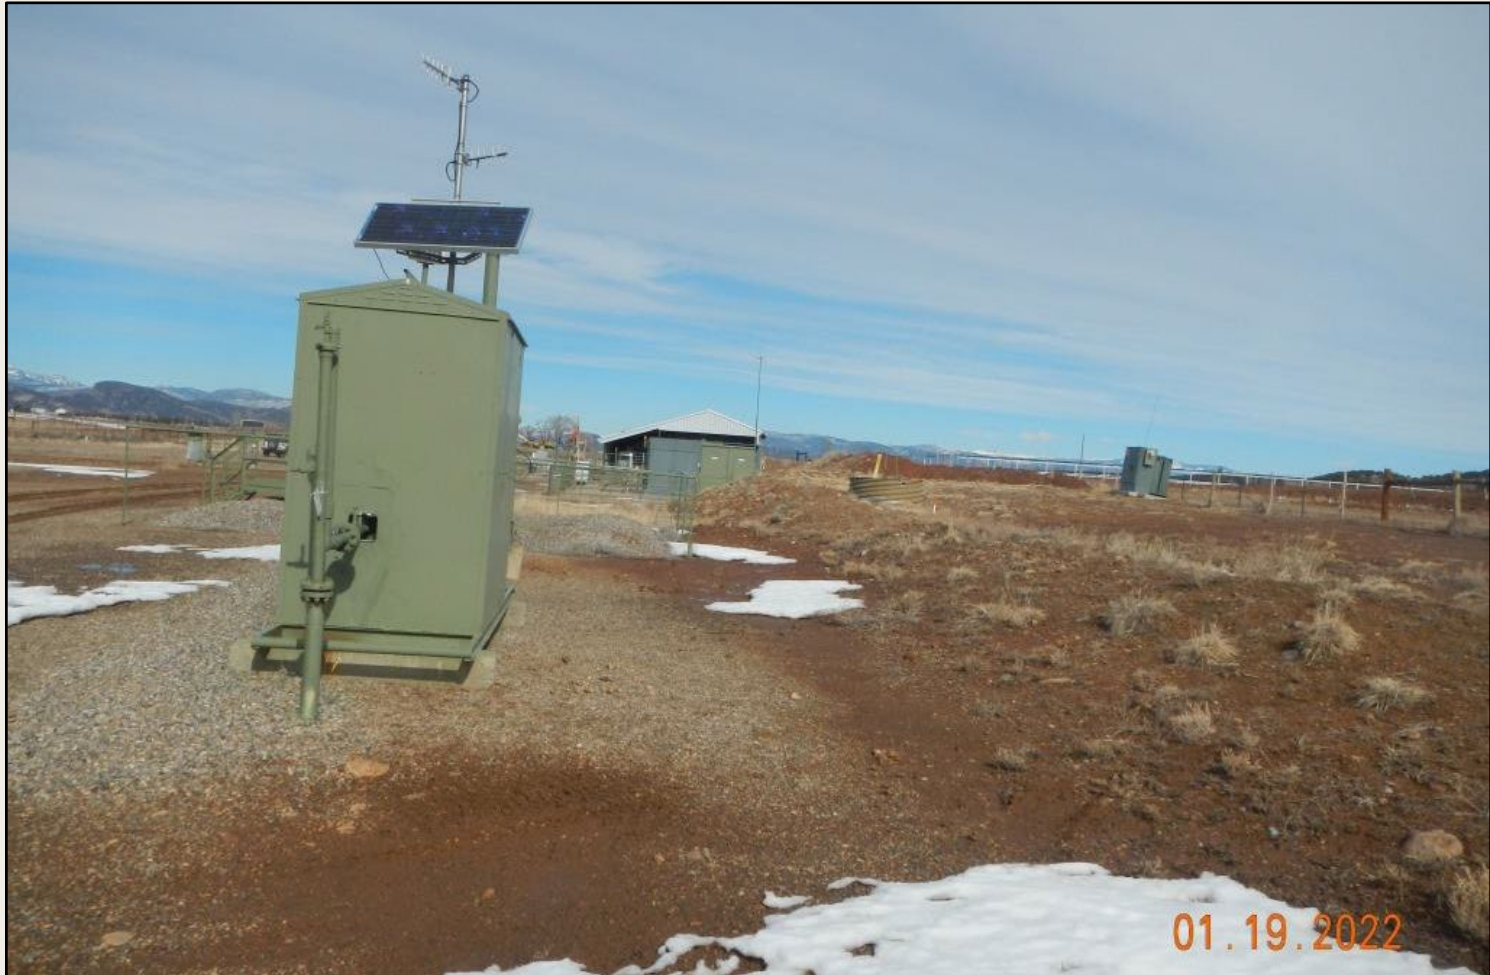
Photo 4. View of the eastern project area from the southeastern corner facing northward.

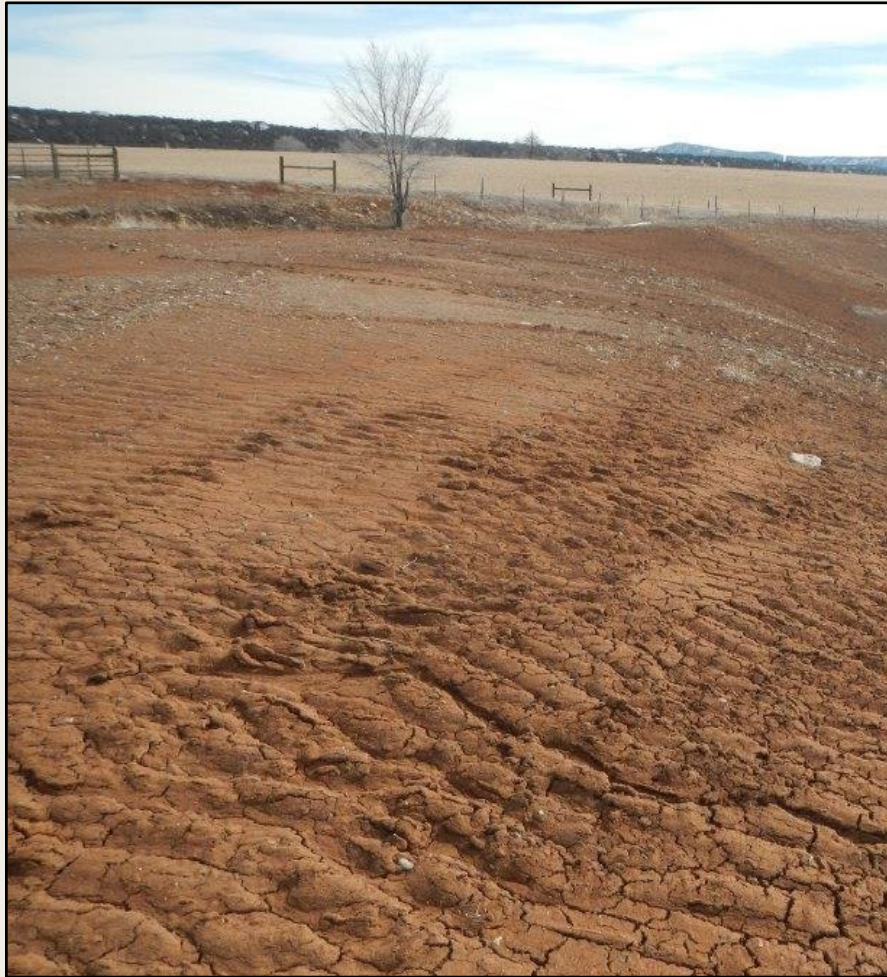
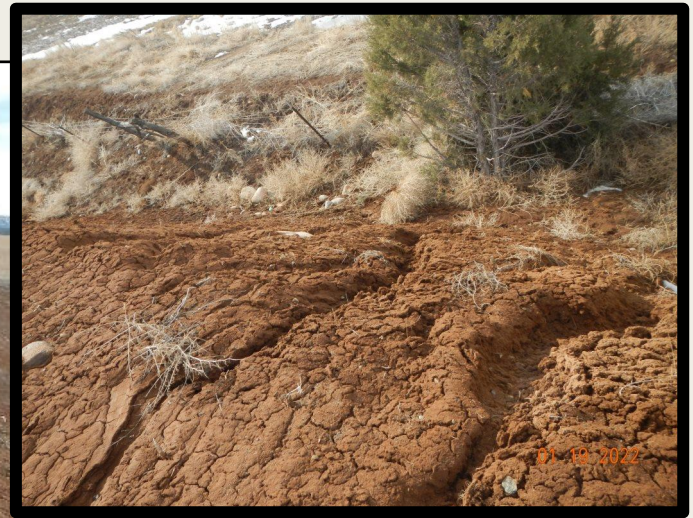
Photo 5. View of bare soils and erosional channeling (inset), up to 10 inches wide and deep within the southern project area. Bare and eroding soils need stabilization here.

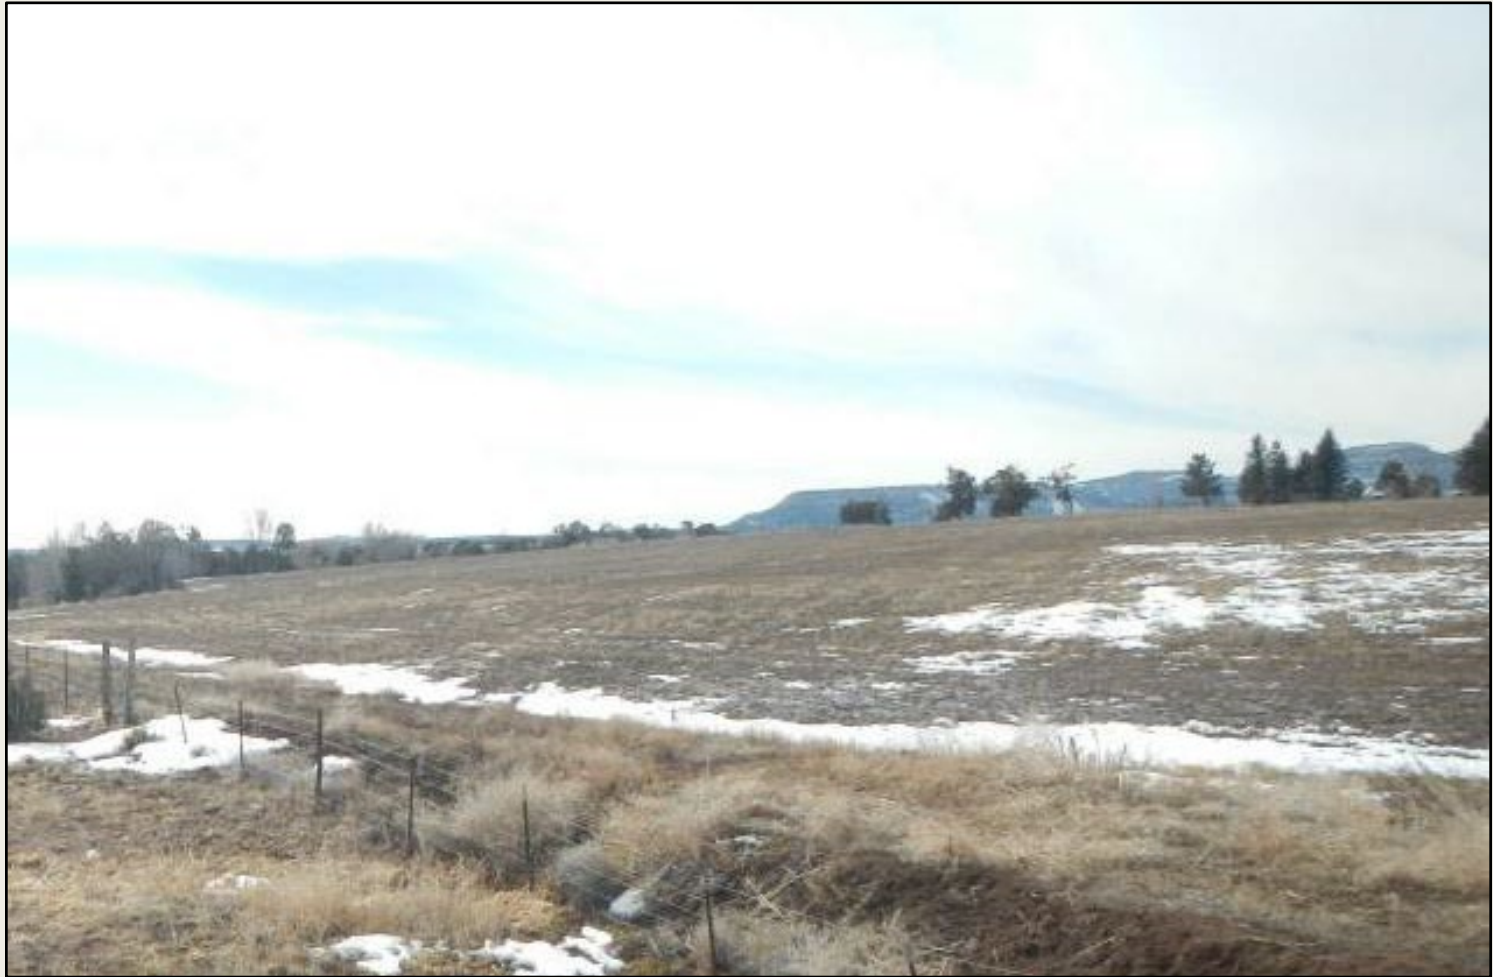
Photo 6. View of reference area comprised of open grass field with smooth brome and western wheatgrass observable.
