Inspection Photos
Operator: Logos
API: 067-08064
Date: 1/19/2022

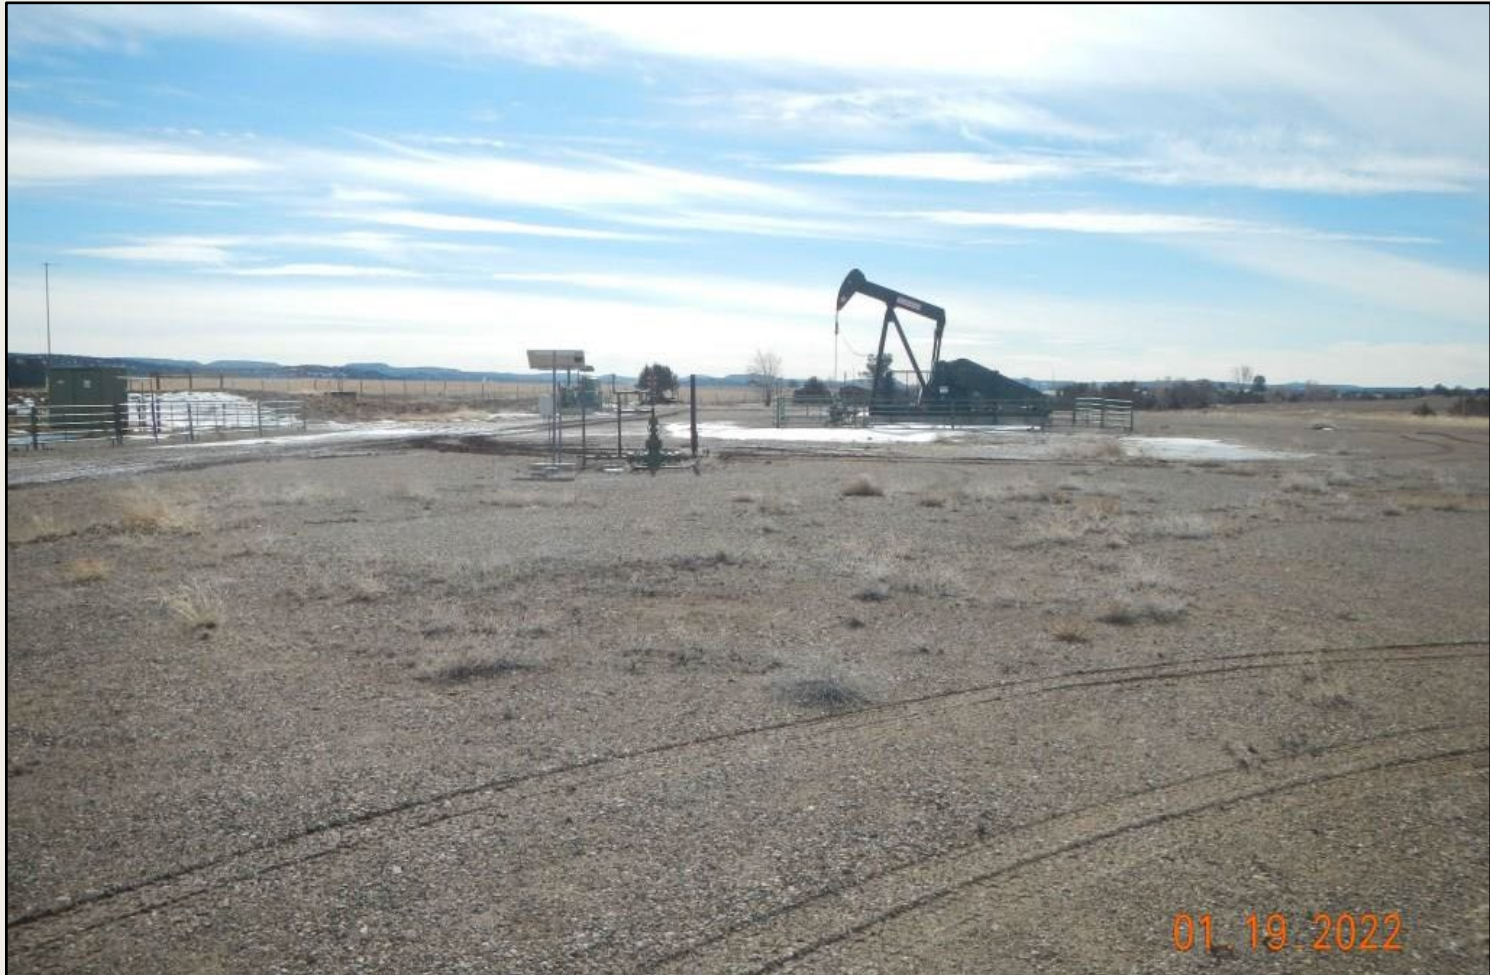
Photo 1. View of project area from the well pad entrance facing center.

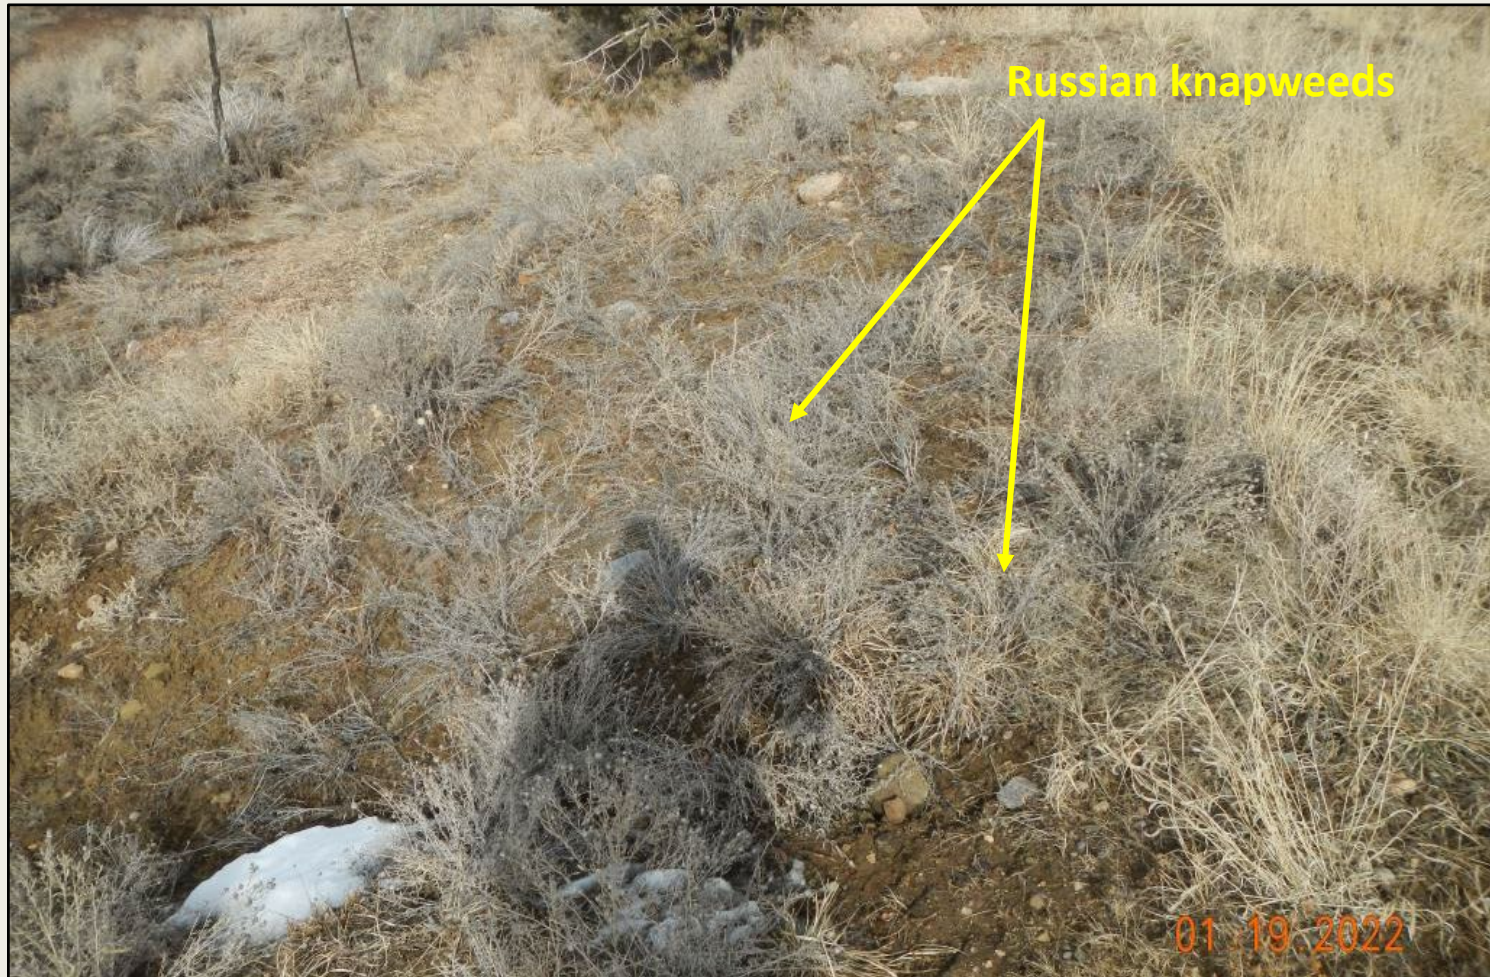
Photo 3. View of dense Russian knapweeds within the western project area. Approximately 500 observed. Scattered spotted knapweeds are also present.

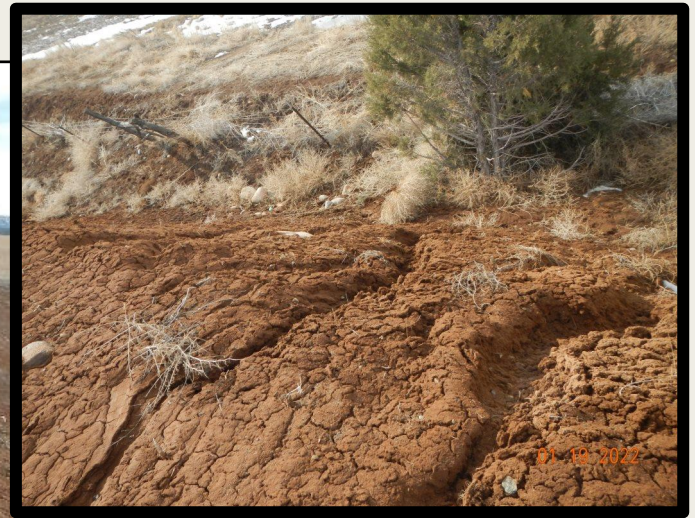
Photo 5. View of bare soils and erosional channeling (inset), up to 10 inches wide and deep within the southern project area. Bare and eroding soils need stabilization here.
