Inspection Photos
Location Name: Sheldon R. Sickler 2
Location ID: 317963

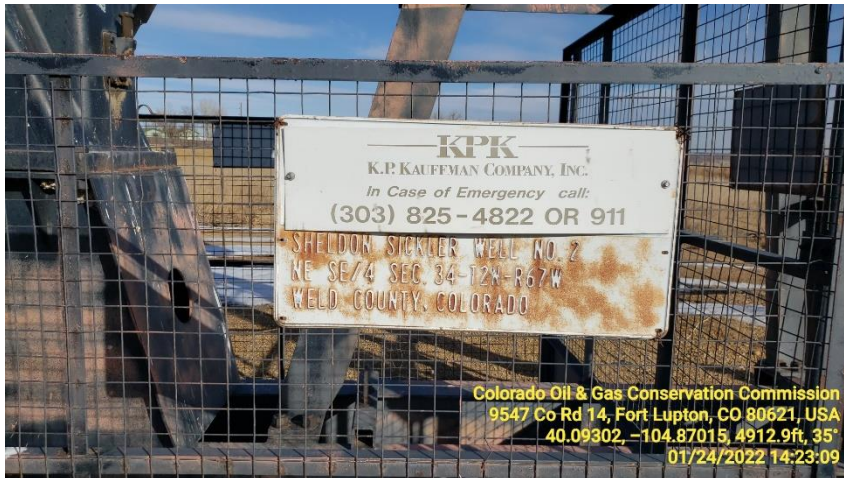
Photo 1 WH sign

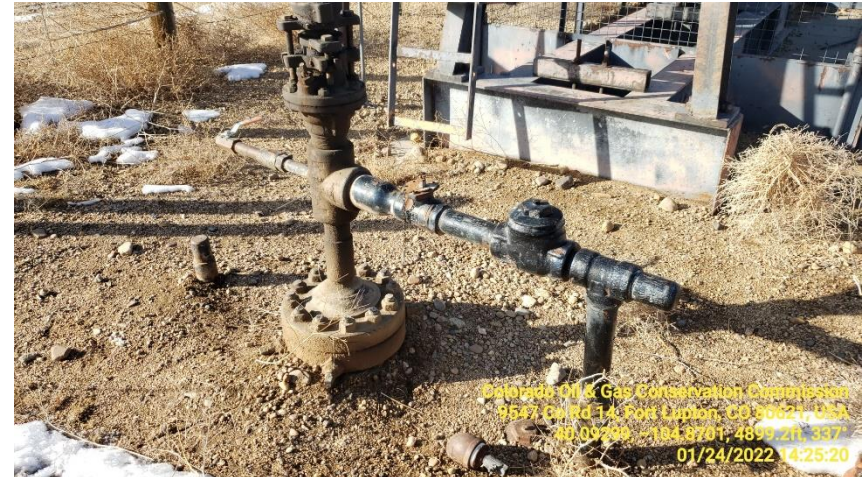
Photo 2 WH

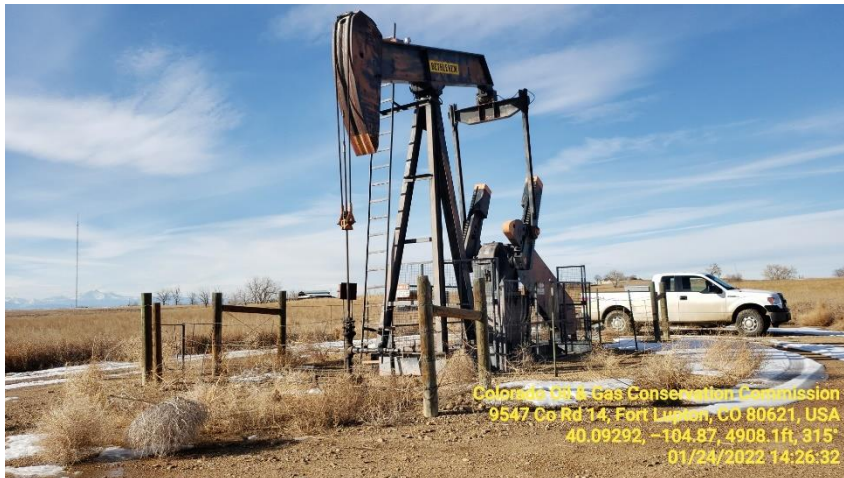
Photo 3 Pump Jack

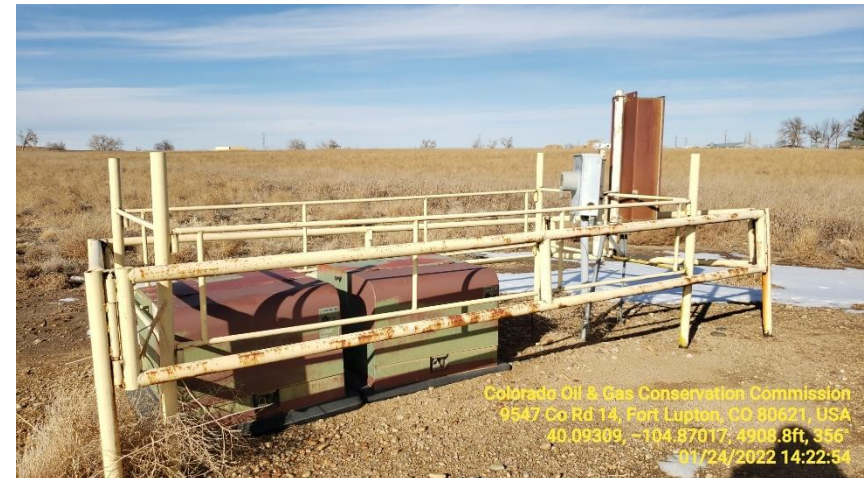
Photo 4 ancillary equipment

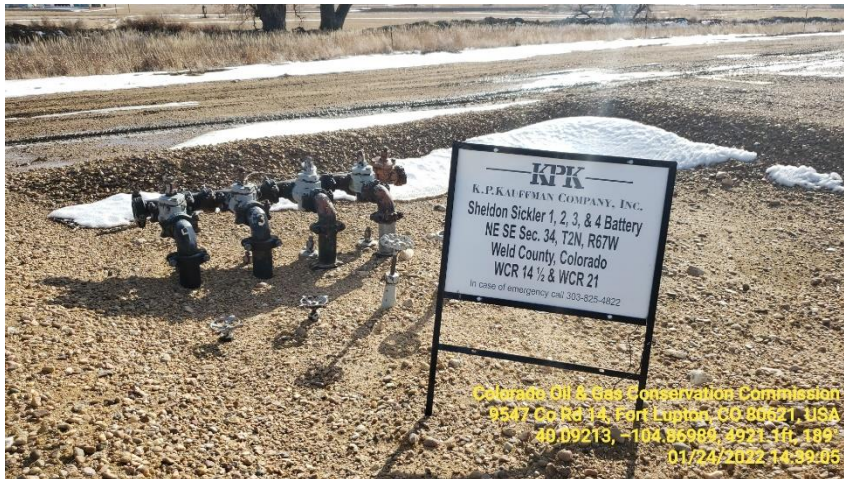
Photo 5 Location sign, flow line manifold

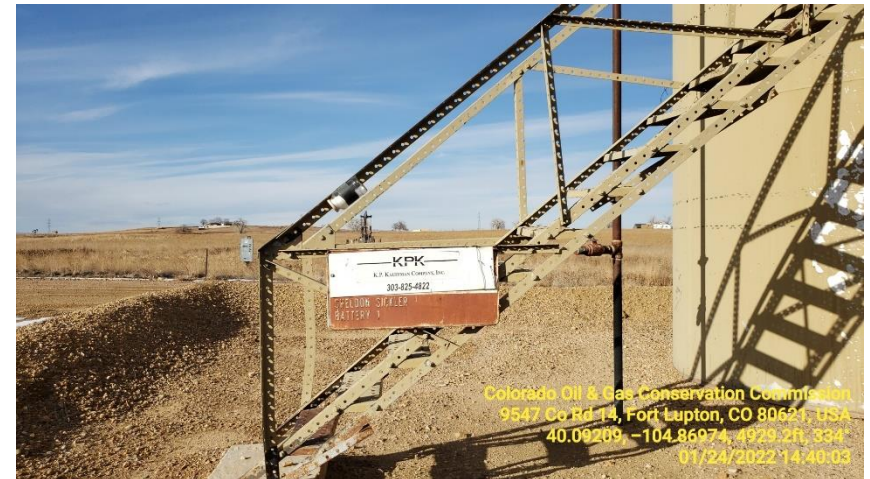
Photo 6 TB sign

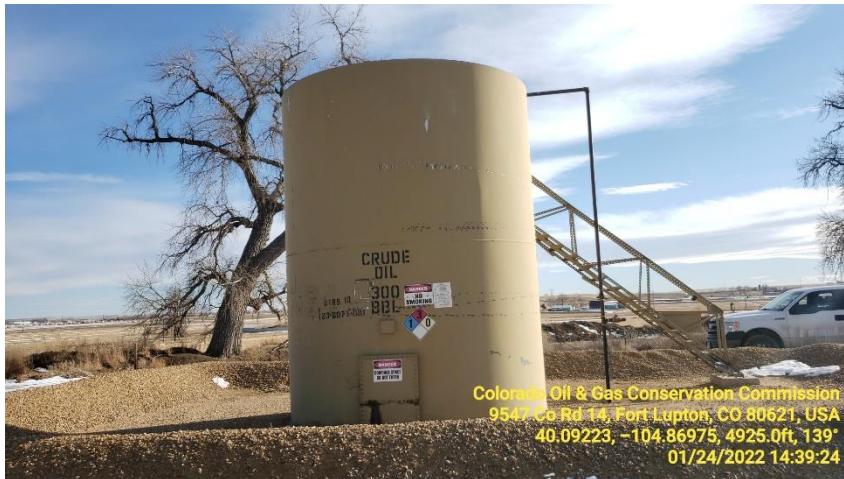
Photo 7 Crude oil tank

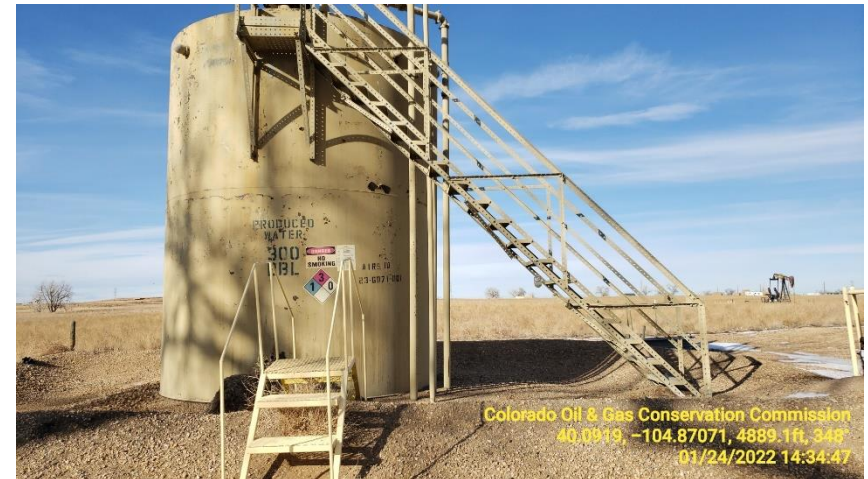
Photo 8 PW tank

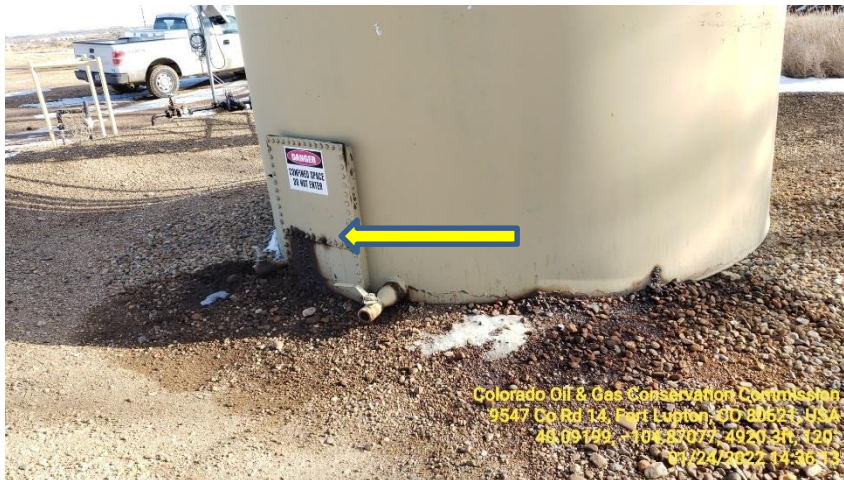
Photo 9 PW tank appears to be leaking from the access port.

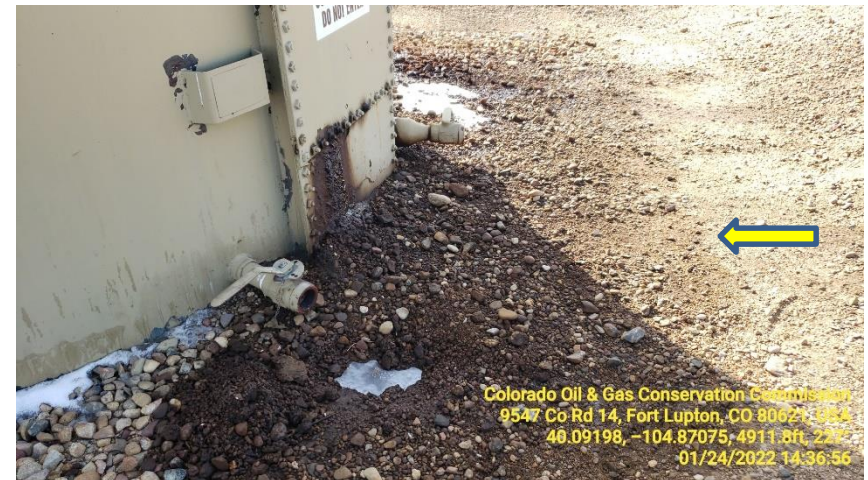
Photo 10 Stained soil by PW tank access port

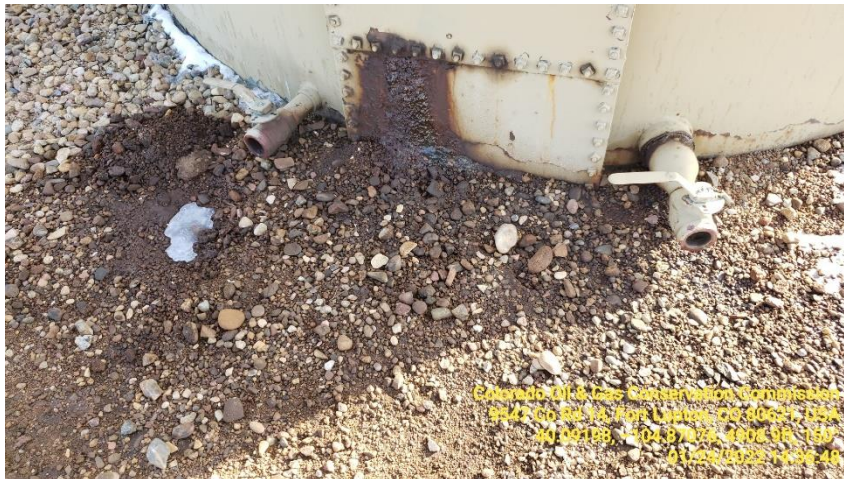
Photo 11 Stained soil by PW tank access port.

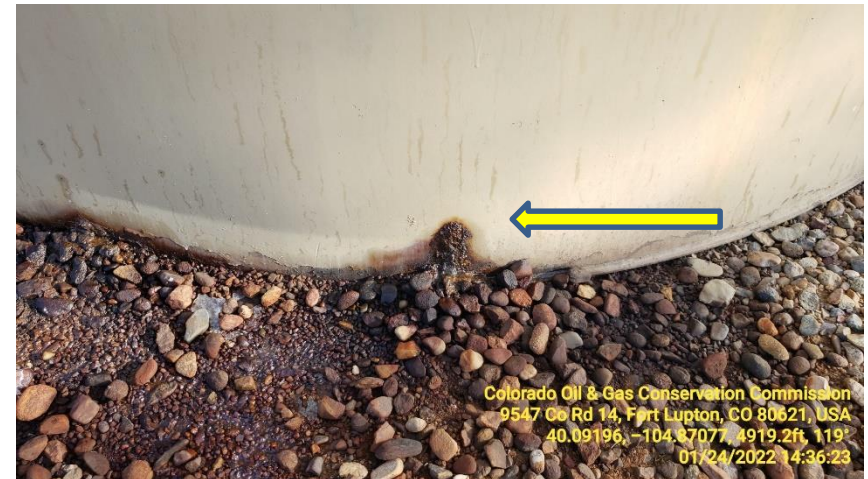
Photo 12 leak on PW tank

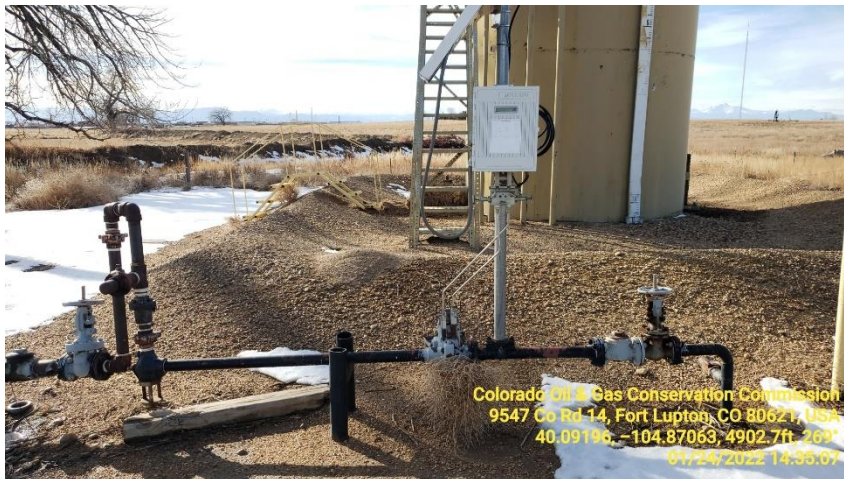
Photo 13 Gas Meter Run.

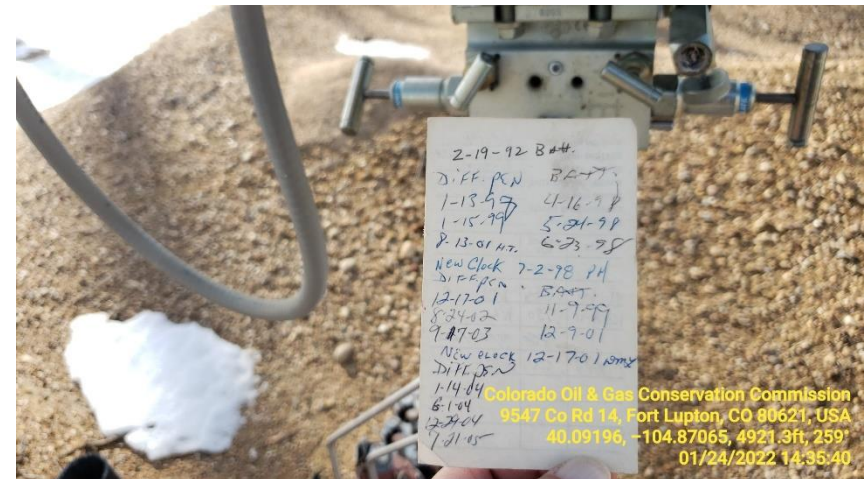
Photo 14 Card in meter house indicates that calibration is not current.

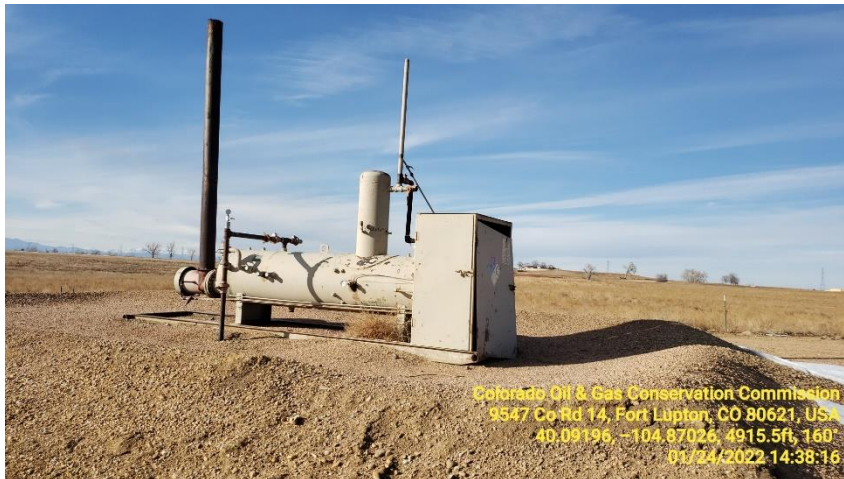
Photo 15 Horiz. Heated Sep.

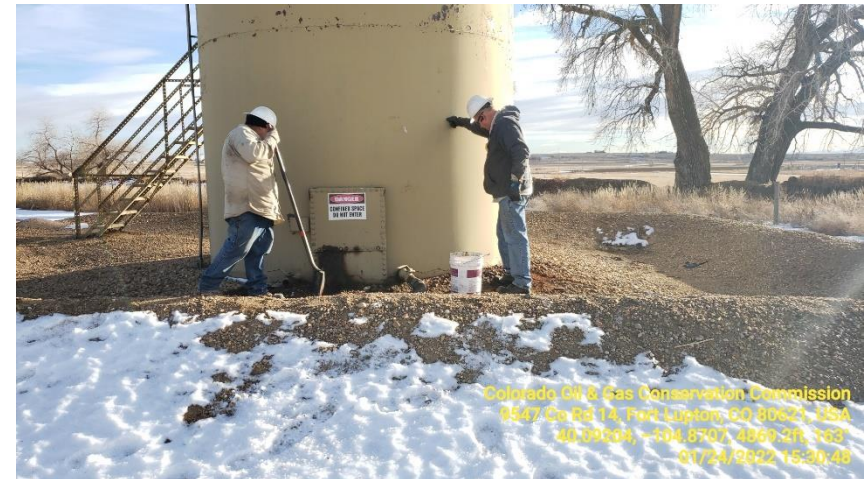
Photo 16 Lease operator and tanker driver draining tank and looking for possible leaks
