# Inspection Photos

API: 071-09381

Operator: XTO ENERGY INC

Inspection Date: 1/24/2021

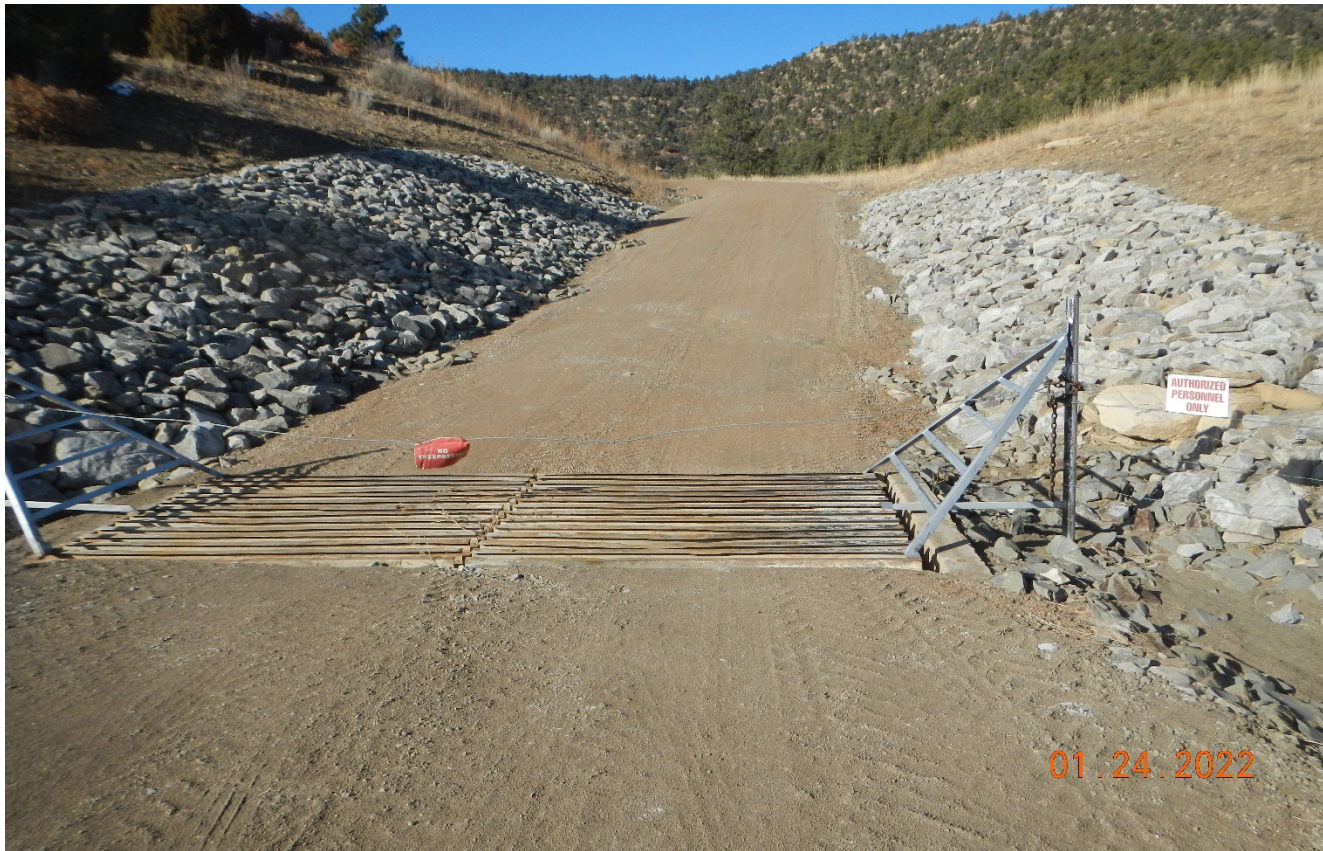
**Photo 1.** Facing north at the beginning of the access road. The cattleguard has been cleaned out and maintained. There is rock rip/rap installed along the road side and additional roadbase has been spread along the road.

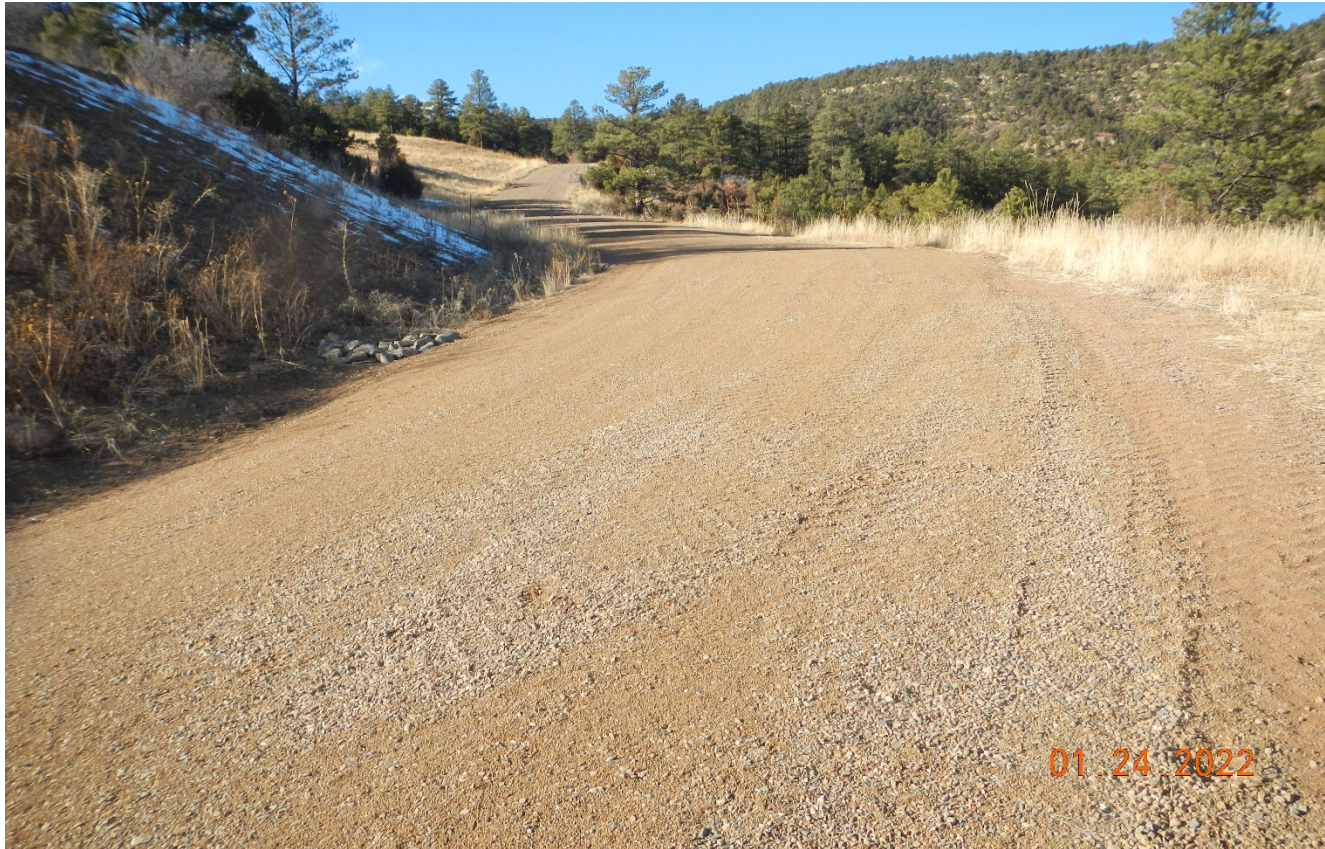
**Photo 2.** Facing northwest along the access road.

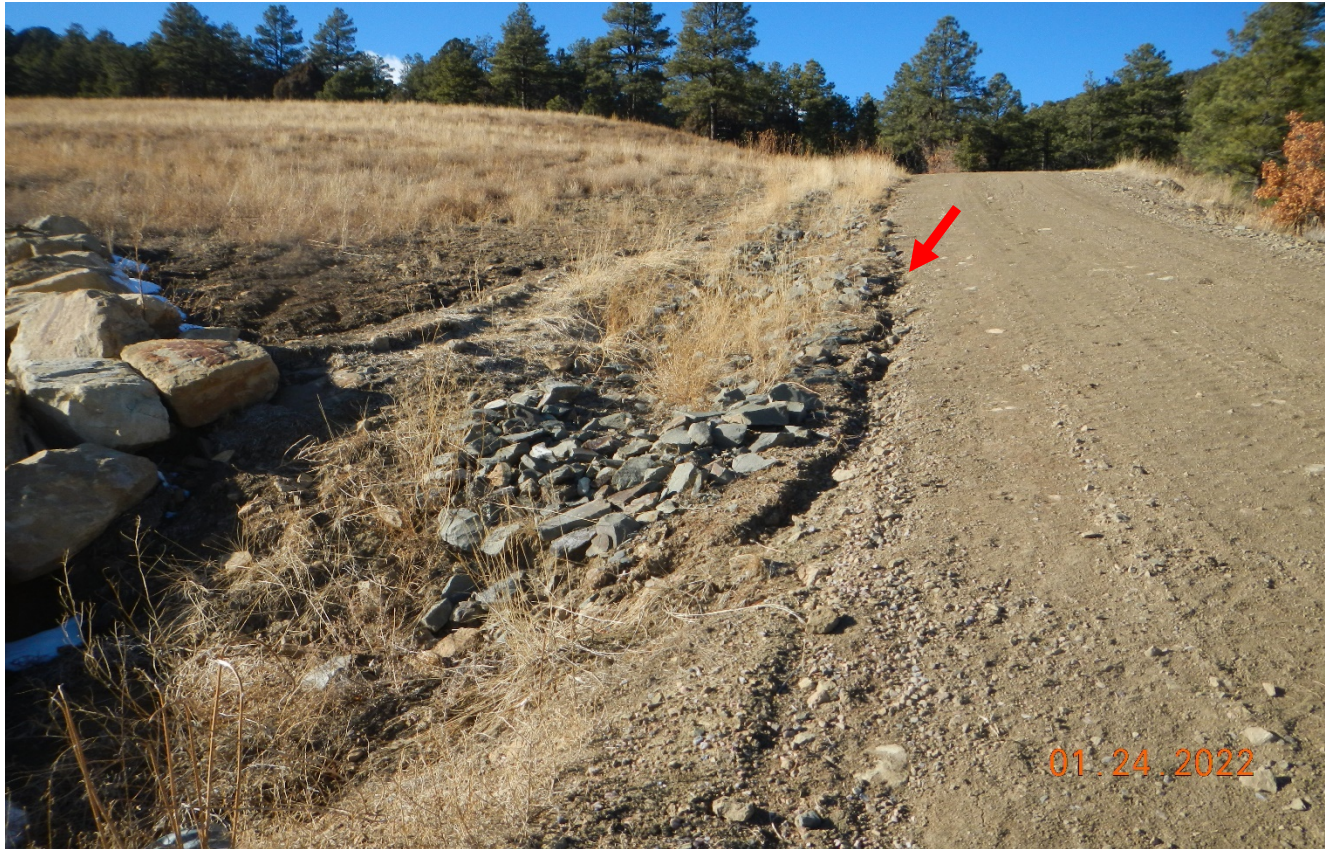
**Photo 3.** There is rock rip/rap placed along the roadside. It appears stormwater erosion is occurring along the side of the rip/rap which will need maintenance.

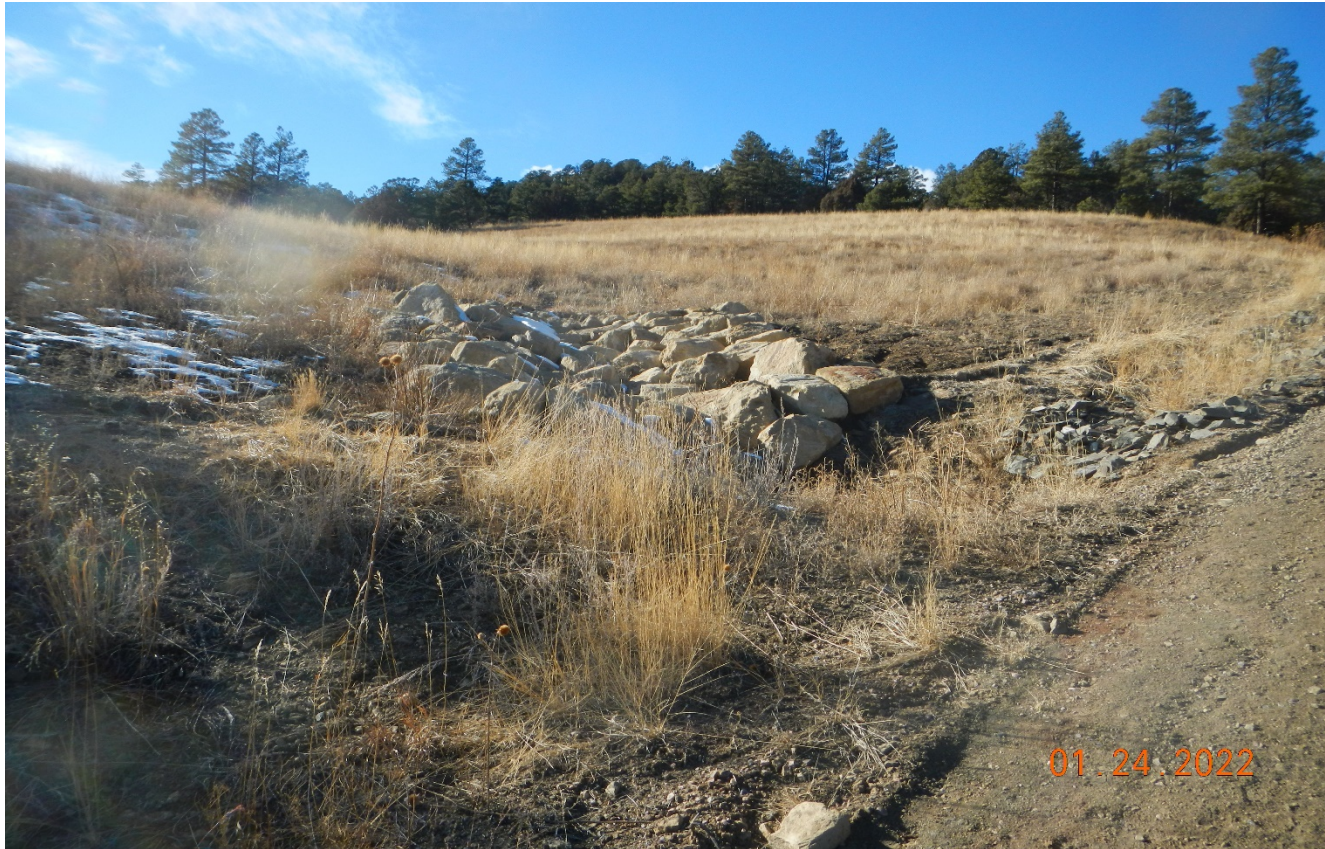
**Photo 4.** Facing northwest toward the location.

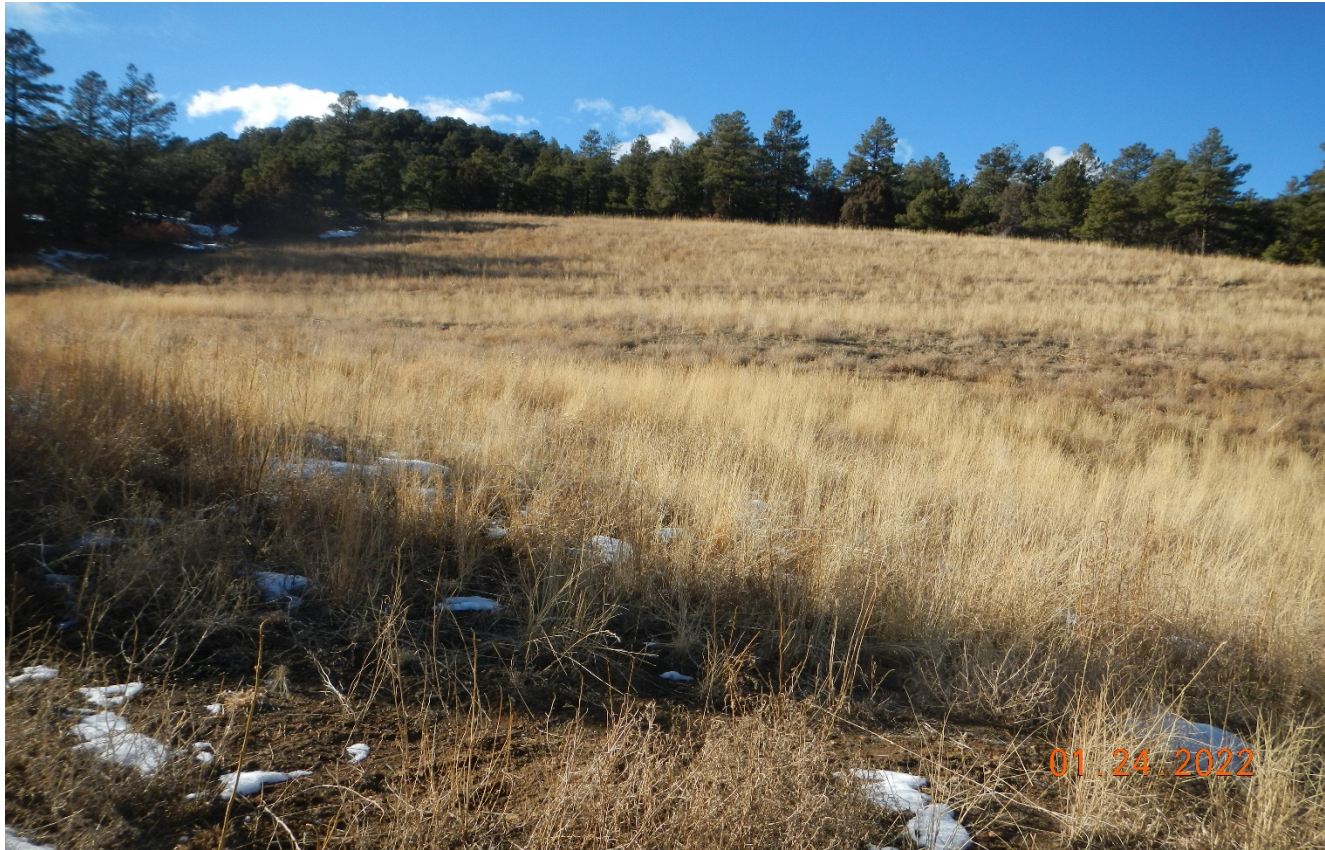
**Photo 5.** Facing northwest at the location.

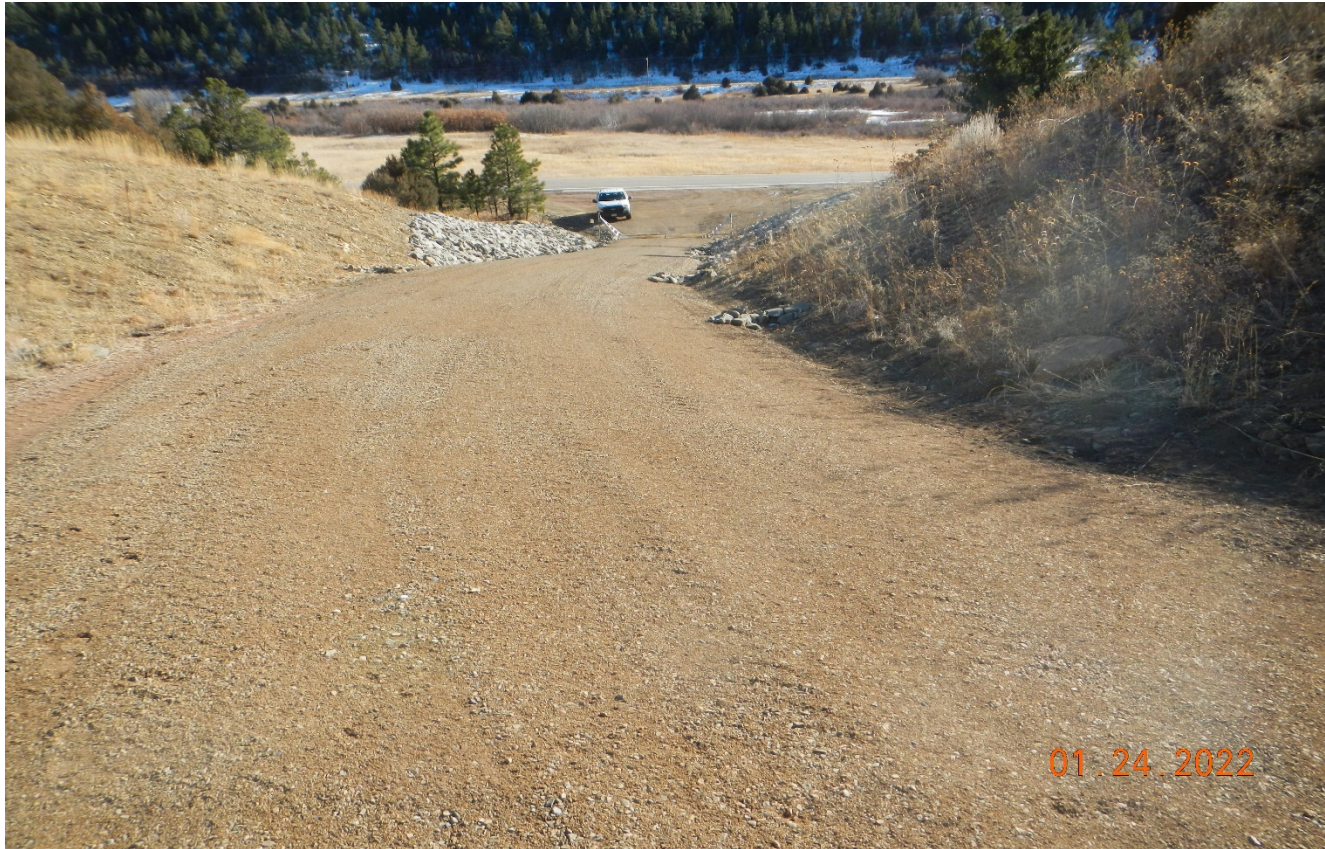
**Photo 6.** Facing back south along the access road.
