Inspection Photos
Operator: Simcoe
API: 067-08764
Date: 1/24/2022

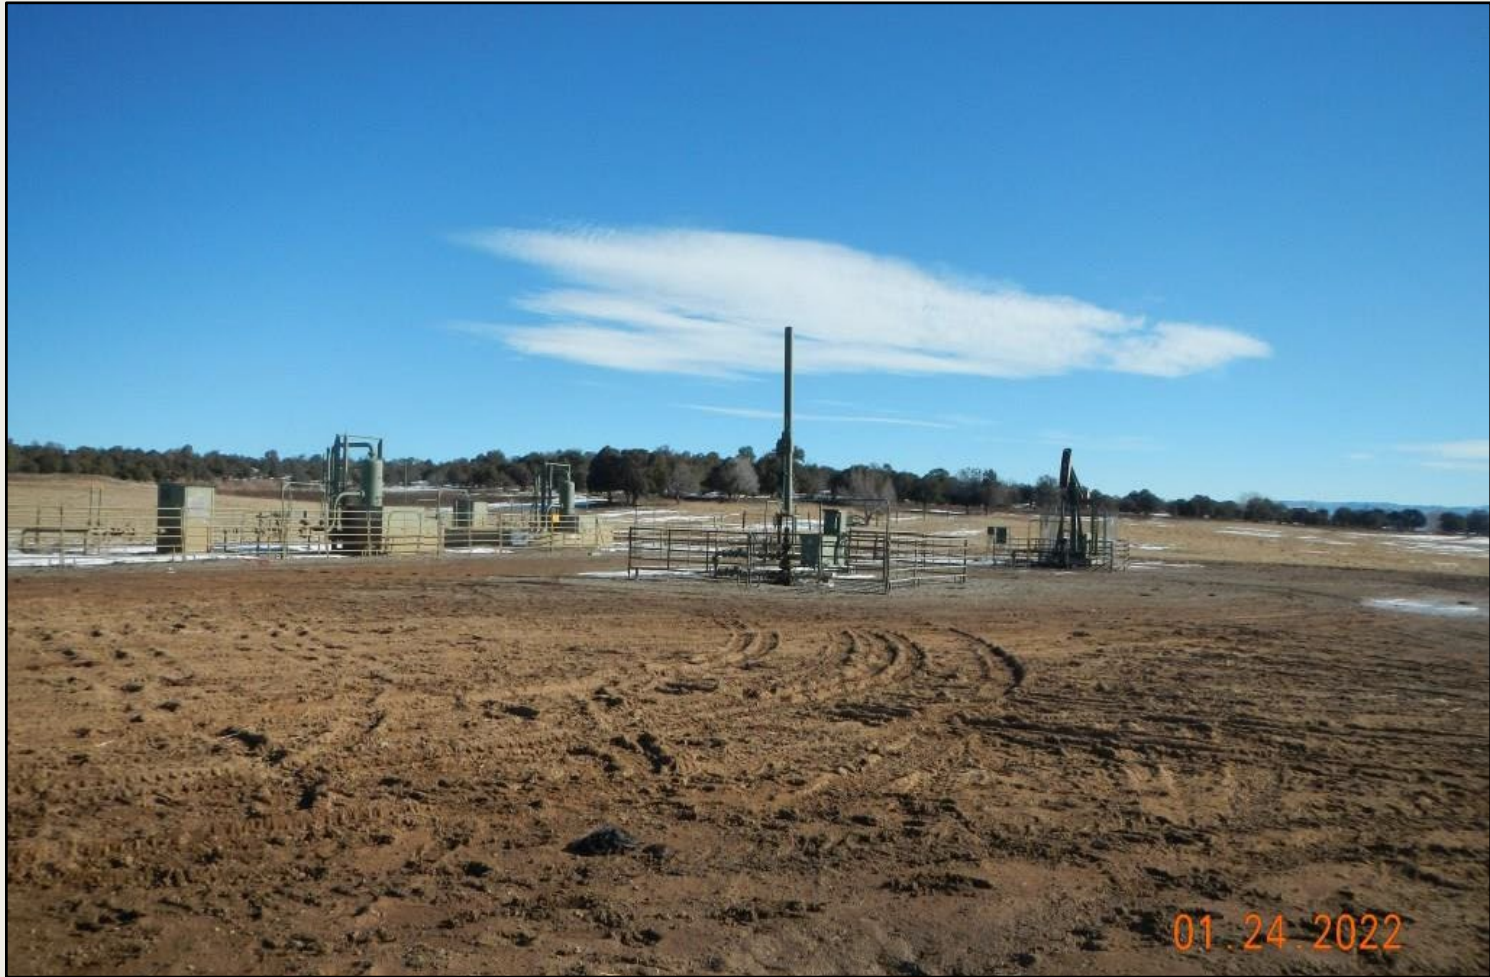
Photo 1. View of project area from the southwestern corner facing center.

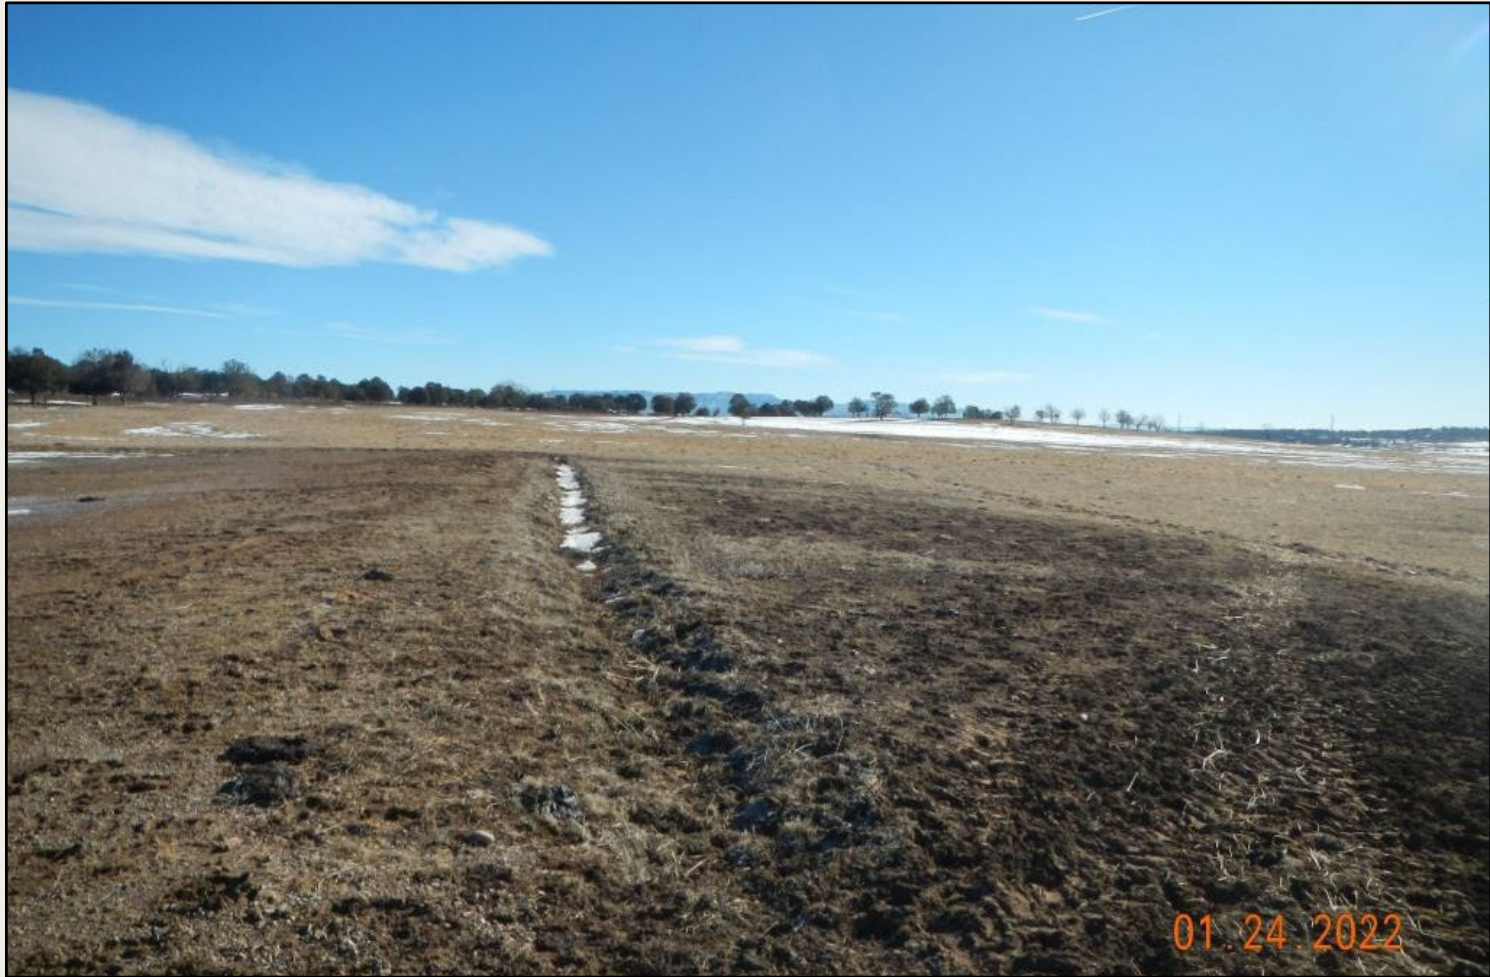
Photo 2. View of the southern project area from the southwestern project area facing eastward. Revegetation is progressing with irrigated grasses such as tall fescue and timothy, largely in a grazed condition.

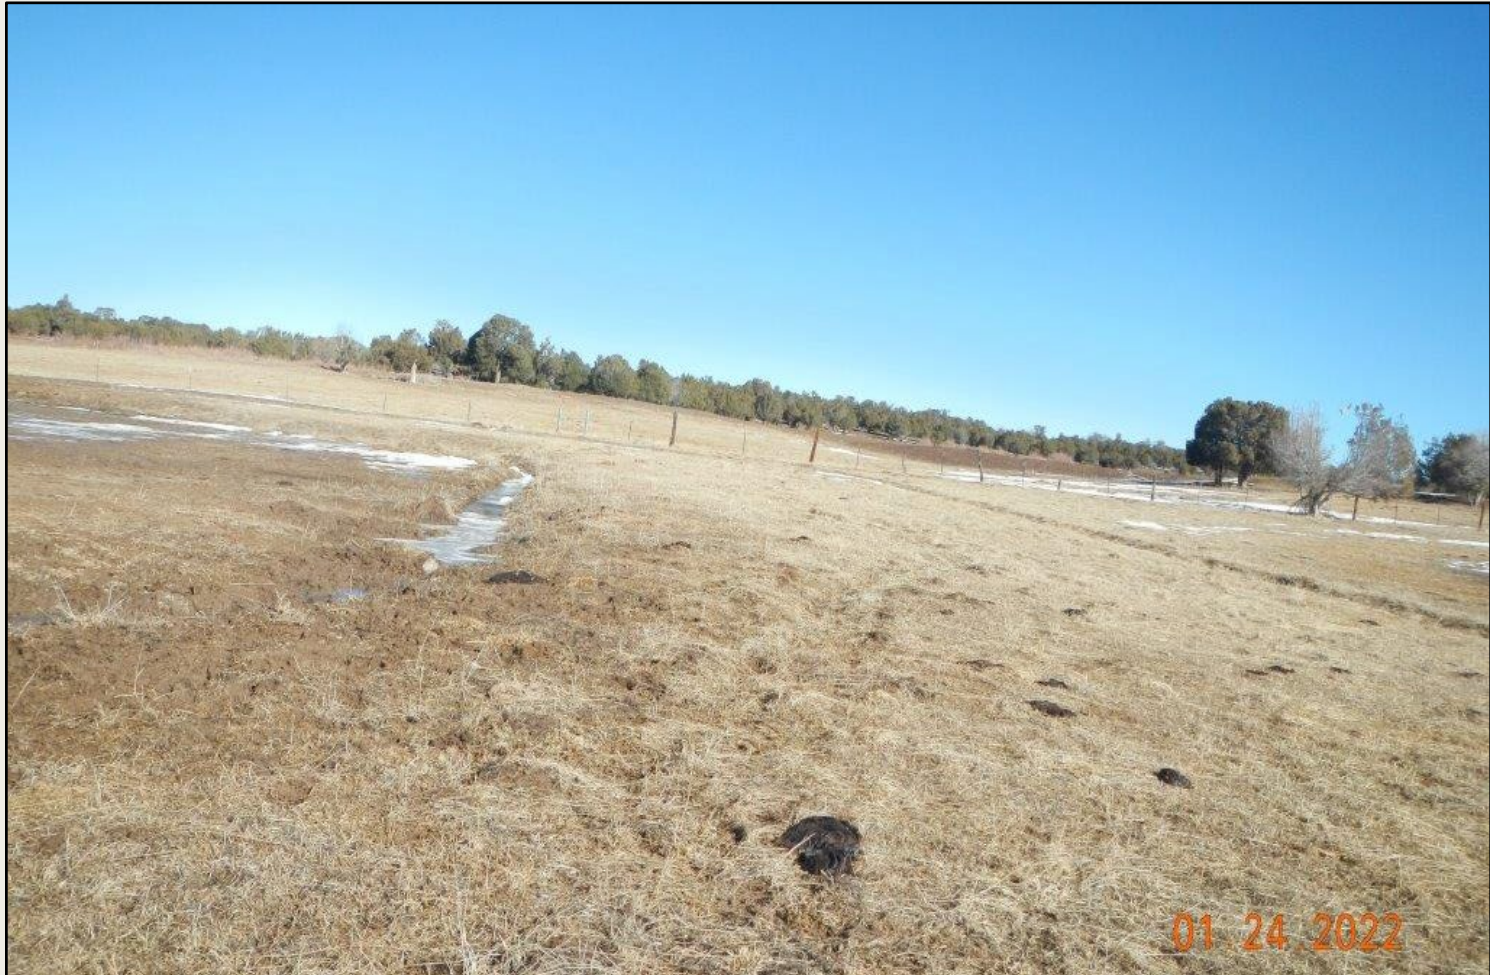
Photo 3. View of the eastern project area from the southeastern corner facing northward.

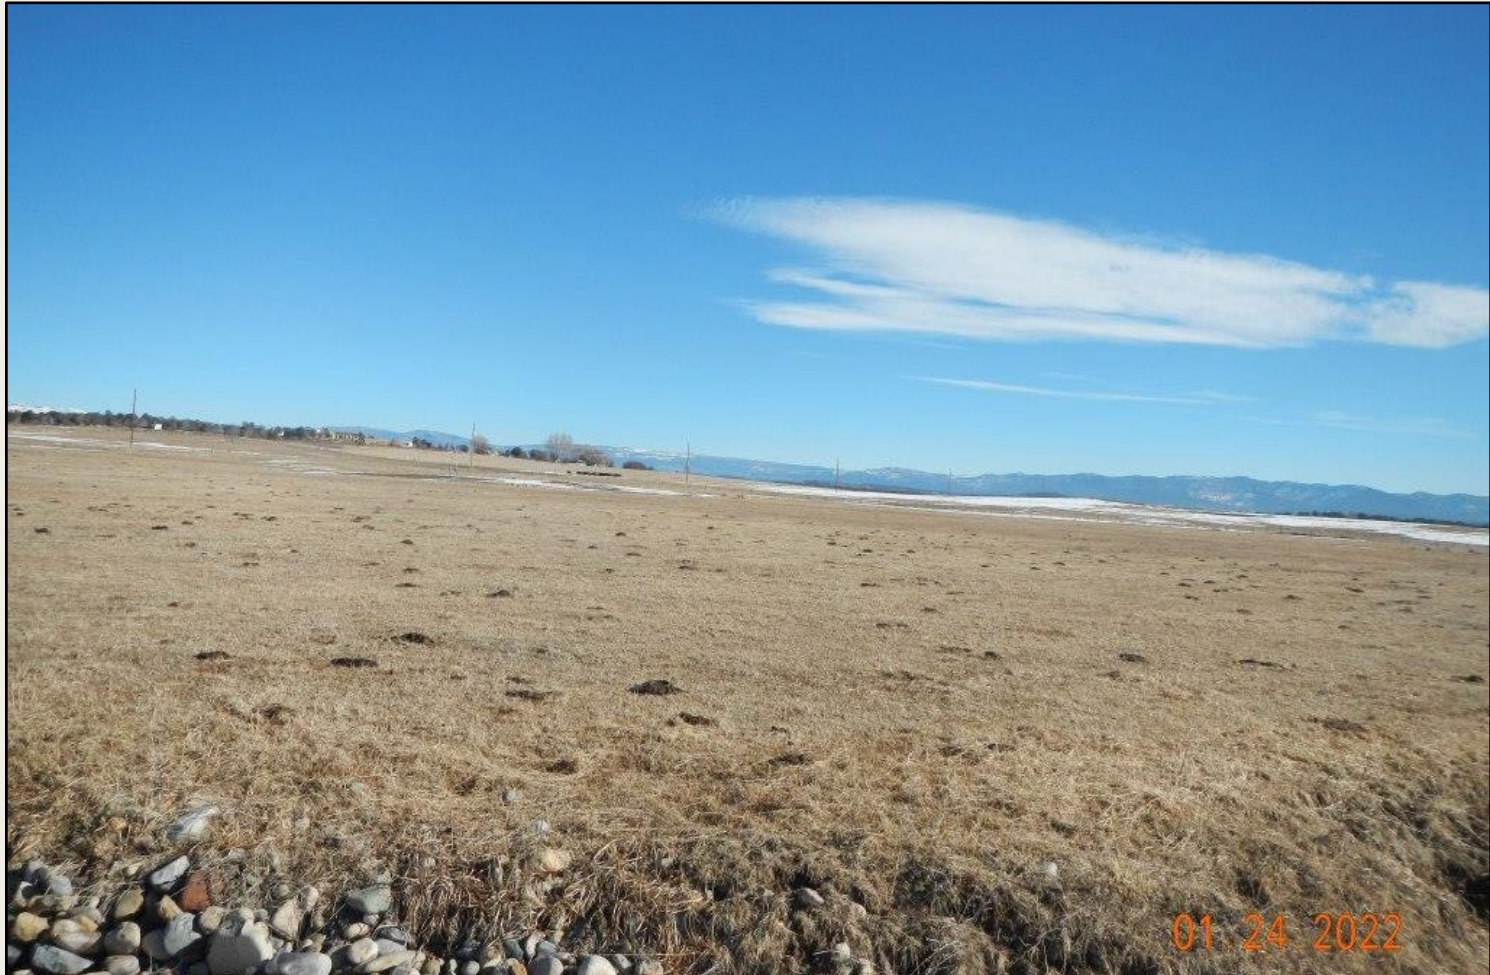
Photo 4. View of reference area vegetation comprised of grasses such as irrigated grass field, with timothy, tall fescue, and meadow brome.
