Inspection Photos  
Operator: Simcoe  
API: 067-06181  
Date: 1/24/2022

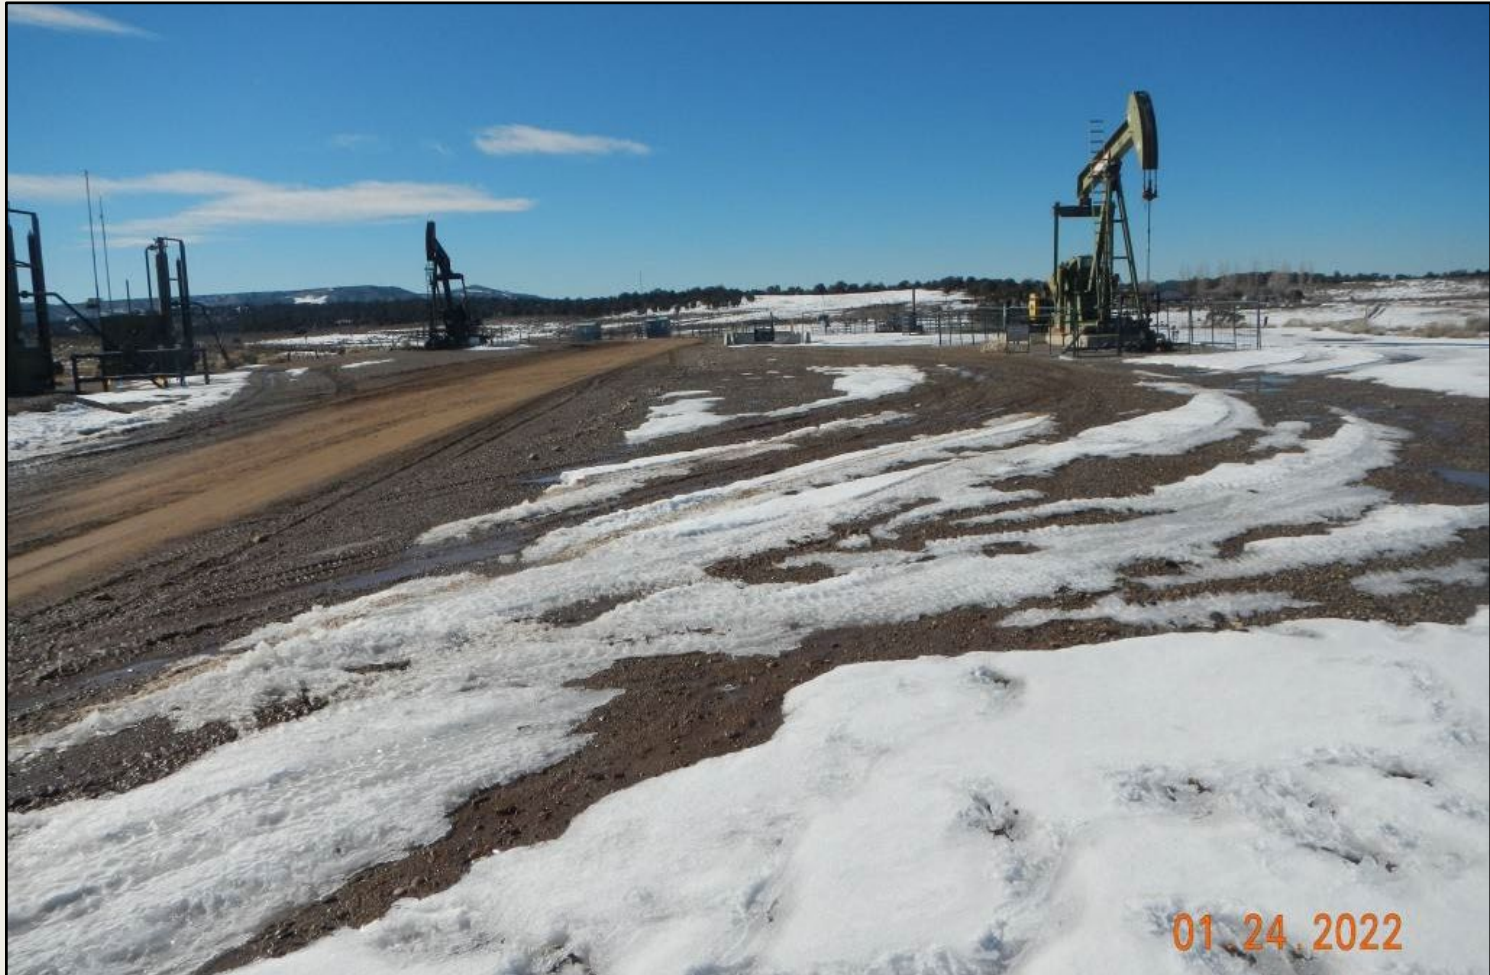
Photo 1. View of project area from the well pad entrance facing center.

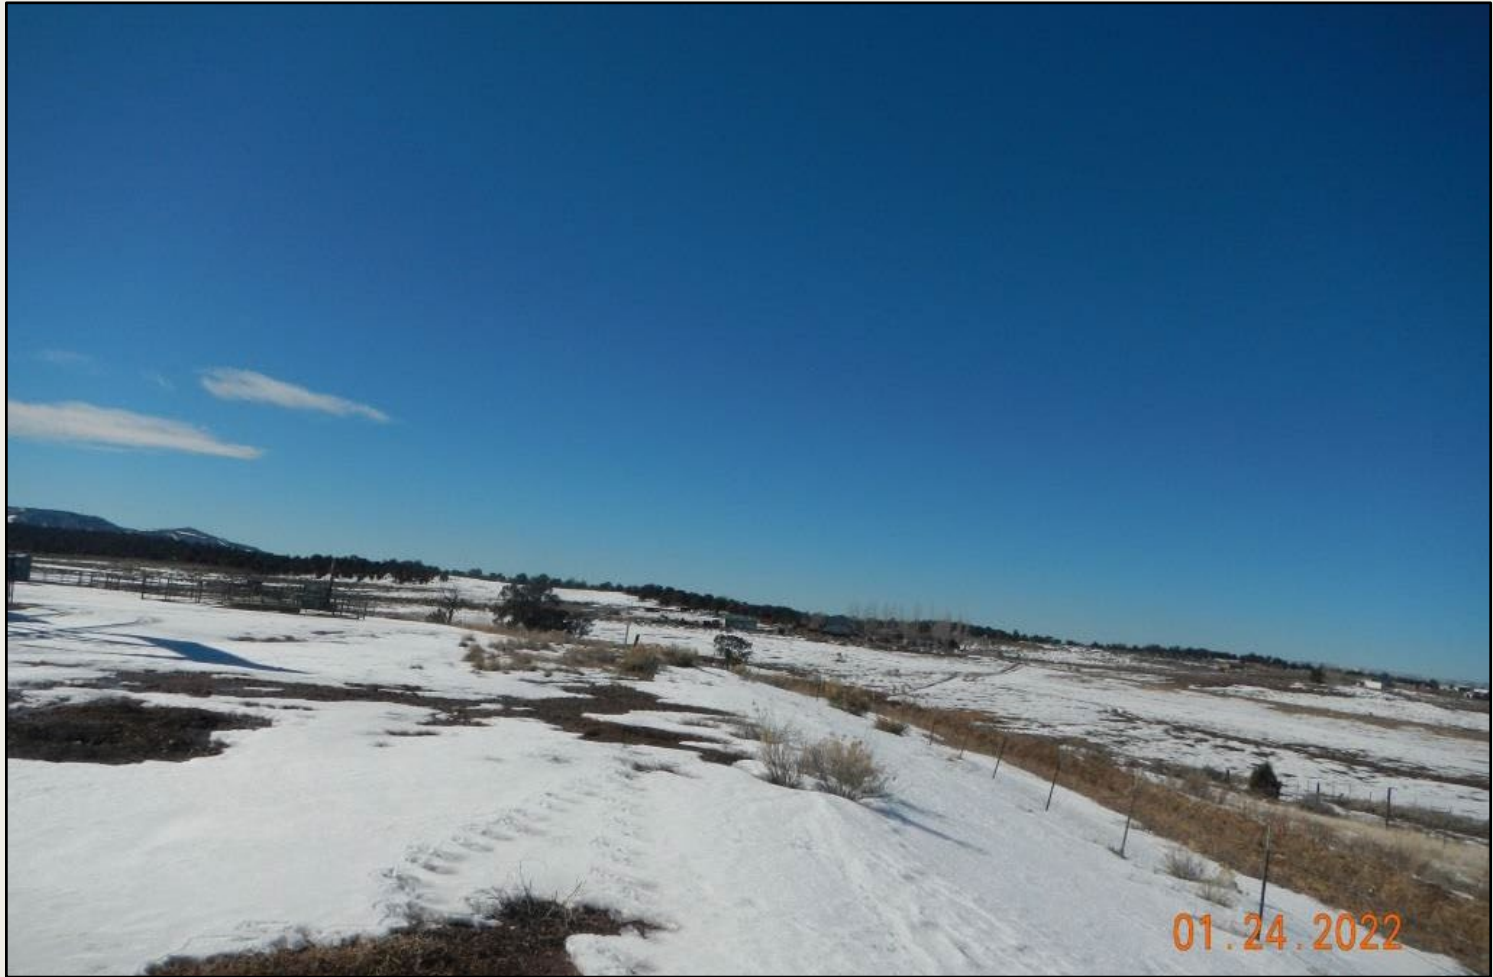
Photo 2. View of the northern project area from the northeastern project area facing westward. Revegetation is progressing with western wheatgrass, smooth brome, and intermediate wheatgrass.

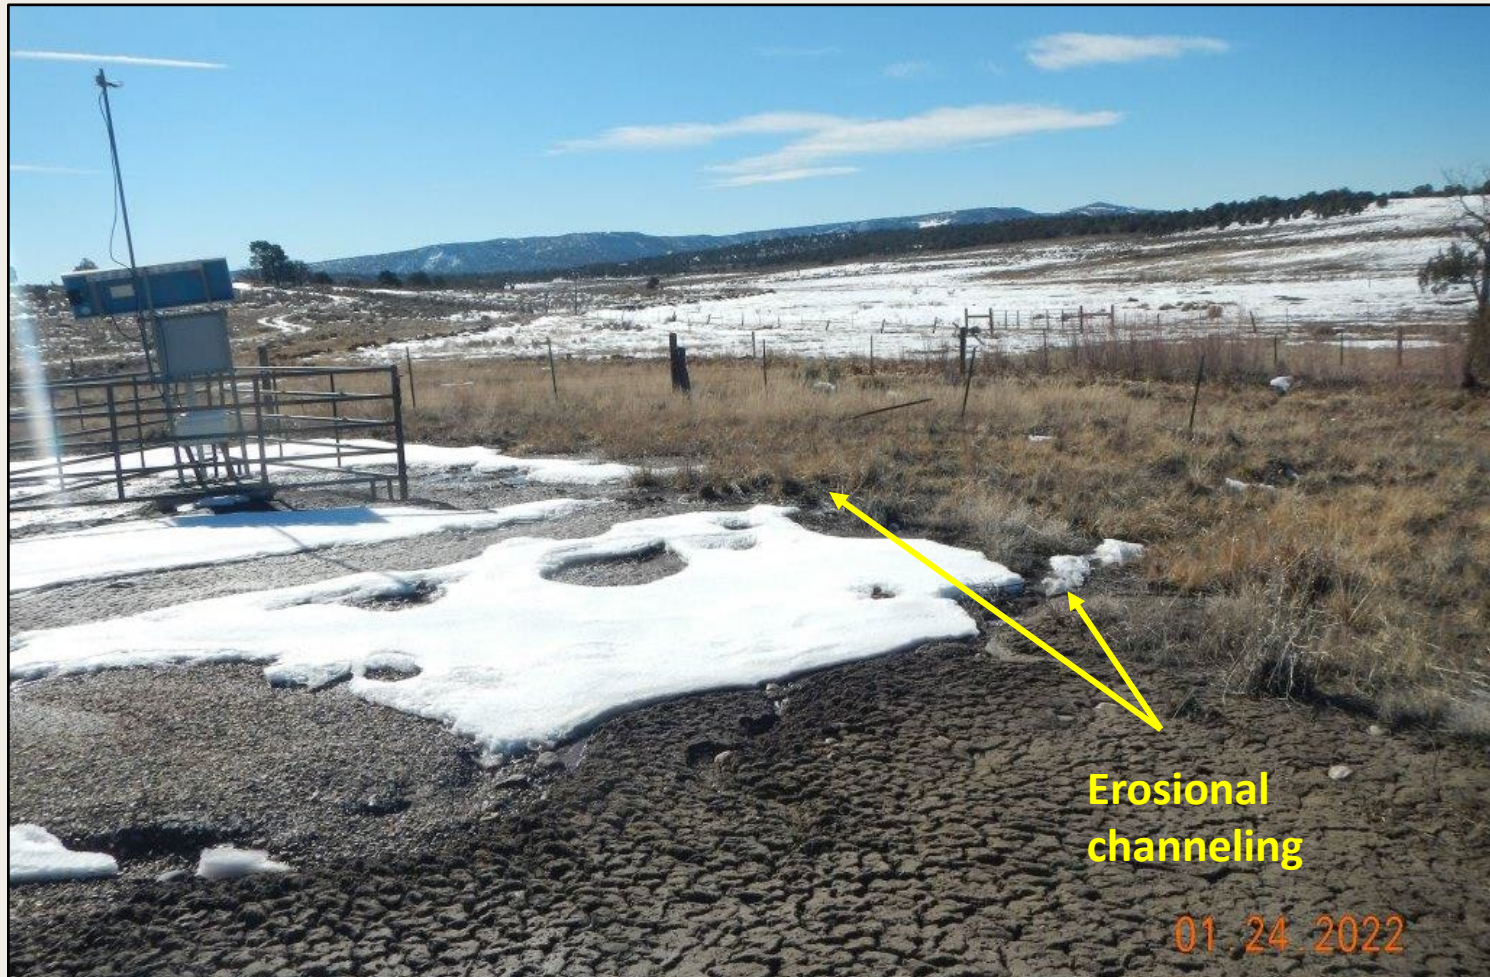
Photo 3. View of areas along the western edge of the working area where concentrated stormwater flows off of the well pad eroding channels that flow directly into an irrigation ditch.

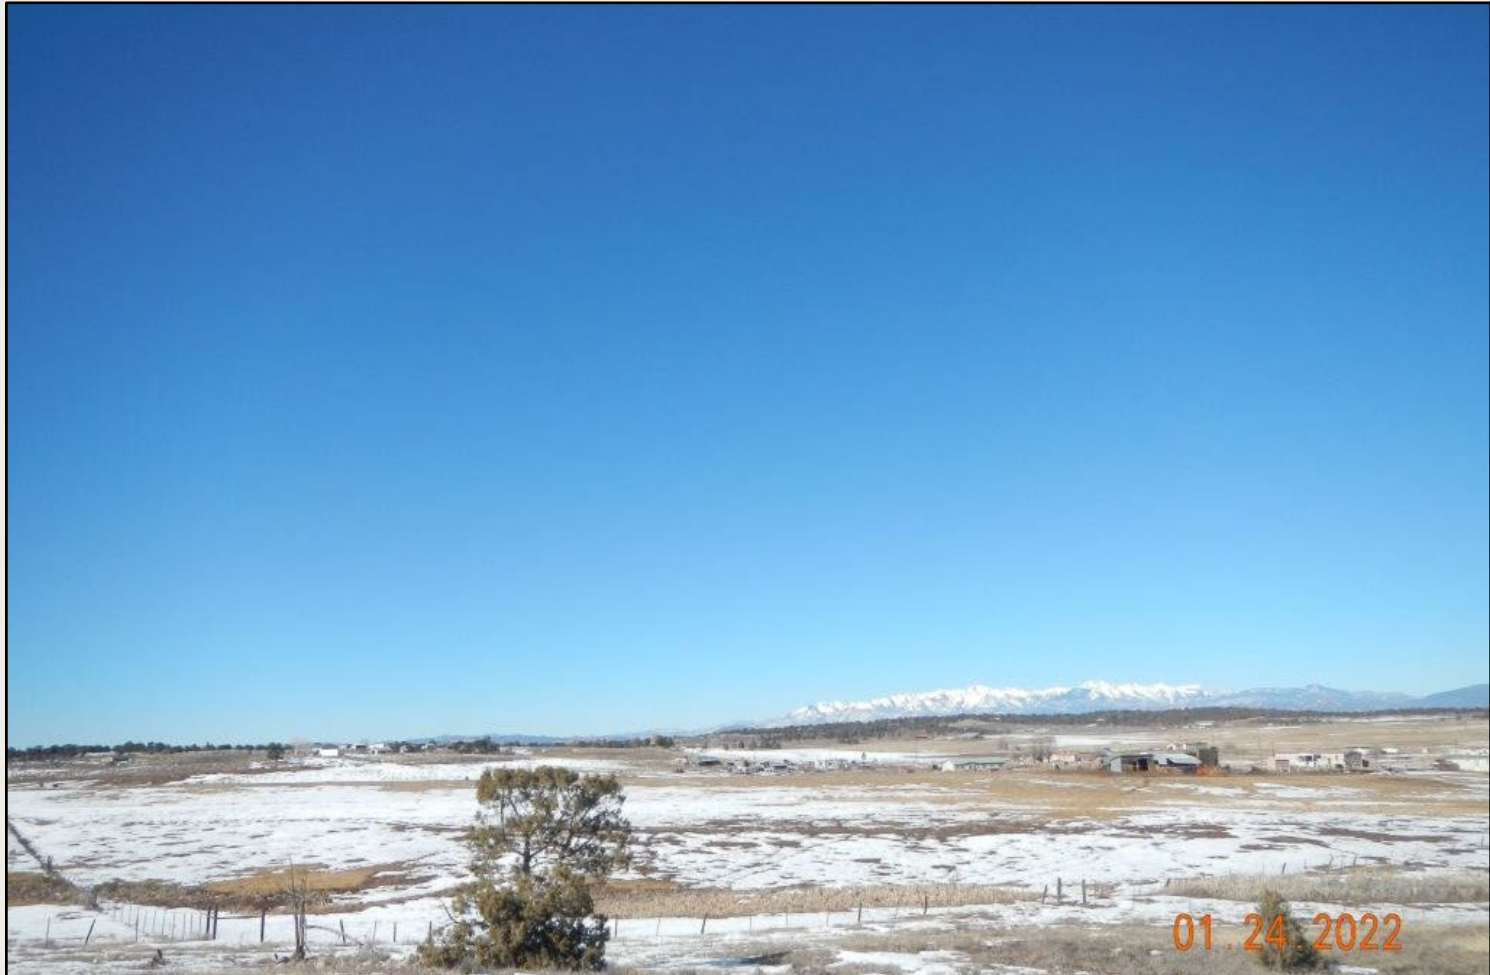
Photo 4. View of reference area comprised of open grass field with western wheatgrass, smooth brome, and scattered sagebrush, dormant at this time.
