Inspection Photos  
Operator: Simcoe  
API: 067-07836  
Date: 1/24/2022

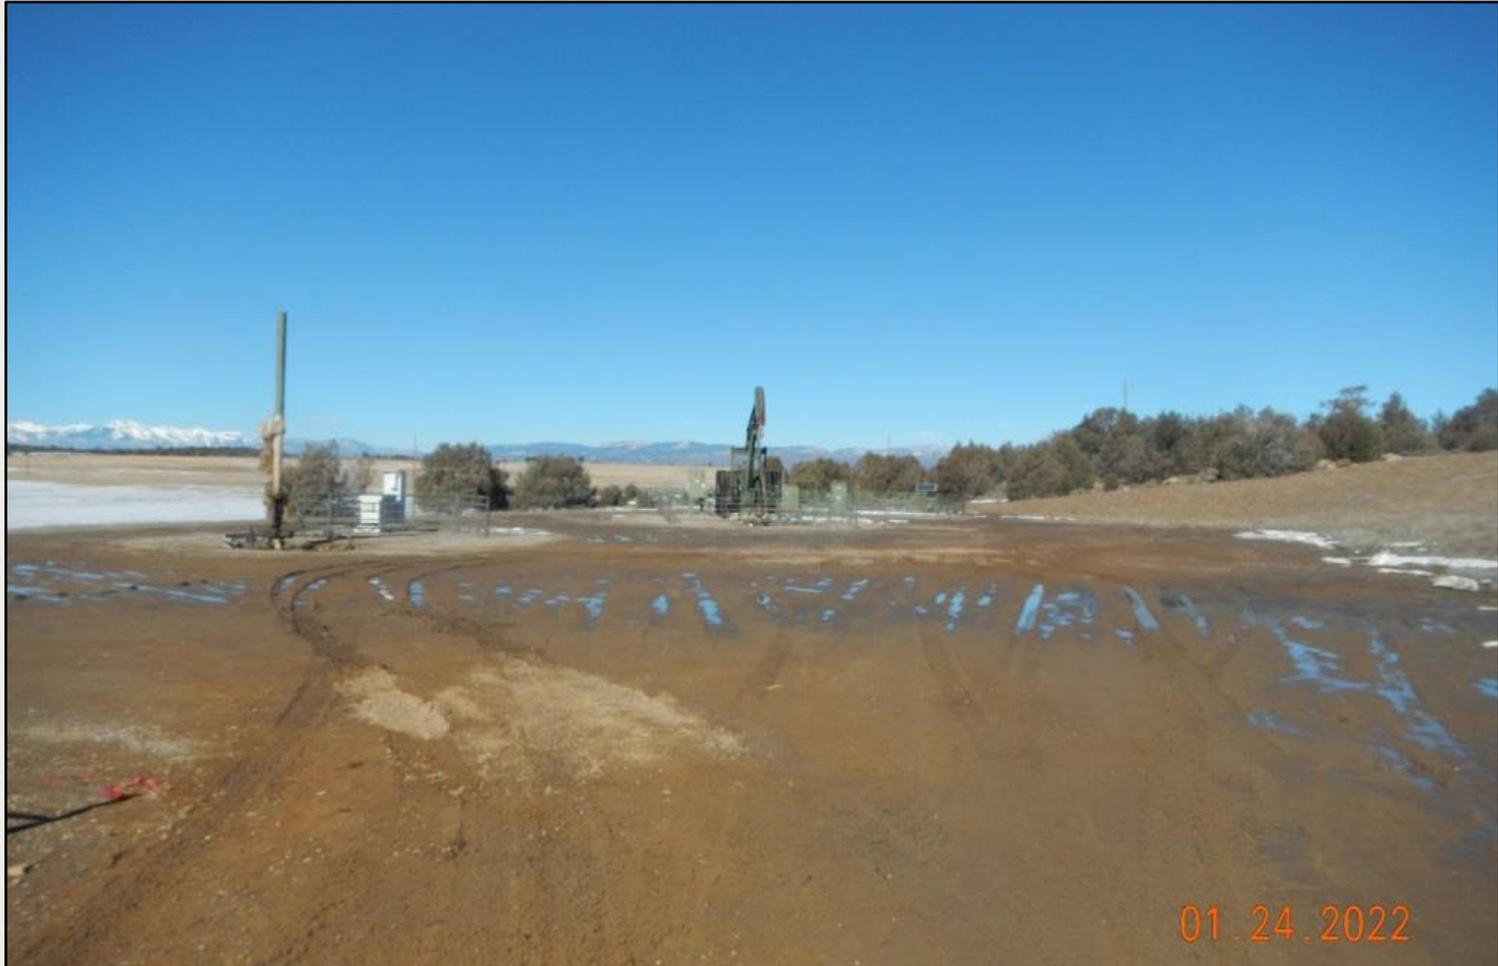
Photo 1. View of project area from the well pad entrance facing center.

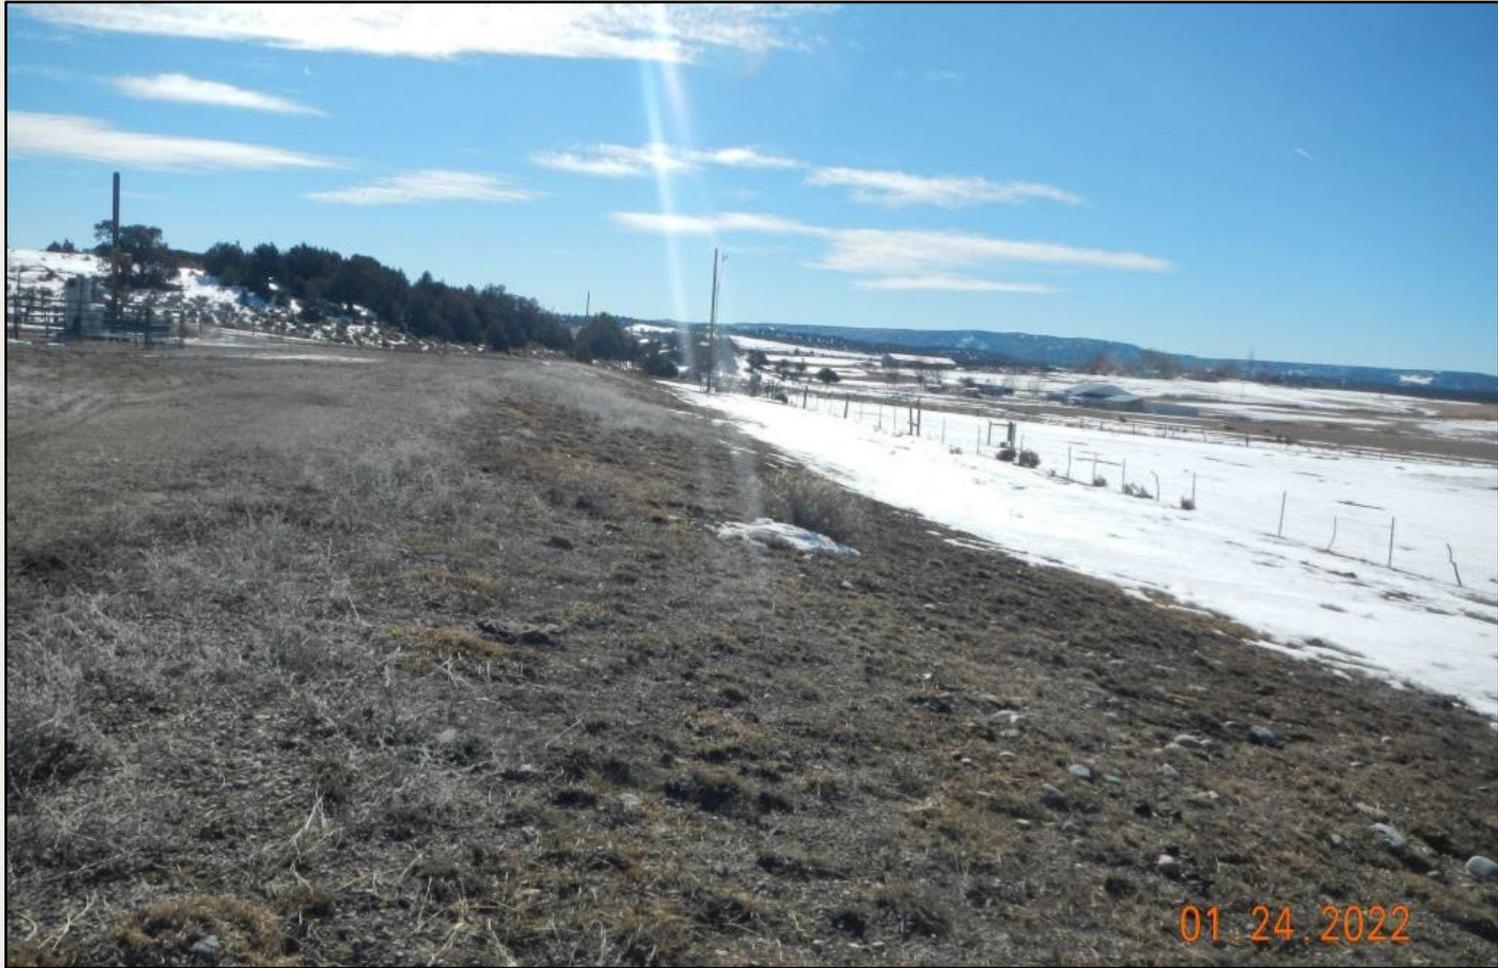
Photo 2. View of the western project area from the northwestern project area facing southward. Revegetation is progressing grasses, largely grazed, with western wheatgrass and crested wheatgrass observable.

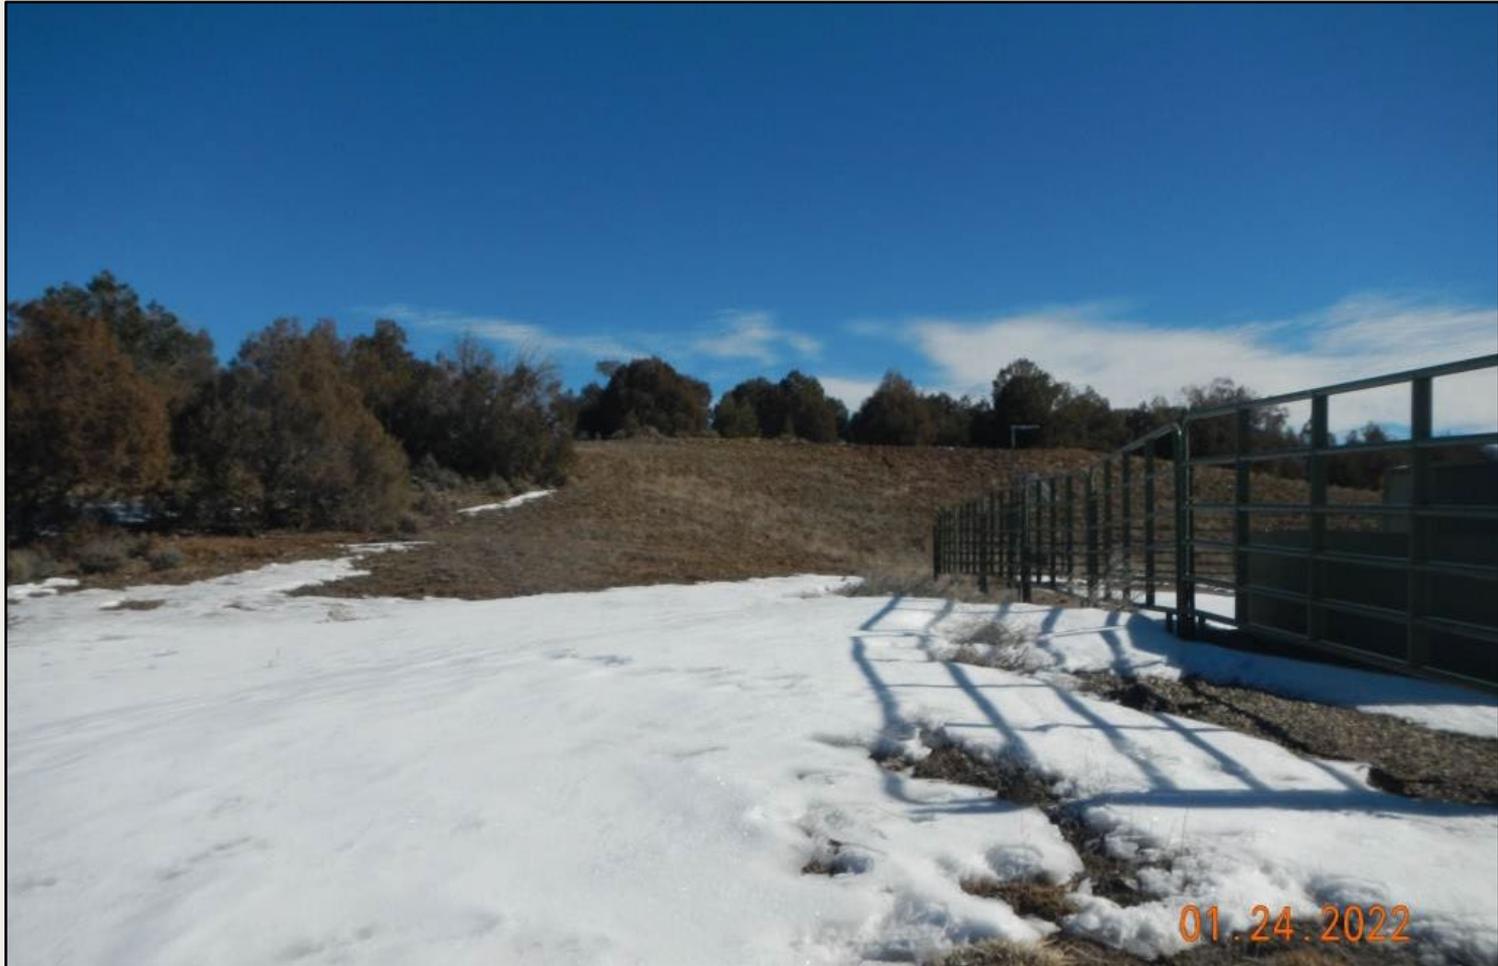
Photo 3. View of the northern project area from the northwestern corner facing eastward.

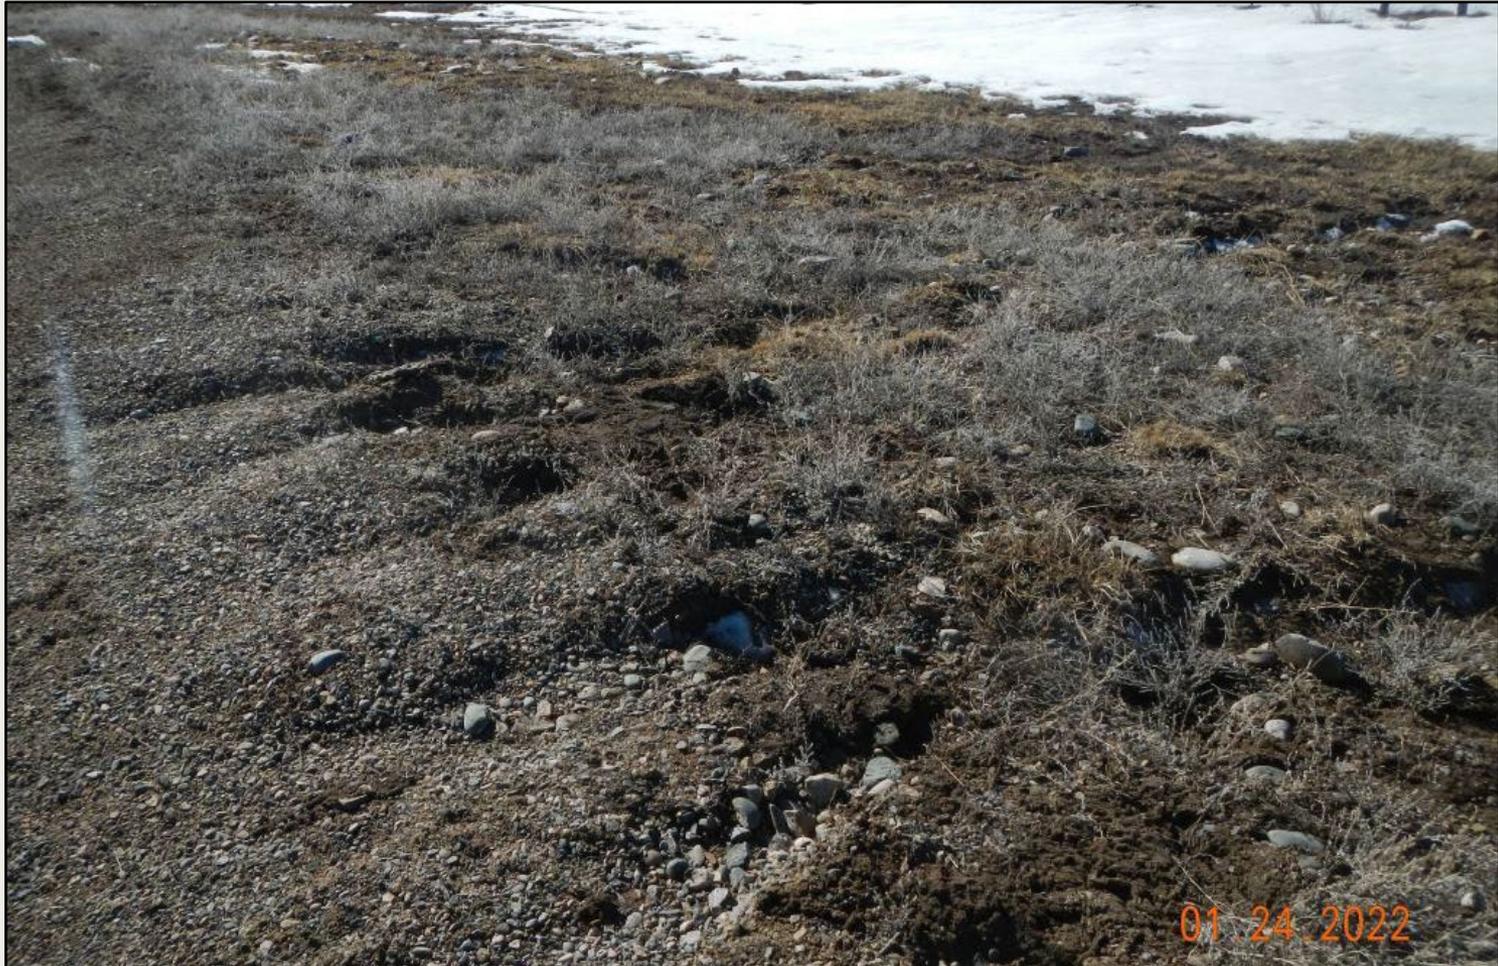
Photo 4. View of erosional rilling observed along the western edge of the working area and in the fill slope.

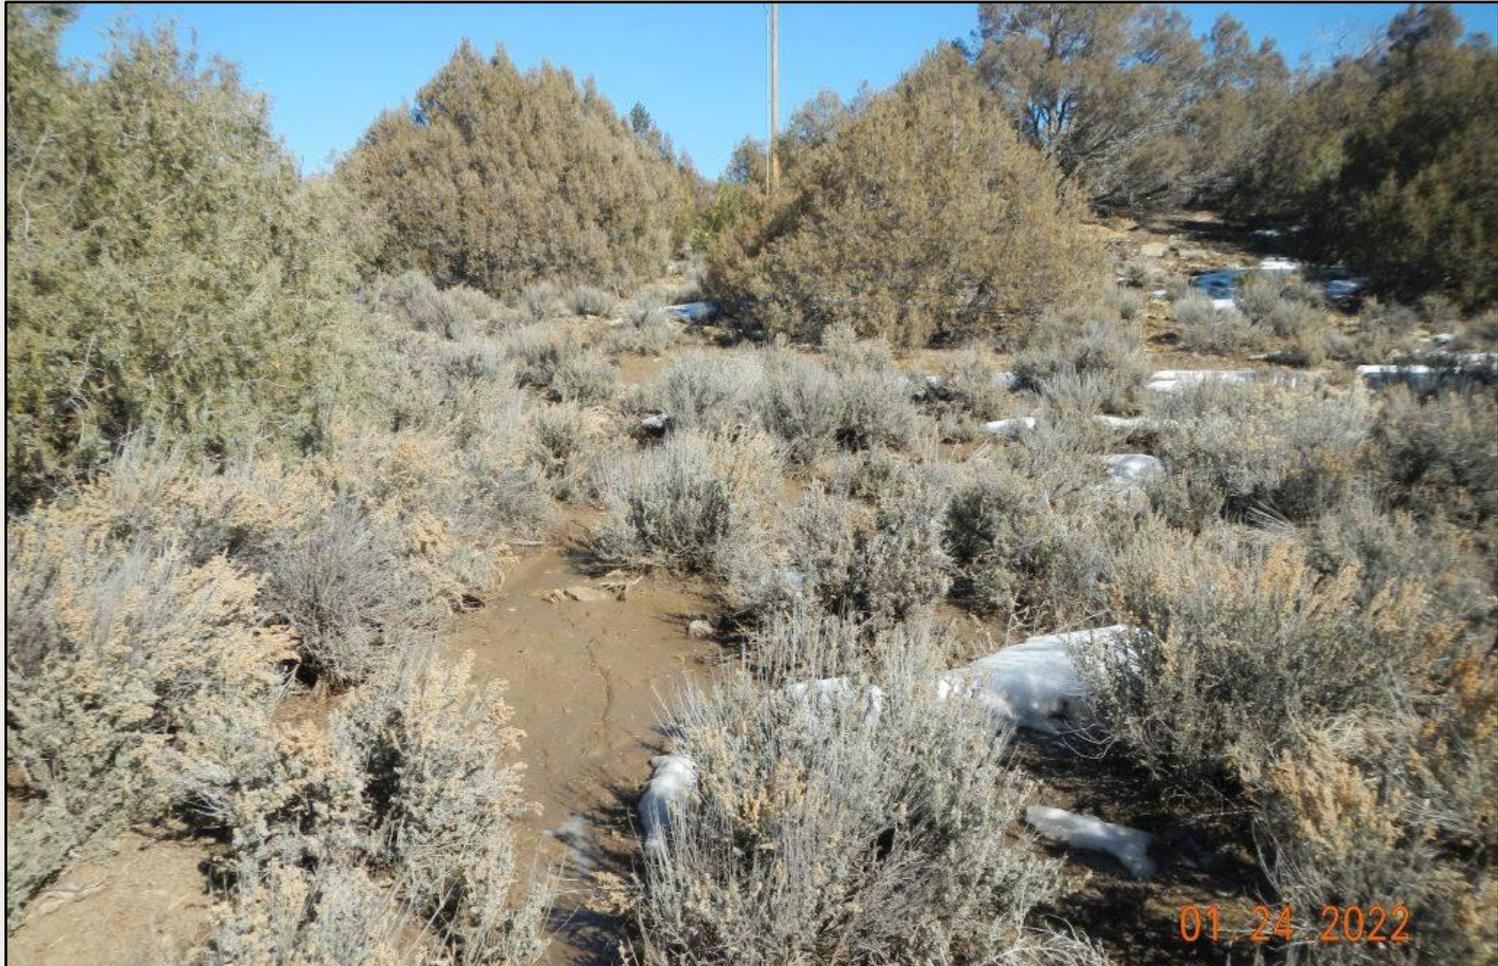
Photo 5. View of pinyon juniper woodland with understory of sagebrush, antelope bitterbrush, prickly pear, James galleta, and mat penstemon.
