Inspection Photos

Location Name: TEP ROCKY MOUNTAIN LLC FEDERAL-67S96W /11NWNE

Location ID: 334982

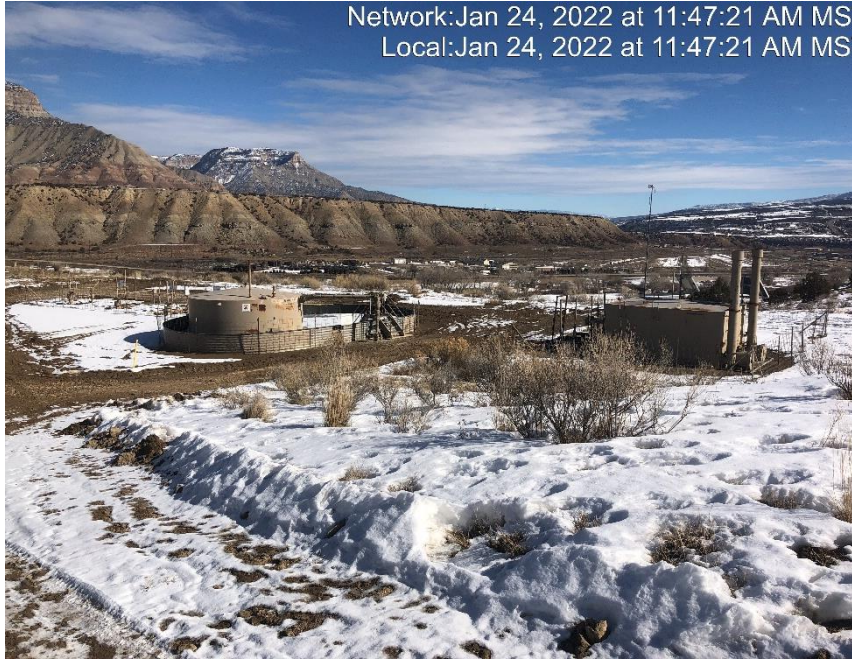
Photo #5760 from entrance to location.

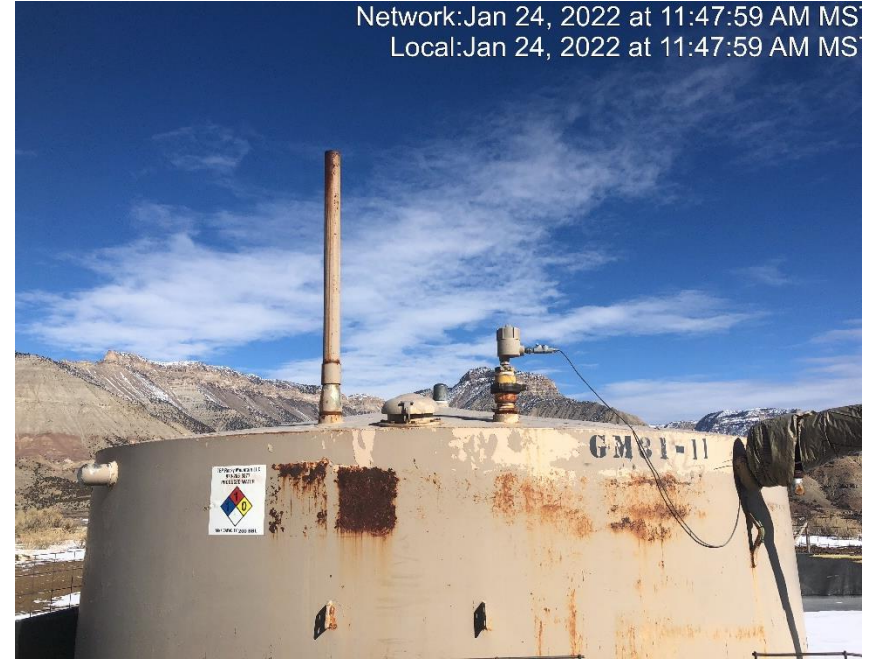
Photo #5761 Vent pipe on tank open ended.

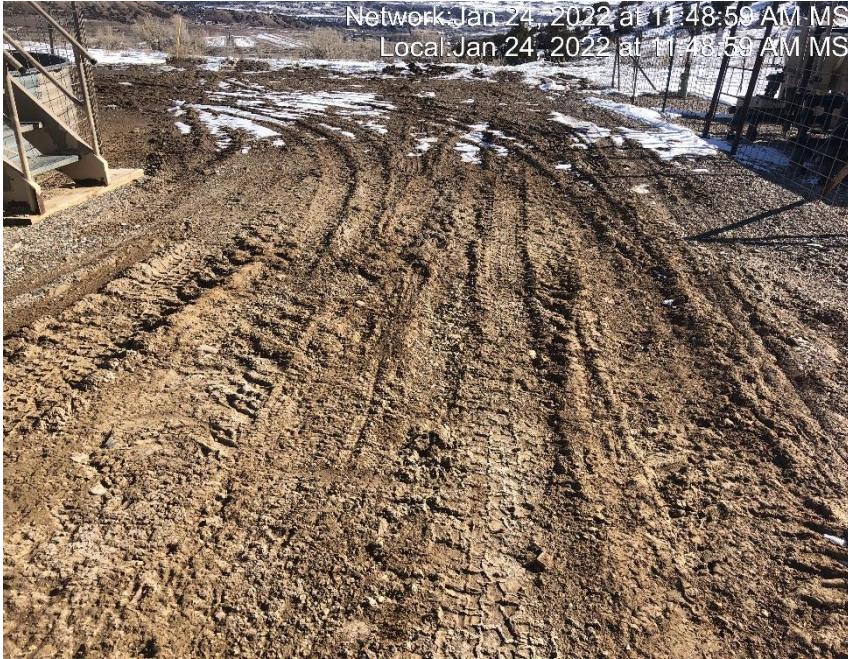
Photo #5762 Location lacks stabilization.

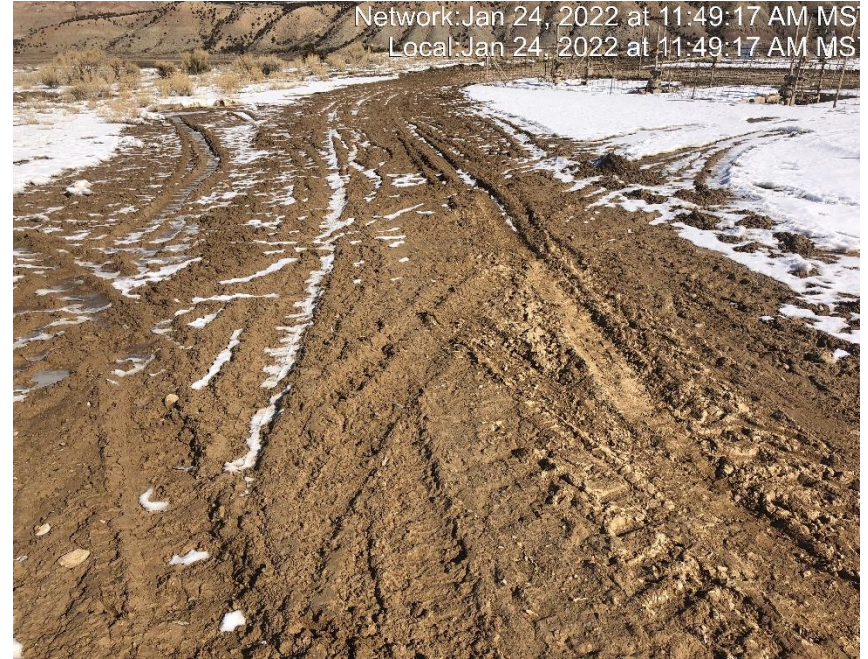
Photo #5763 Location lacks stabilization.

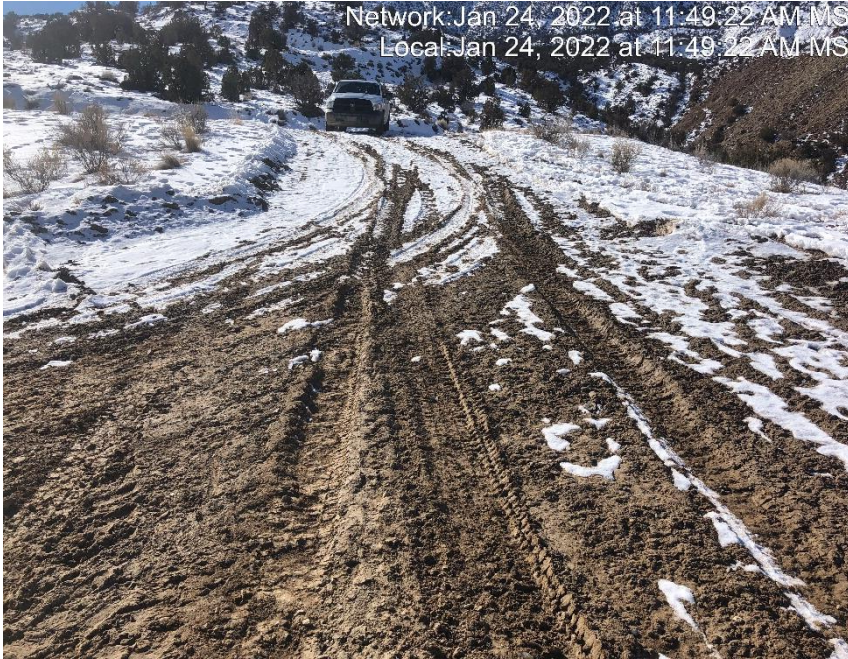
Photo #5764 Insufficient tacking BMP at entrance to location.
