Final Reclamation Inspection

Operator: PDC ENERGY INC - 69175

Location ID: 323096

Inspection Document #: 701900287

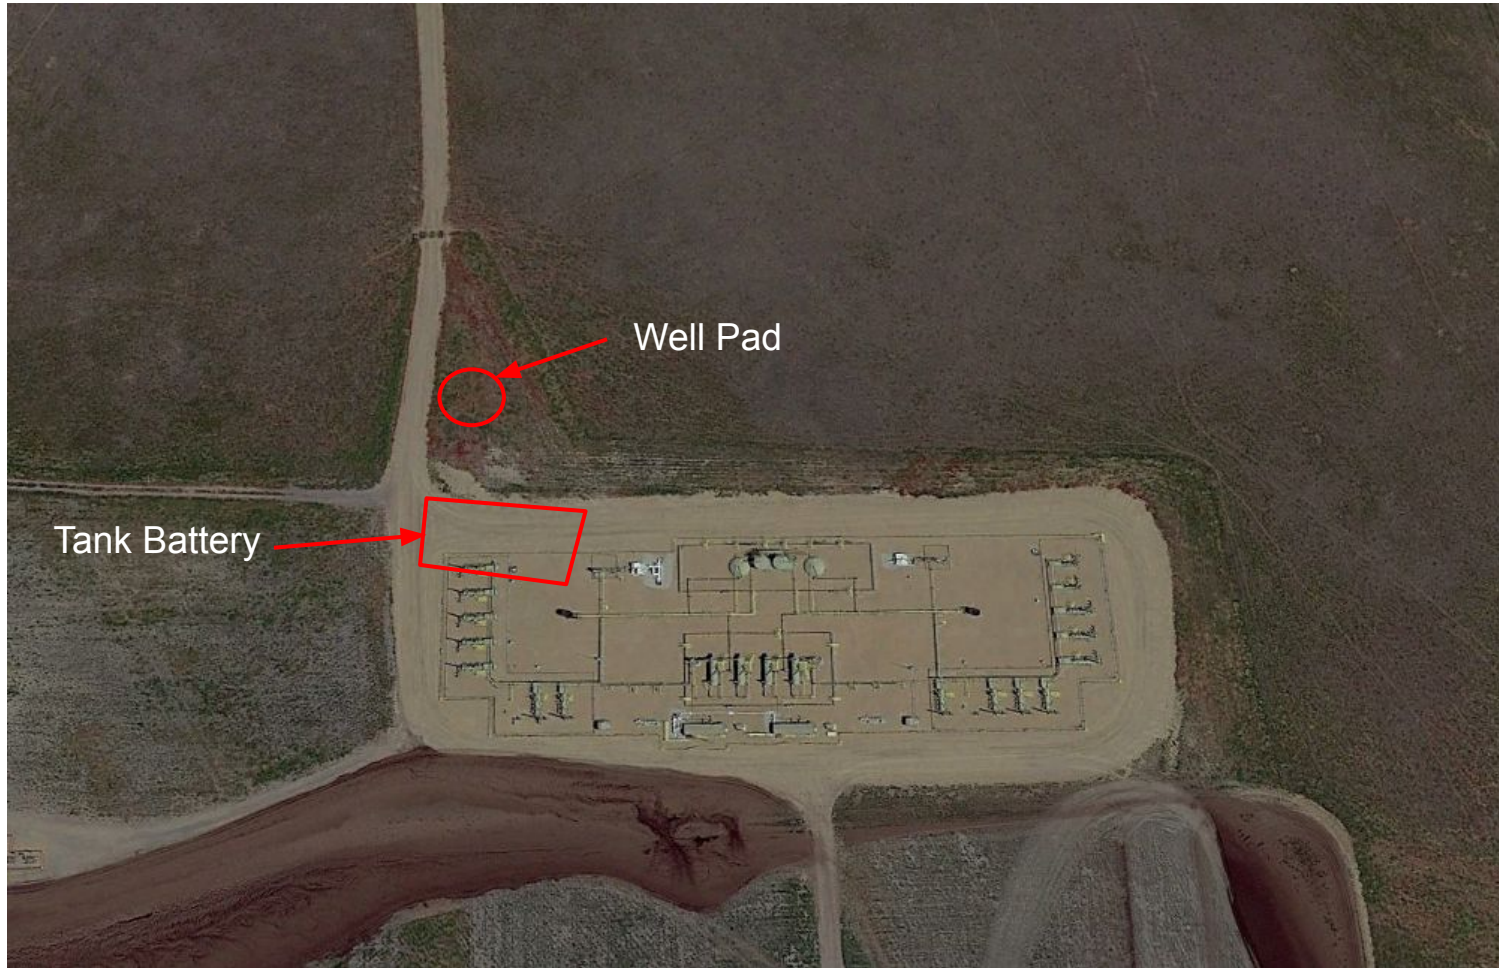
Photo 1. 2021 aerial imagery of the well pad and tank battery (north is up).
Note: The tank battery has been subdued by a new facility owned by another operator.

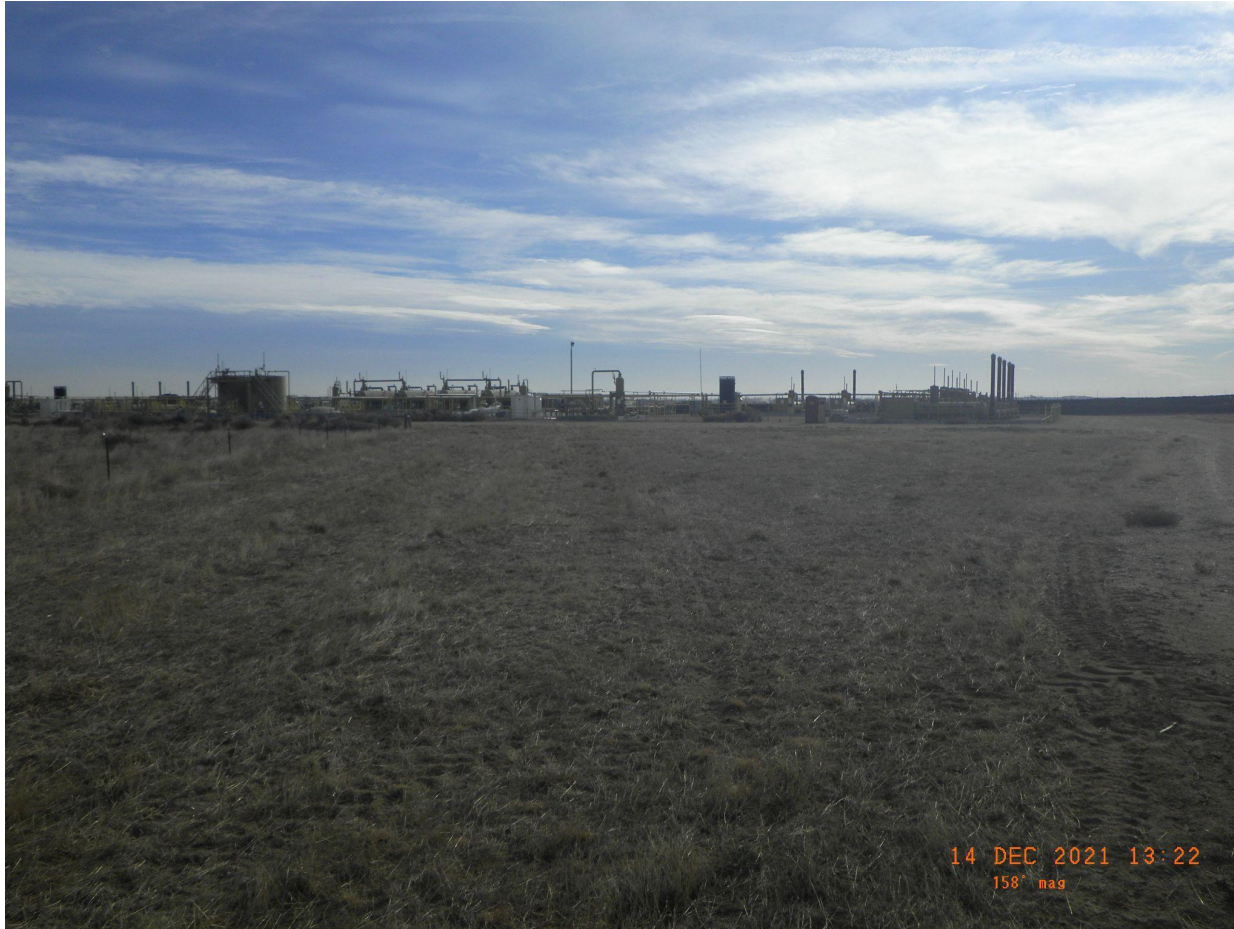
Photo 2. Overview photo of the well pad taken at ground level from the northern edge looking south.

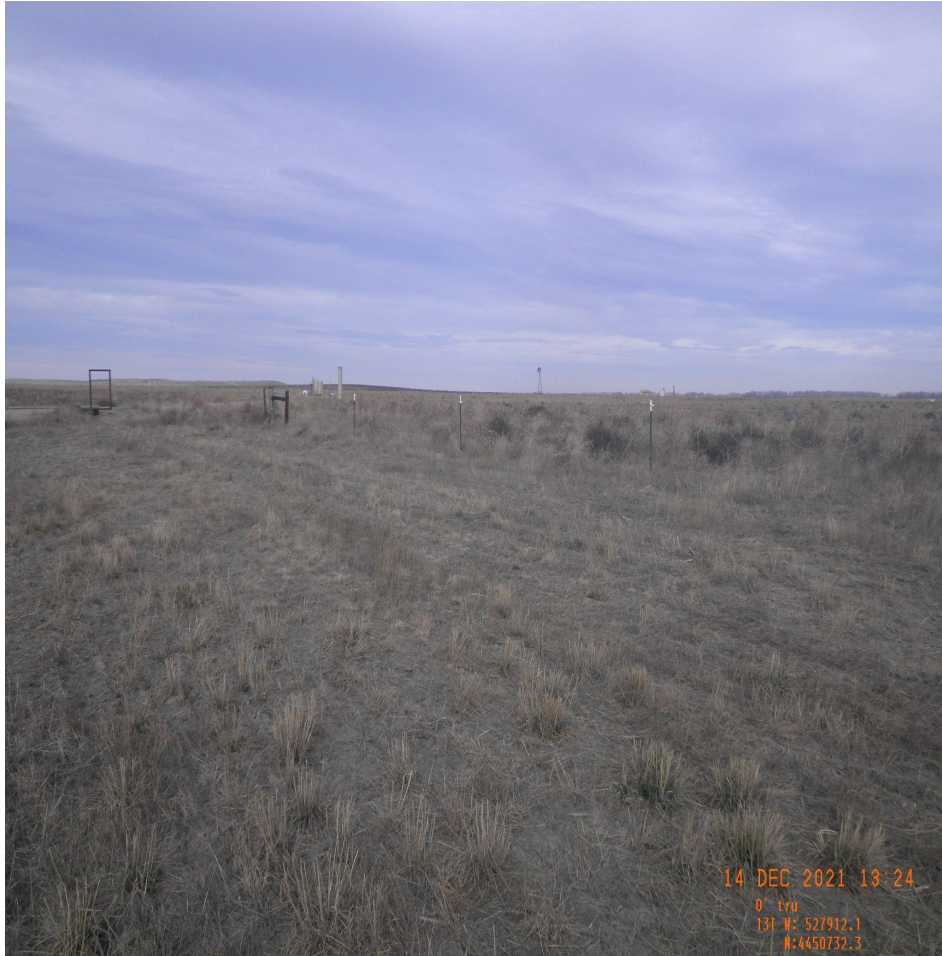
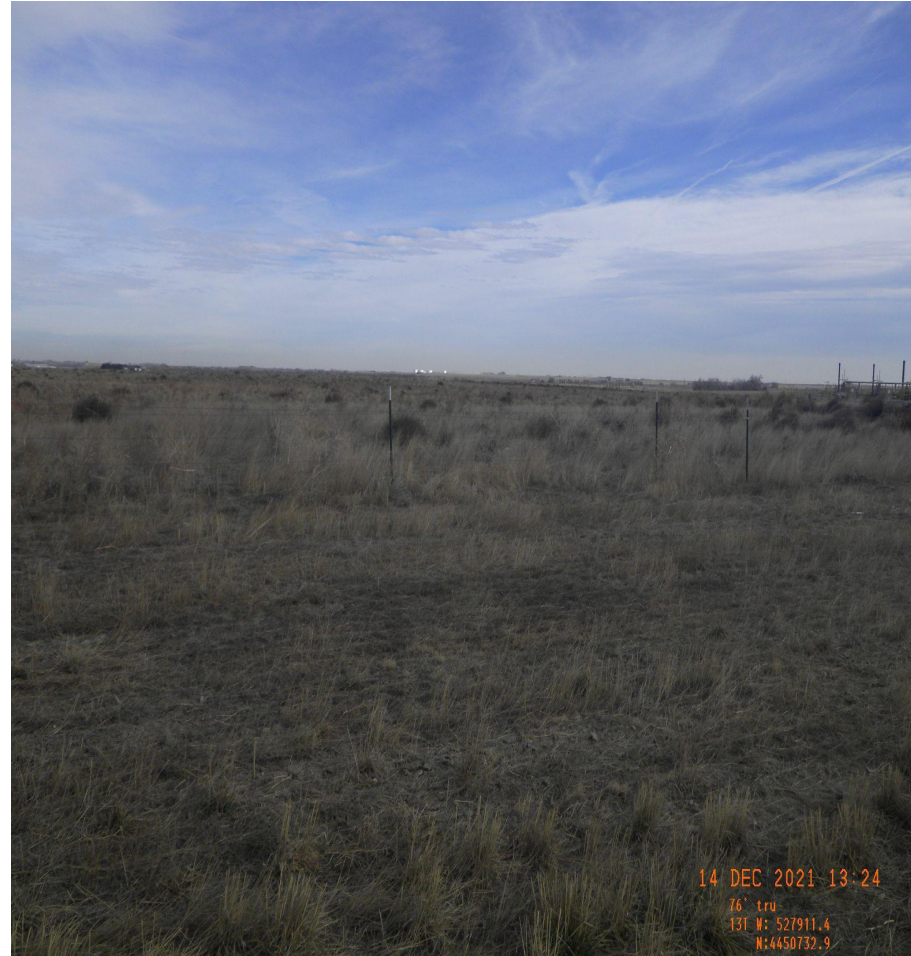
Photo 3. Photos taken from the middle of the well pad. Left photo facing north and right photo facing east. See description under photo 4.

Photo 4. Photos taken from the middle of the well pad. Left photo facing south and right photo facing west. Reclaimed well pad vegetation has not yet established and will need to be re-inspected.

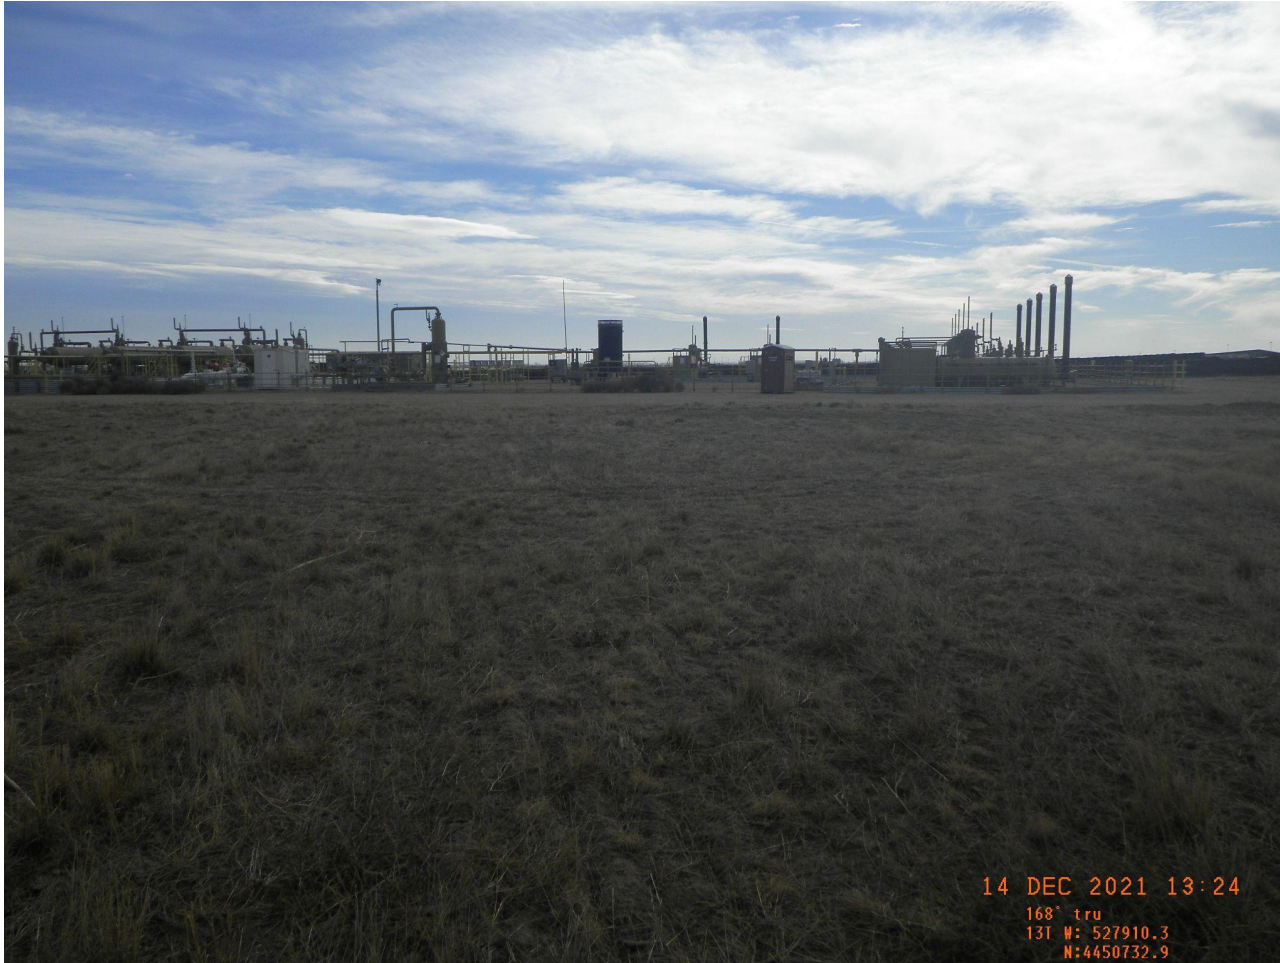
Photo 5. Overview photo of the tank battery taken at ground level from the northern edge looking south.

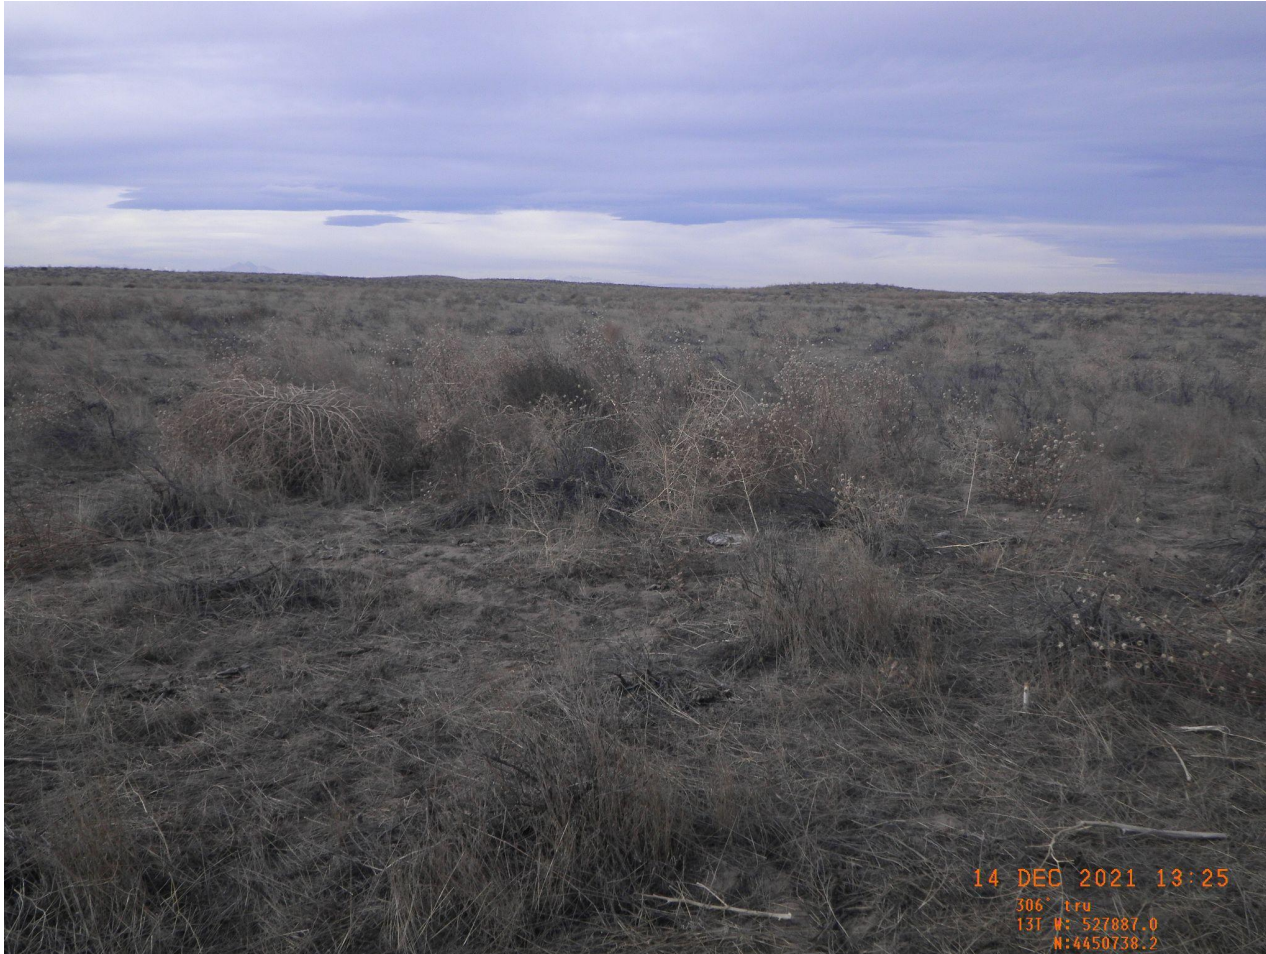
Photo 6. Reference area to the west of the well pad and tank battery.
