Inspection Photos
Operator: Logos Operating
API: 067-08365
Date: 1/27/2022

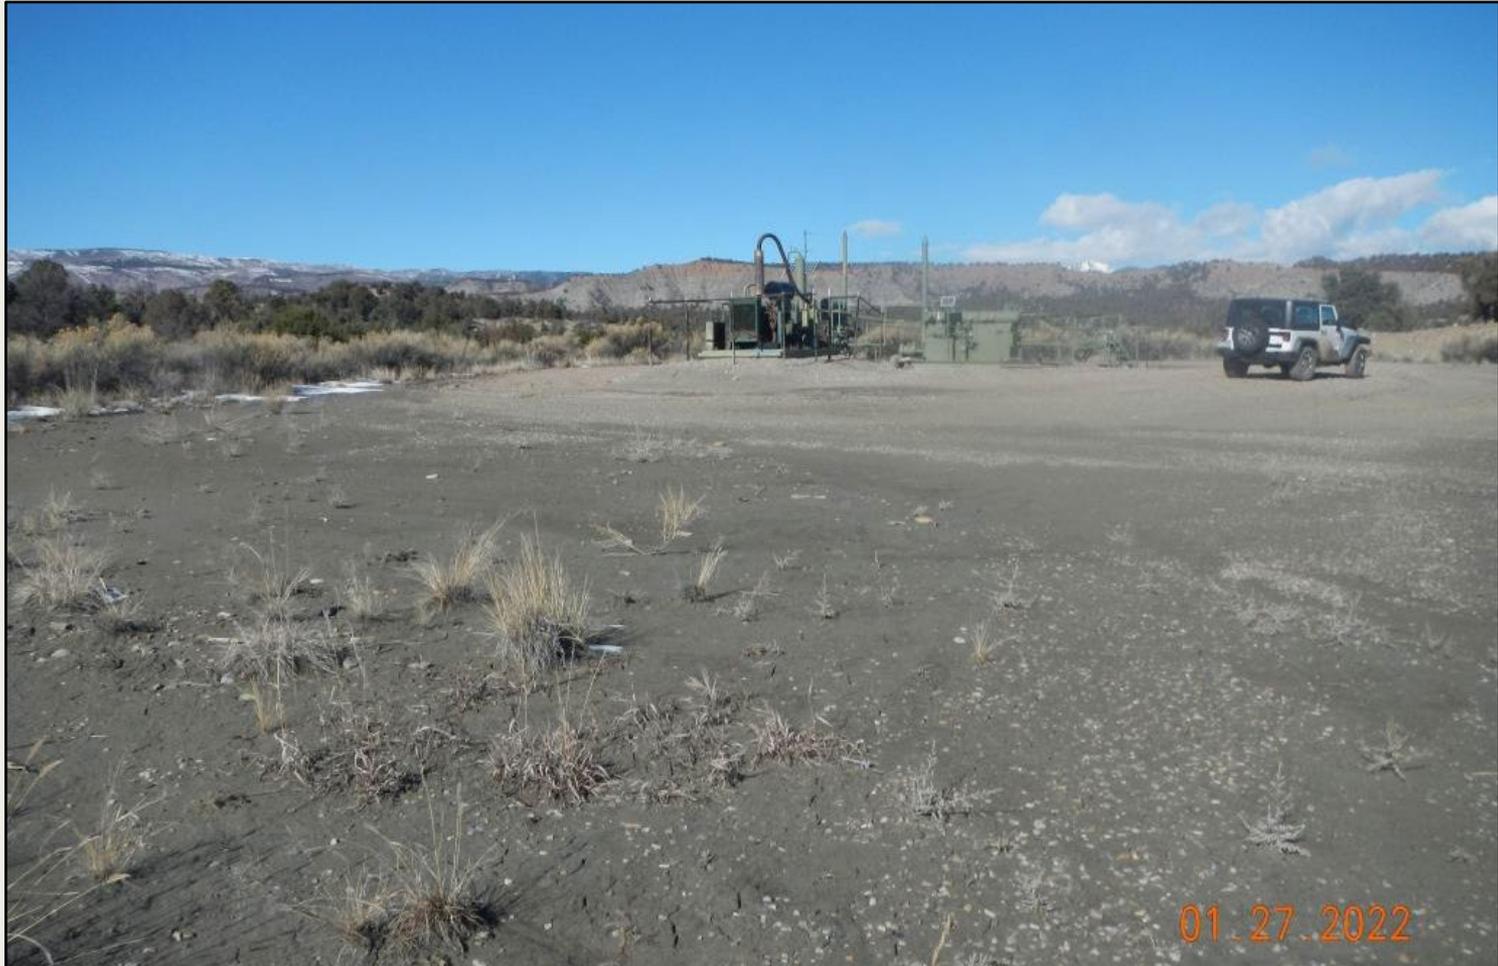
Photo 1. View of project area from the southeastern corner facing center.

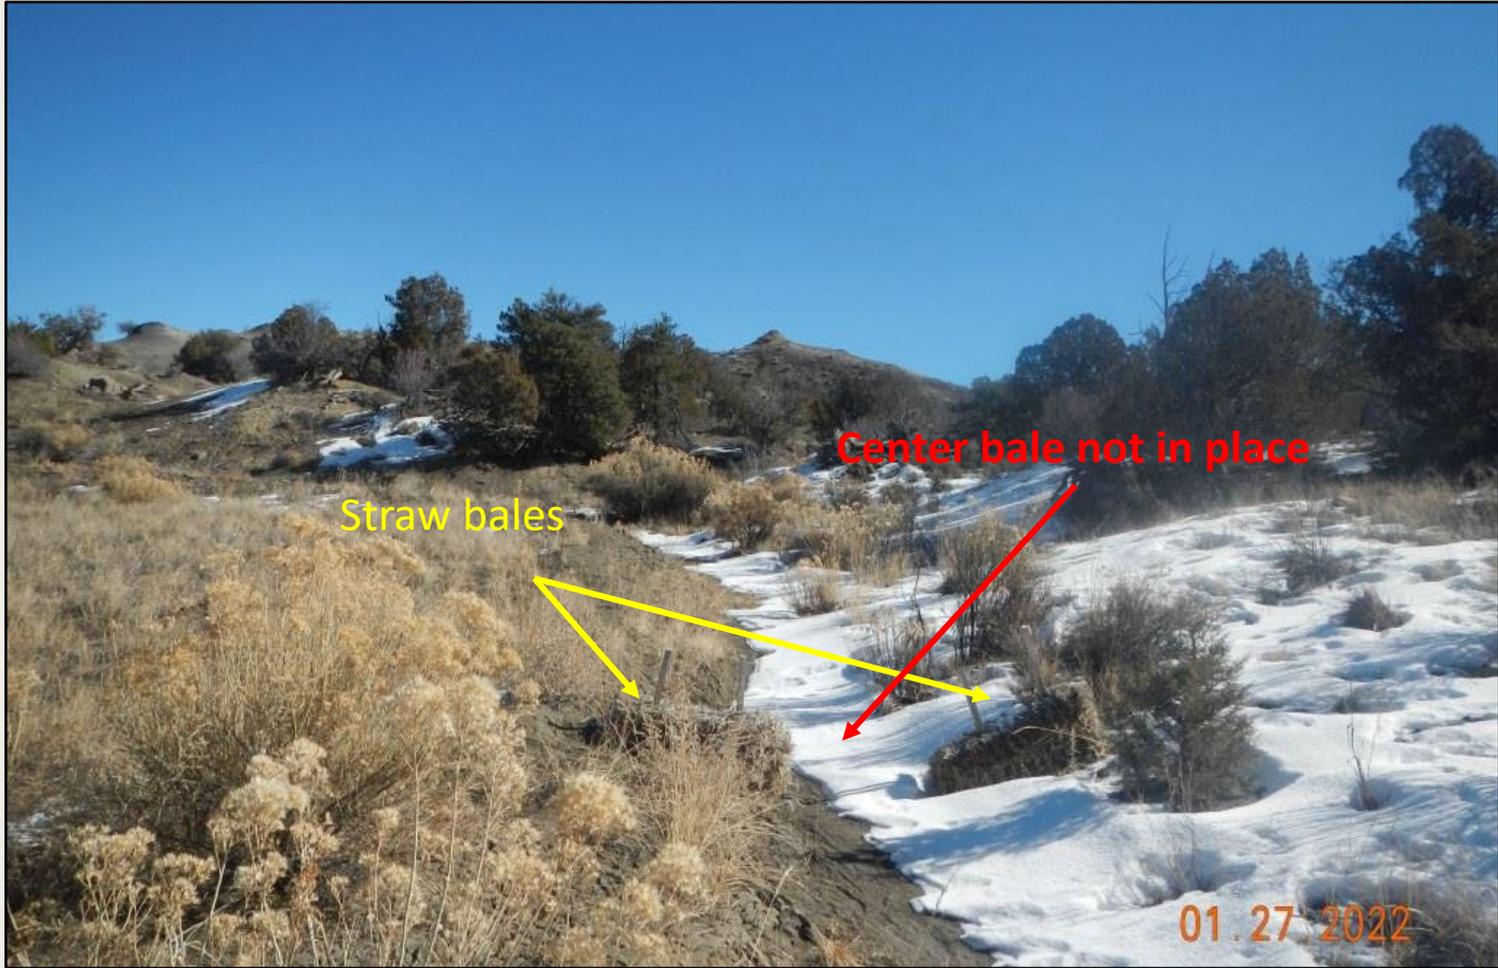
Photo 2. View of the southern project diversion facing eastward (upslope). Straw bails installed, are not an appropriate BMP to de-energize stormwater flows, additionally center straw bale is no longer in place.

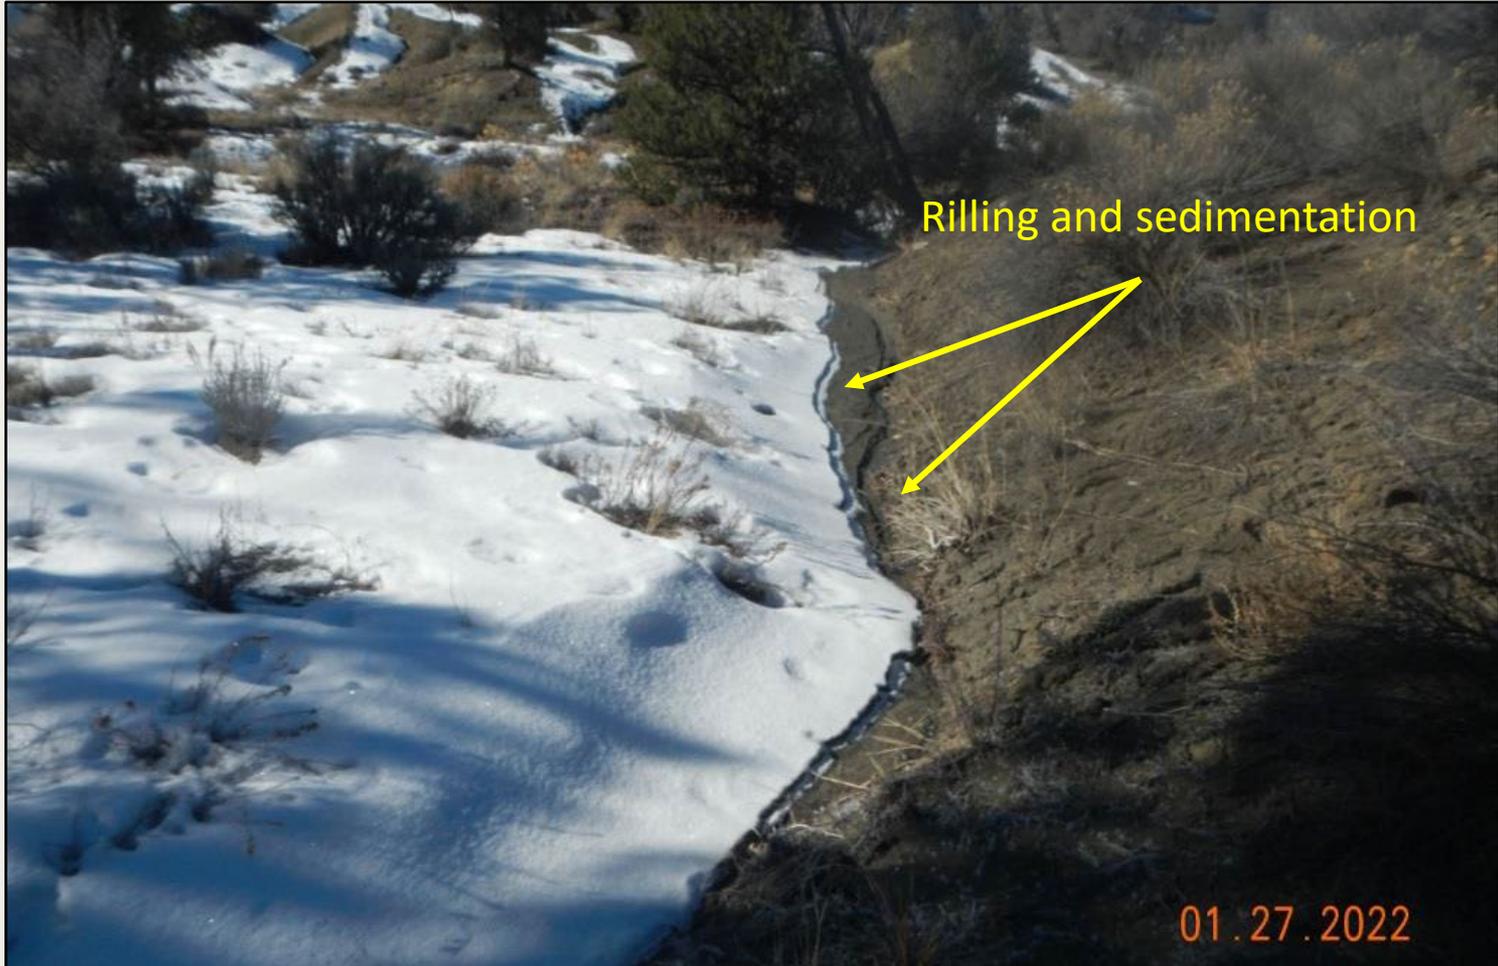
Photo 3. View of southern diversion, facing downslope, although partially snow covered, erosional rilling and sedimentation continues here.

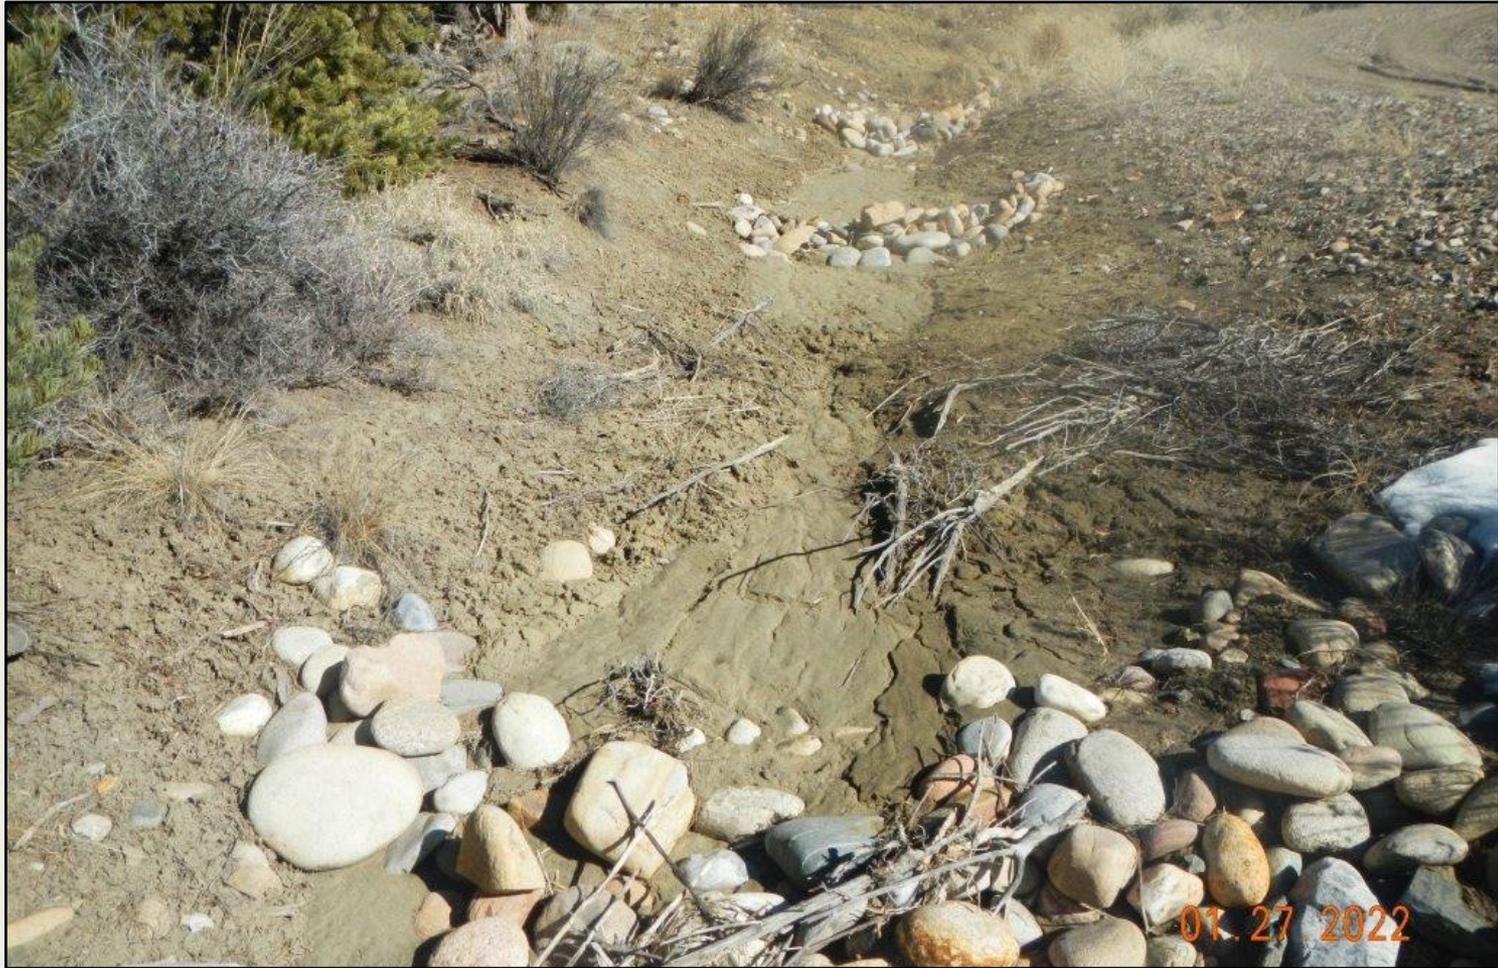
Photo 4. View of cobble BMPs along the access road, are full of sediment, are not adequately sized or properly installed.

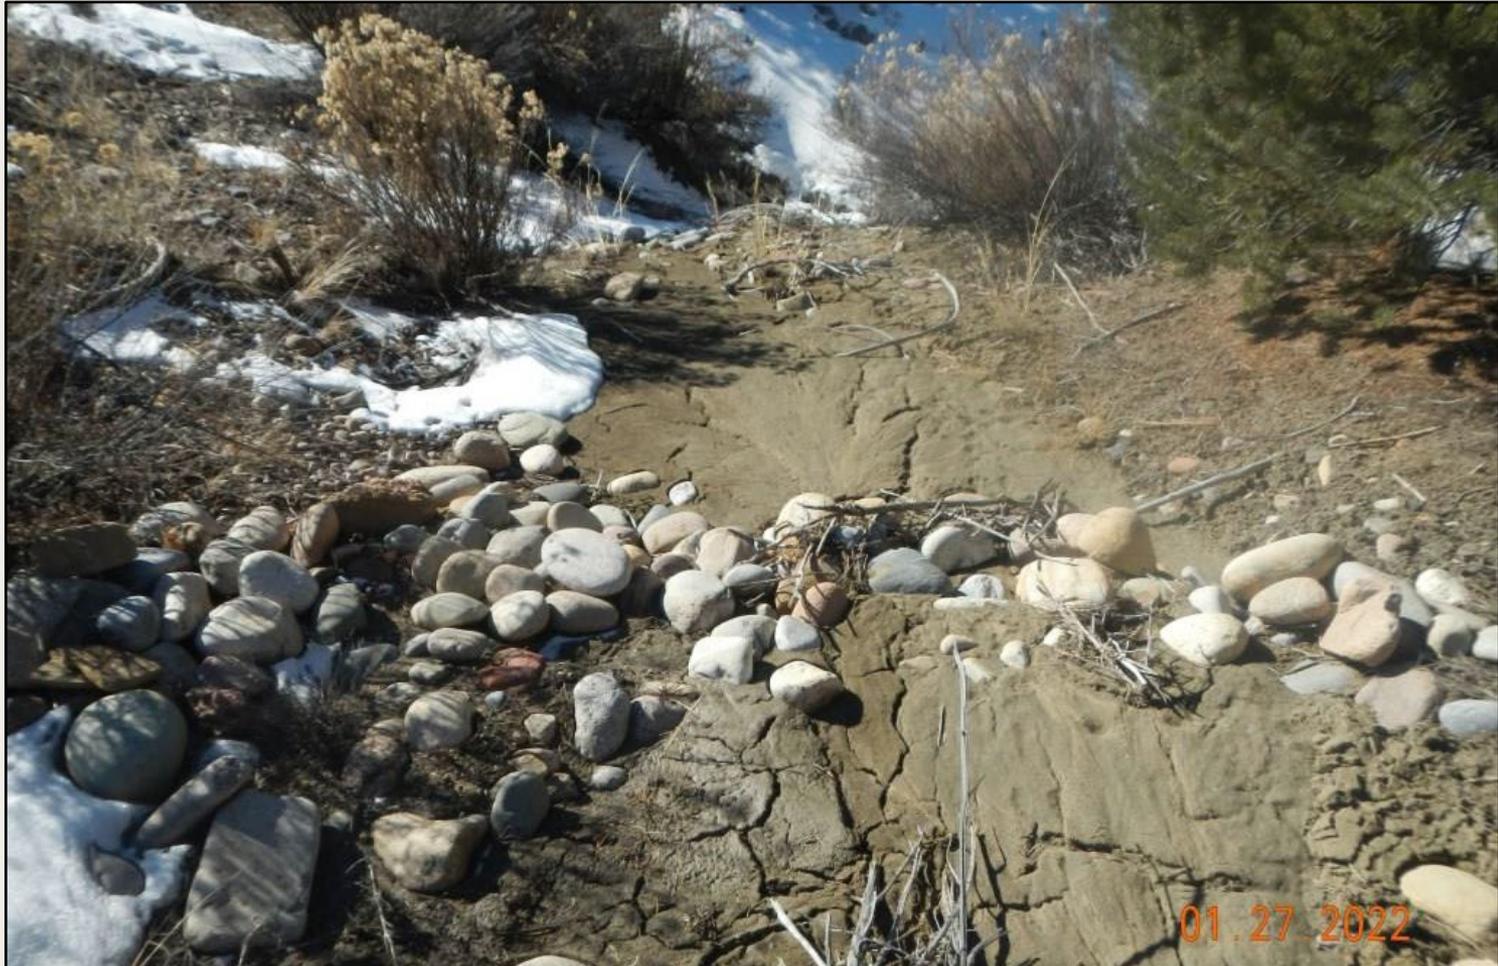
Photo 5. View of cobble BMP where stormwater flows from the access road discharge down-slope into a drainage. Diversion is full of sediment and BMP is not adequate.

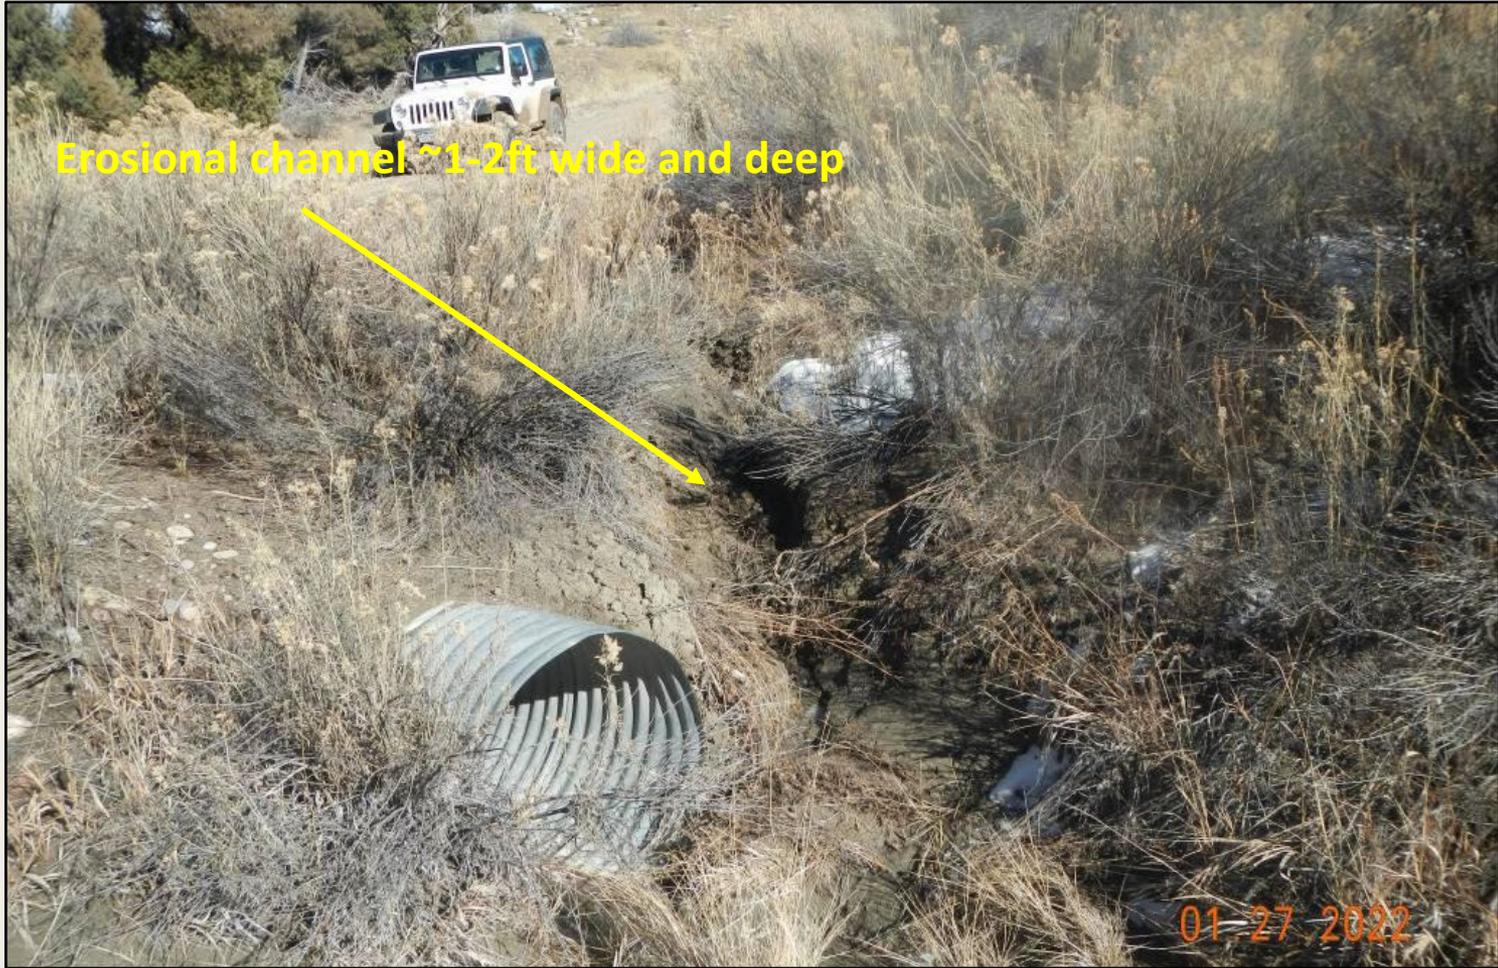
Erosional channel ~1-2ft wide and deep

Photo 6. View of culvert inlet along the access road. Erosional down-cutting and sedimentation occurring from diverted roadside flows. Note that stream elevation is at or near inlet depth.

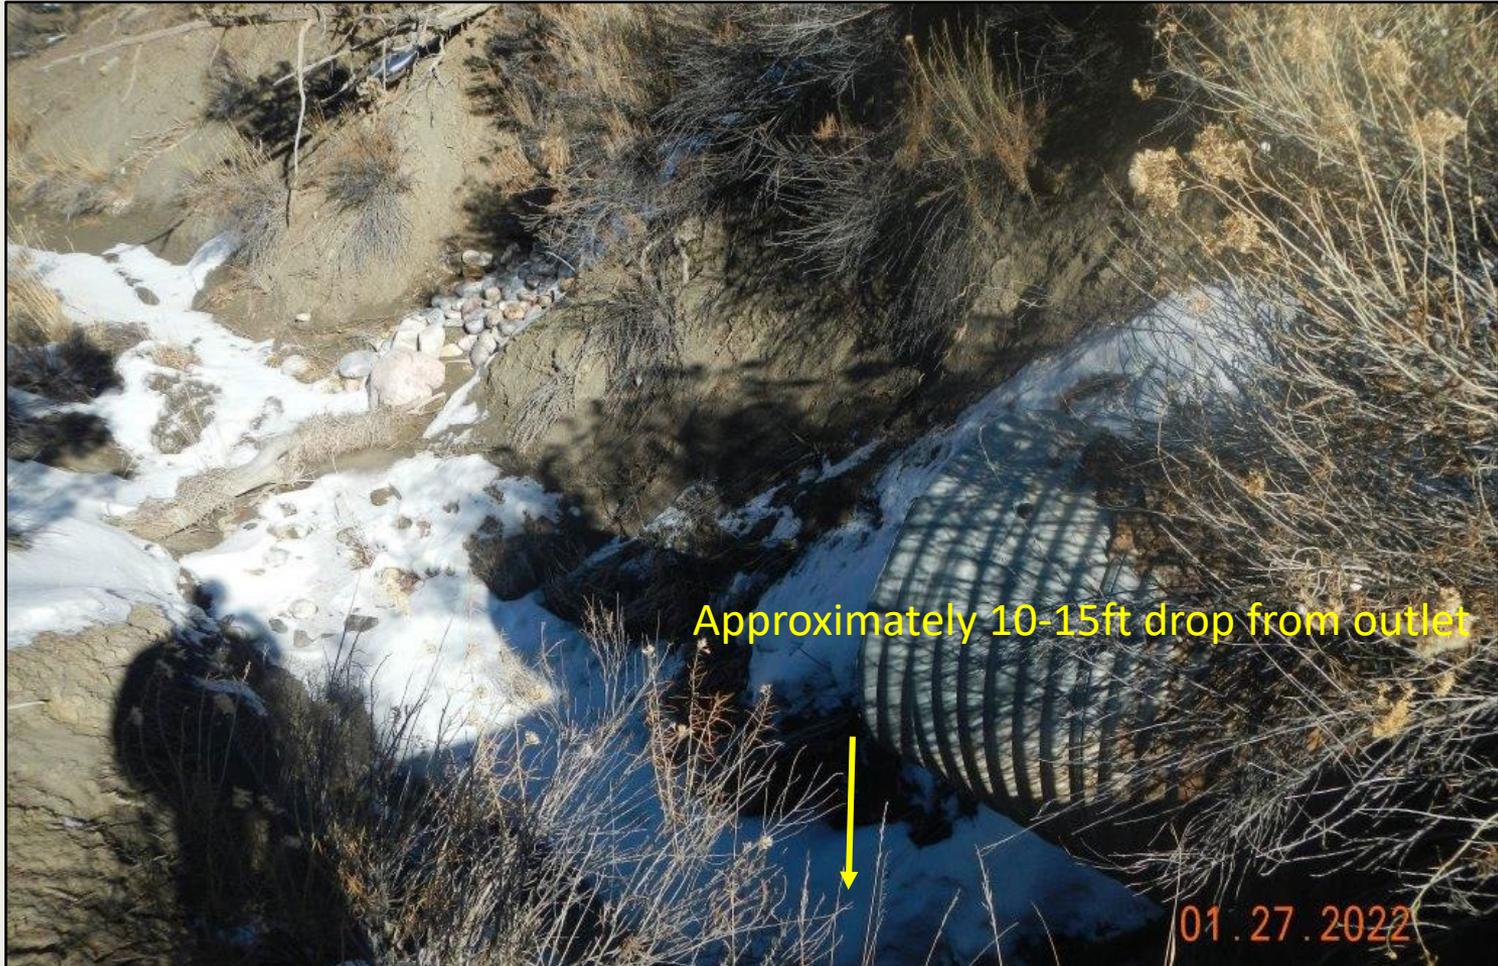
Photo 7. View of culvert outlet from culver shown in Photo 6. Outlet depth is approx 10-15ft below grade, indicating unstablized outlet and erosional down-cutting.

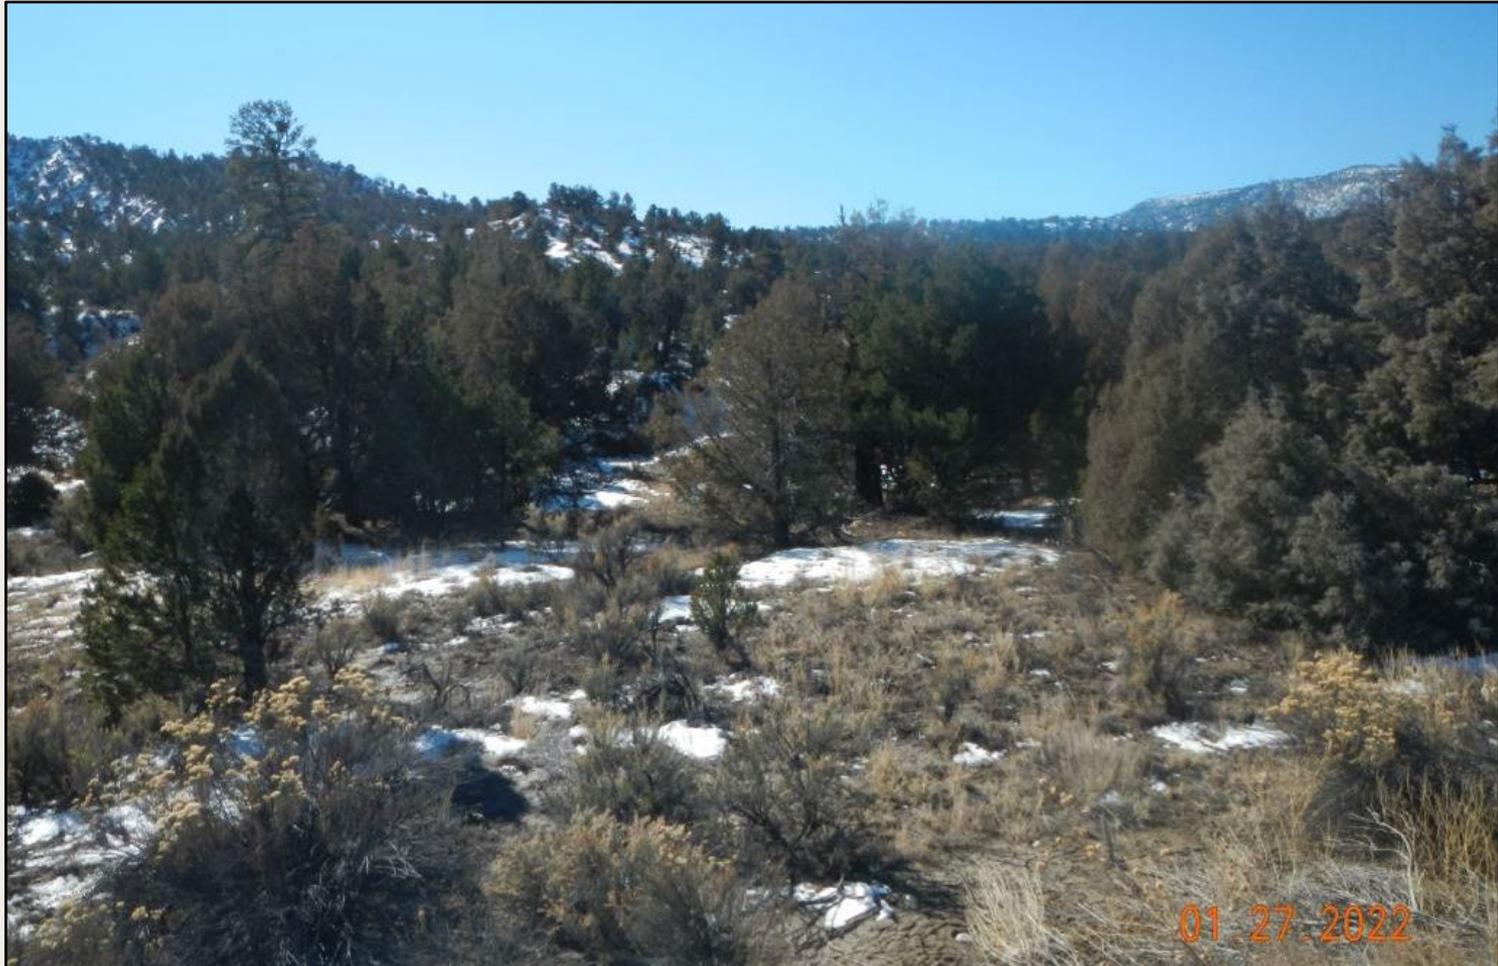
Photo 8. View of reference area comprised of pinyon and juniper mixed with big sagebrush, James galleta, yucca, and Indian ricegrass.
