# Inspection Photos

API: 009-06236

Operator: DOVER ATWOOD CORPORATION

Inspection Date: 1/31/2022

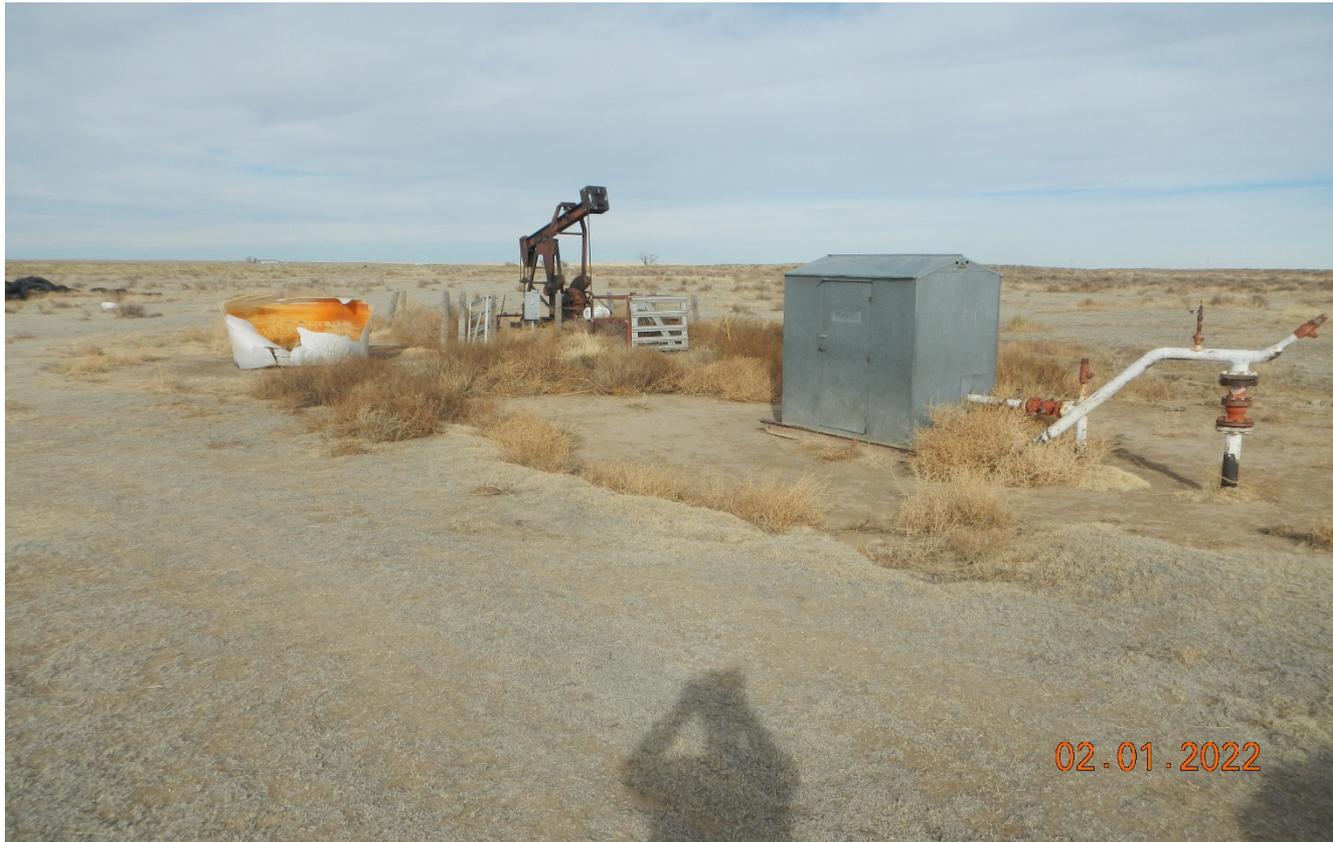
**Photo 1.** Facing northeast toward wellsite.

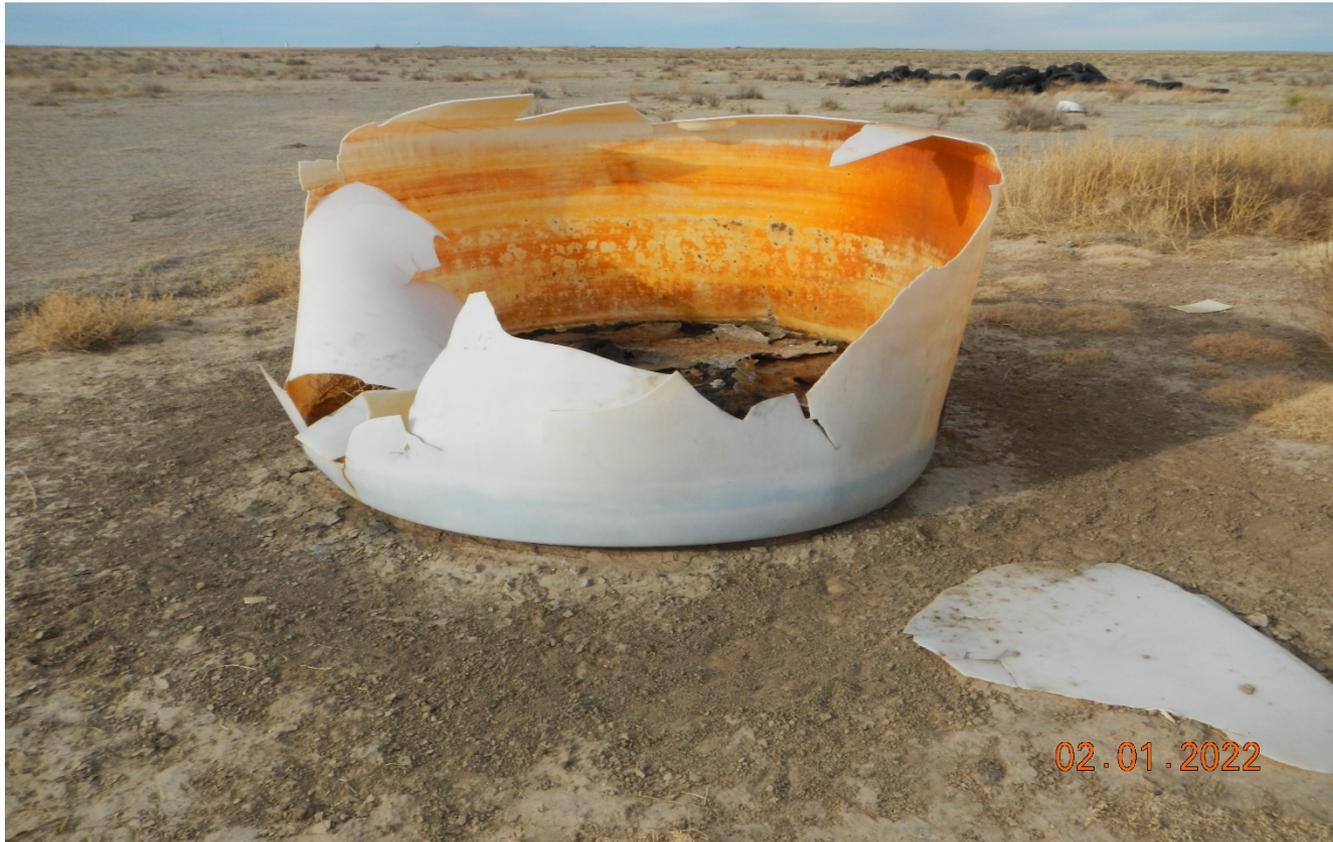
**Photo 2.** The tank on the location is busted apart and there is a solidified oily substance inside the tank which appears to have spilled out.

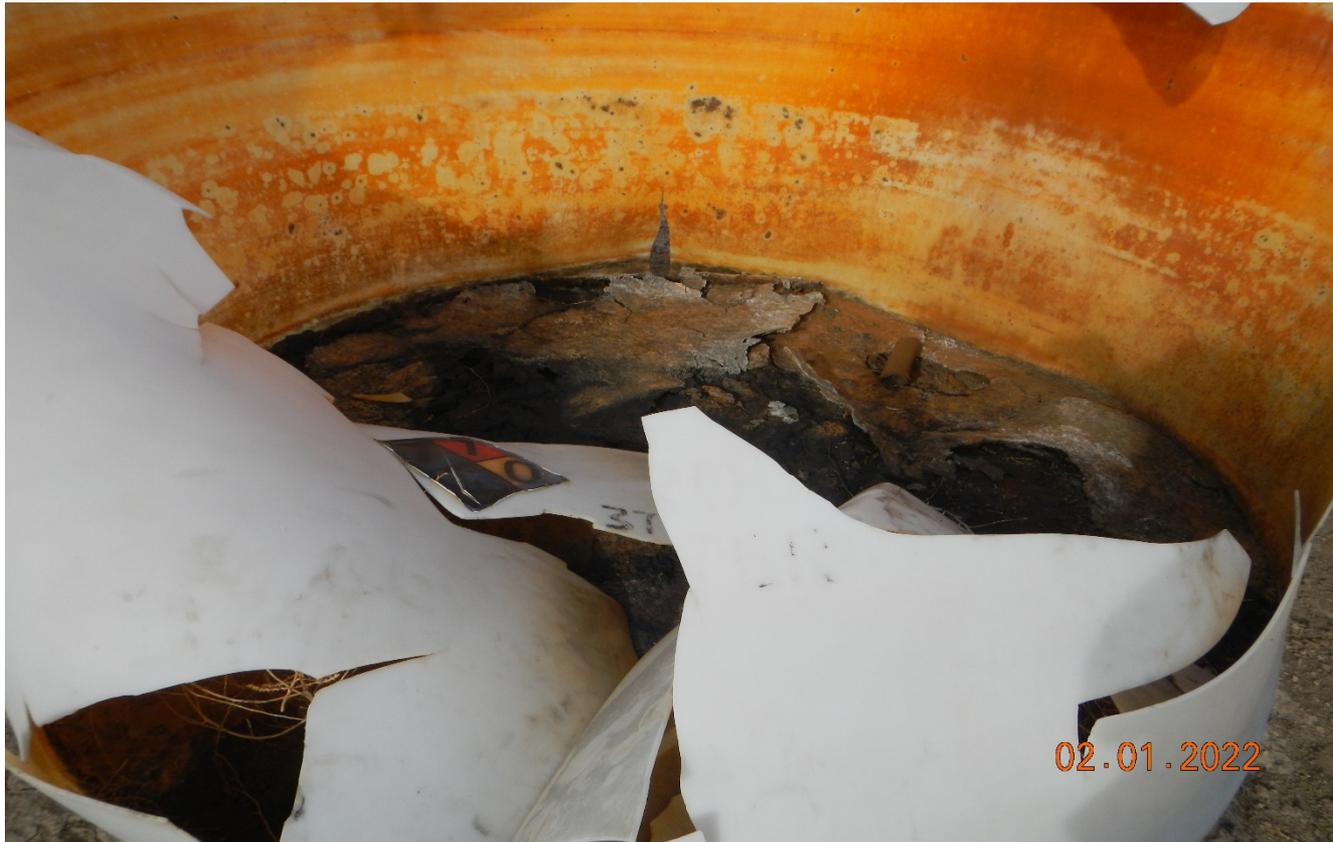
**Photo 3.** This photo shows the solidified oily substance inside the tank.

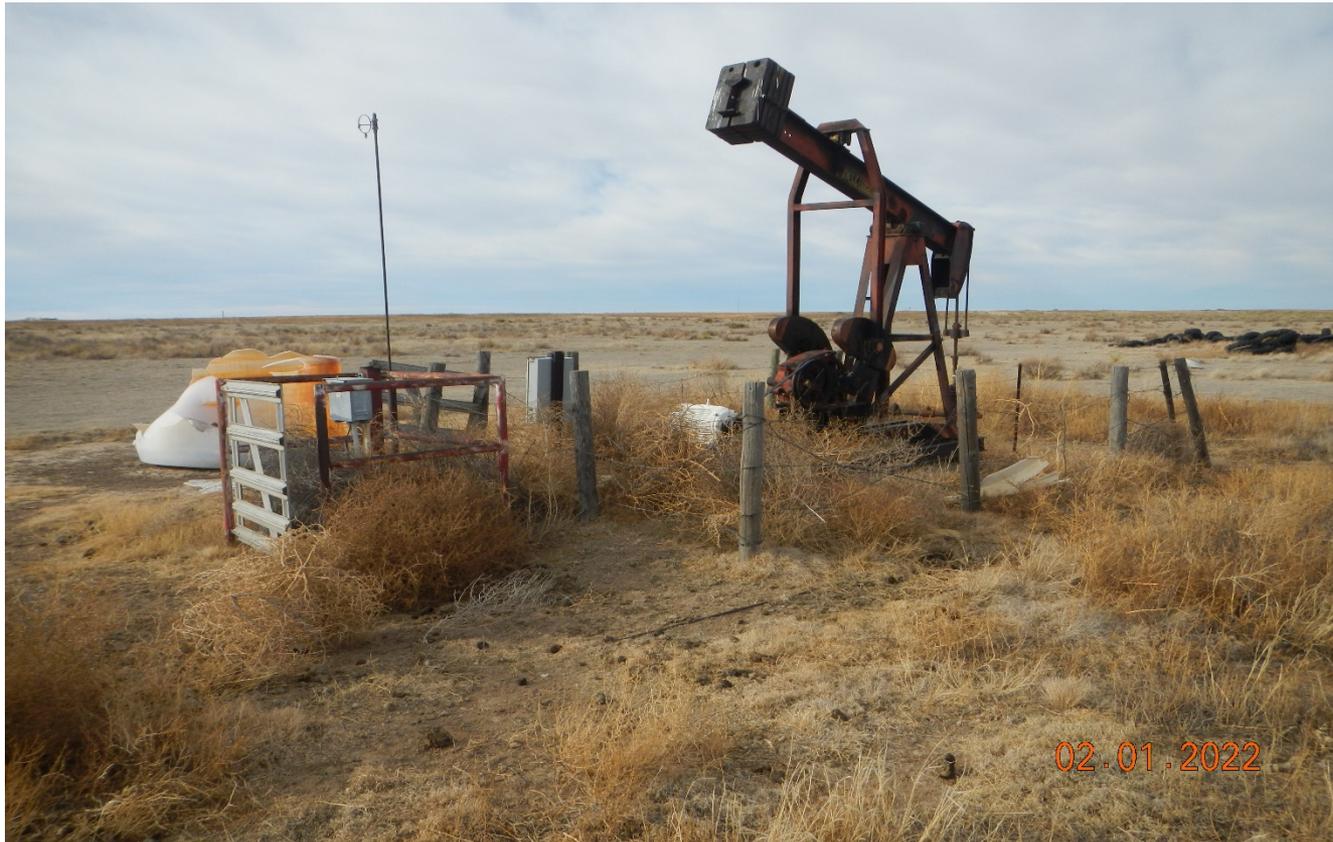
**Photo 4.** There is weed debris around the equipment which is a fire hazard.

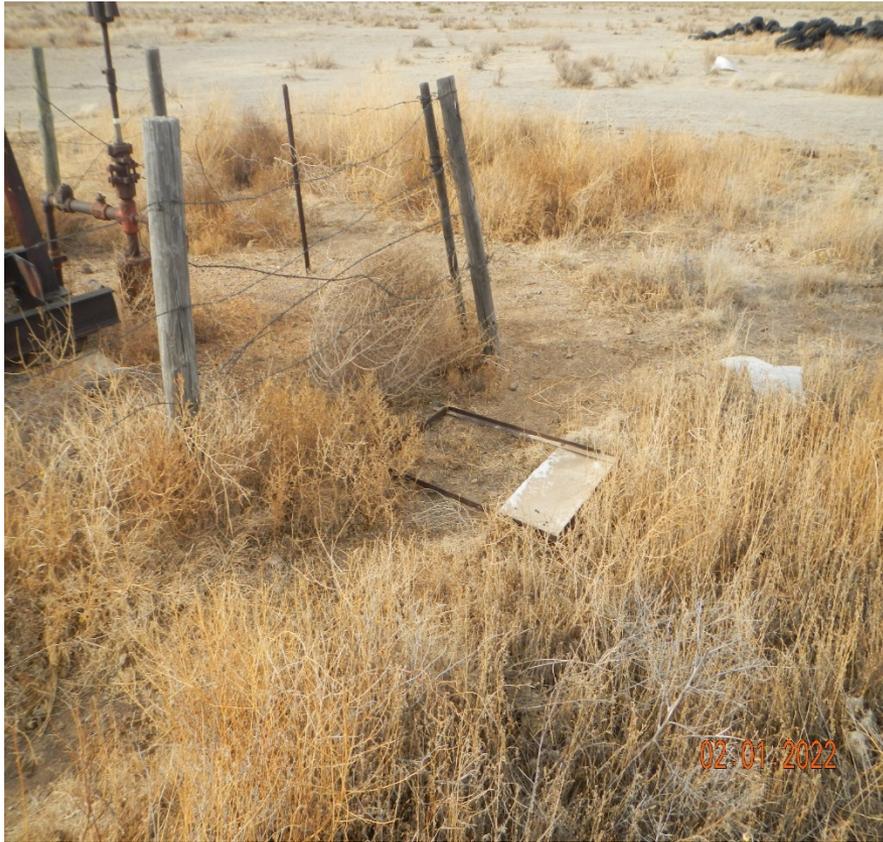
**Photo 5.** The well sign has fallen over and needs to be properly installed.

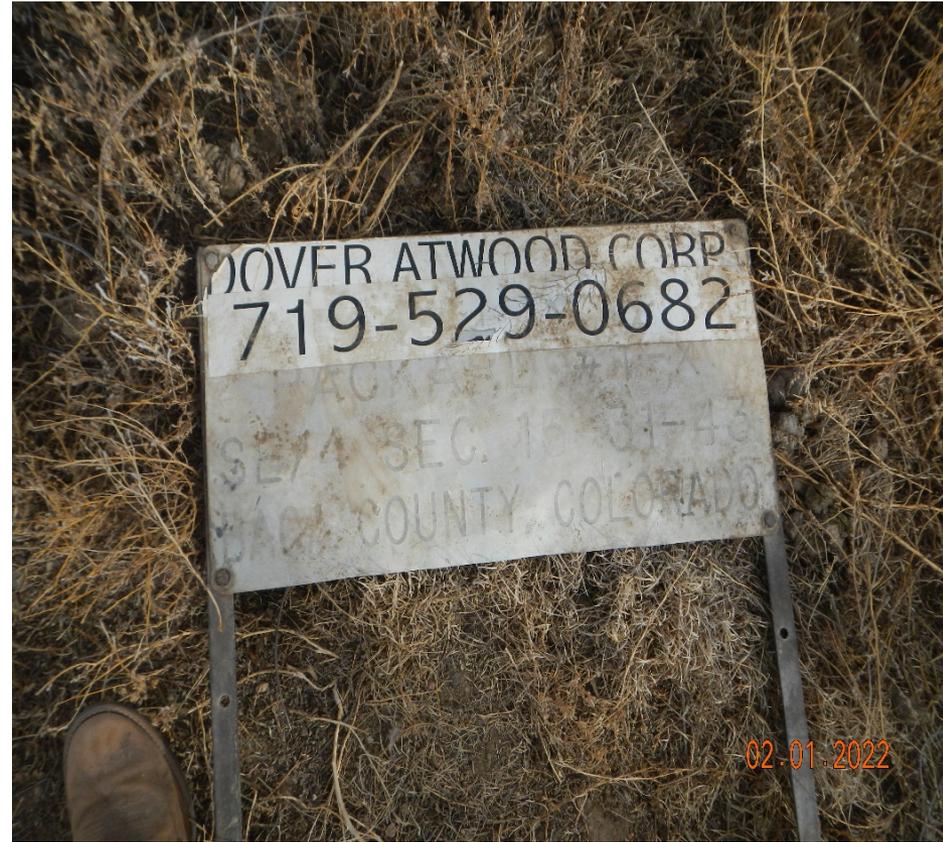
**Photo 6.** The emergency contact number was not valid and does not meet the signage requirements.
