Inspection Photos

Location Name: TEP ROCKY MOUNTAIN LLC SPECIALTY RESTAURANTS /SG 33-32

Location ID: 413524

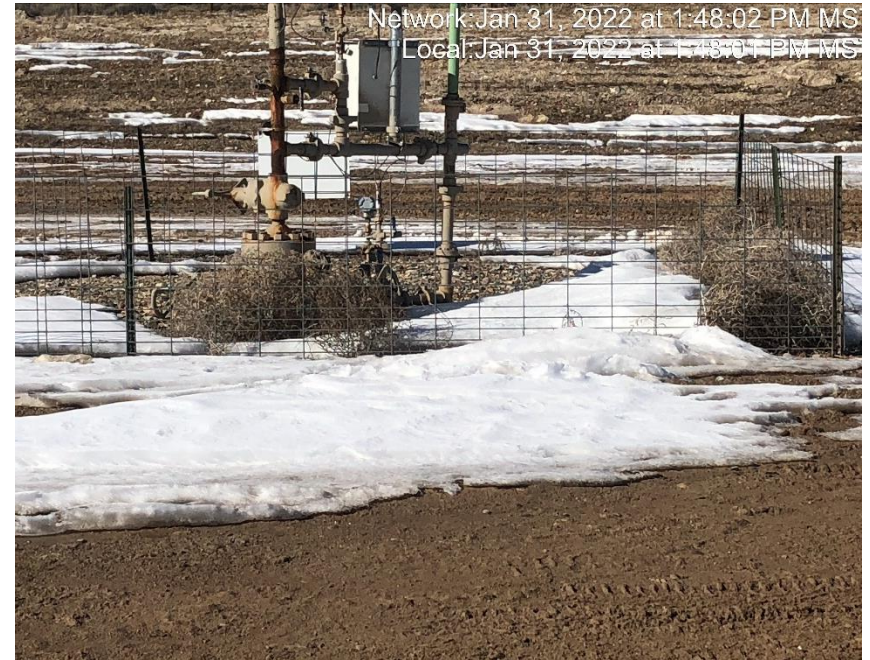
Photo #5850 Debris located by wellheads.

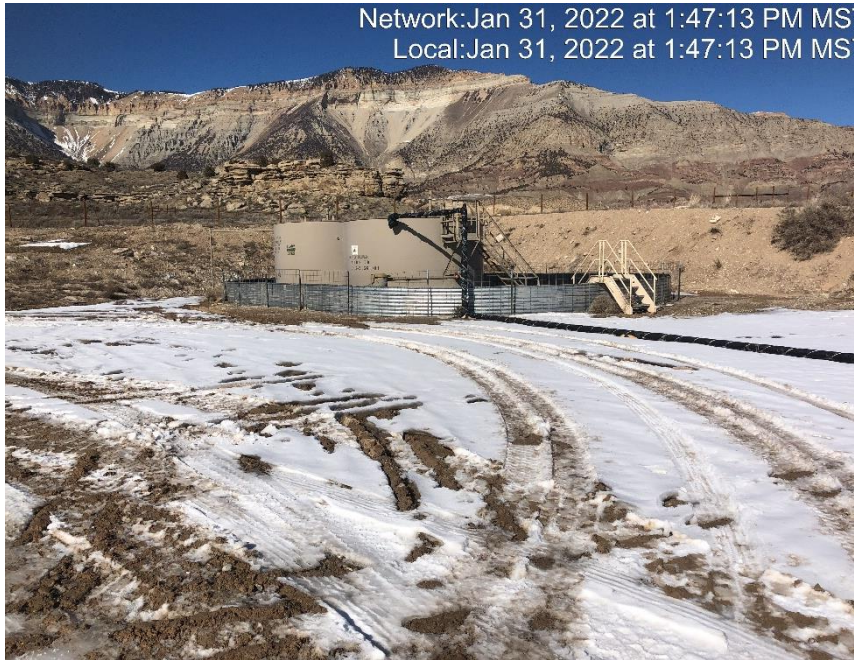
Photo #5849 No battery sign located at the tank battery.

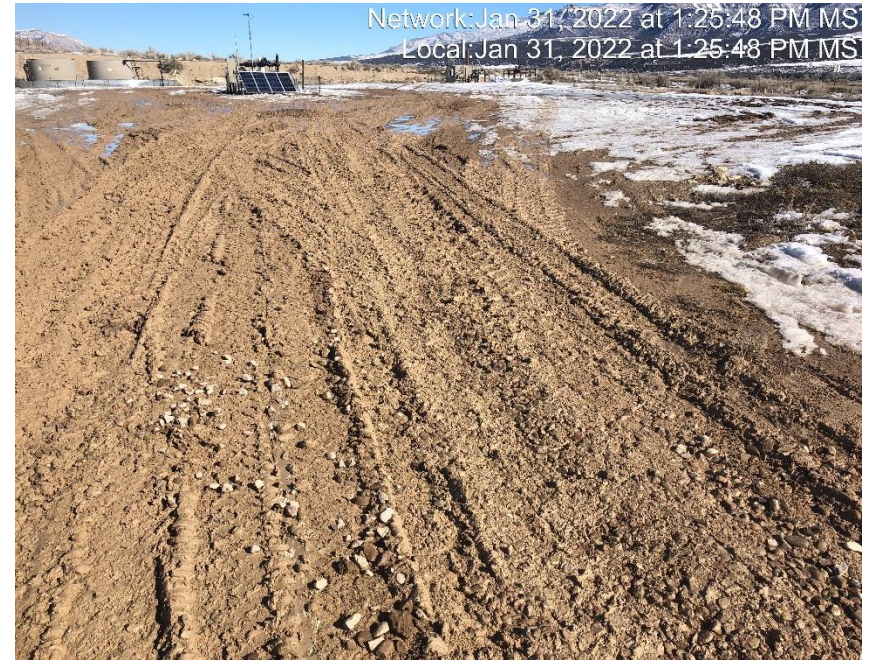
Photo #5838 Location lacks stabilization.

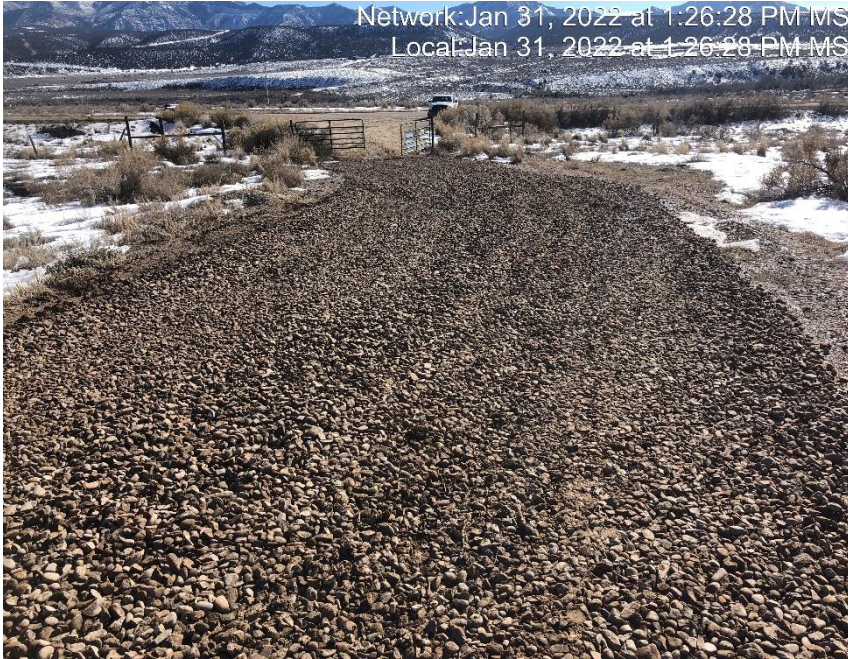
Photo #5840 Gavel has been added to access road.

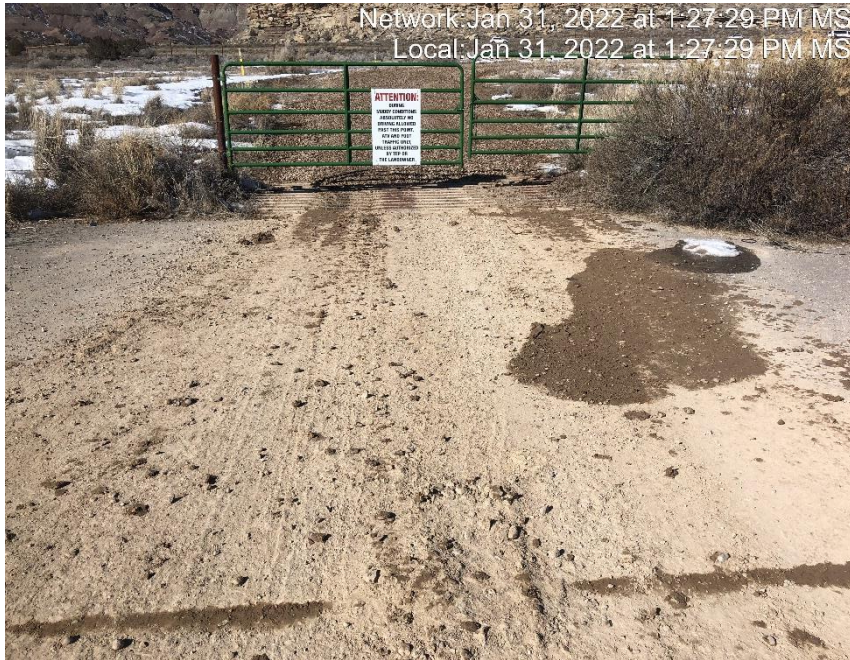
Photo #5842 Insufficient tracking BMP located at entrance to location.

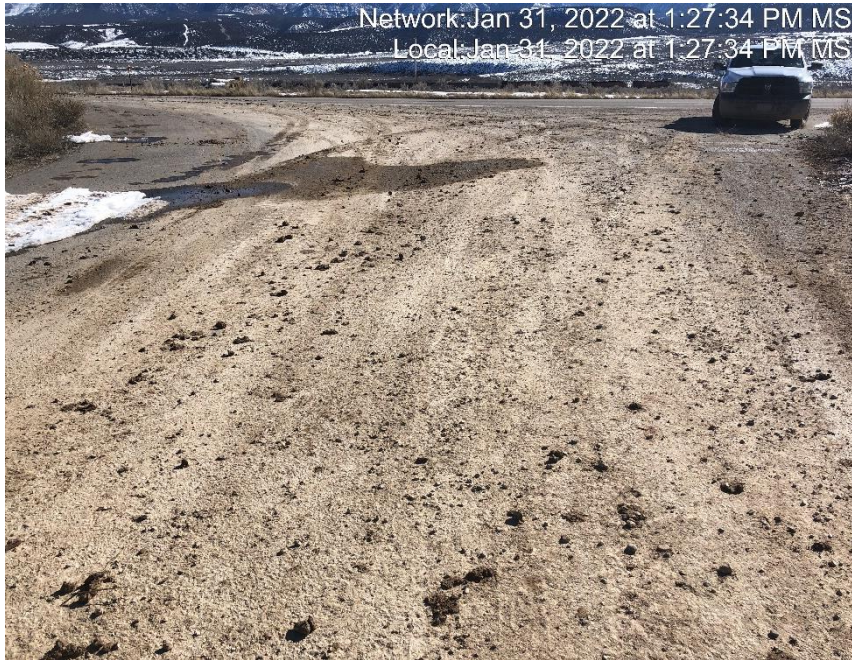
Photo #5843 Tracking occurring on to highway 6.

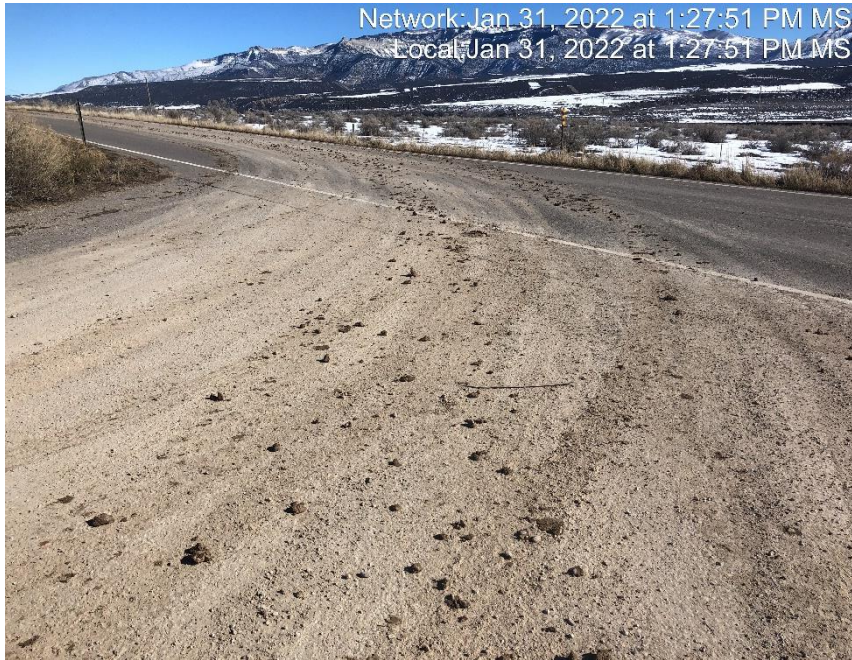
Photo #5844 Tracking continuing on to highway 6.

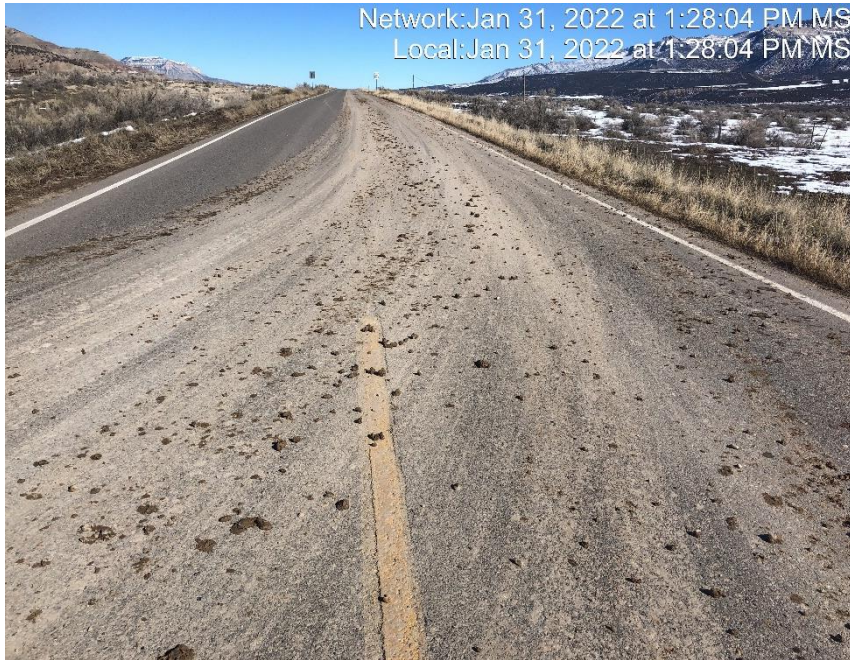
Photo #5845 Tracking occurring from location and access road for approximately 100 yards.

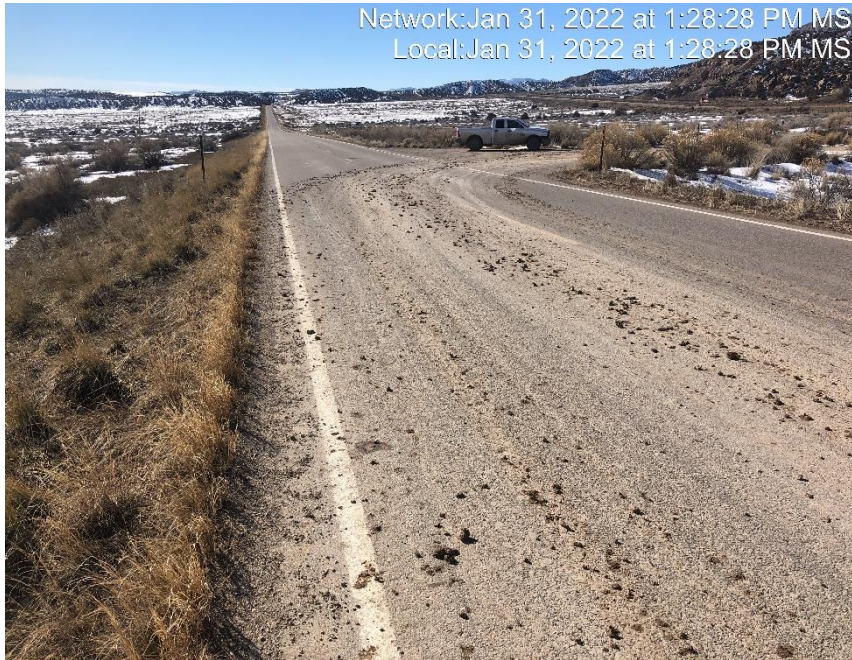
Photo #5846 Tracking occurring on highway 6 continued.

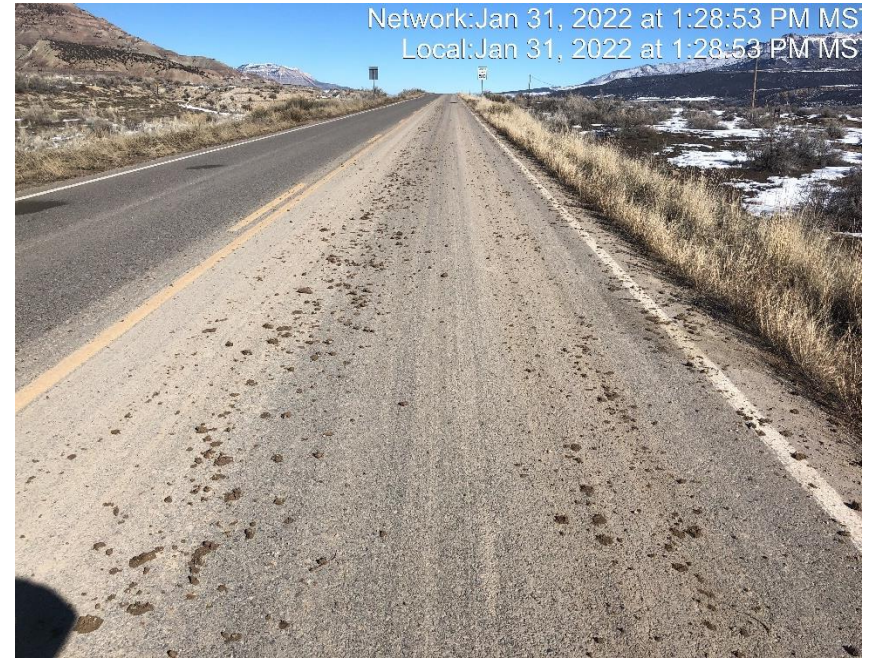
Photo #5847 The transportation of sediment continued for approximately 100 yards.

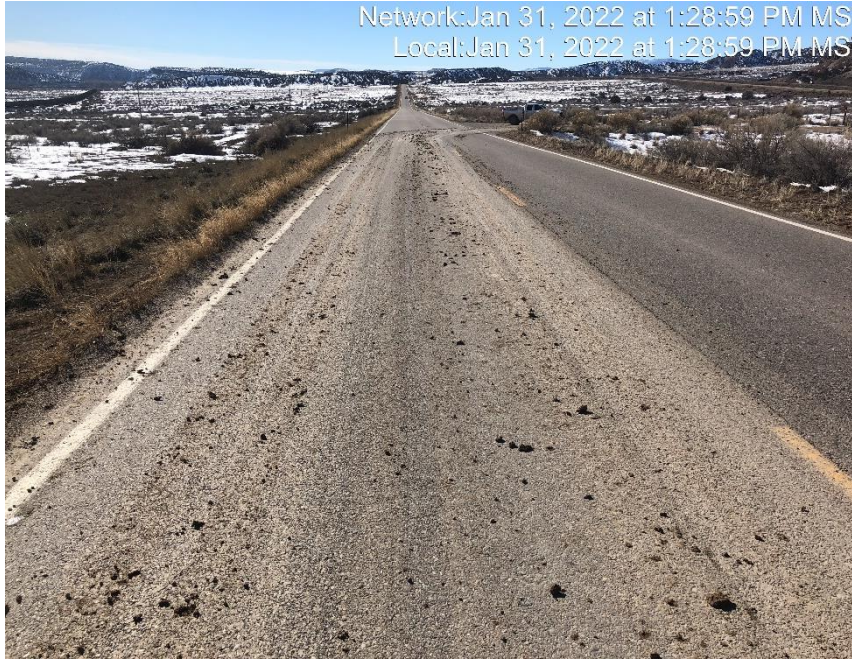
Photo #5848 Tracking occurring on highway 6 continued.
