Inspection Photos

ID:438617

Operator: DOVER ATWOOD CORPORATION

Inspection Date: 1/31/2022

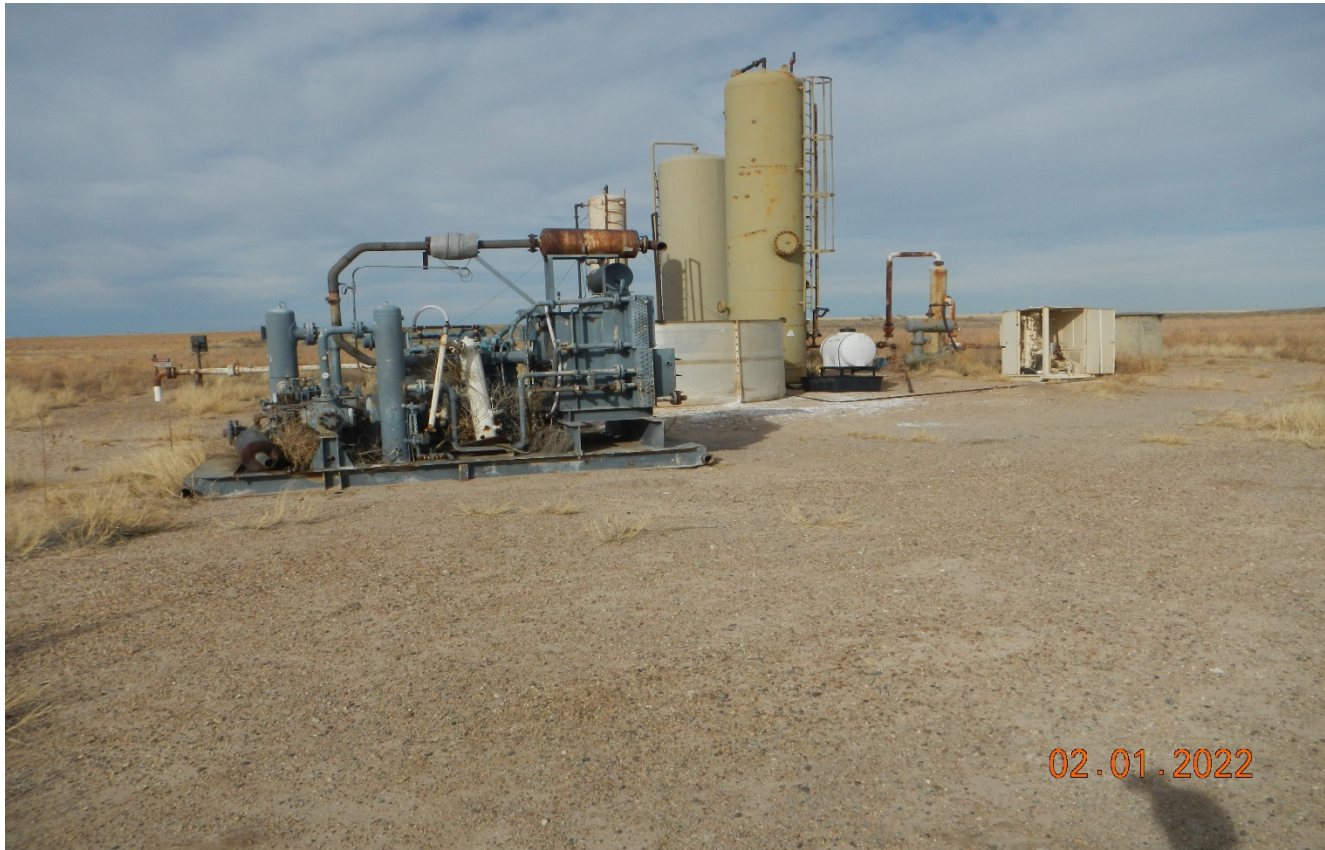
Photo 1. Facing northeast toward the gas treatment facility.

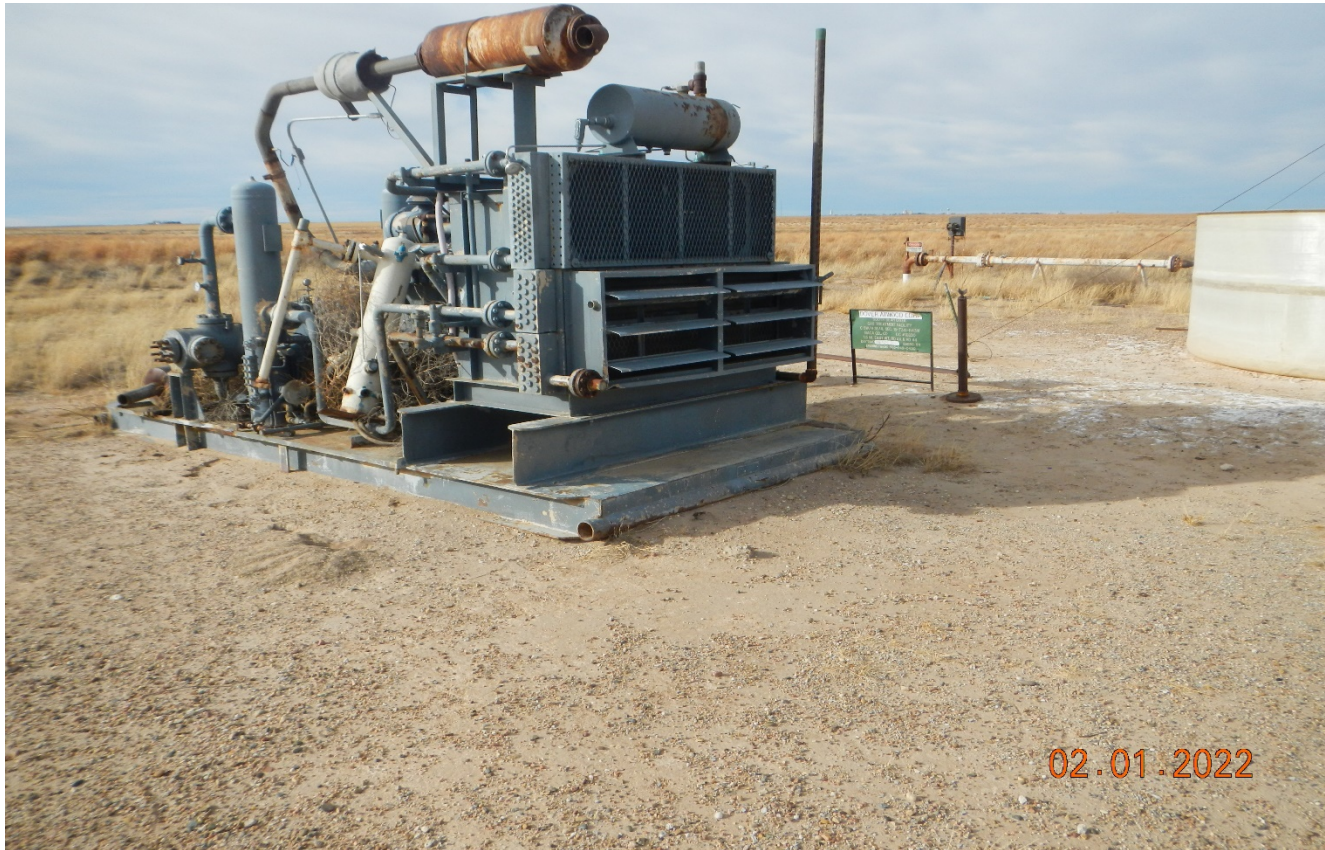
Photo 2. There is an unused compressor stored on location that need to be removed.

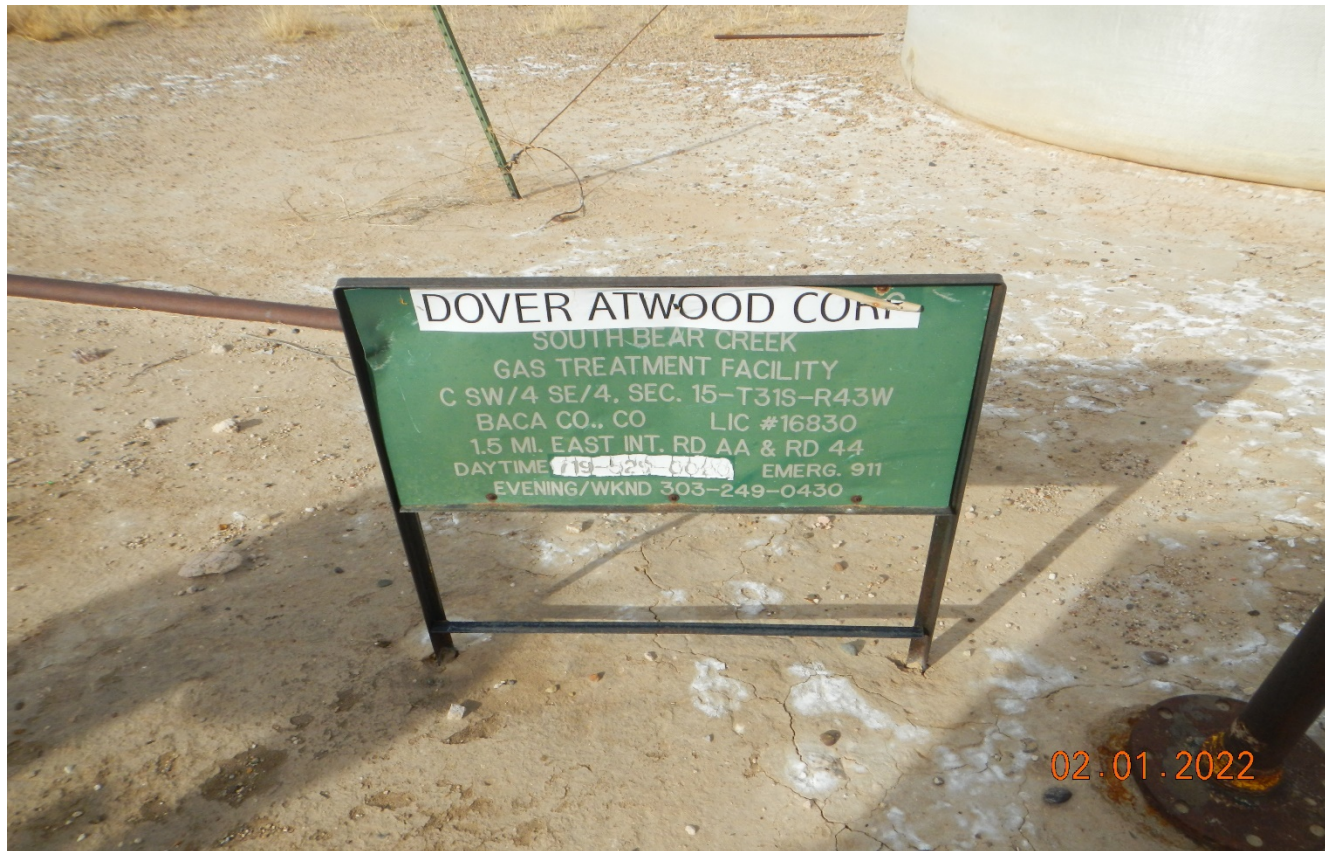
Photo 3. The facility sign is obscured behind the compressor. The emergency contact number is not valid.

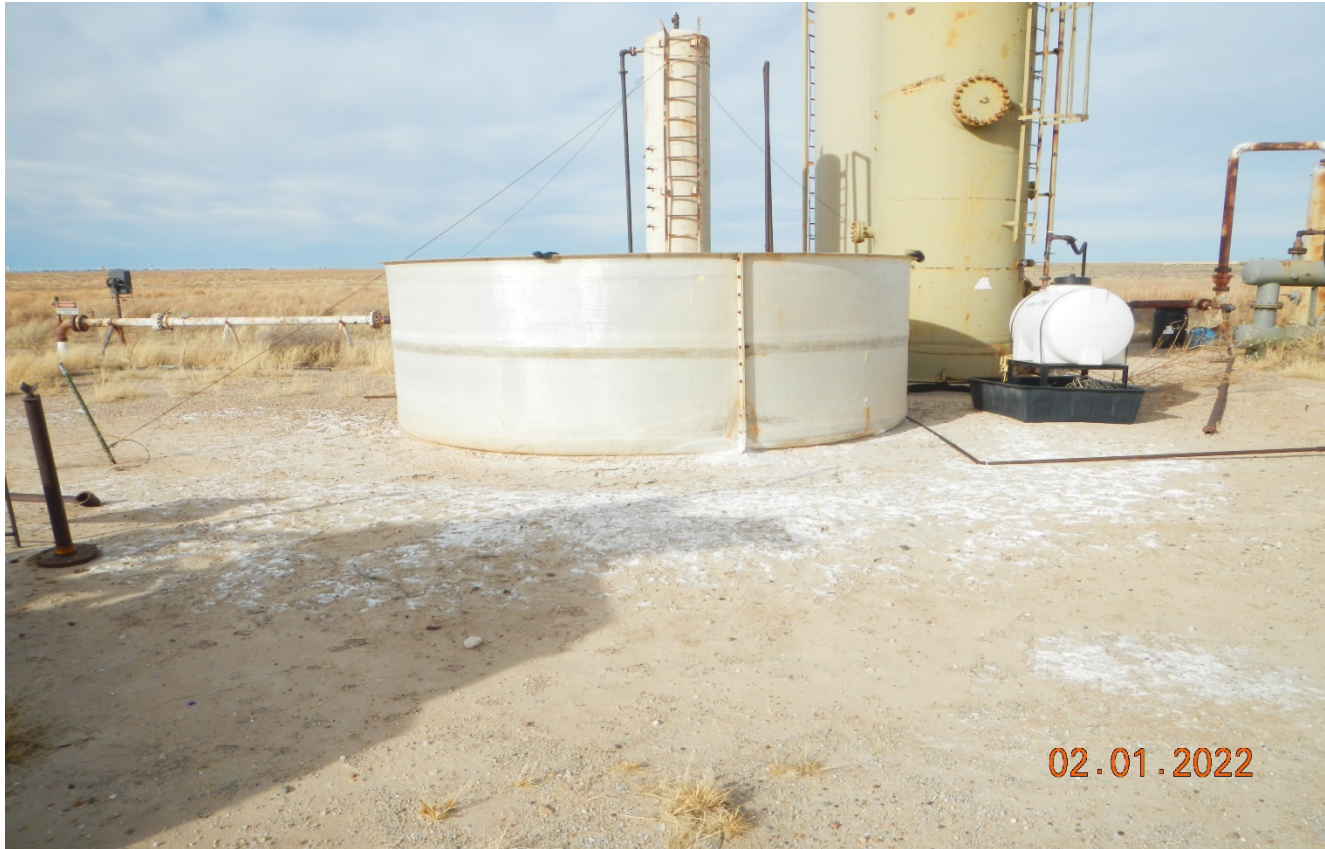
Photo 4. Facing toward the open top tank. It appears the tank has previously leaked due to white stained soil. There is no secondary containment around the tank. There is no signage on the tank.

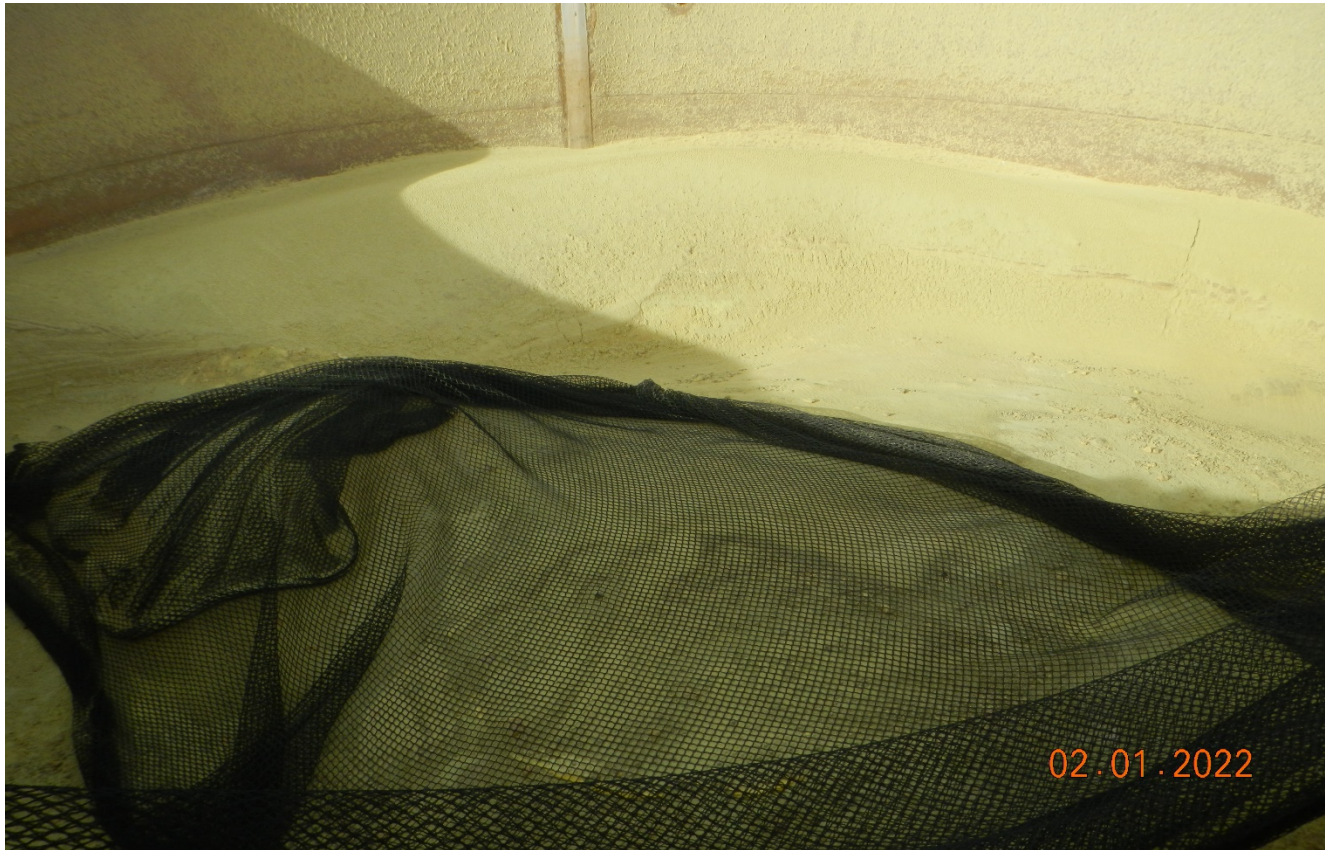
Photo 5. The netting over the tank is not installed.

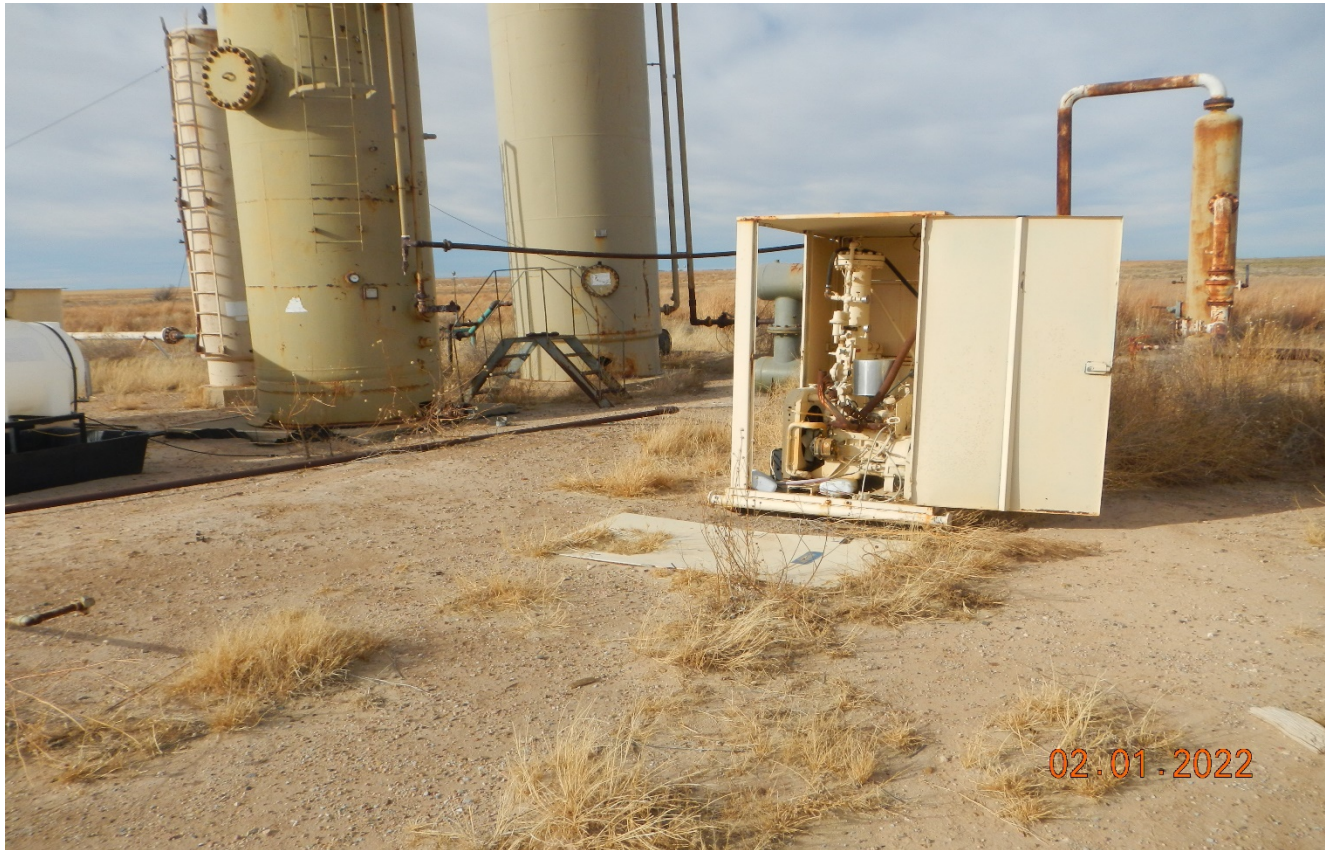
Photo 6. There is unused or equipment not maintained on location. Door has fallen off this shed.

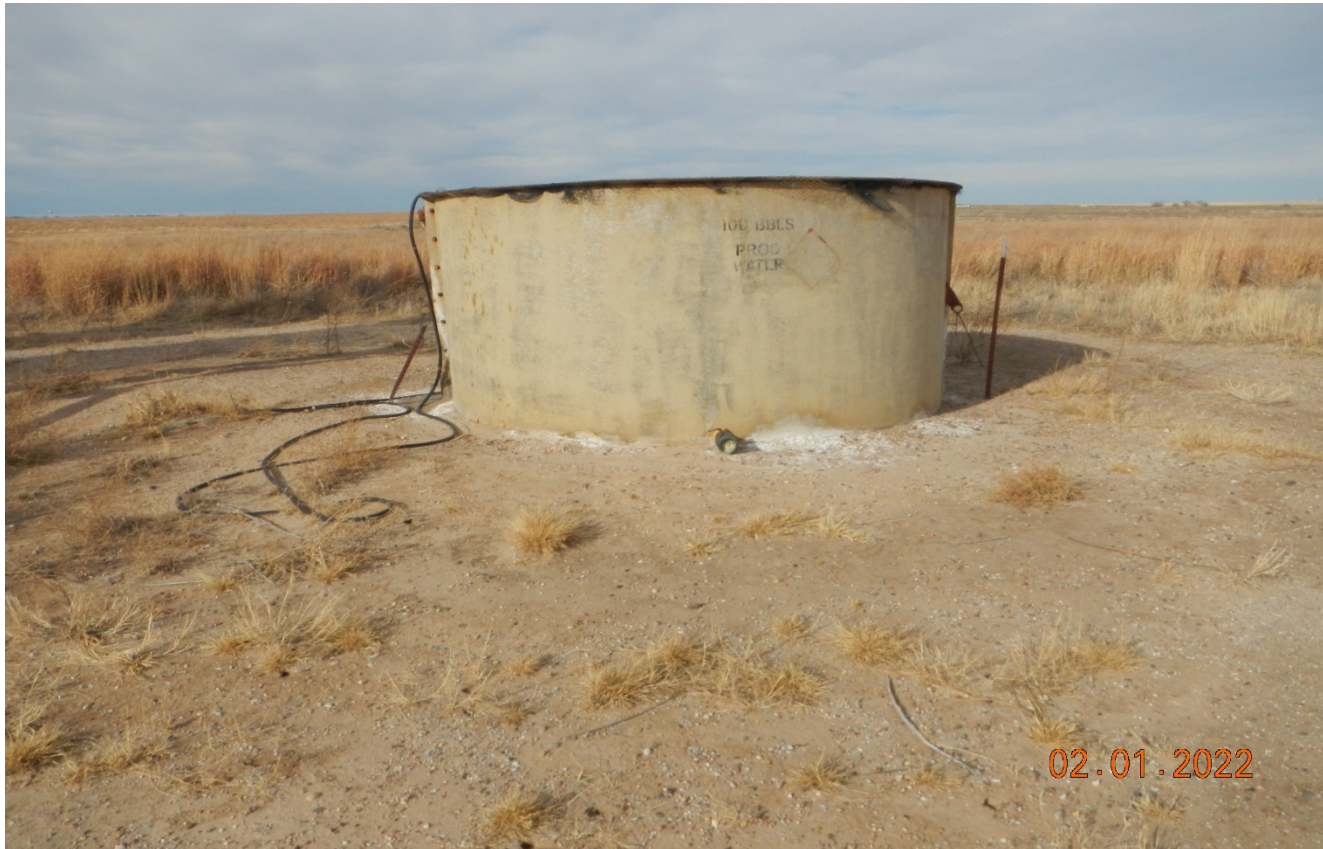
Photo 7. There is an open top tank at the east side of the location. It appears the tank has previously leaked due to white stained soil. There is no secondary containment around the tank. The signage has faded.

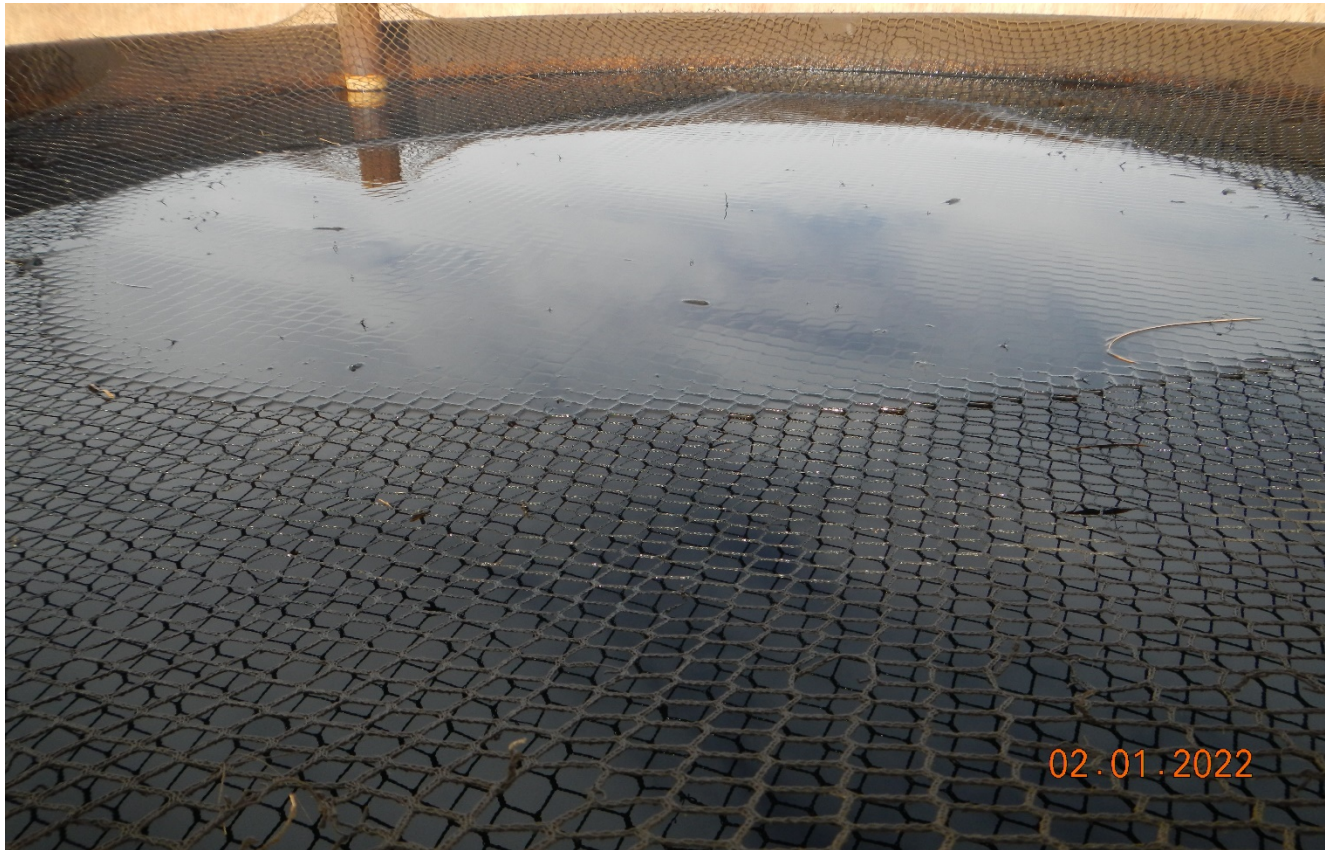
Photo 8. The liquid in the tank is near the top which could spill over. The netting is not adequate to prevent wildlife entry.

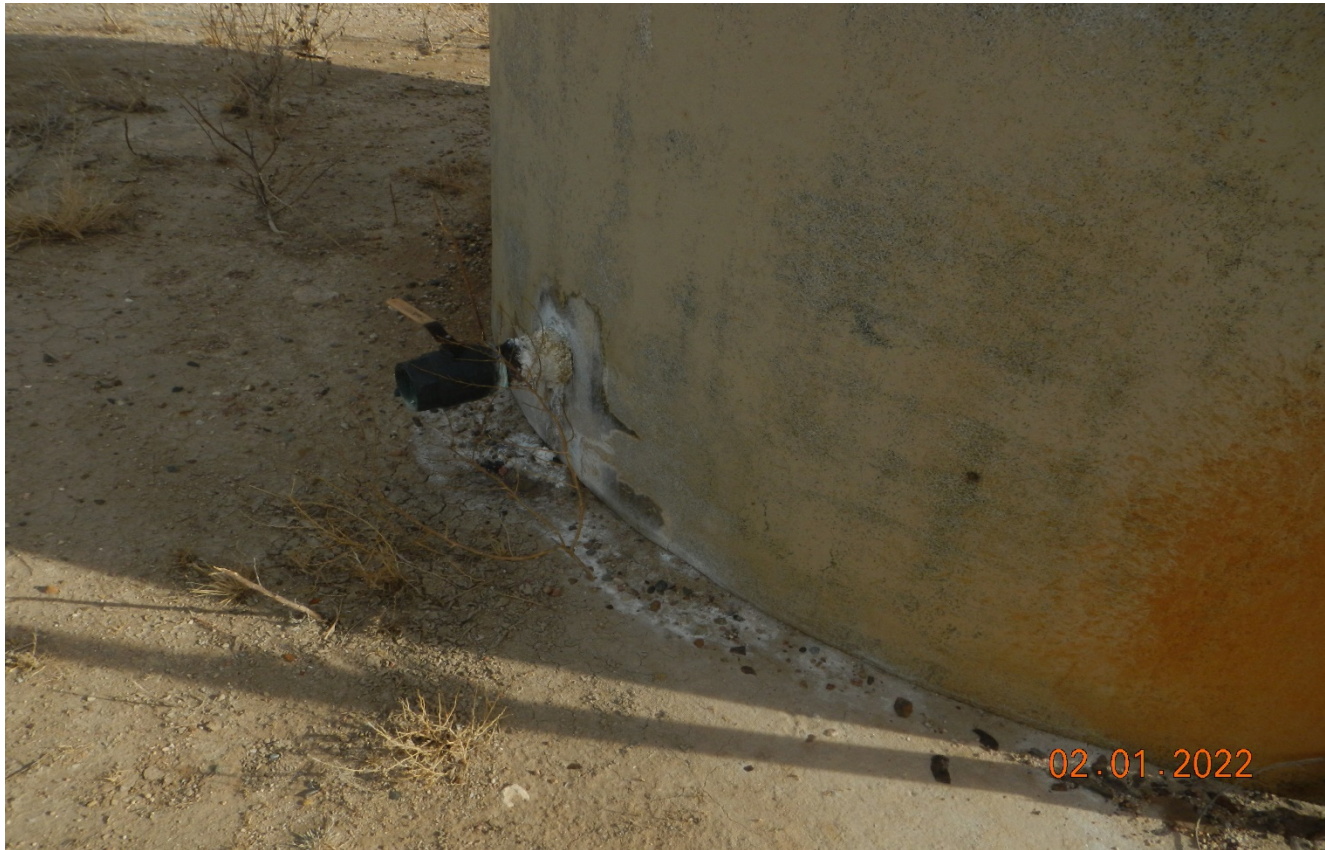
Photo 9. There are signs of a previous leak at the pipe fitting.

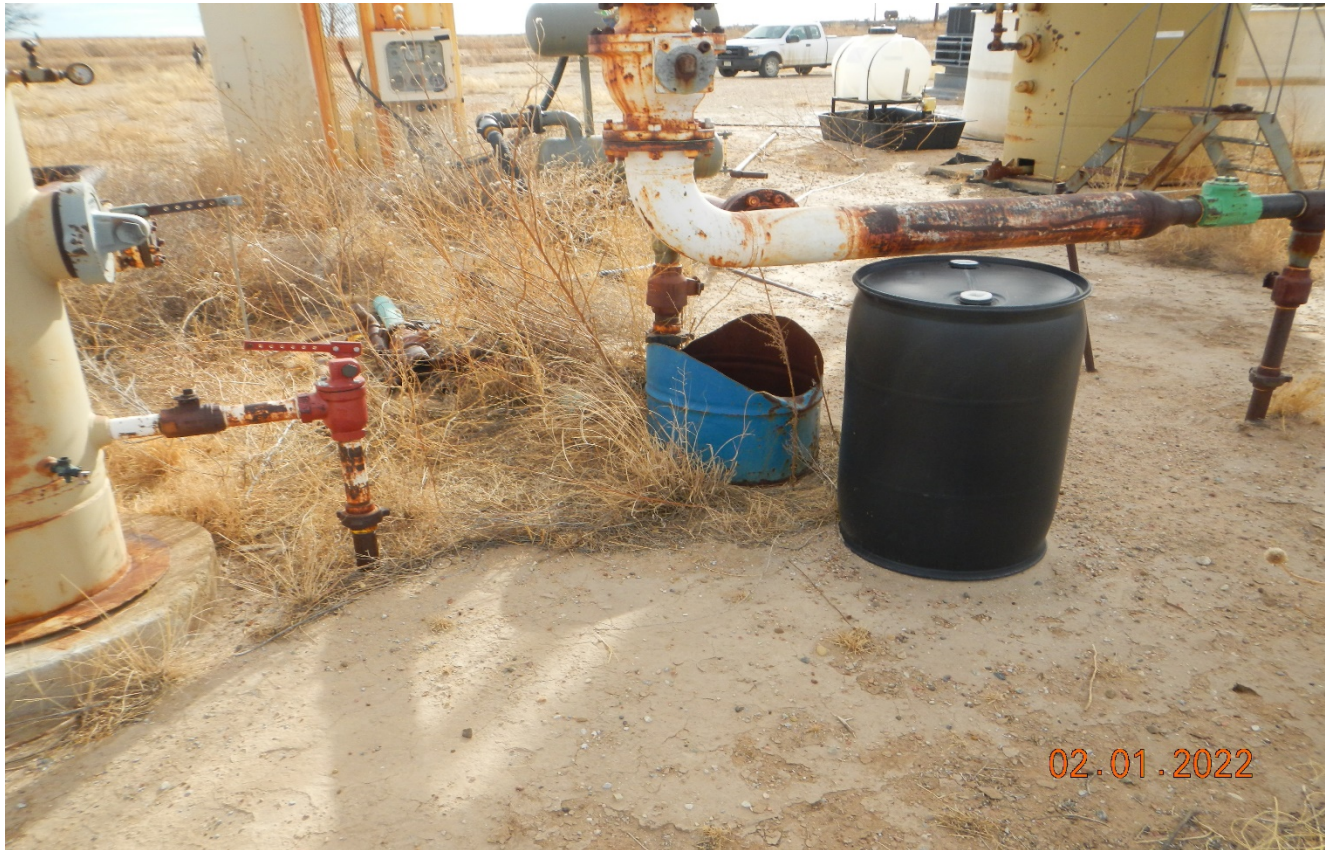
Photo 10. There is unused supplies and a black barrel with no labeling.

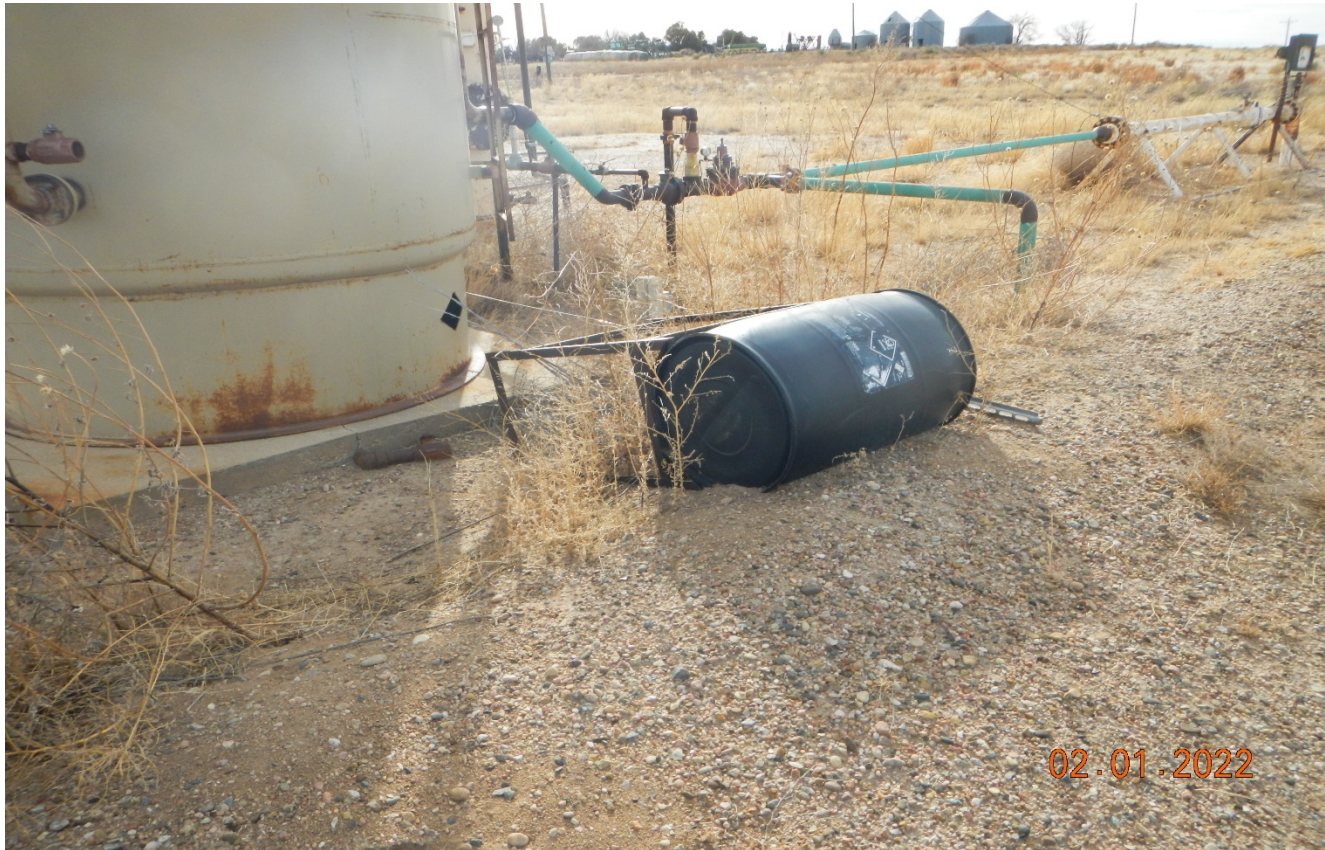
Photo 11. The barrel and stand have fallen over.

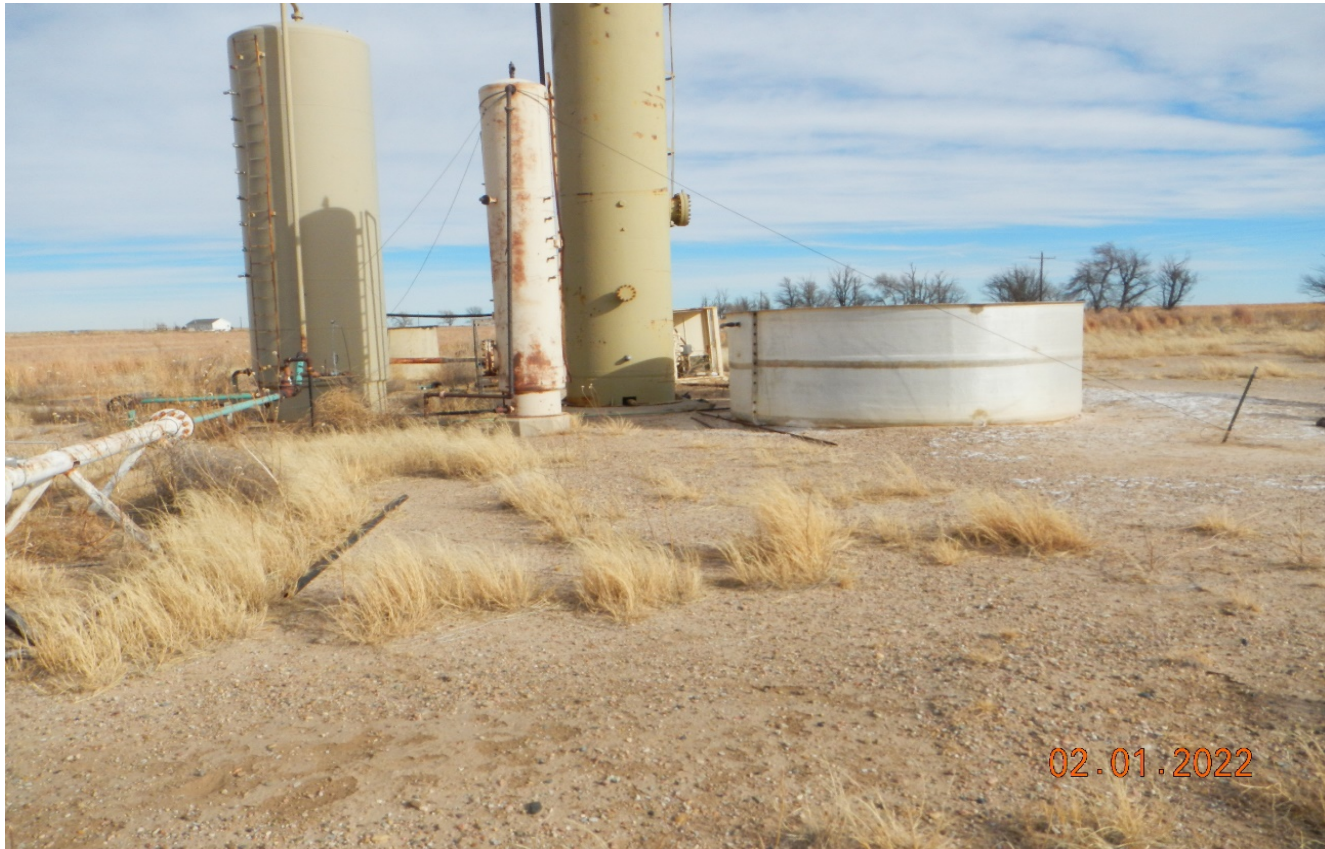
Photo 12. Facing east toward the facility.
