Inspection Photos

ID# 441082

Operator: DOVER ATWOOD CORPORATION

Inspection Date: 1/31/2022

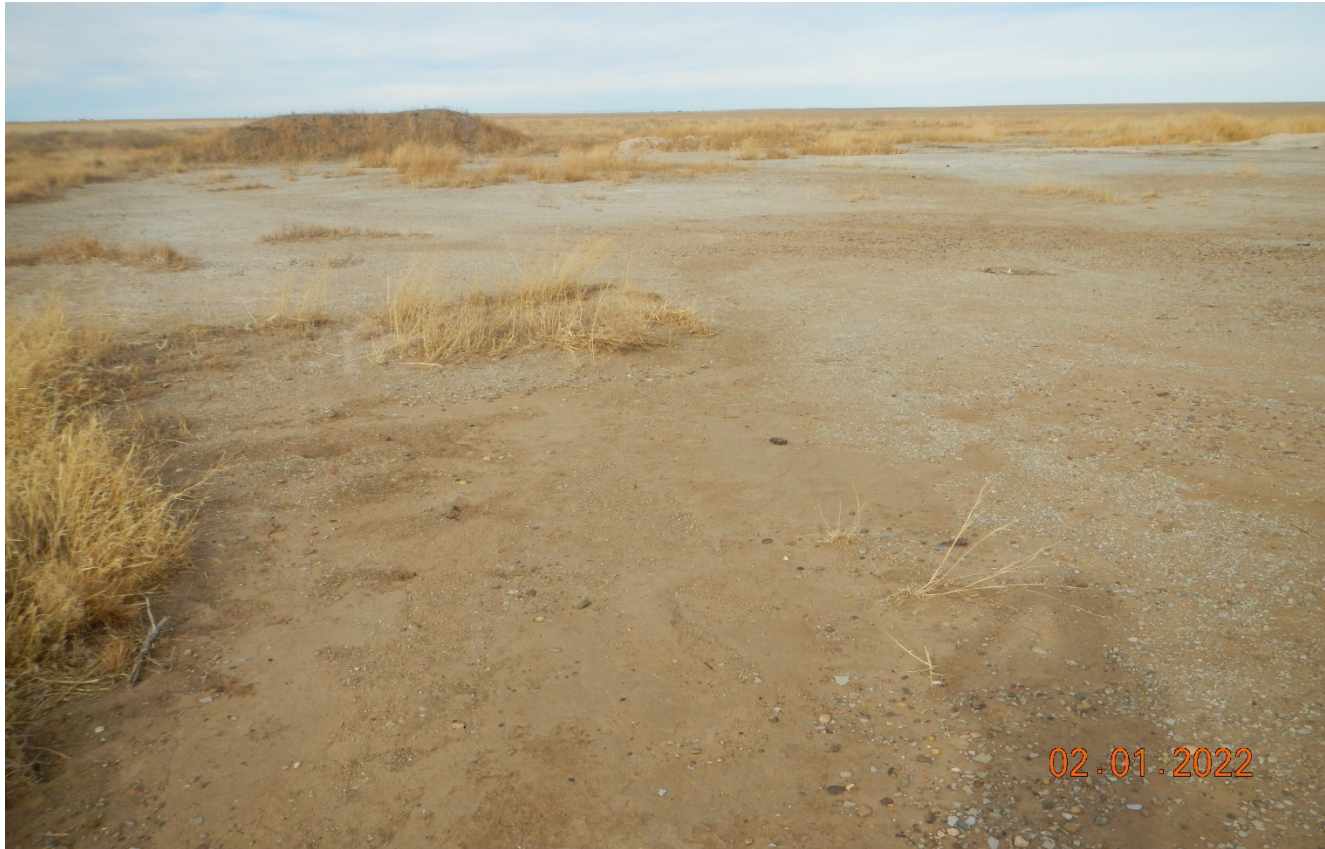
Photo 1. Facing northeast toward the location. The disturbed location has not been reclaimed. Previous corrective actions were not performed.

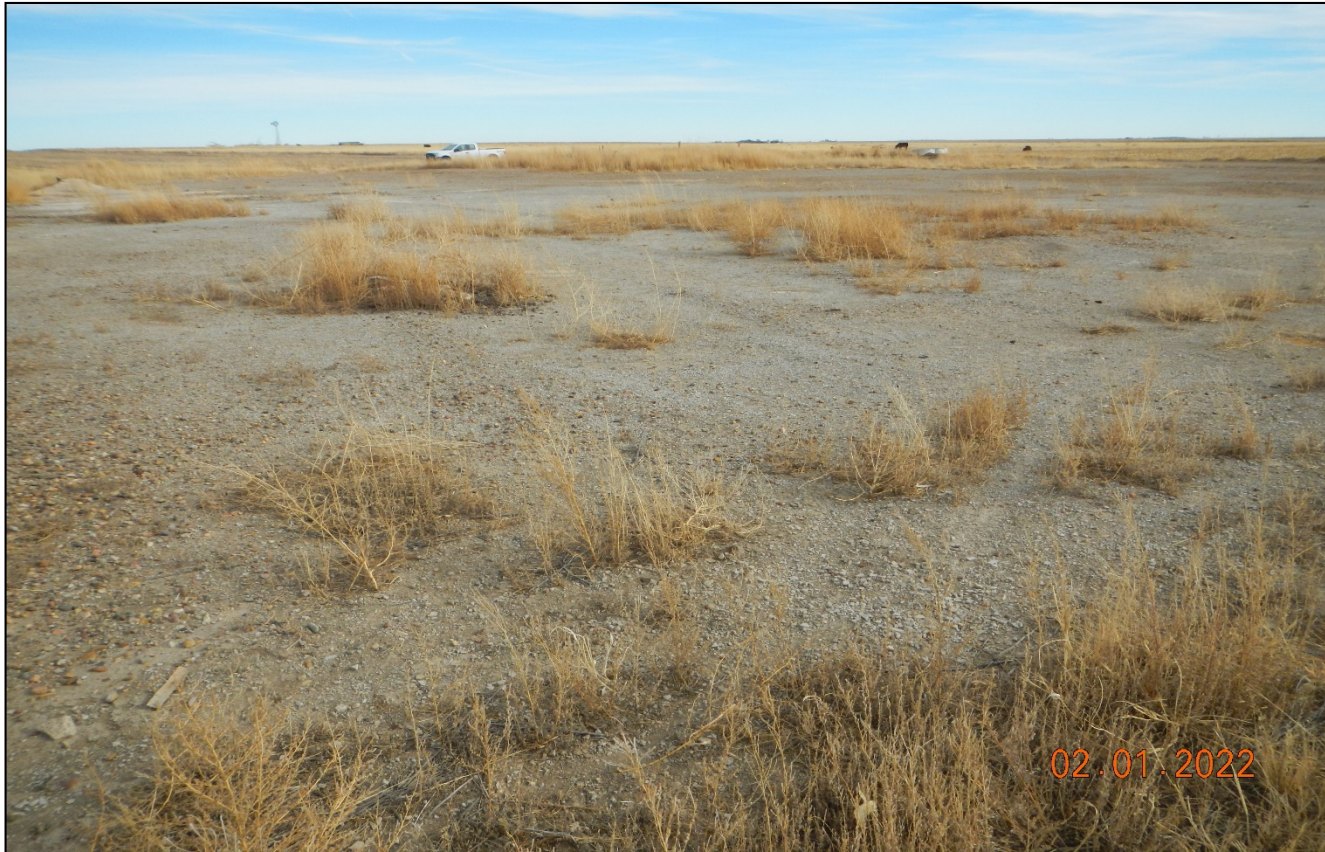
Photo 2. Facing southeast at the location. Soils are compacted and the location has not been reclaimed. Previous corrective actions were not performed. Soils must be decompacted by cross ripping to a depth of 18 inches.

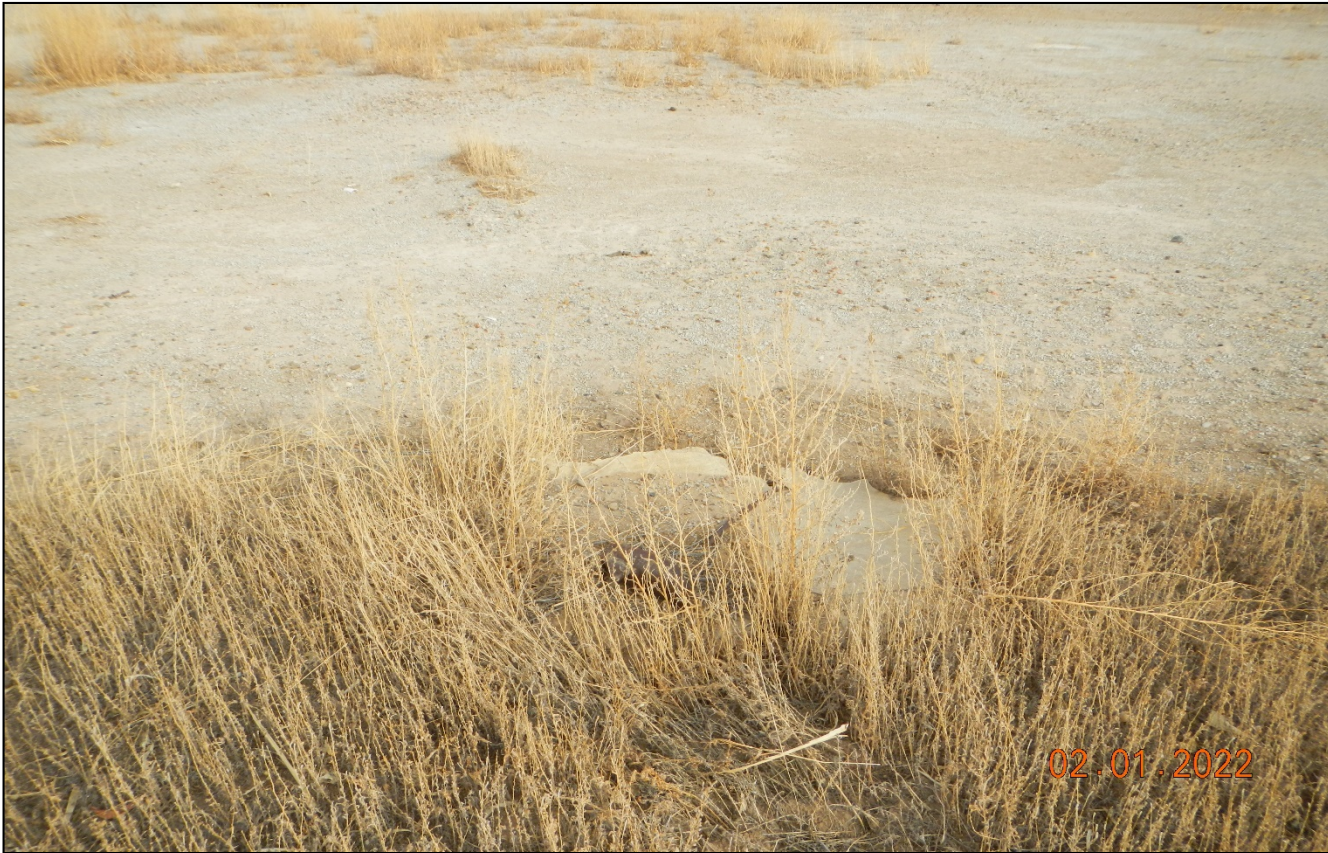
Photo 3. There is various debris that remains around the location.

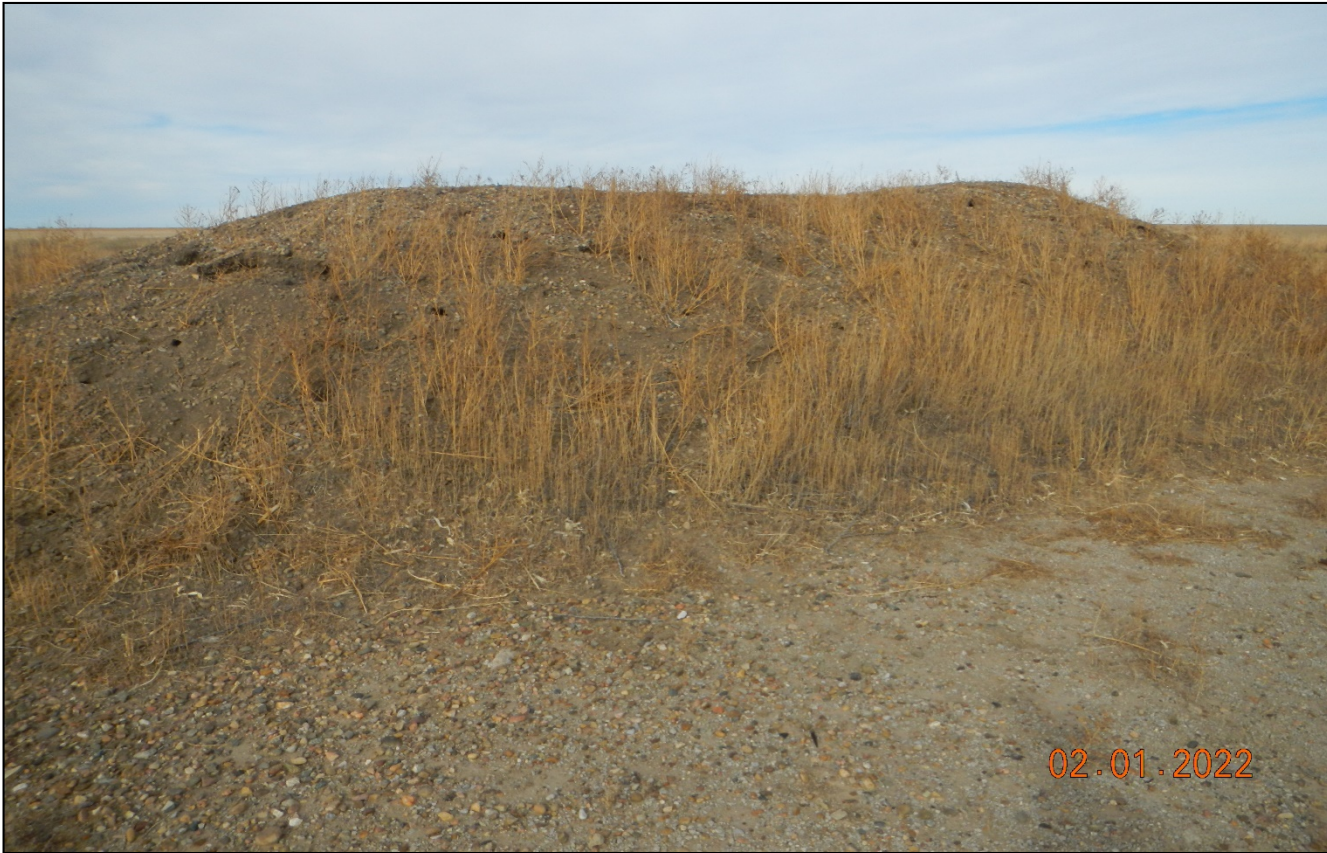
Photo 4. There are gravel and soil piles that remain at the north side of the location. The piles need to be removed. There are undesirable weeds growing on the piles.

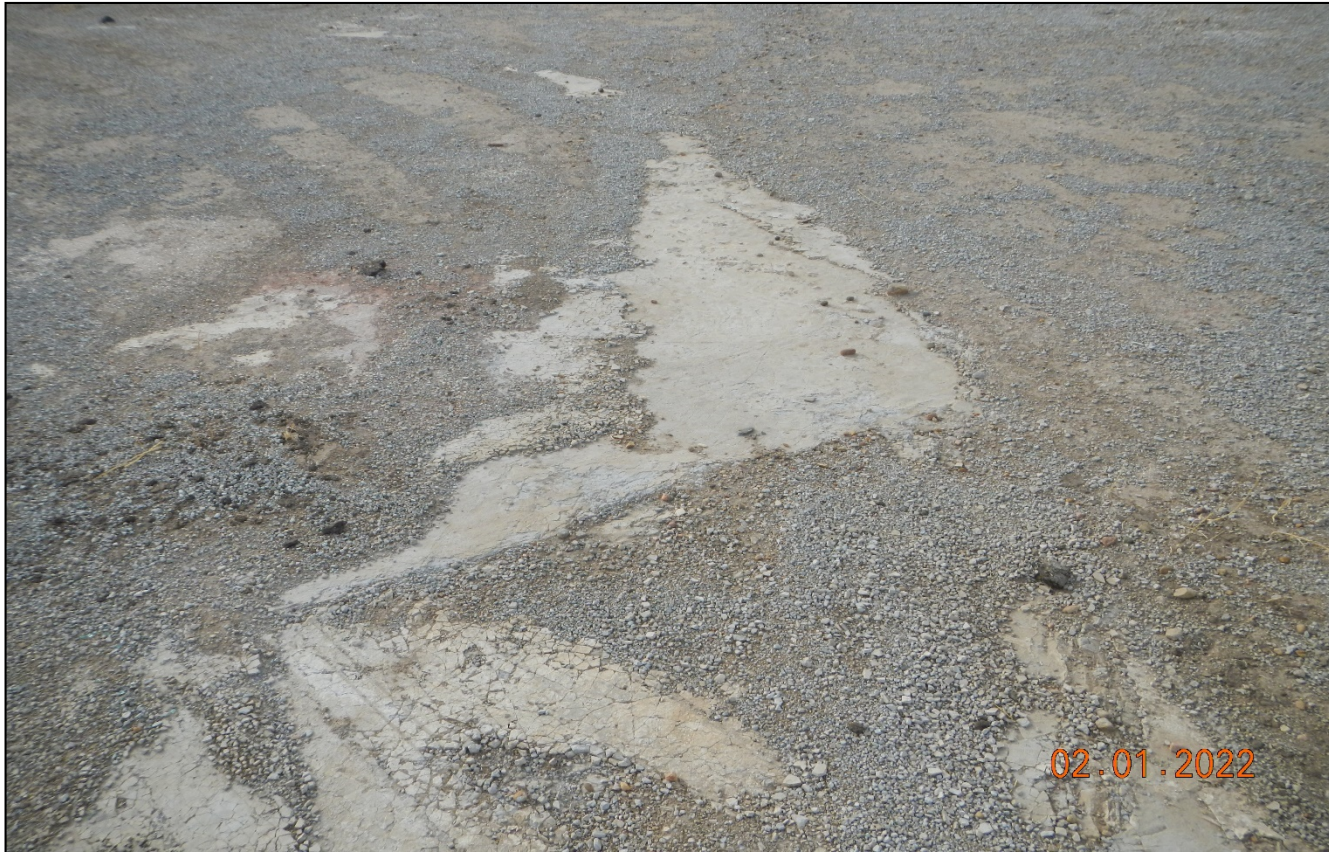
Photo 5. There is cement debris that remains on the location.

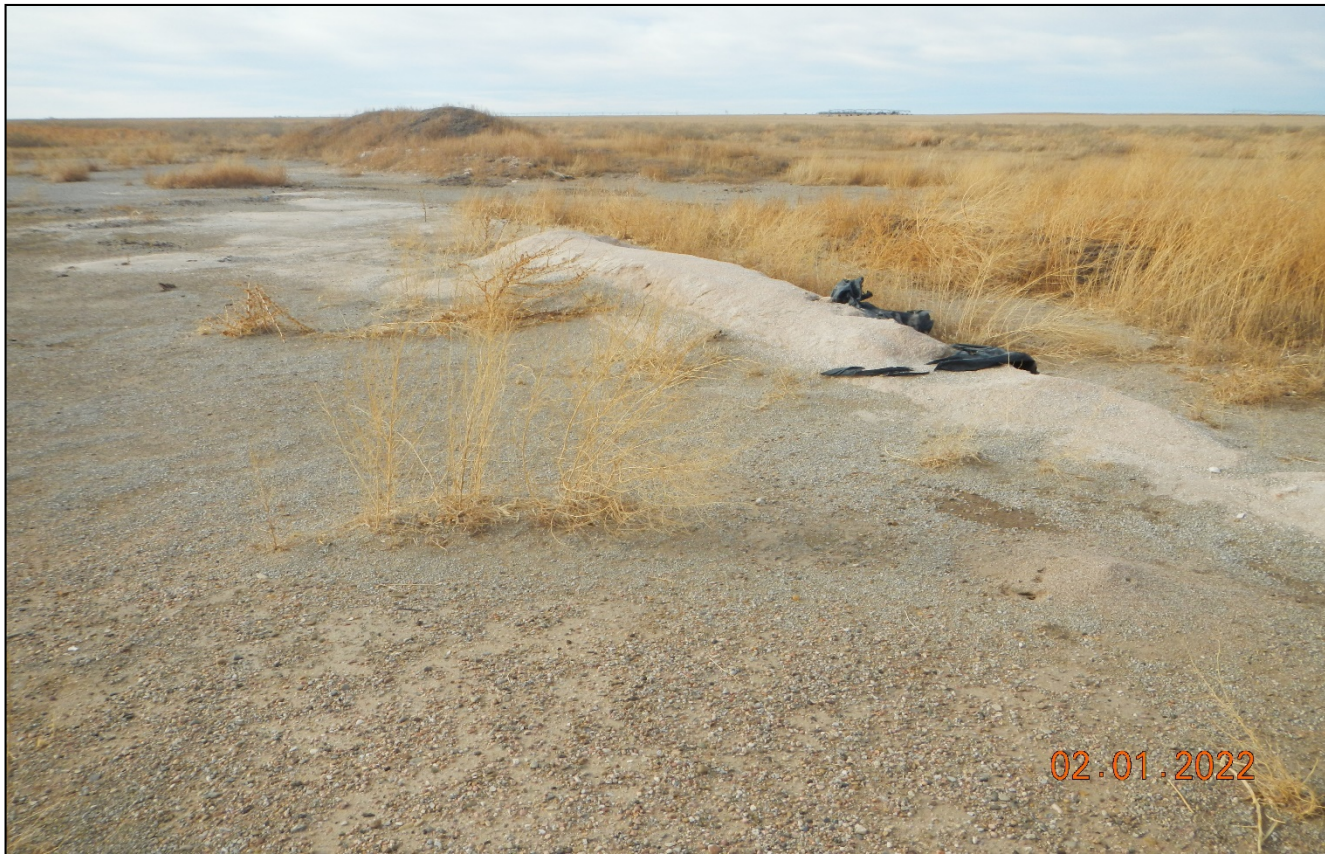
Photo 6. There are piles of manure and material left on the location.

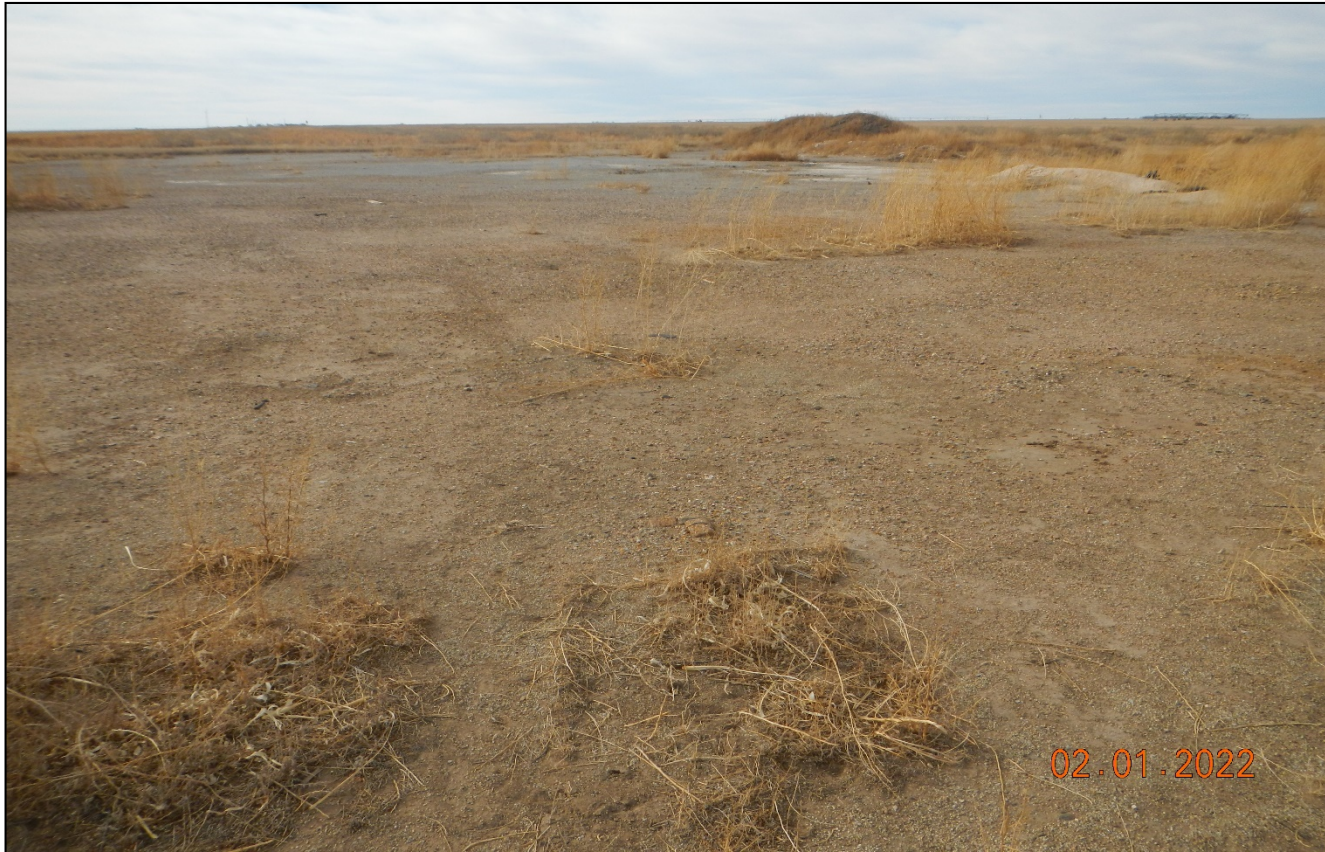
Photo 7. Facing west at the location. Soils are compacted and the location has not been reclaimed. Previous corrective actions were not performed.

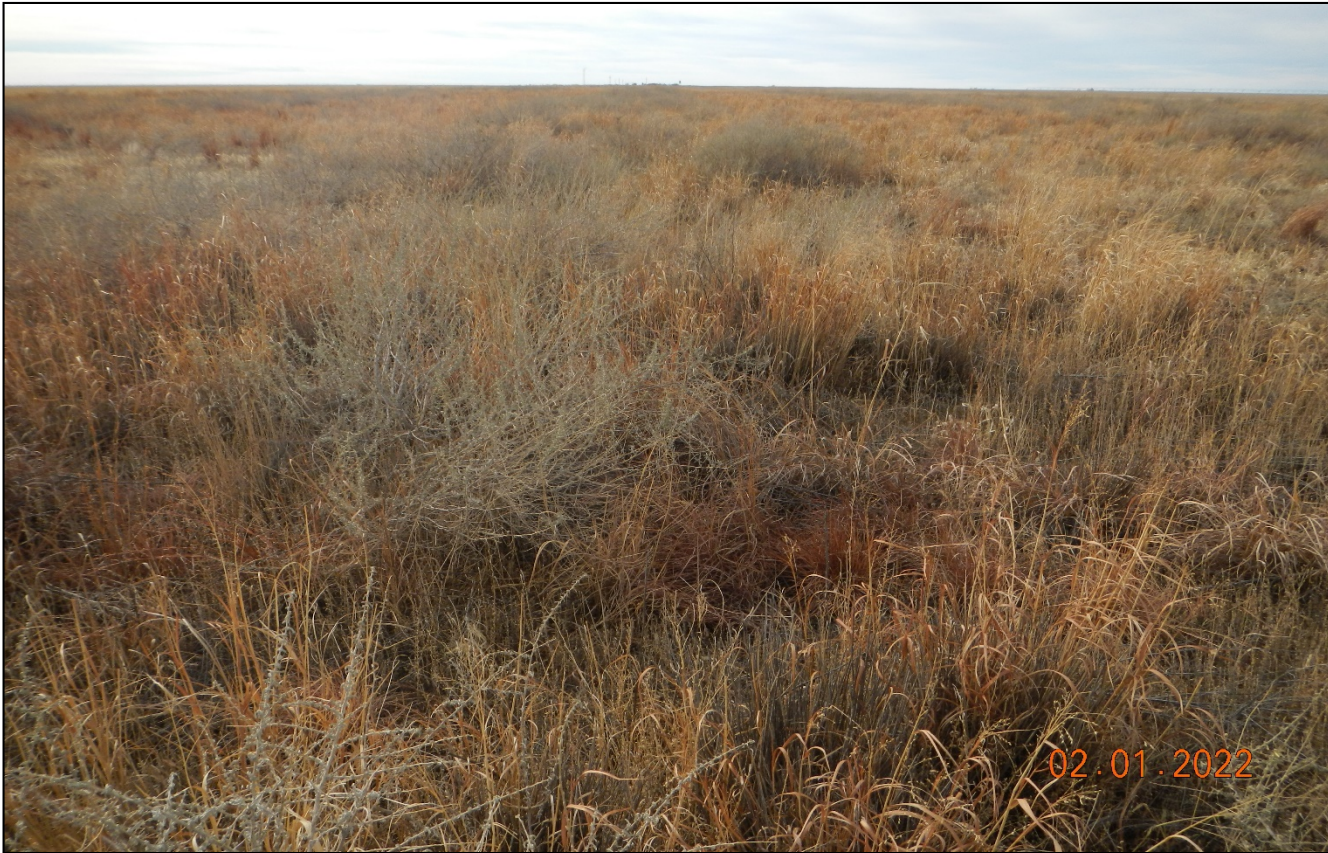
Photo 9. Facing east toward the surround reference vegetation which consists of desirable vegetation cover.
