Inspection Photos

API: 009-06669

Operator: JETTA OPERATING COMPANY

Inspection Date: 2/1/2022

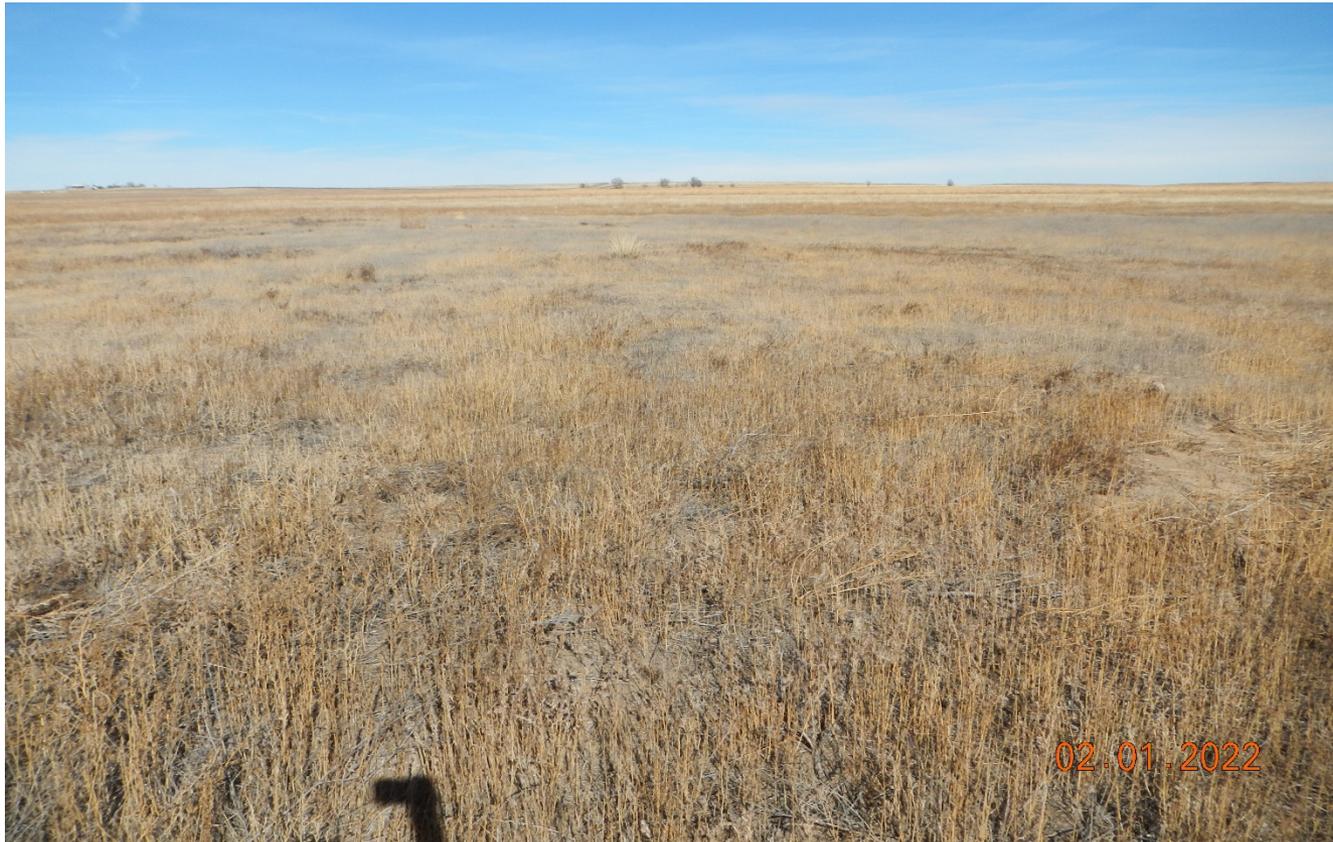
Photo 1. Facing north at the location. The location consists almost entirely of undesirable weeds. (Kochia sp., Russian thistle)

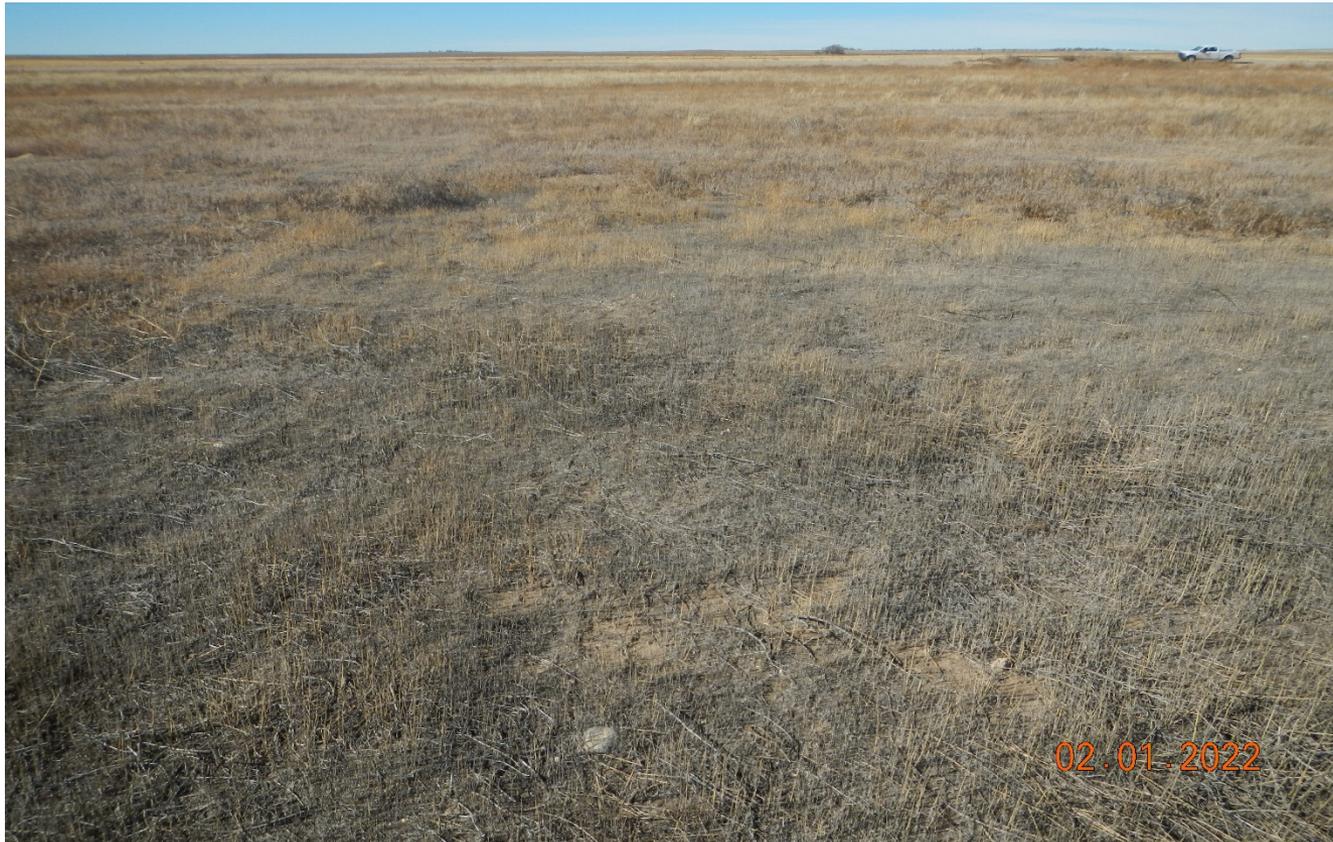
Photo 2. Center of the location facing west. The perennial vegetation has not reestablished and there is undesirable weeds throughout the location.

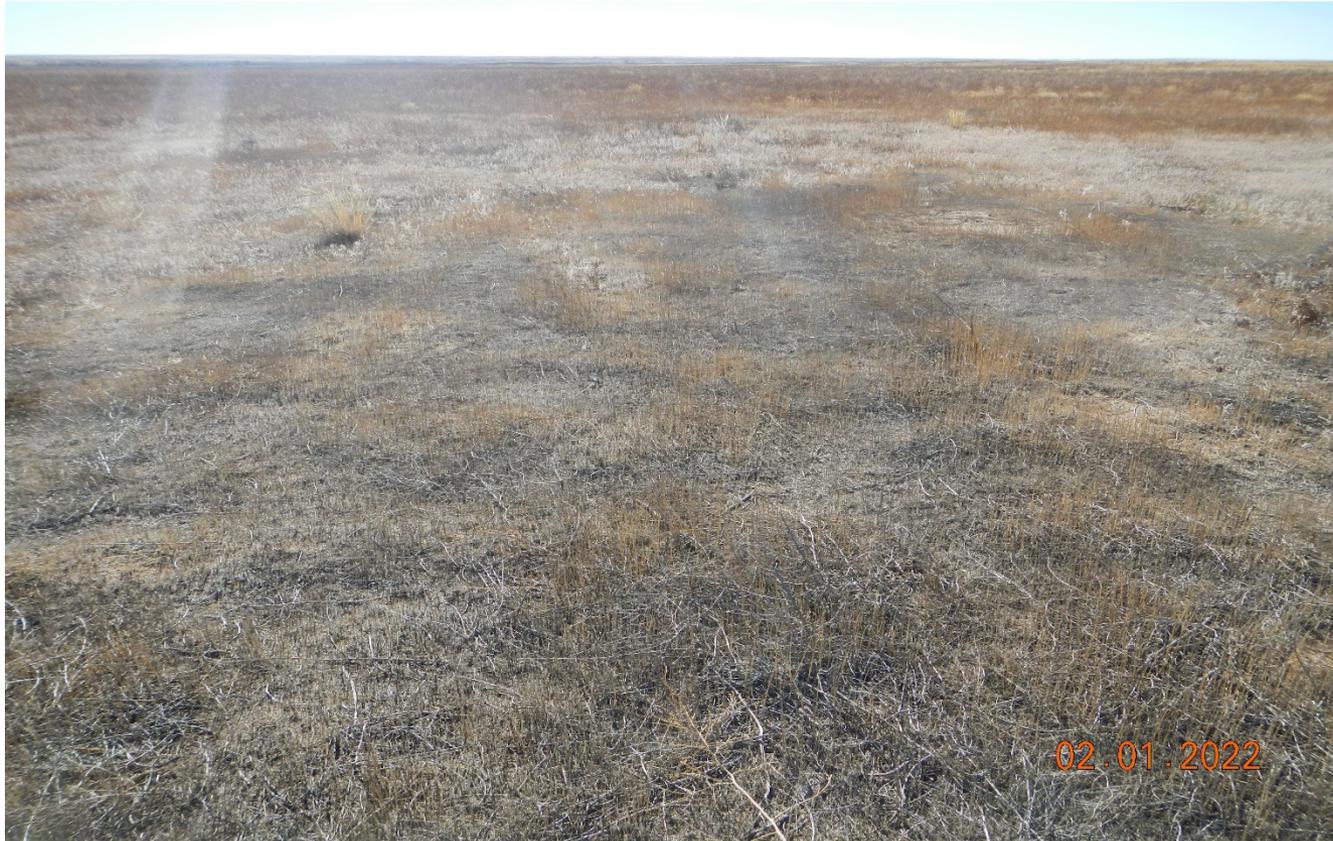
Photo 3. Center of the location facing south. The perennial vegetation has not reestablished and there is undesirable weeds throughout the location.

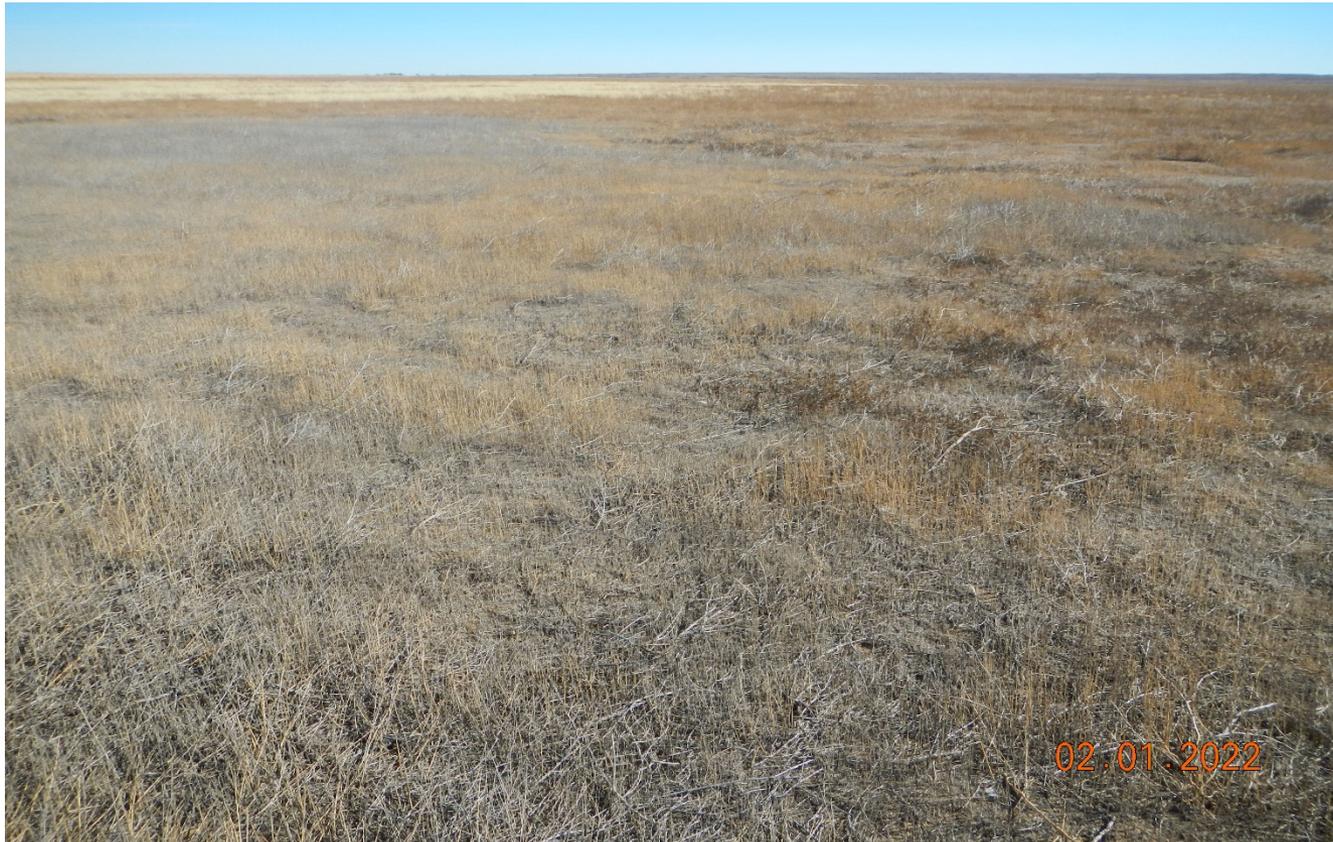
Photo 4. Center of the location facing east. The perennial vegetation has not reestablished and there is undesirable weeds throughout the location.

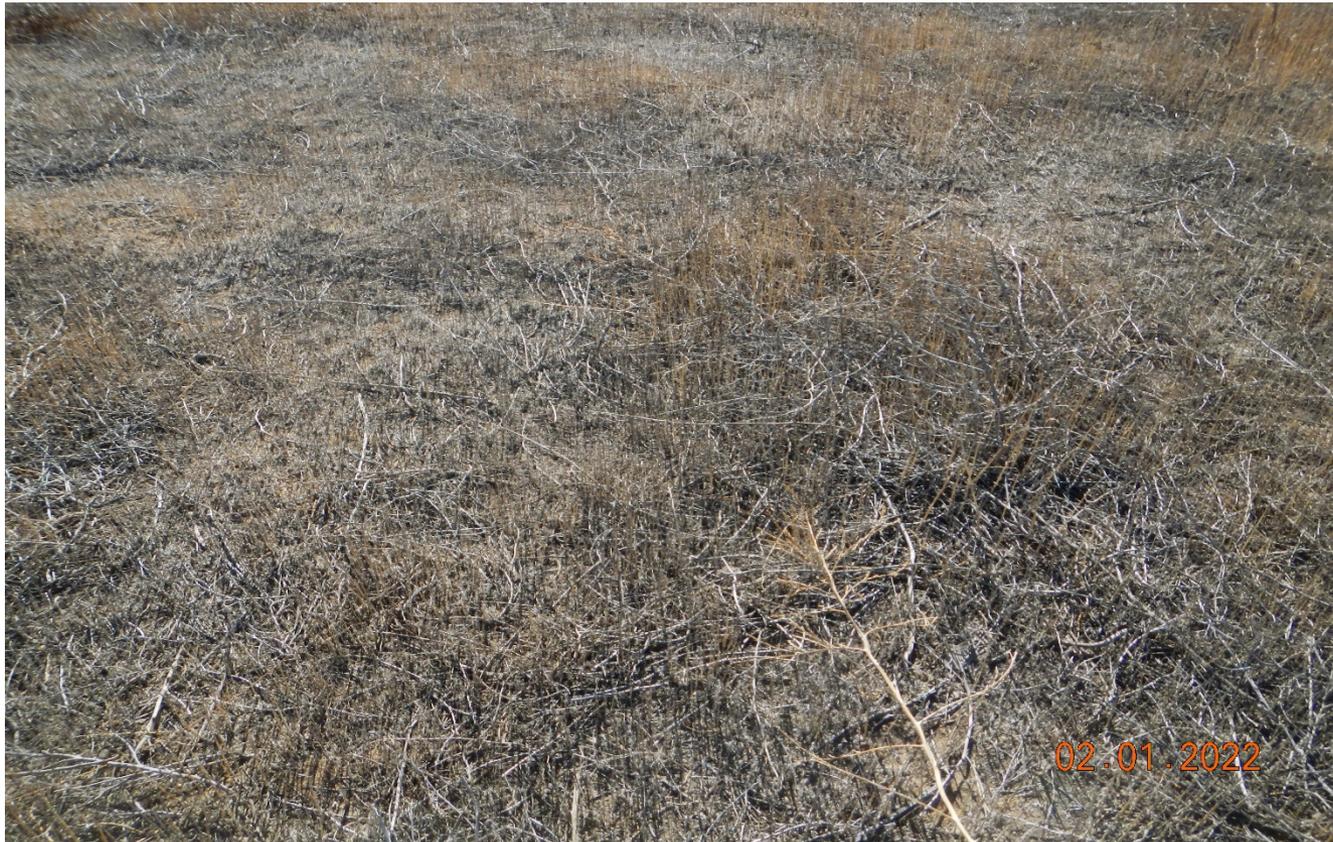
Photo 5. View of groundcover shows undesirable weeds consisting of Kocki sp. and Russian thistle.

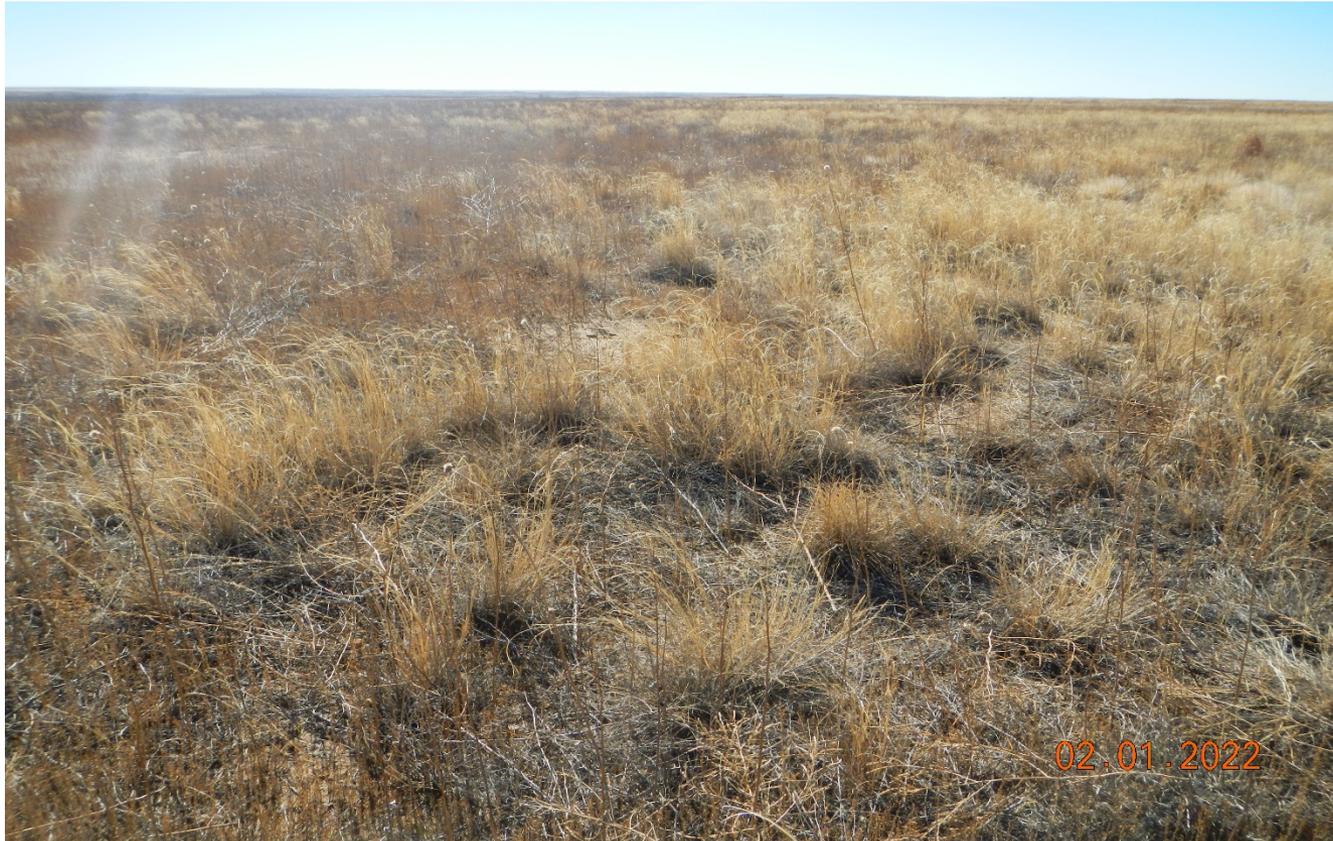
Photo 6. Facing southwest off the location. The surrounding field has perennial vegetation growth (Sand drop seed).
