OFFENSE REPORT

CR#920472

Investigated Death

3.4 miles south of Milner off RCR 179 (Titty Peak Ranch)

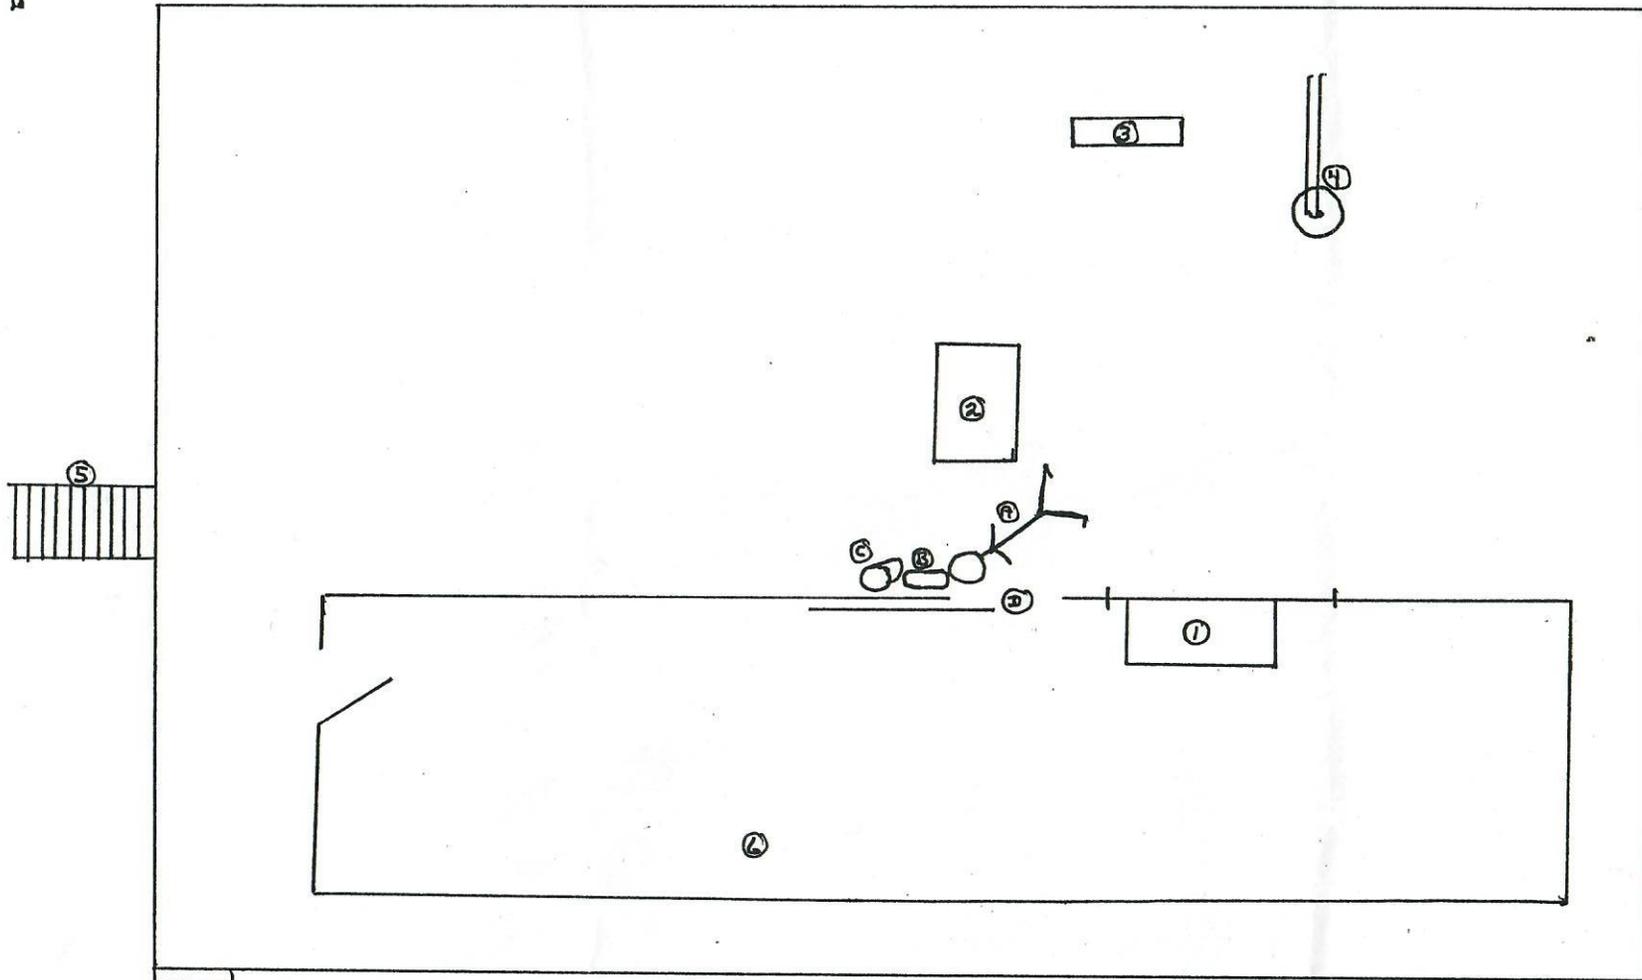
CR 920472
DR 922043

- (A) BODY ABOUT 2'
FROM DOOR INITIALLY
FACE DOWN
- (B) BROKEN METAL FROM
TONG
- (C) HARD HAT OF VICTIM
- (D) SLIDING DOOR

- (1) DESK
- (2) CONTROL PANEL
- (3) GAUGE PANEL
- (4) DRILLING PIPE & HOLE
- (5) STAIRS
- (6) SHED
