**Inspection Photos**  
**Location Name: UPRR 48 PAN AM H#1**  
**Location ID: 319999**

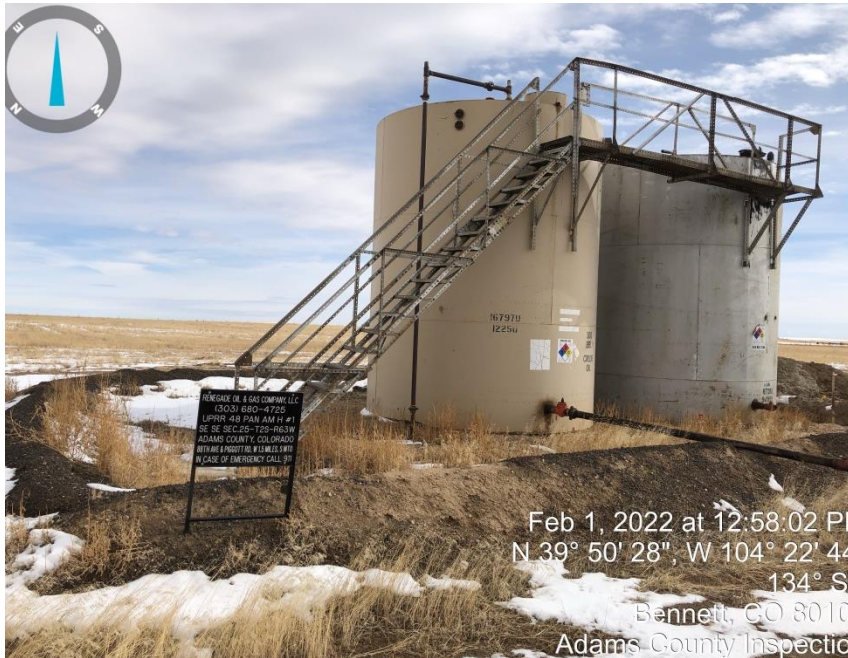
**Photo#1 Production Tanks**

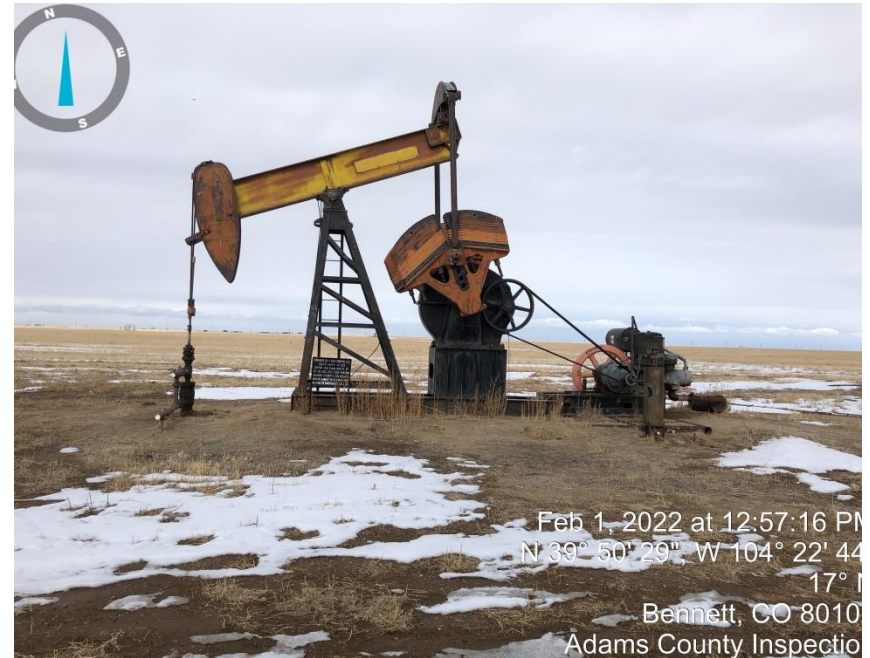
**Photo#2 Pumpjack/Wellhead**

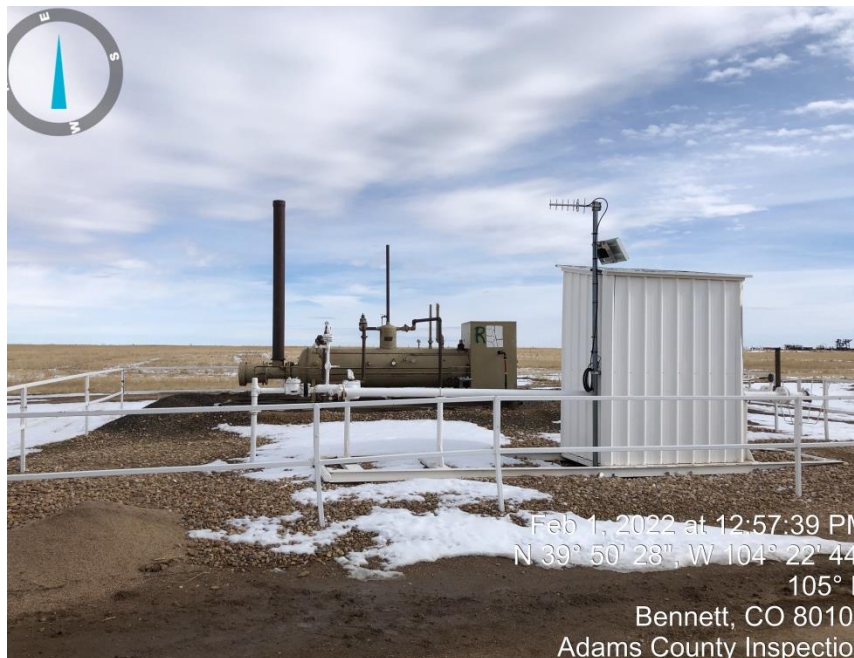
Photo#3 Separator/Gas Meter

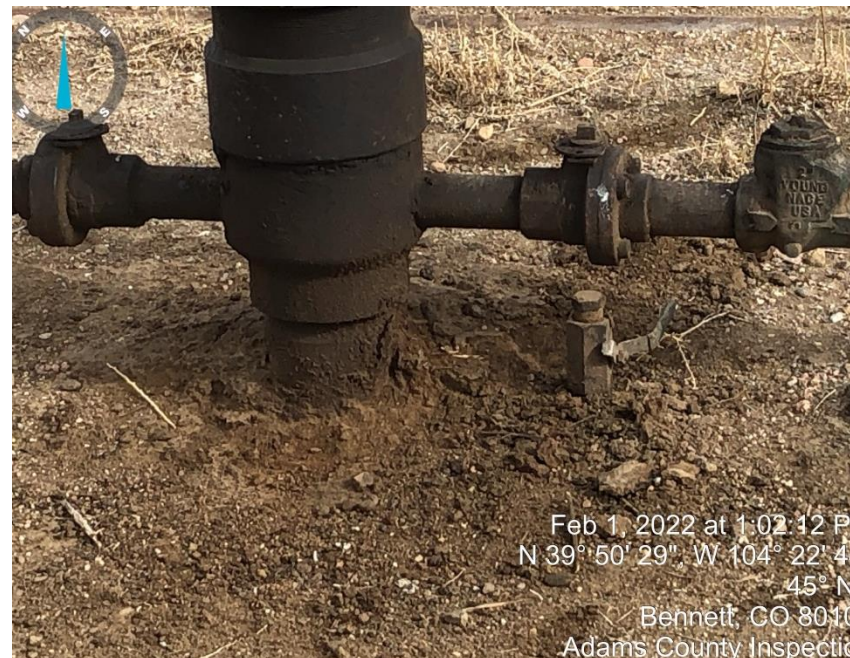
Photo#4 Stained Soil around wellhead

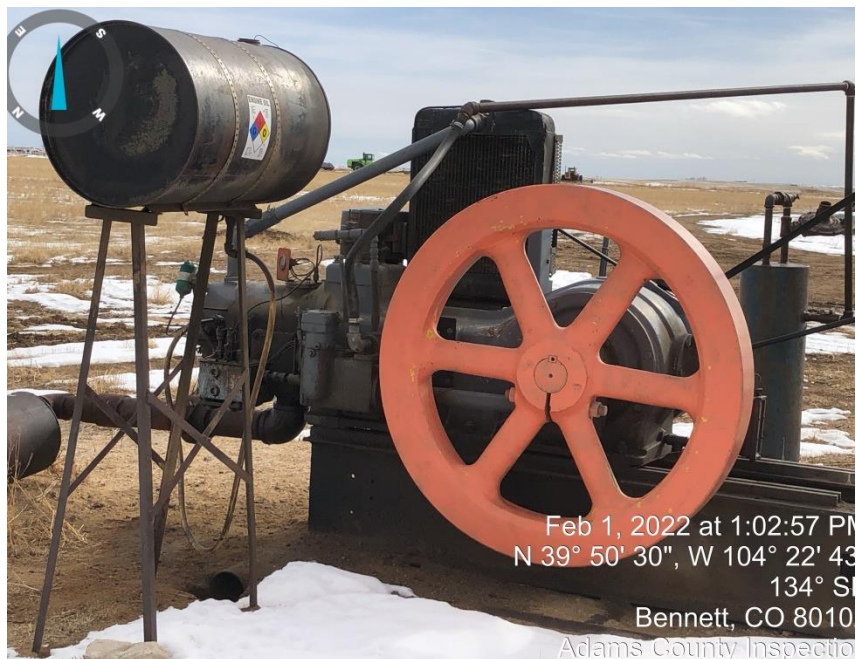
**Photo#5 Corrective Action: No Secondary Containment under chemical tank. Repair or install berms or other secondary containment devices per Rule 603.o.**

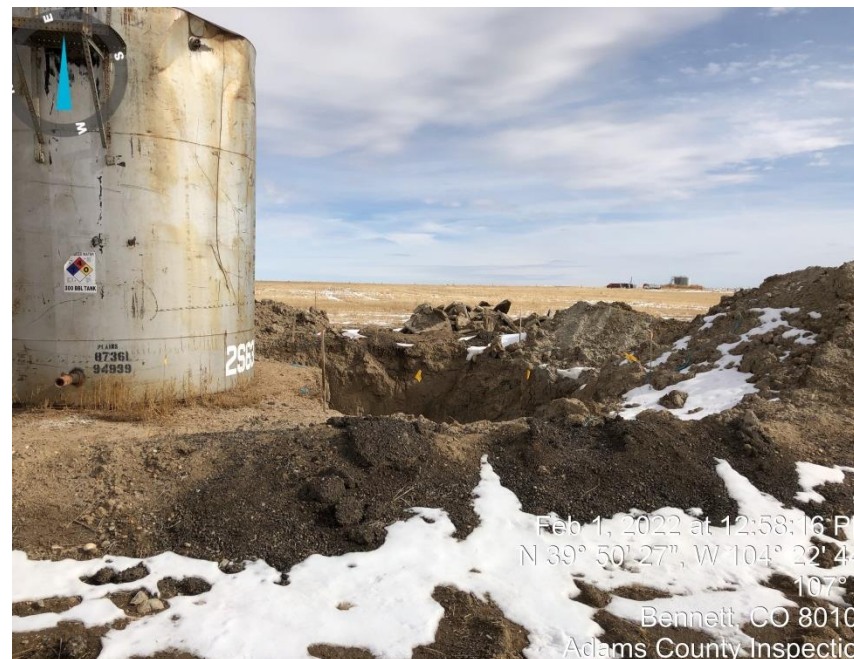
**Photo#6 Open remediation work**

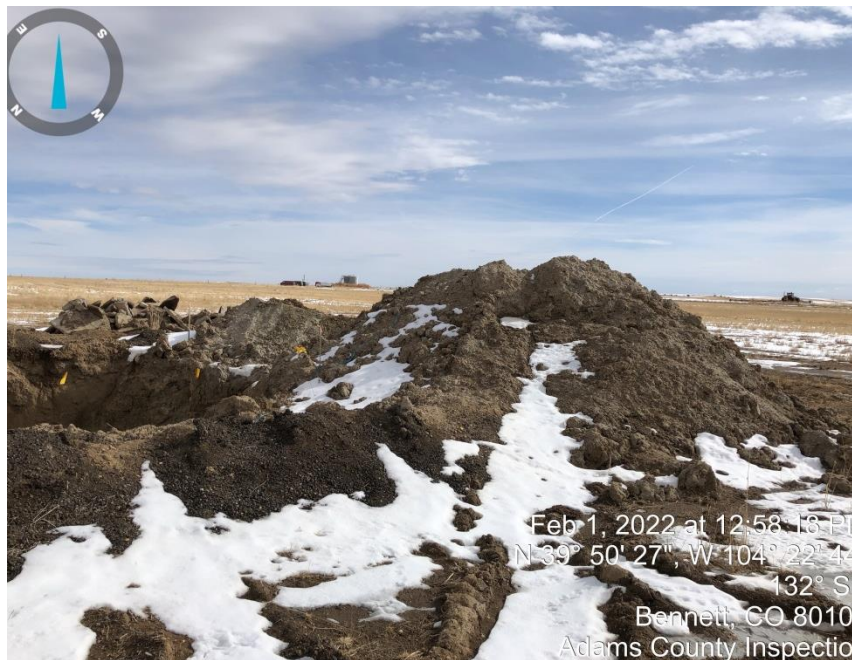
**Photo#7 Open remediation work/Stained soil**

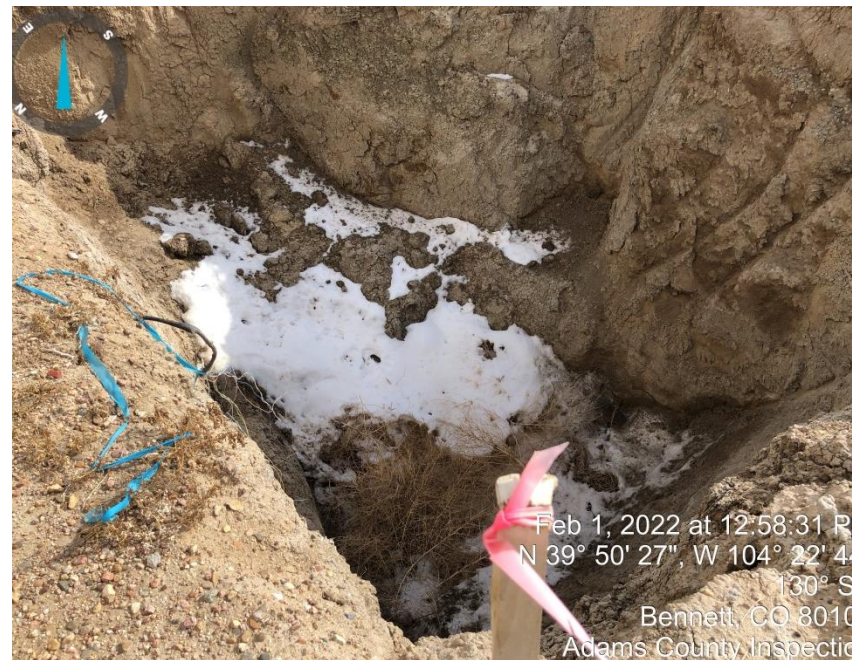
**Photo#8 Open remediation work/Open hole where concrete water vault was.**

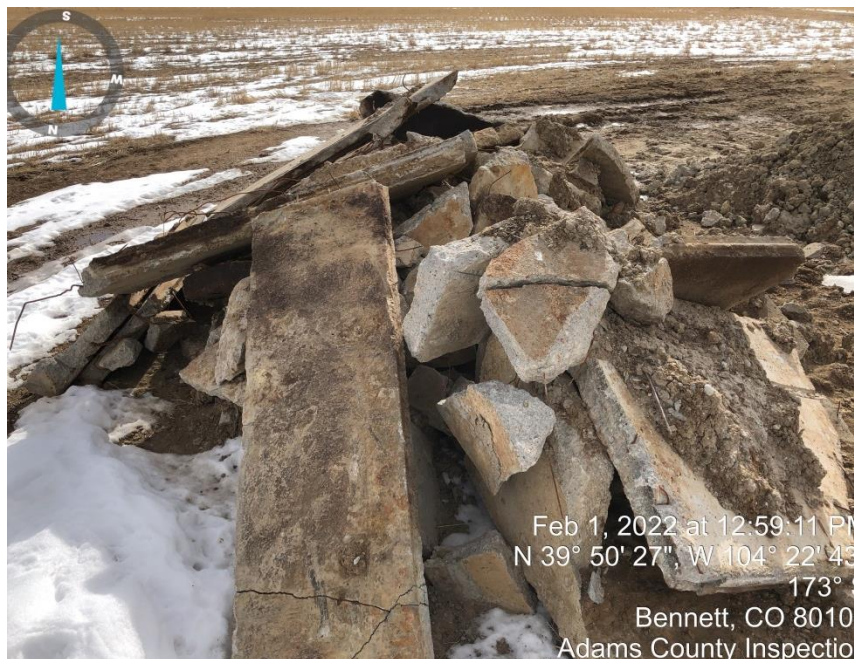
**Photo#9 Broken concrete vault**

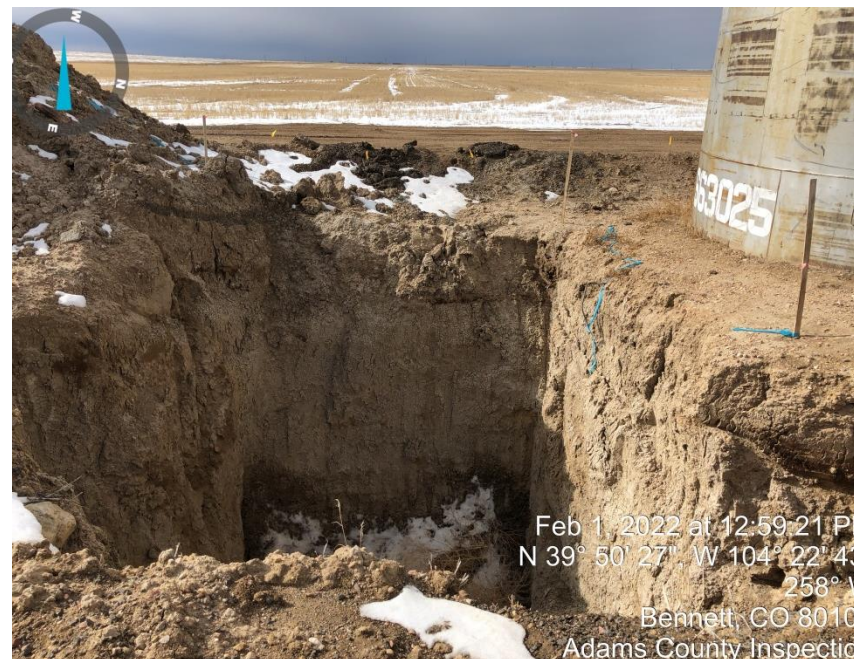
**Photo#10 Open remediation work/No Safety fencing around hole.**

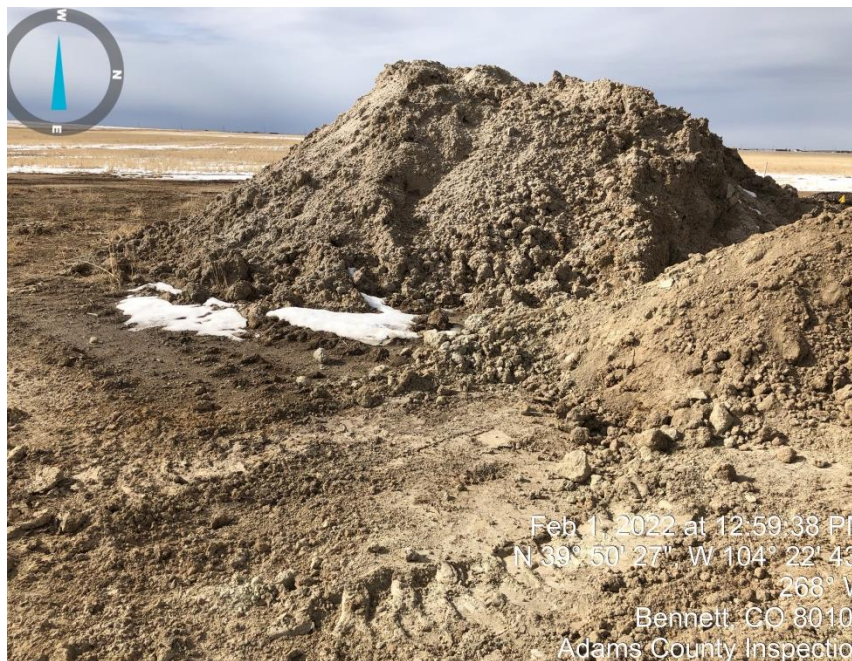
**Photo#11 Pile of contaminated soil**

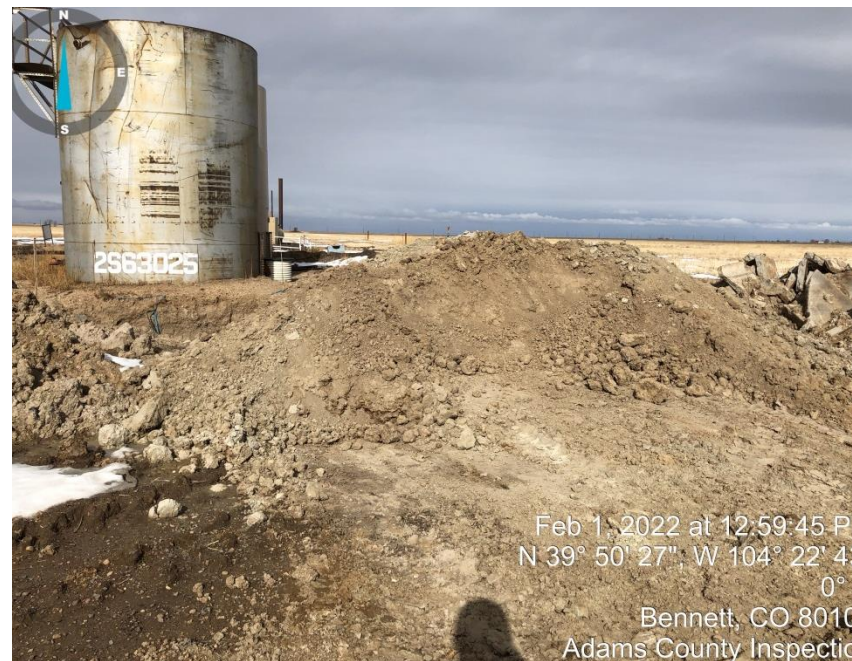
**Photo#12 Pile of contaminated soil**

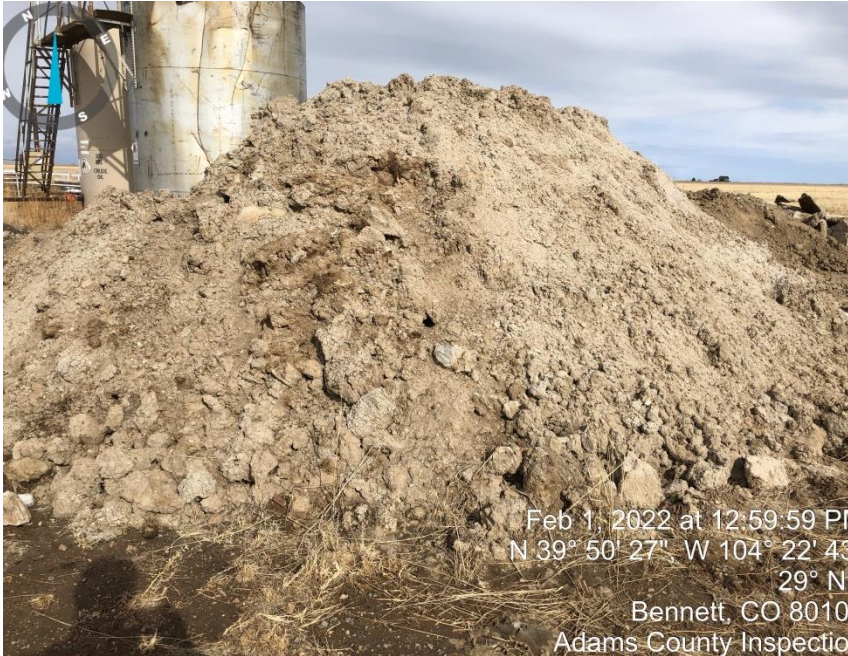
**Photo#12 Pile of contaminated soil**

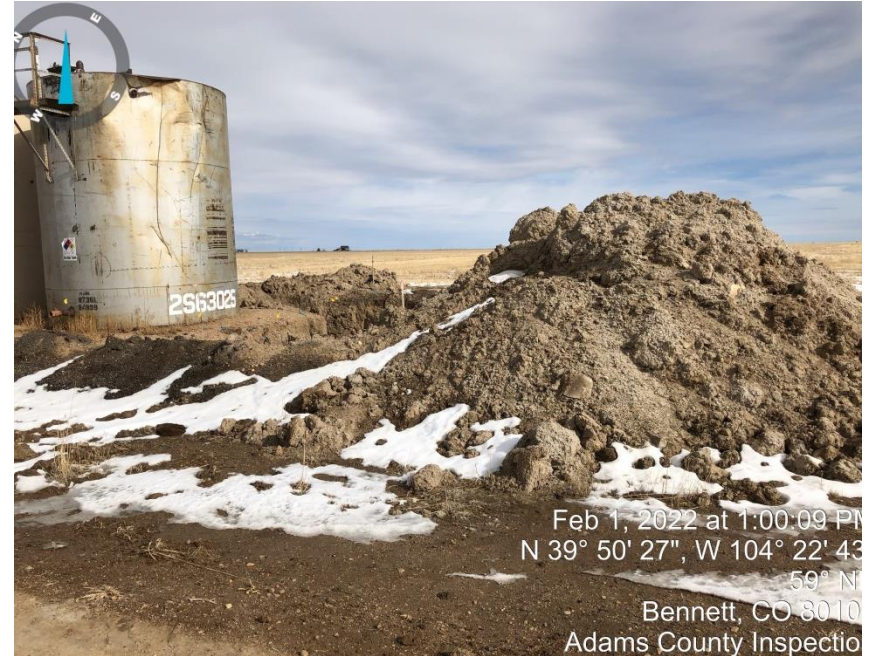
**Photo#13 Pile of contaminated soil**

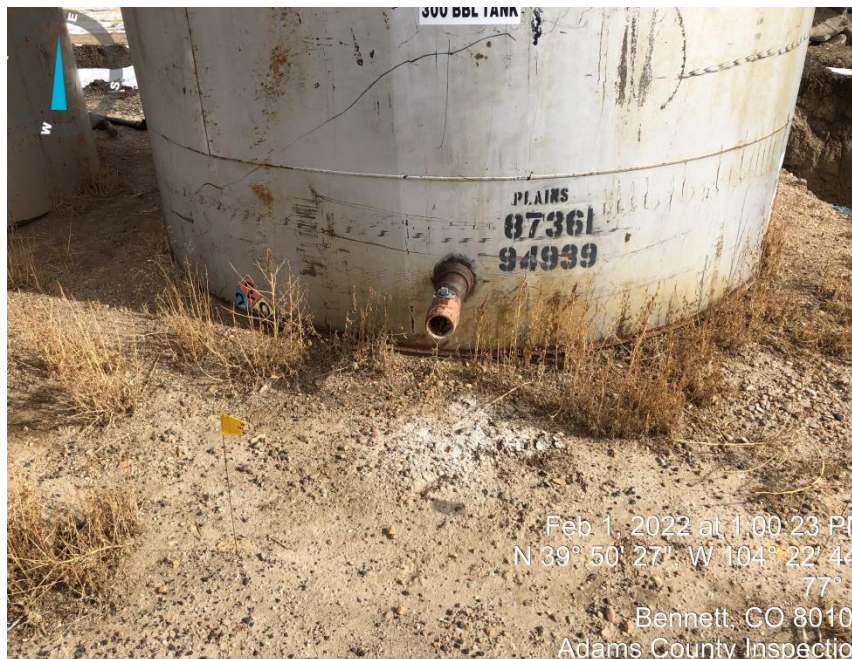
**Photo#14 Corrective Action: 603.i.**  
**All loadlines will be bullplugged or capped.**

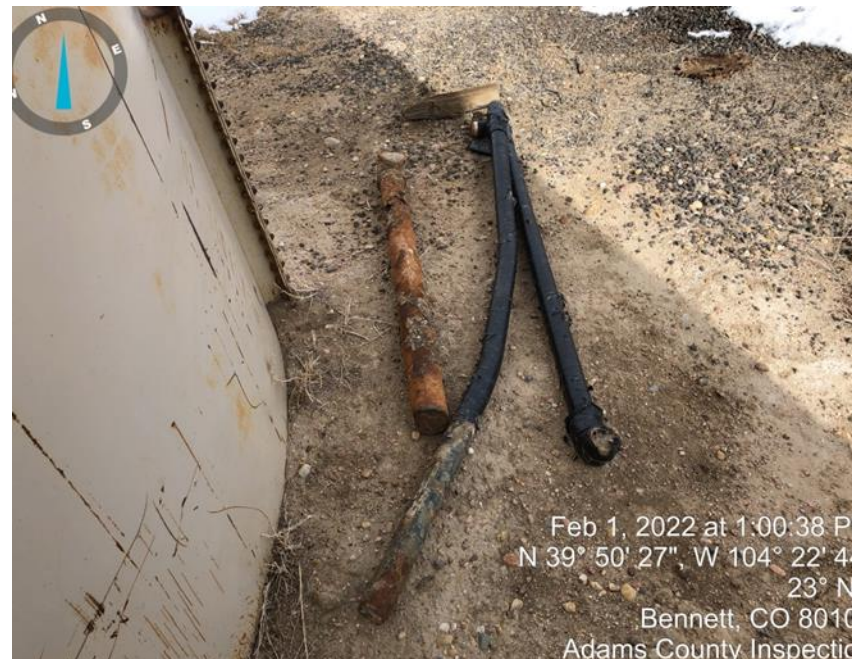
**Photo#15 Corrective Action: Comply with Rule 606, Statewide unnecessary equipment, weeds, waste, and trash requirements**
