Inspection Photos

Location Name: TEP ROCKY MOUNTAIN LLC UNION-67S96W /3SWNE

Location ID: 323956

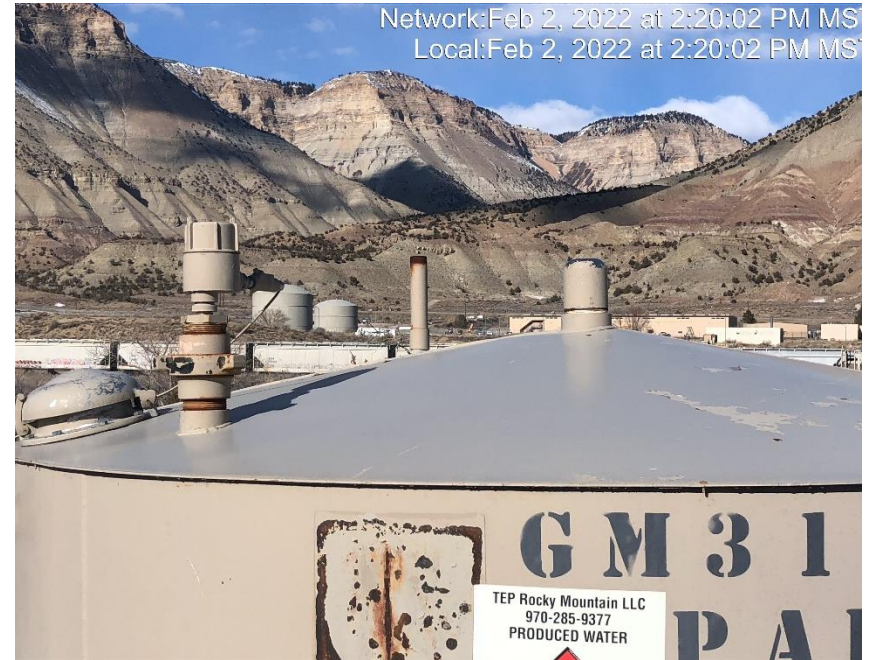
Photo #5869 Vent pipe on tank open ended.

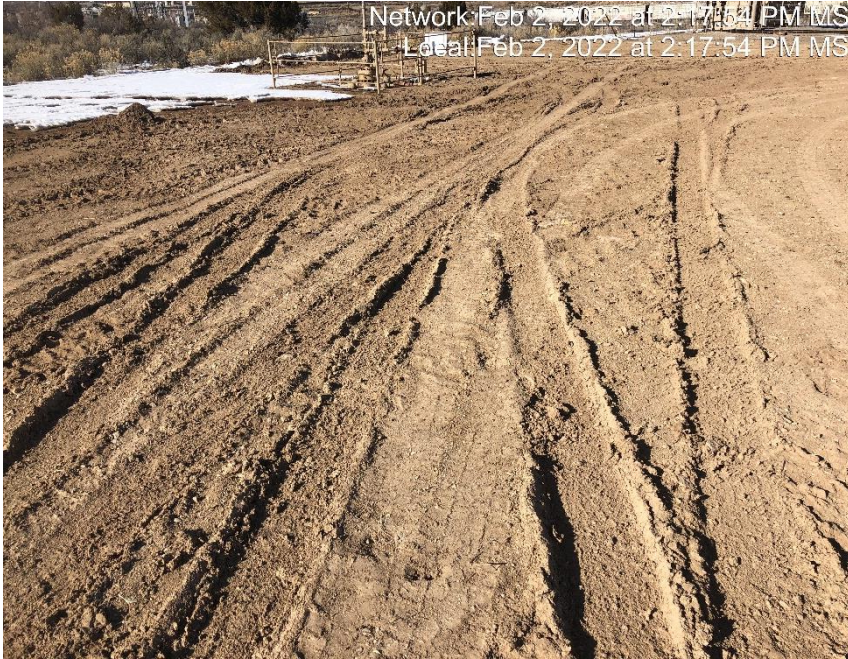
Photo #5867 Location lacks stabilization.

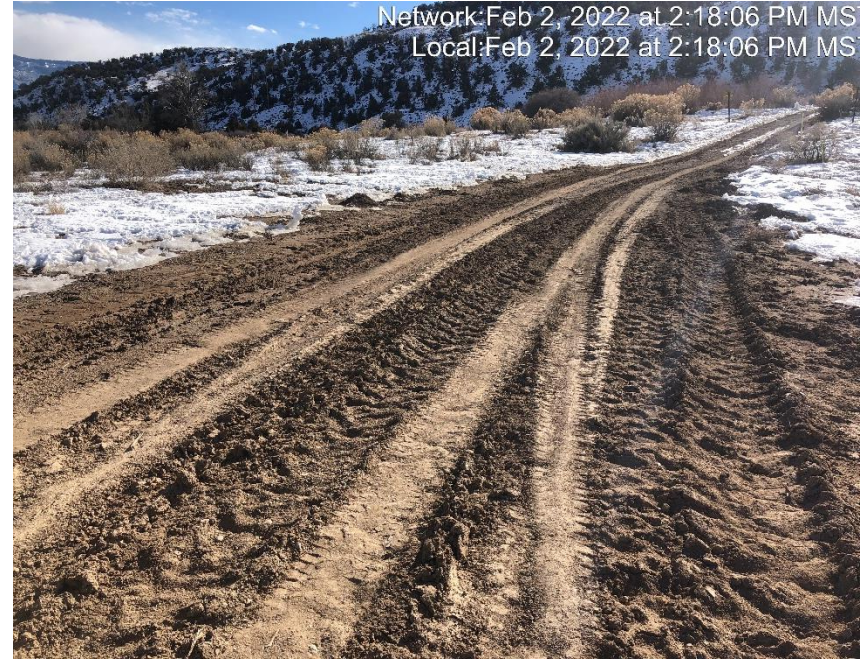
Photo #5868 Insufficient tracking BMP at entrance to location.
