HILL RANCH 34-16 API# 05-071-07815 – OGRIS OPERATING LLC
OGCC OPERATOR NUMBER 10758 - DATE: NOVEMBER 05, 2021
CORRECTIVE ACTIONS COMPLETED REGARDING COGCC FIR DOCUMENT # 695104890

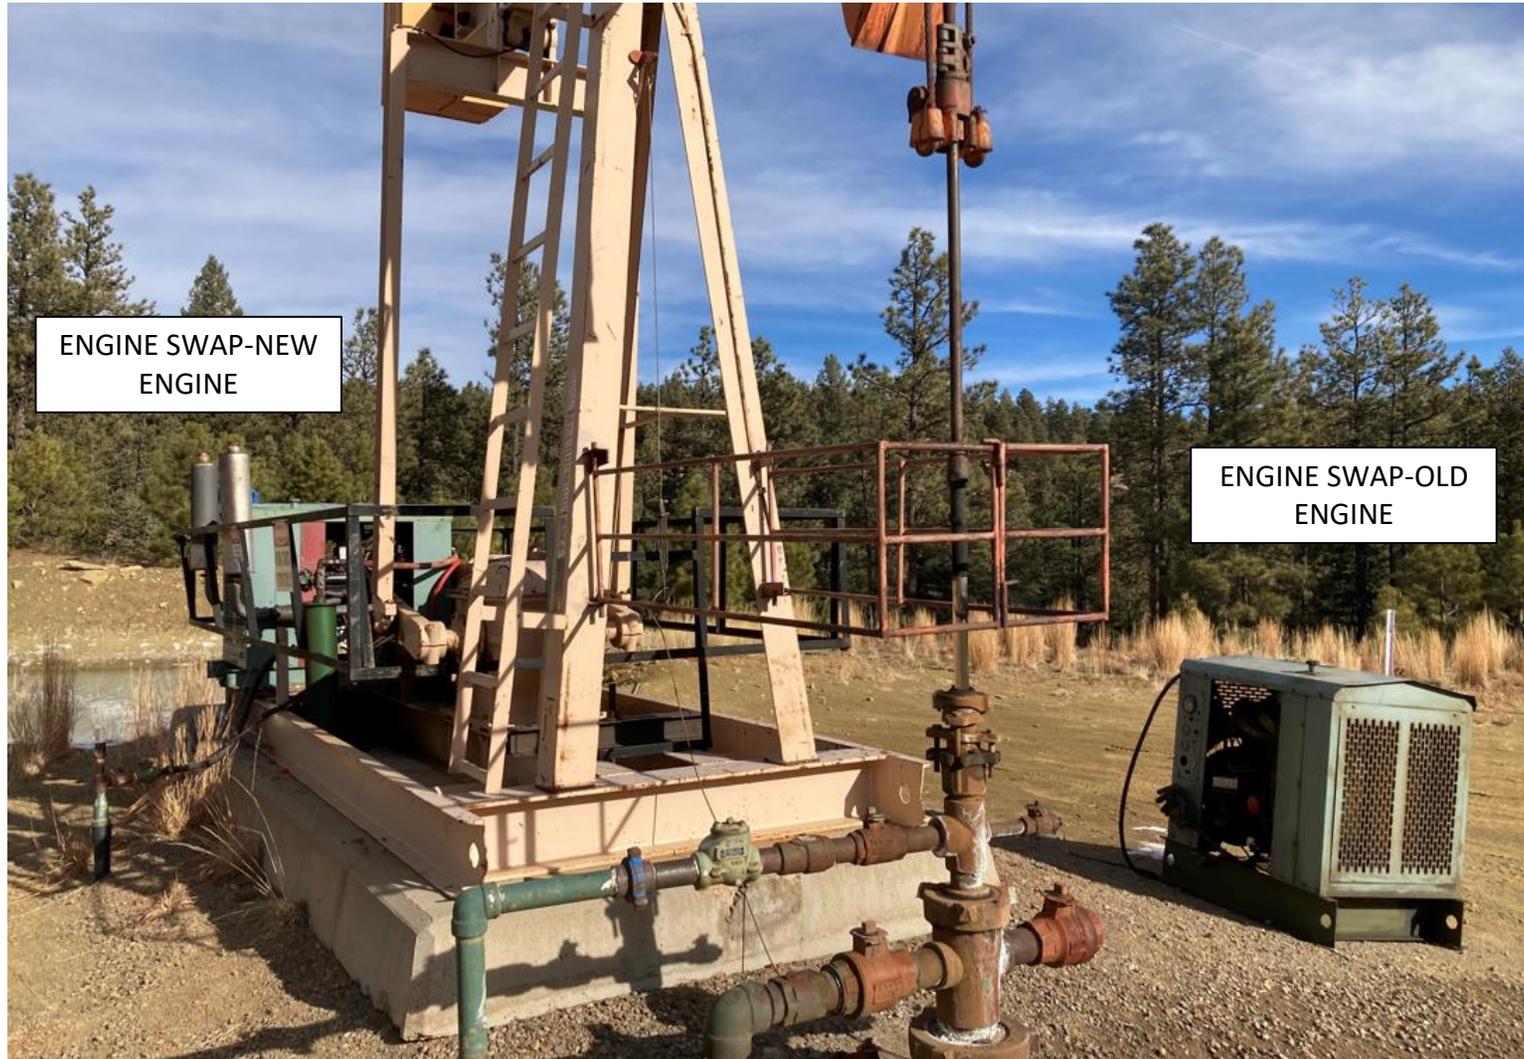
THE PUMPING JACK MOTOR WAS FOUND TO BE LEAKING AGAIN. THE ENGINE WAS REPLACED AND NO LEAKS WERE DETECTED.
