Inspection Photos
Location Name: Myers 19-11HA
Location ID: 441283

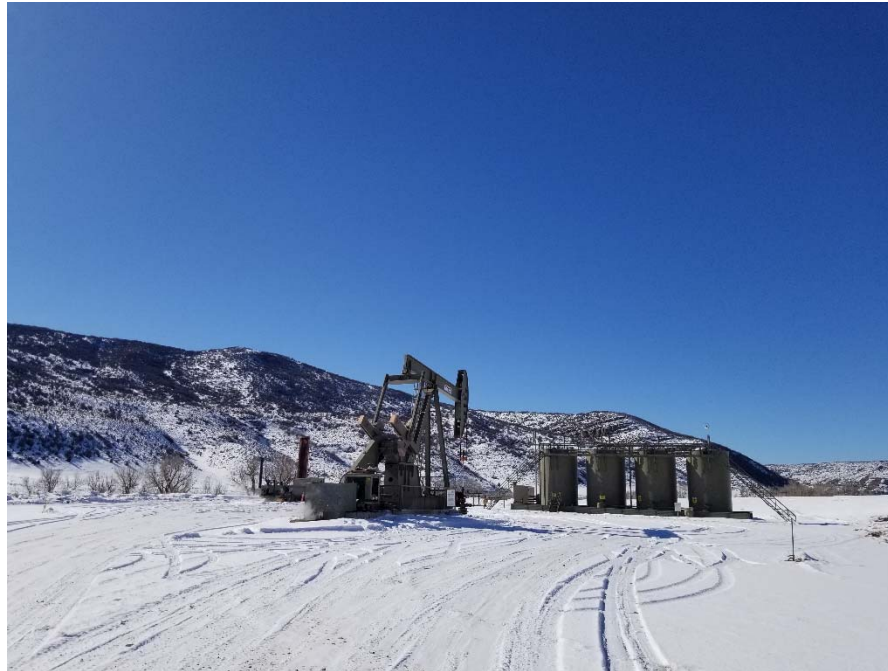
Photo 1. Overview of location taken facing southwest.

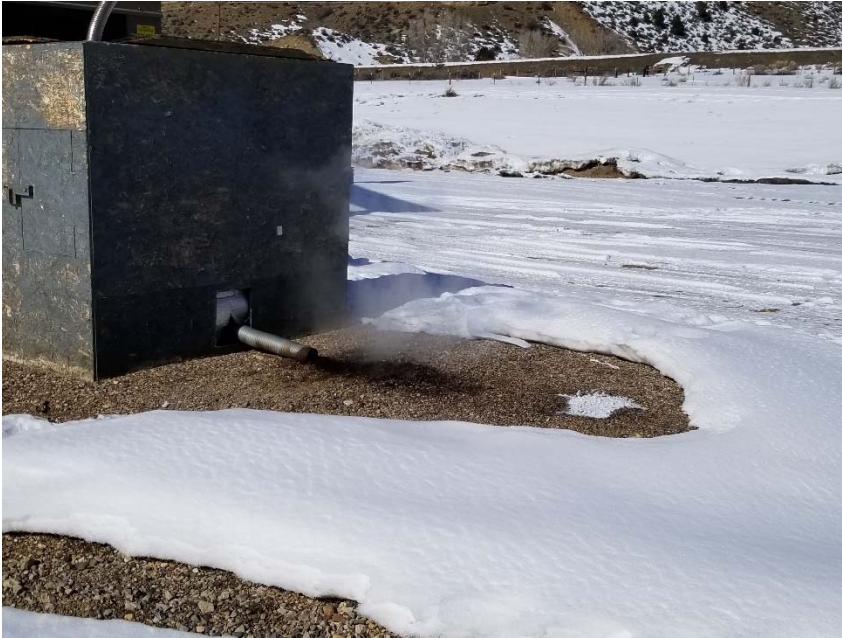
Photo 2. Stained soil at pump jack exhaust.

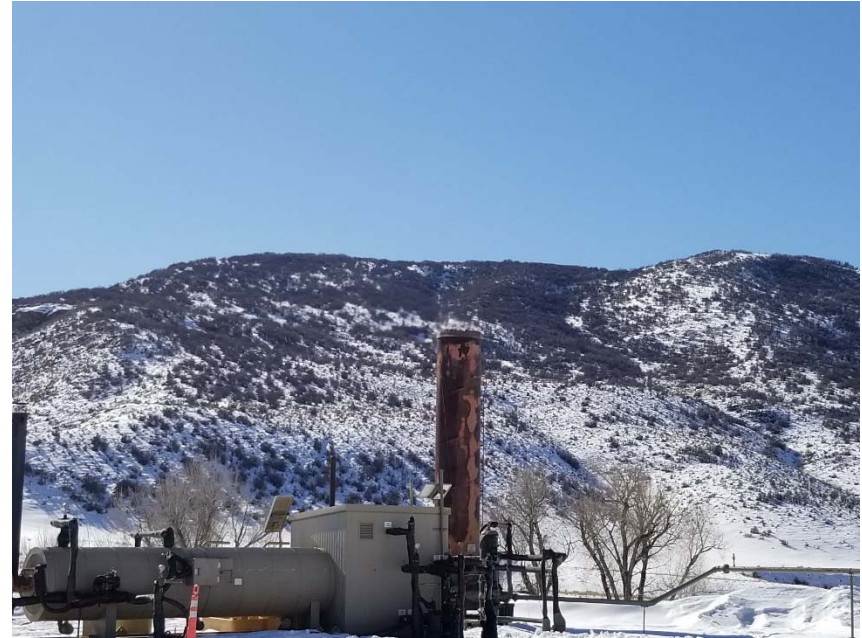
Photo 3. Combustor lit.
