Inspection Photos

Location Name: TEP ROCKY MOUNTAIN LLC BARRETT-66S96W /36SESW

Location ID: 334947

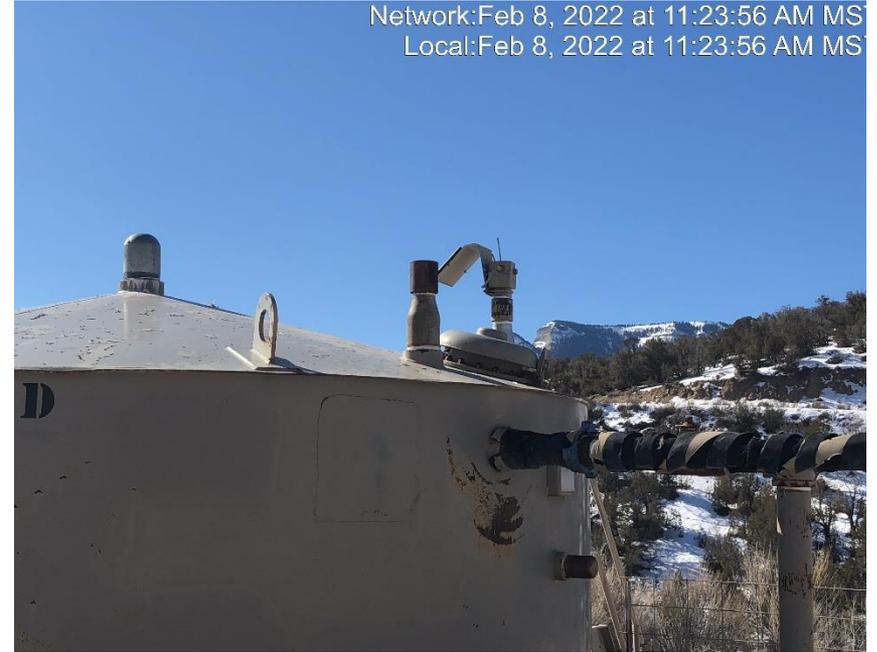
Photo #5894 Vent pipe open on tank open ended.

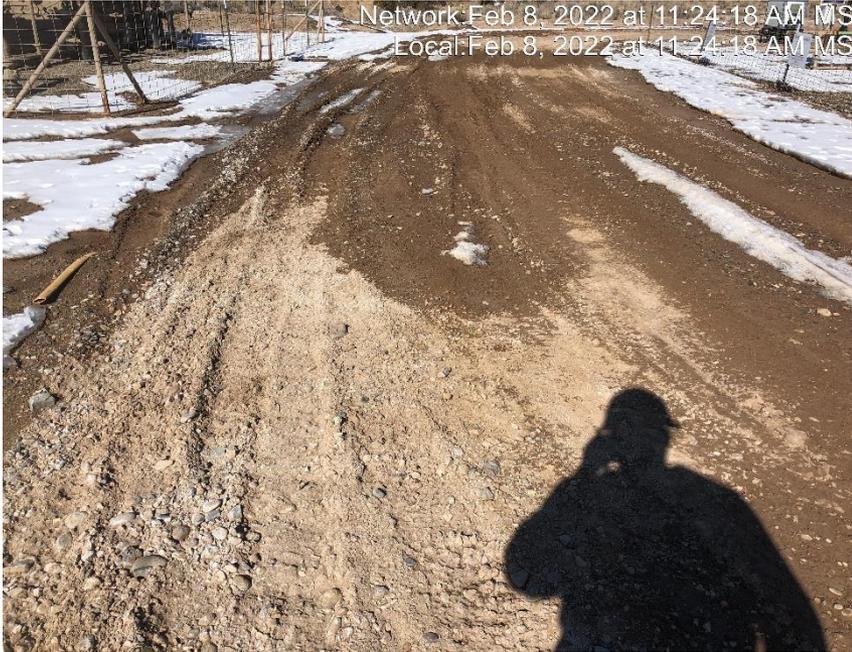
Photo #5895 Location lacks stabilization.

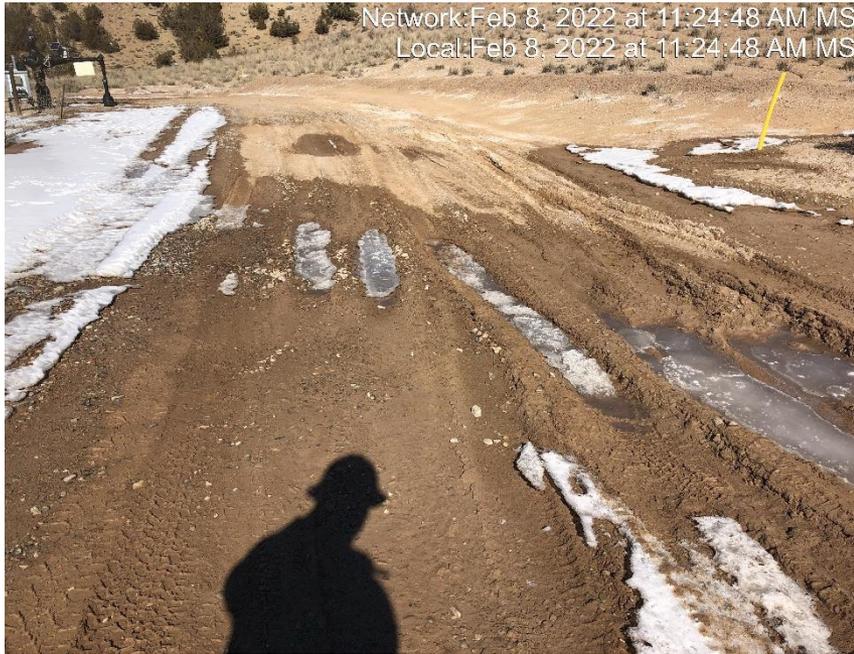
Photo #5896 Location lacks stabilization.

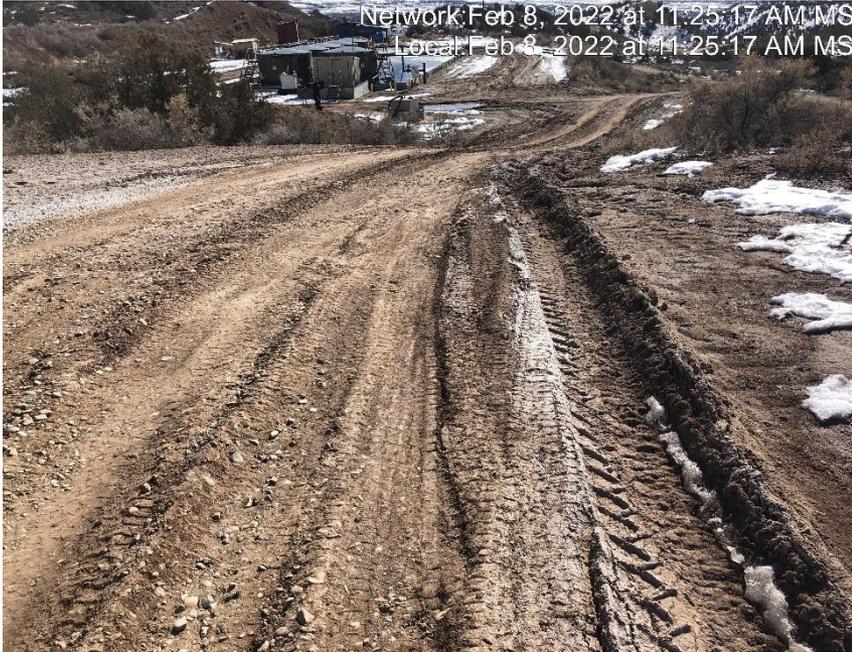
Photo #5897 Insufficient tracking BMP at entrance to location..
