## Inspection Photos

Location Name: TEP ROCKY MOUNTAIN LLC AMERICAN SODA-67S96W /2NWNE

Location ID: 324178

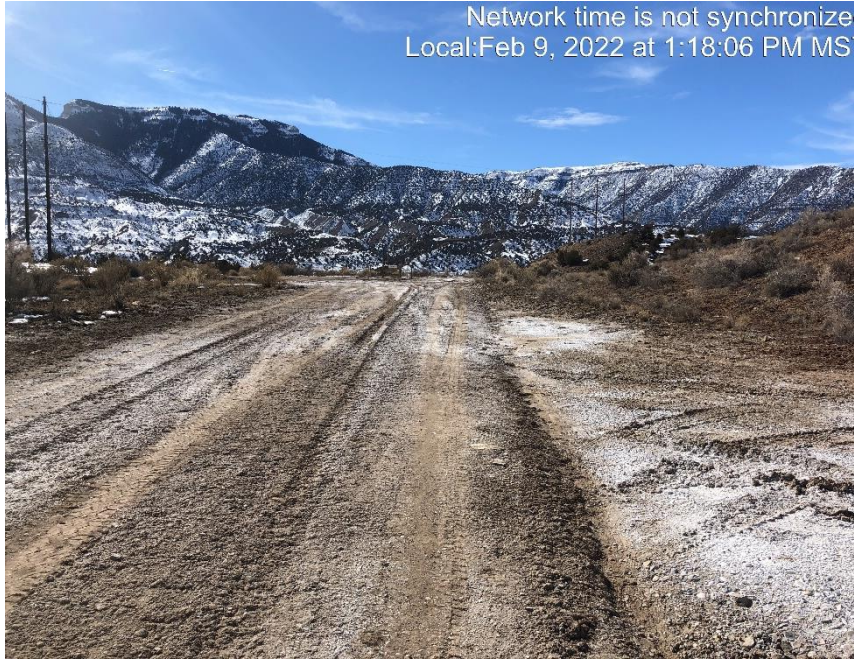
Photo #5908 from entrance to location.

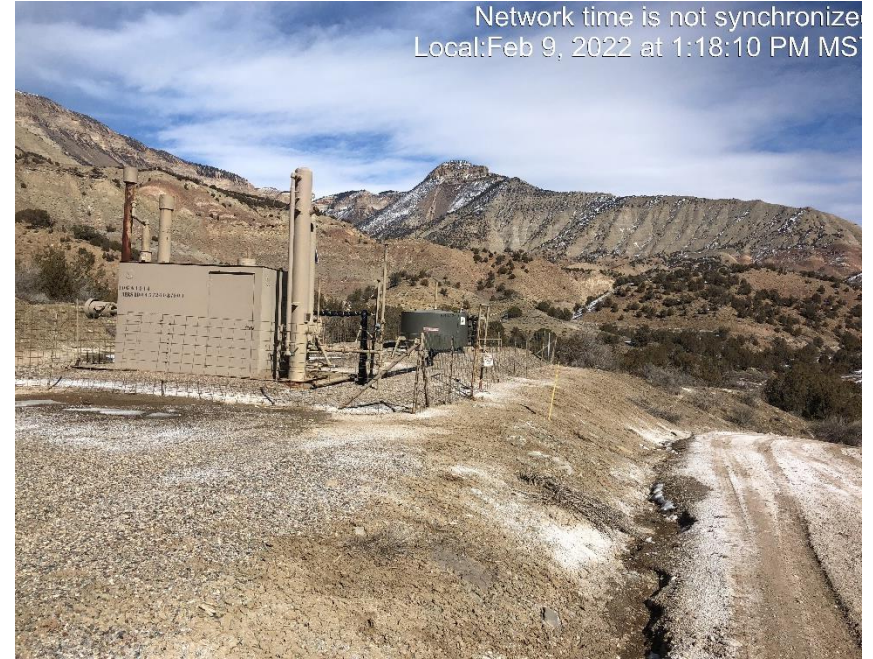
Photo #5909 from entrance to location.

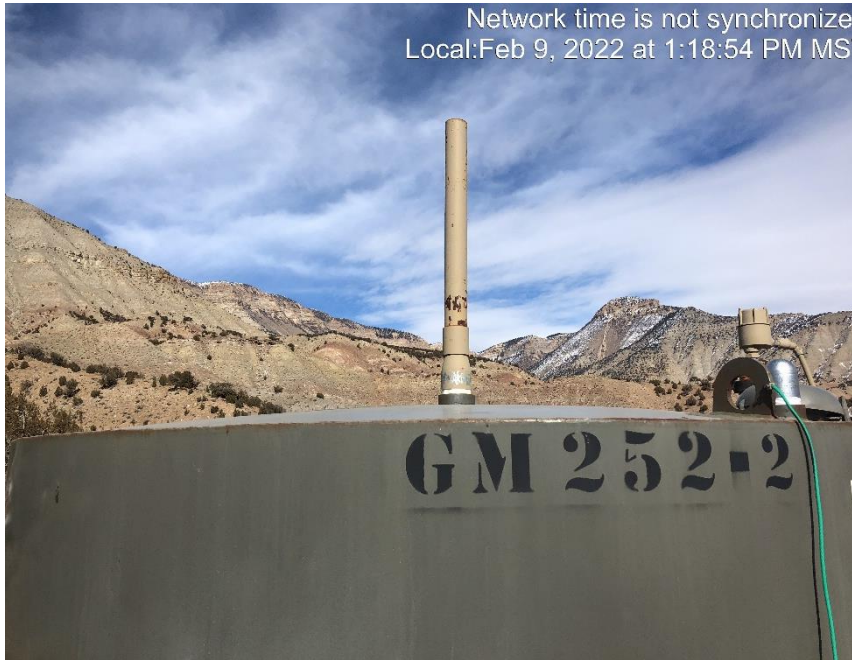
**Photo #5910 Vent pipe on tank open ended.**

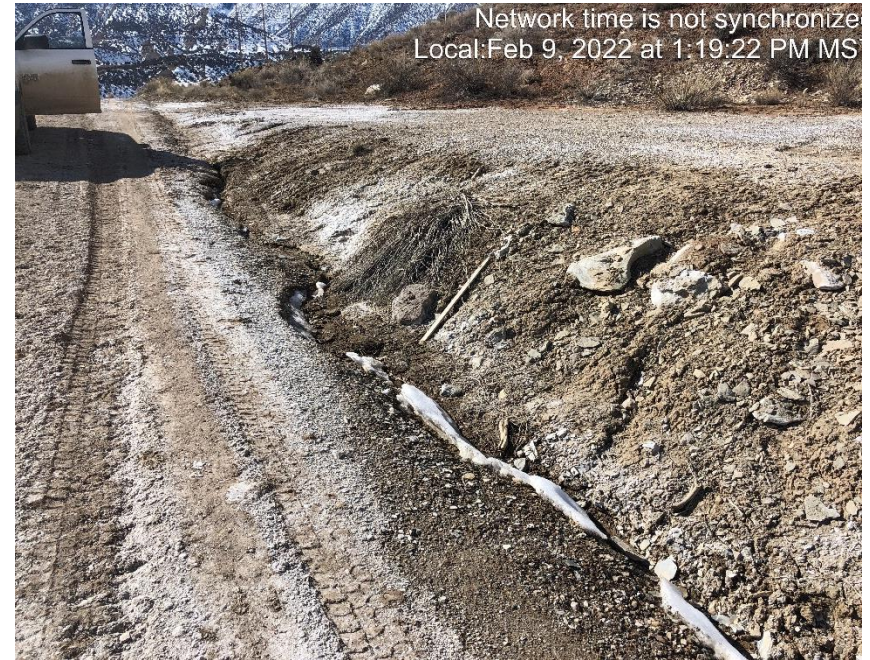
**Photo #5911 Rill erosion occurring in ditch.**

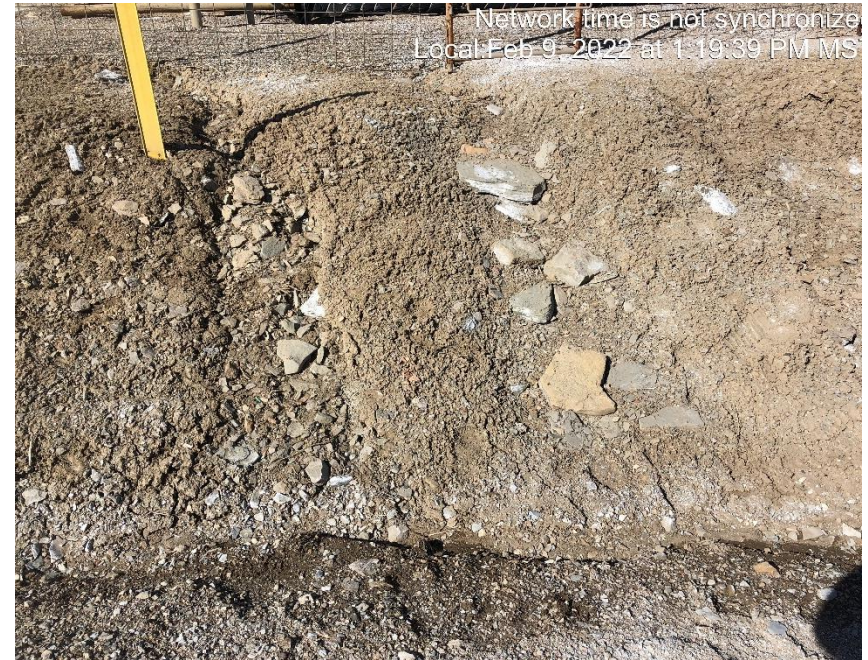
**Photo #5913 Rill erosion occurring on berm.**

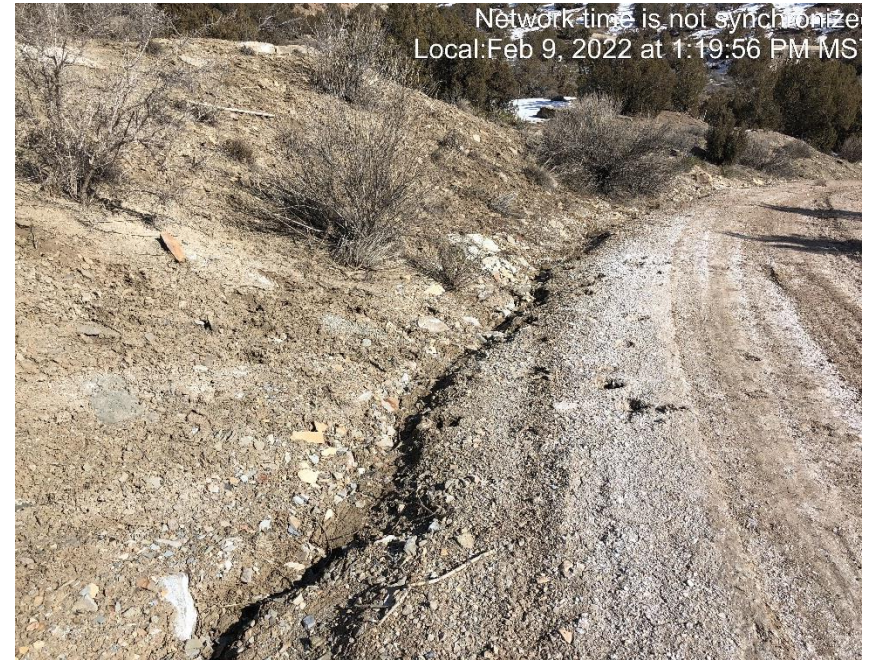
Photo #5914 Insufficient velocity checks.

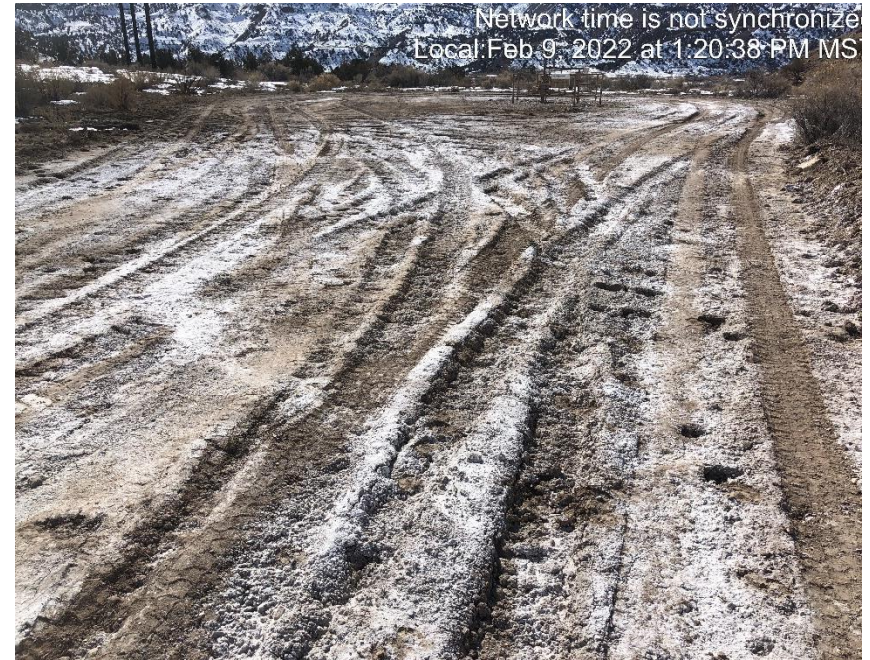
Photo #5915 Location lacks stabilization.

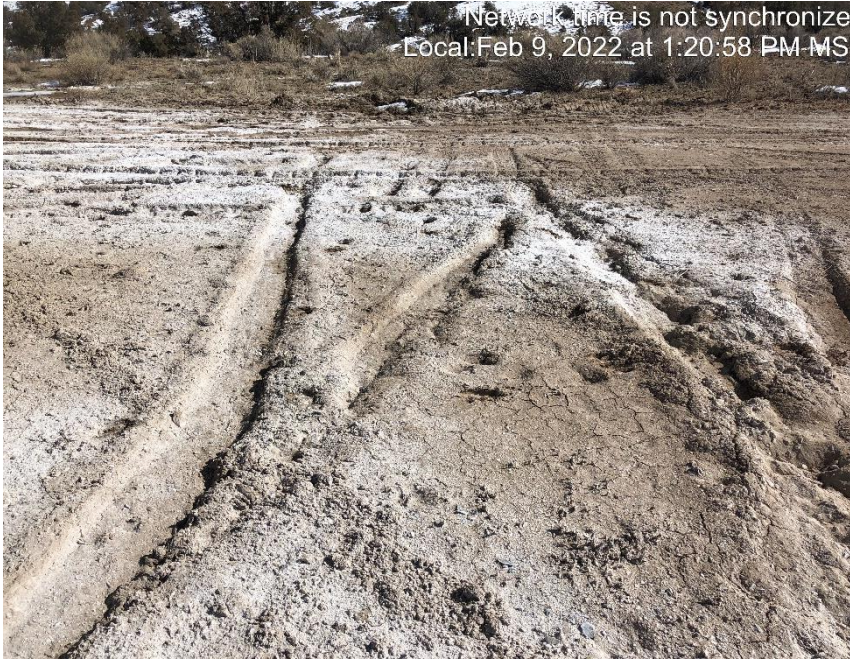
Photo #5916 Location lacks stabilization.

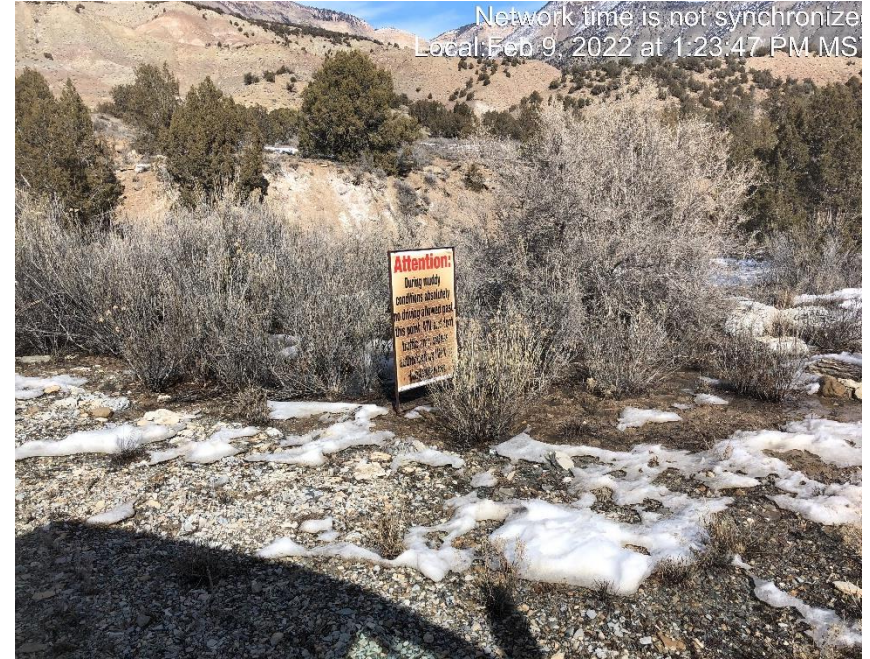
Photo #5917 Insufficient tracking BMP located at entrance to location.
