Inspection Photos
Operator: Logos Operating
API: 067-05363
Date: 2/11/2022

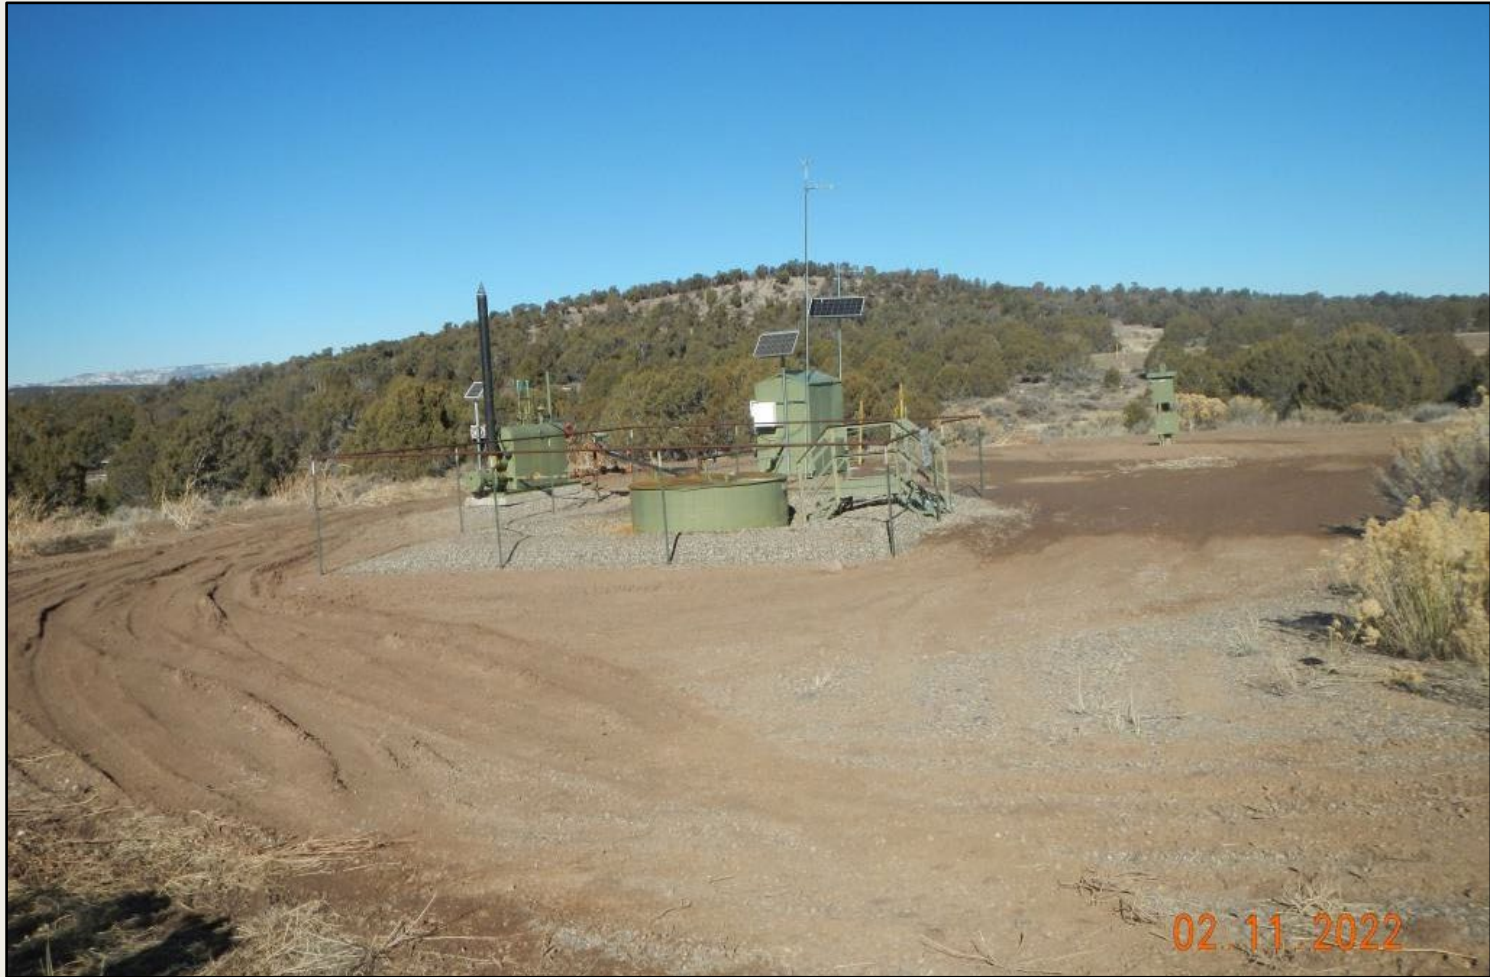
Photo 1. View of project area from the northwestern corner of the working area facing center.

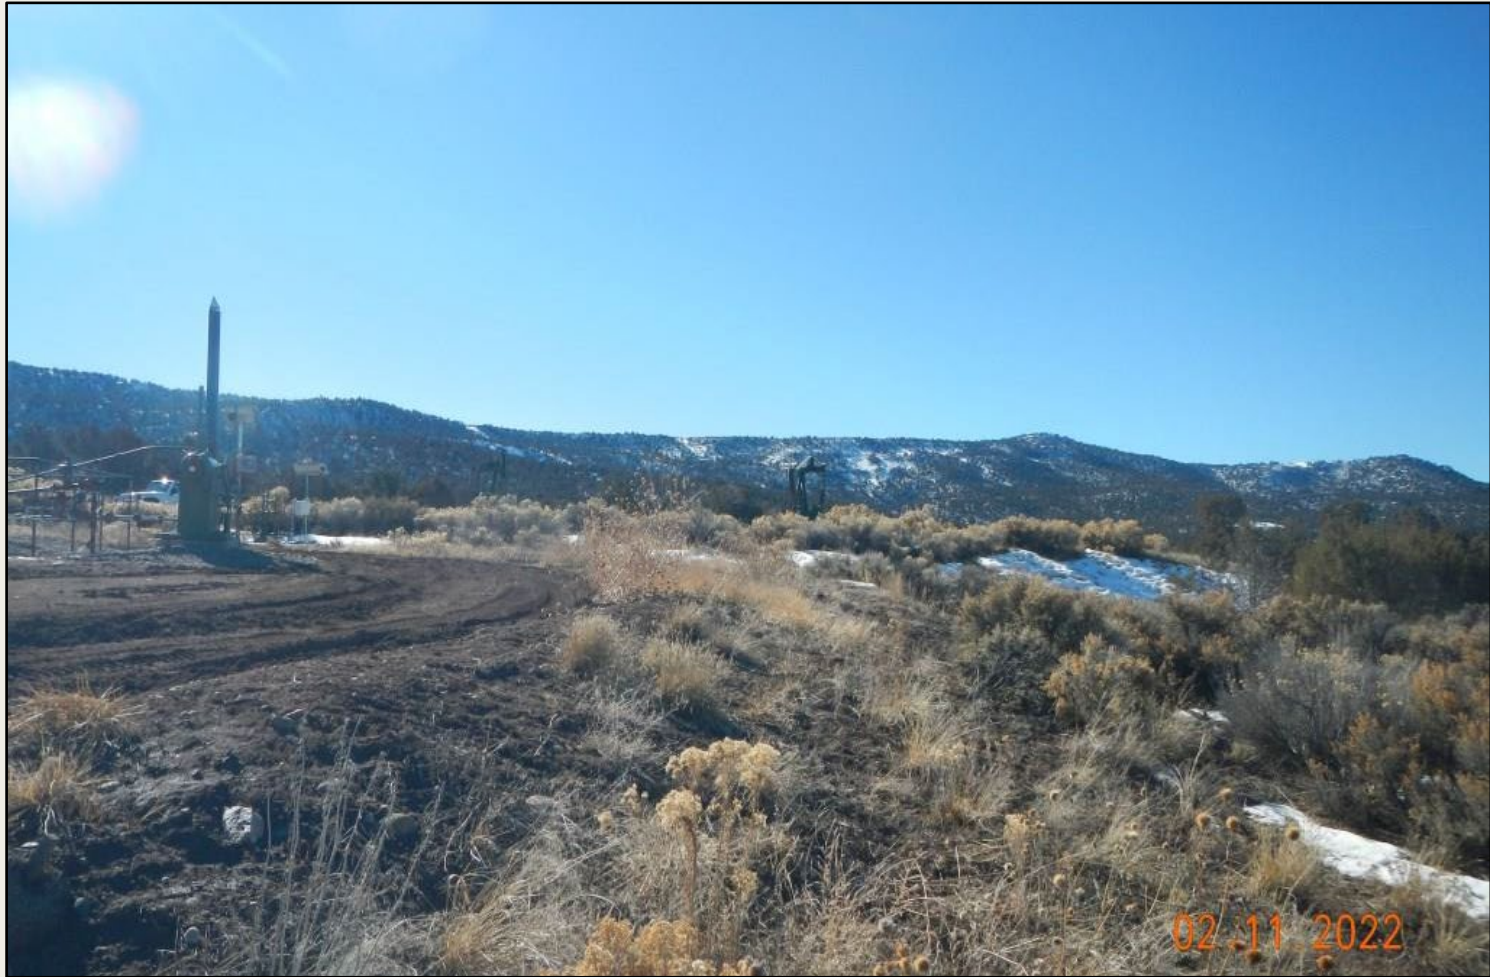
Photo 2. View of the western project area from the northwestern corner facing southward. Revegetation is progressing with smooth brome, crested wheatgrass, and western wheatgrass.

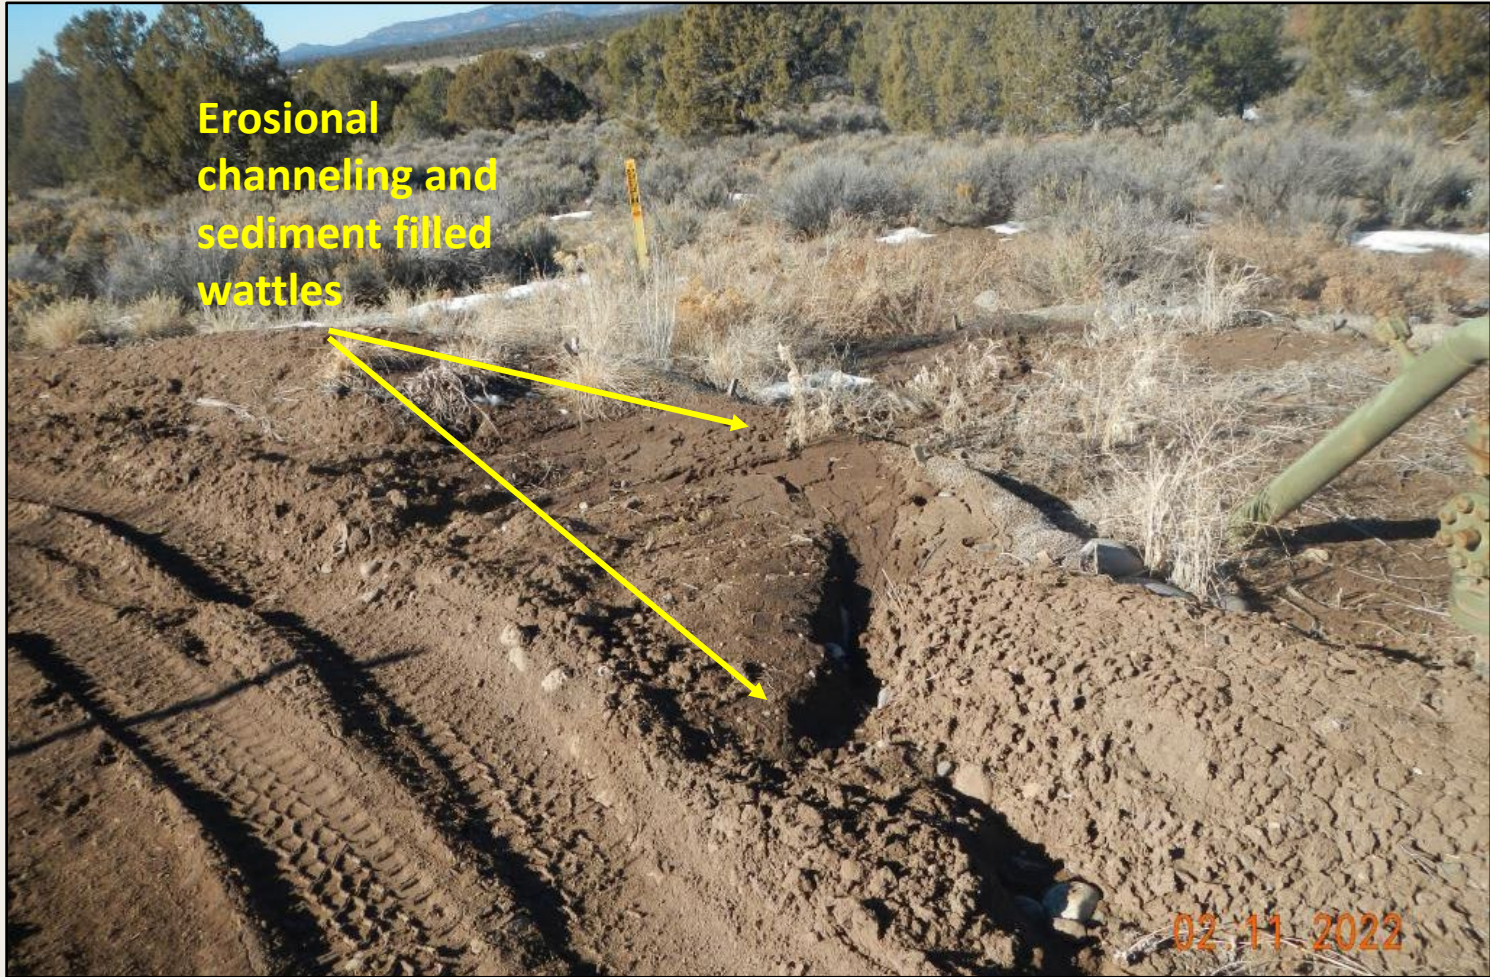
Photo 3. View of area in the northwestern project area where concentrated stormwater flows off of the working area. Erosional channeling and sedimentation observed on the working pad surface and flowing into wattles full of sediment and not longer functioning.

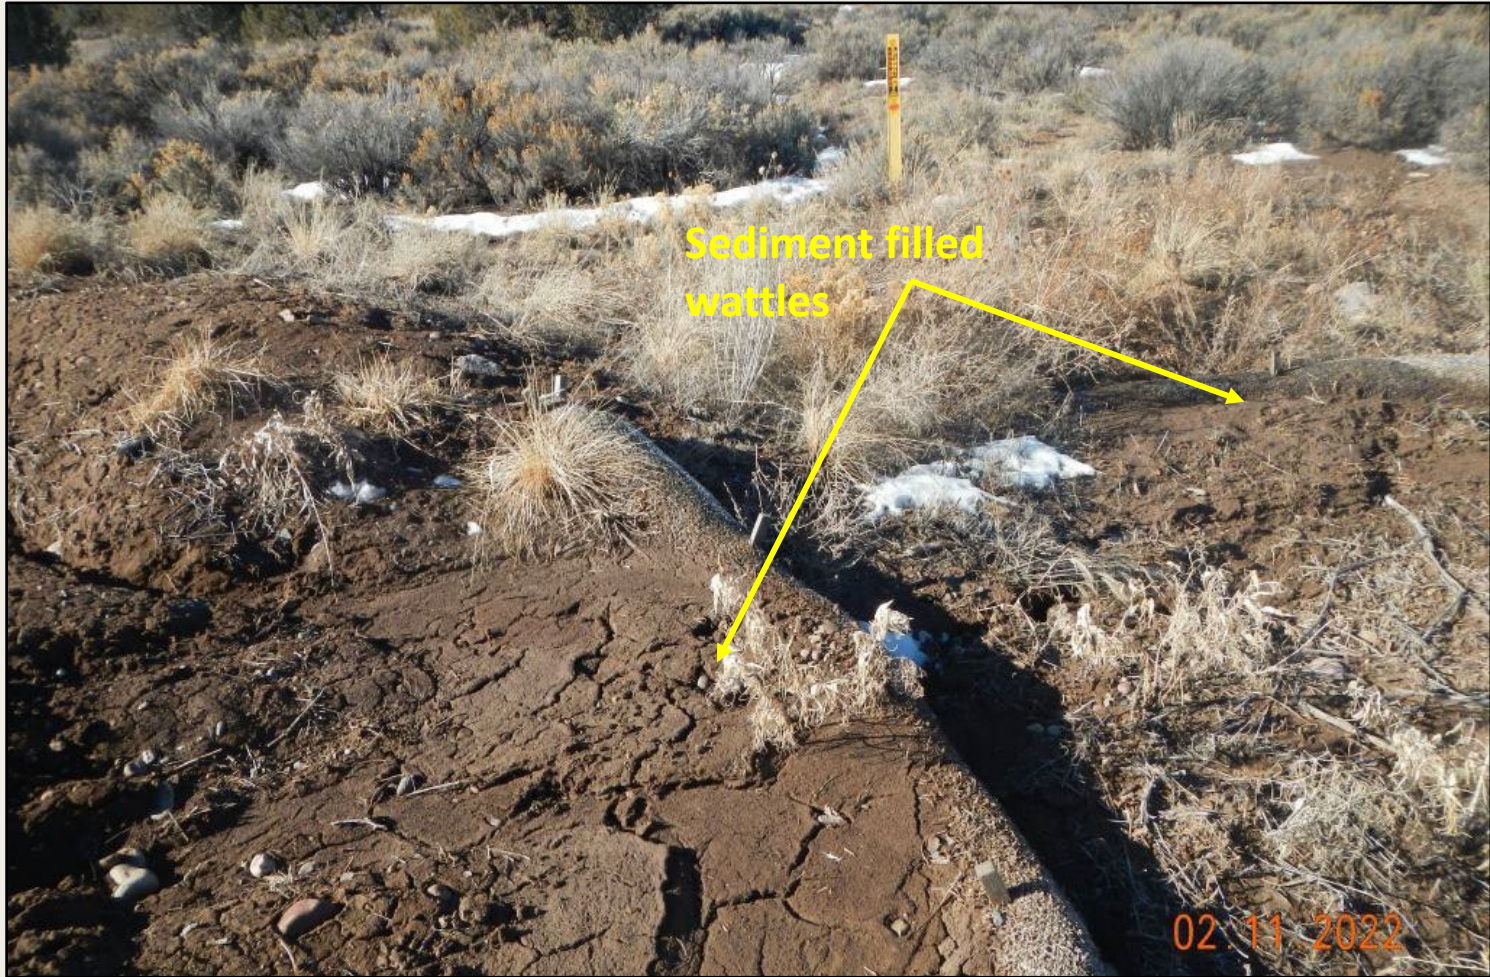
Photo 4. View of sediment filled wattles in the northwestern project area, downstream from Photo 3.

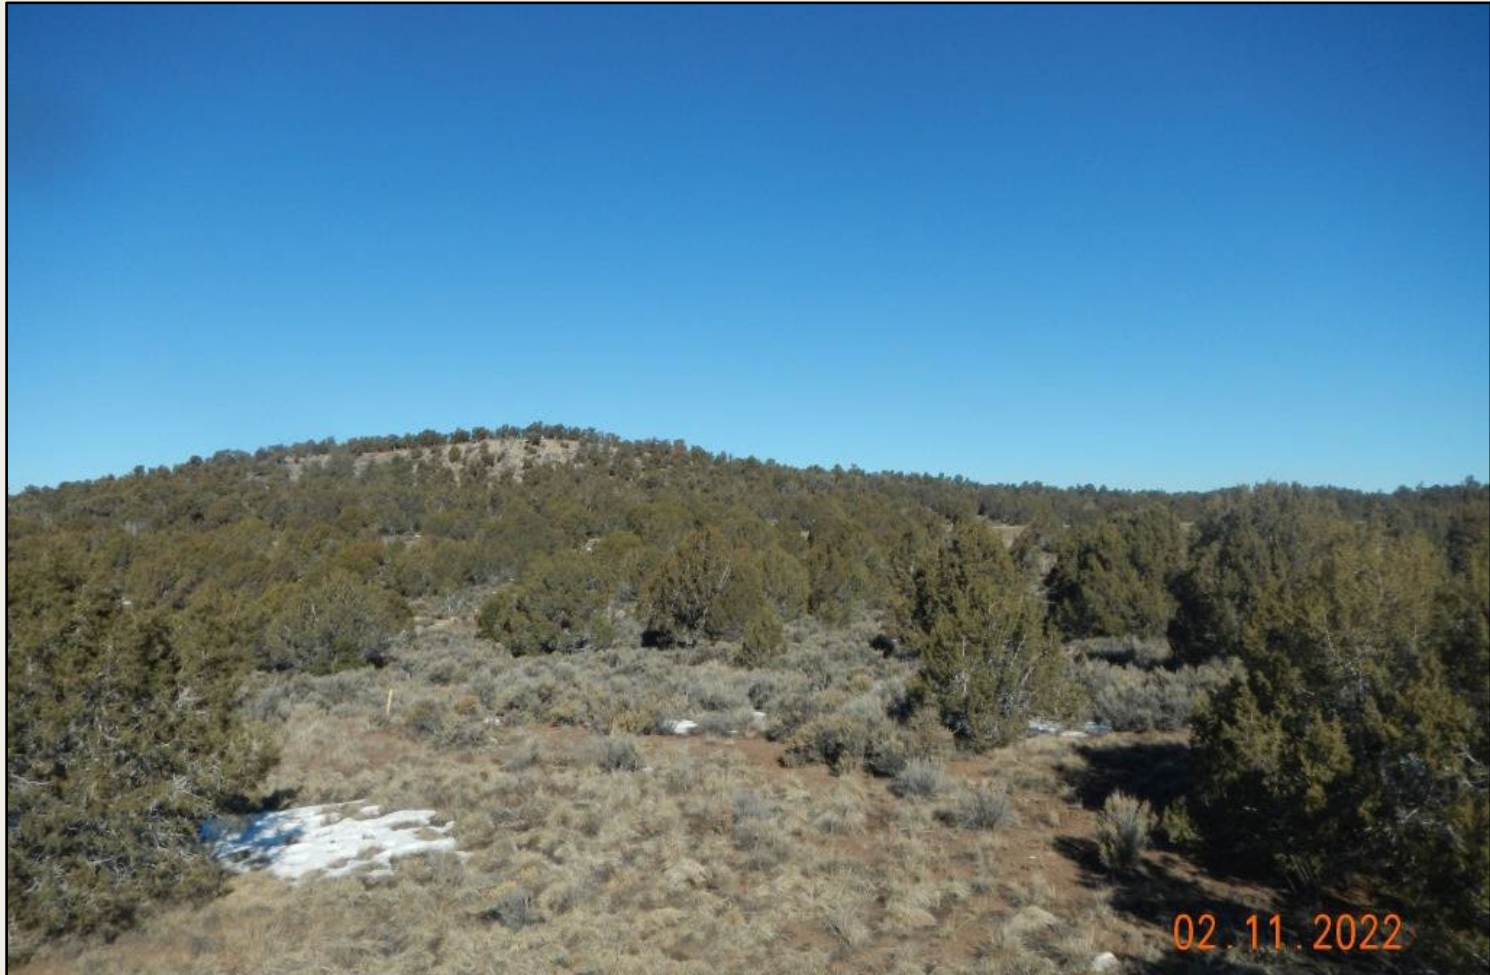
Photo 5. View of reference area comprised of pinyon and juniper/sagebrush shrubland mosaic with Indian ricegrass, squirreltail, blue grama, and snakeweed in the understory.
