Inspection Photos  
Operator: Epic Energy  
API: 067-05367  
Date: 2/11/2022

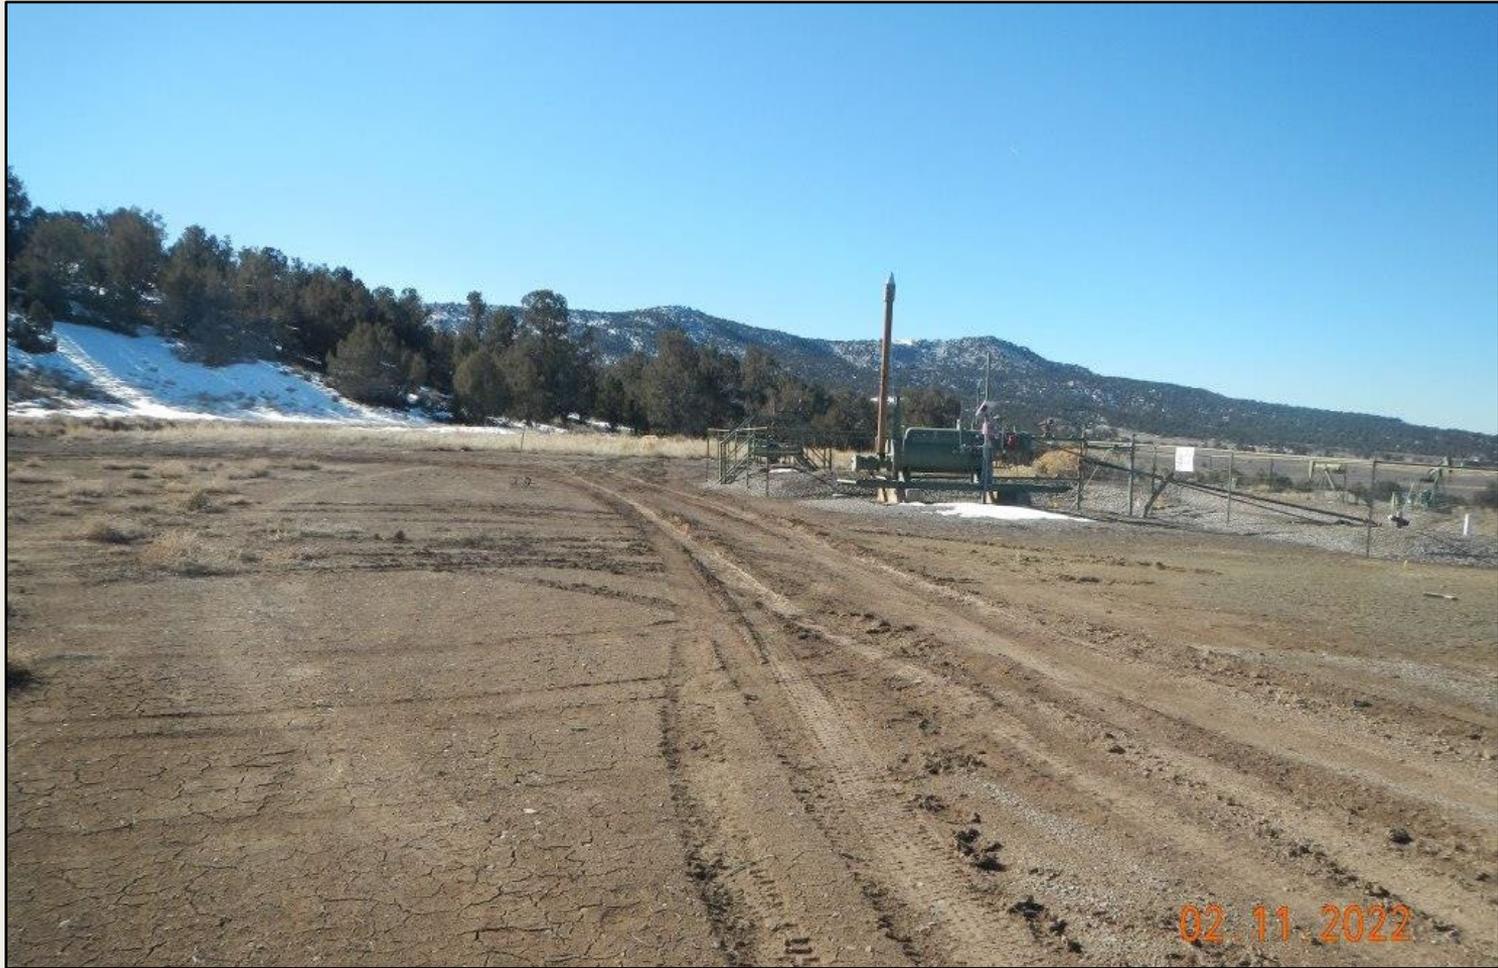
Photo 1. View of project area from the well pad entrance facing center.

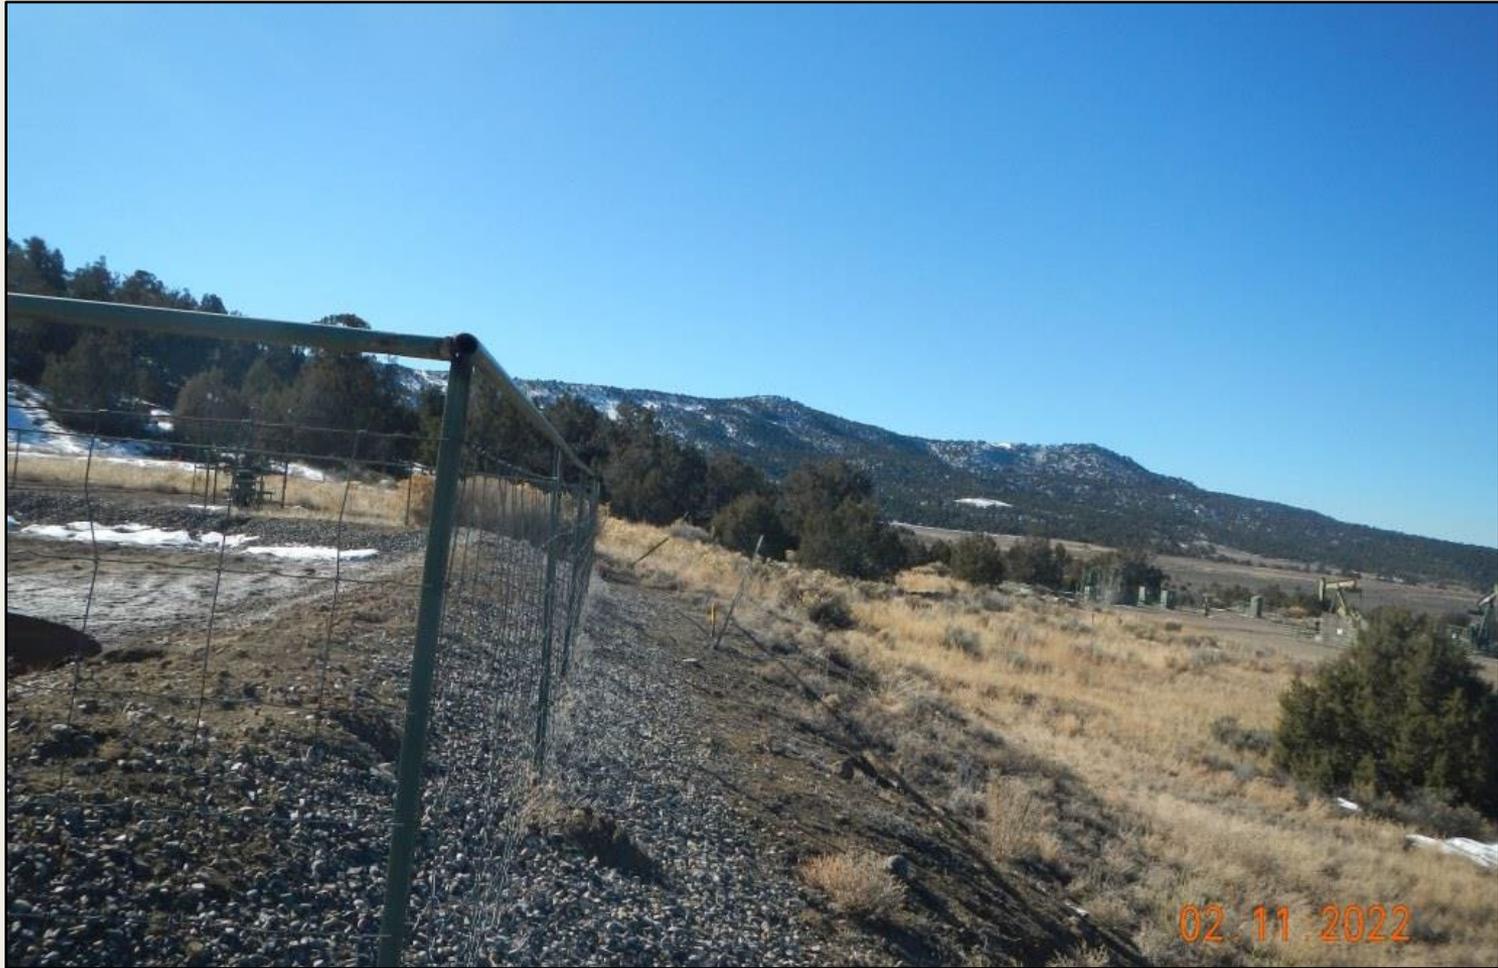
Photo 2. View of the western project area from the northwestern corner facing southward. Revegetation is sparse.

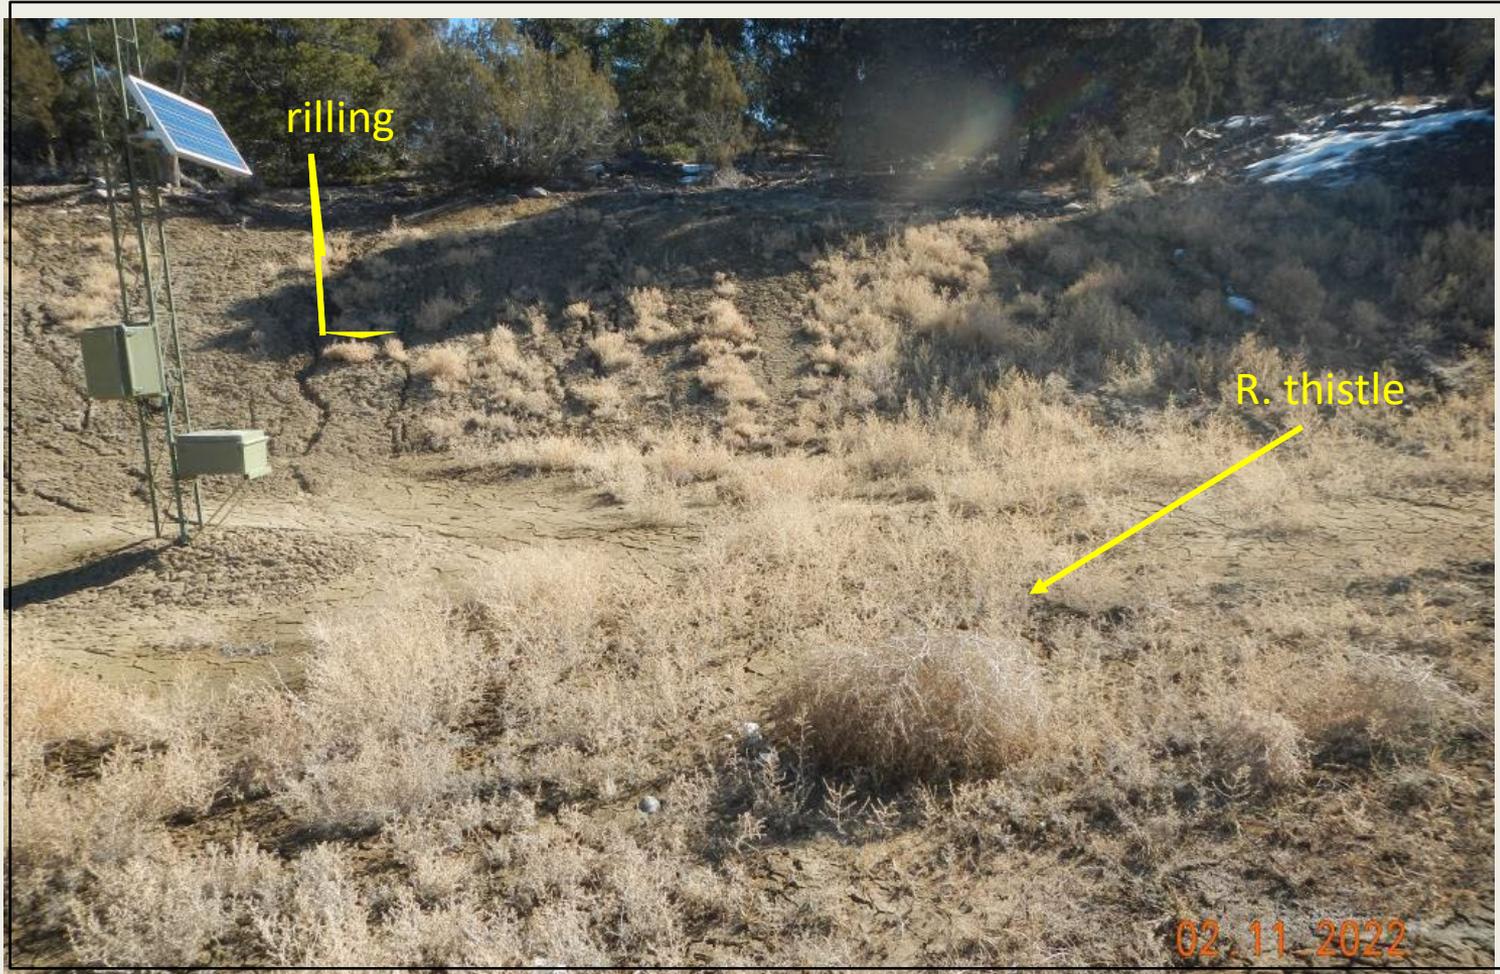
Photo 3. View of the eastern cut-slope. Rilling observed in several areas, up to approx. 10 inches deep. Little desirable vegetation observed. Bare soils are eroding. Russian thistle debris present.

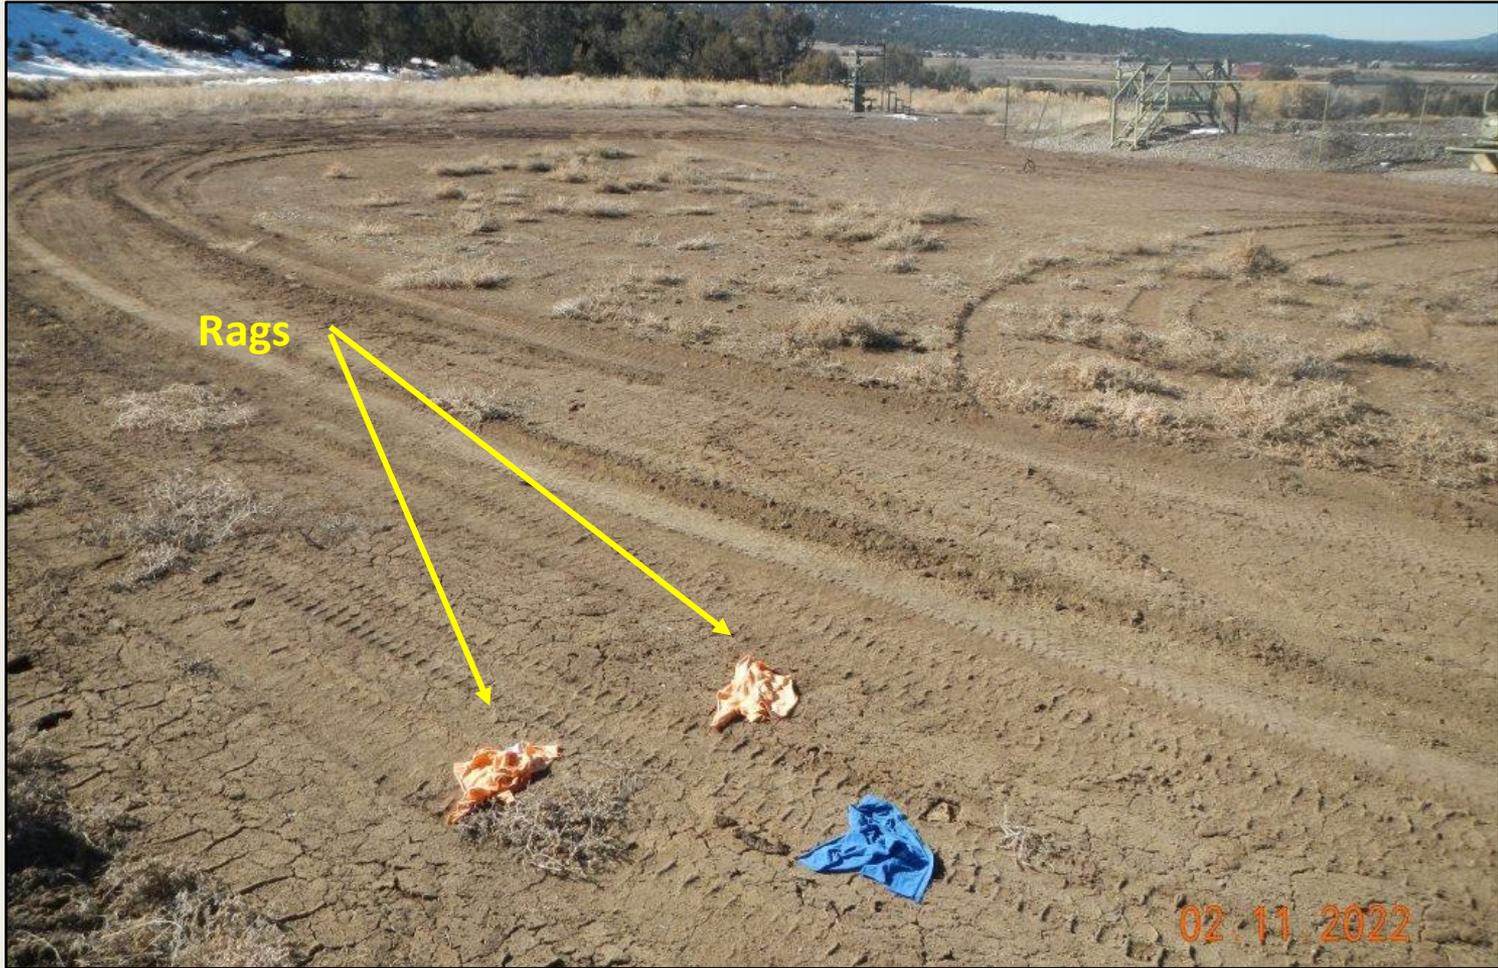
Photo 4. View of waste observed on the well pad needs to be properly disposed of.

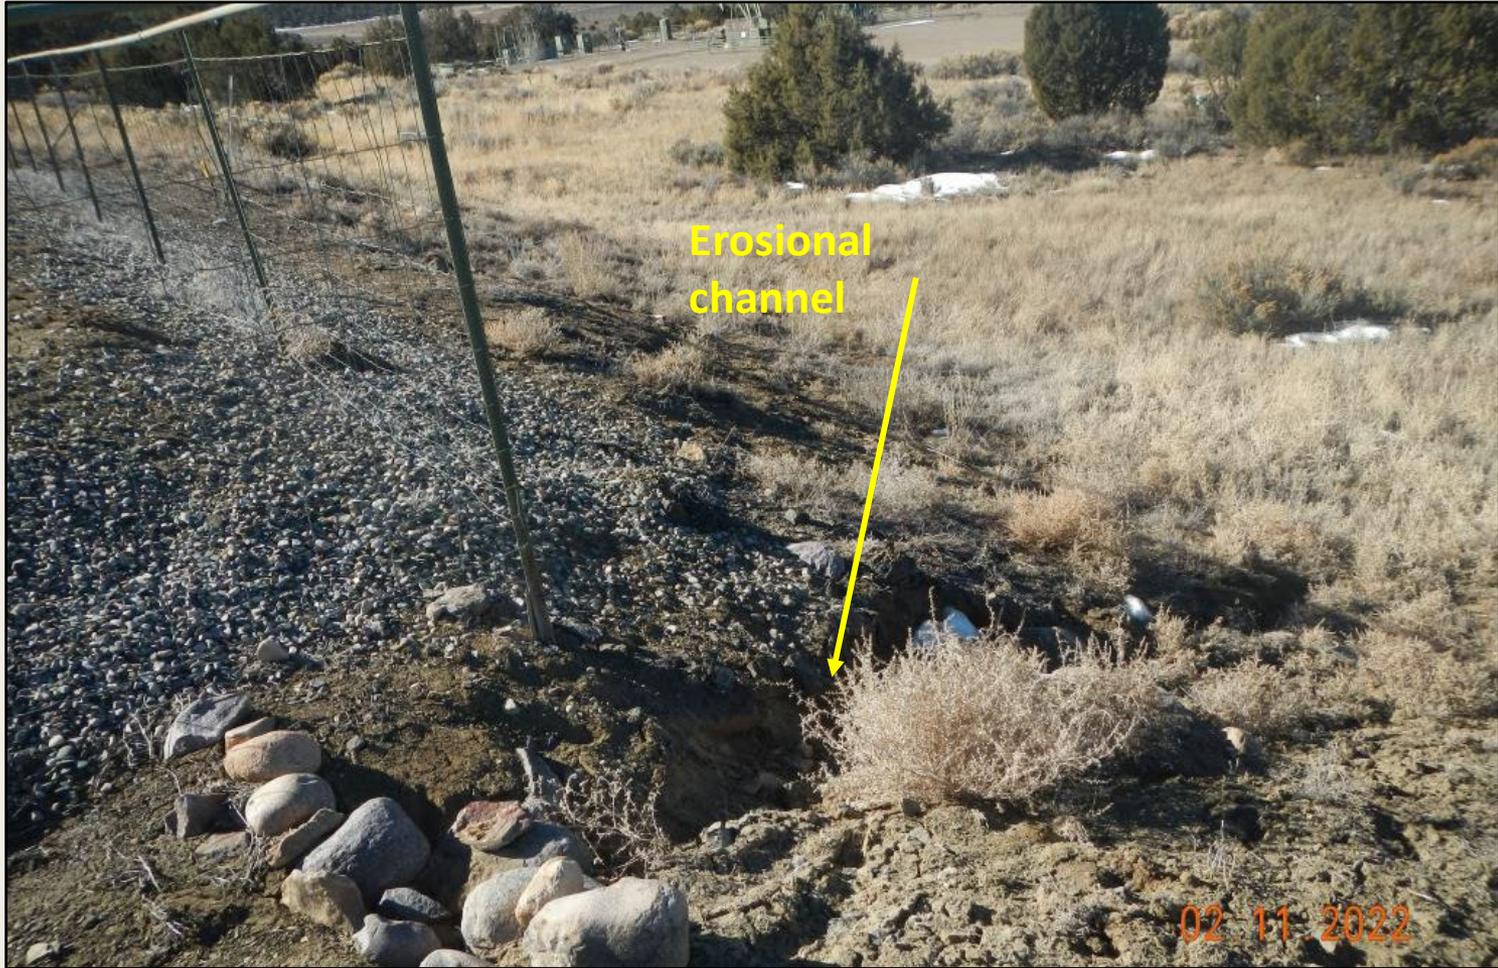
Photo 5. View of erosional channeling approx 2ft wide and deep in the northwestern project area. Cobble BMP is not adequate and no longer functioning as it is full of sediment.

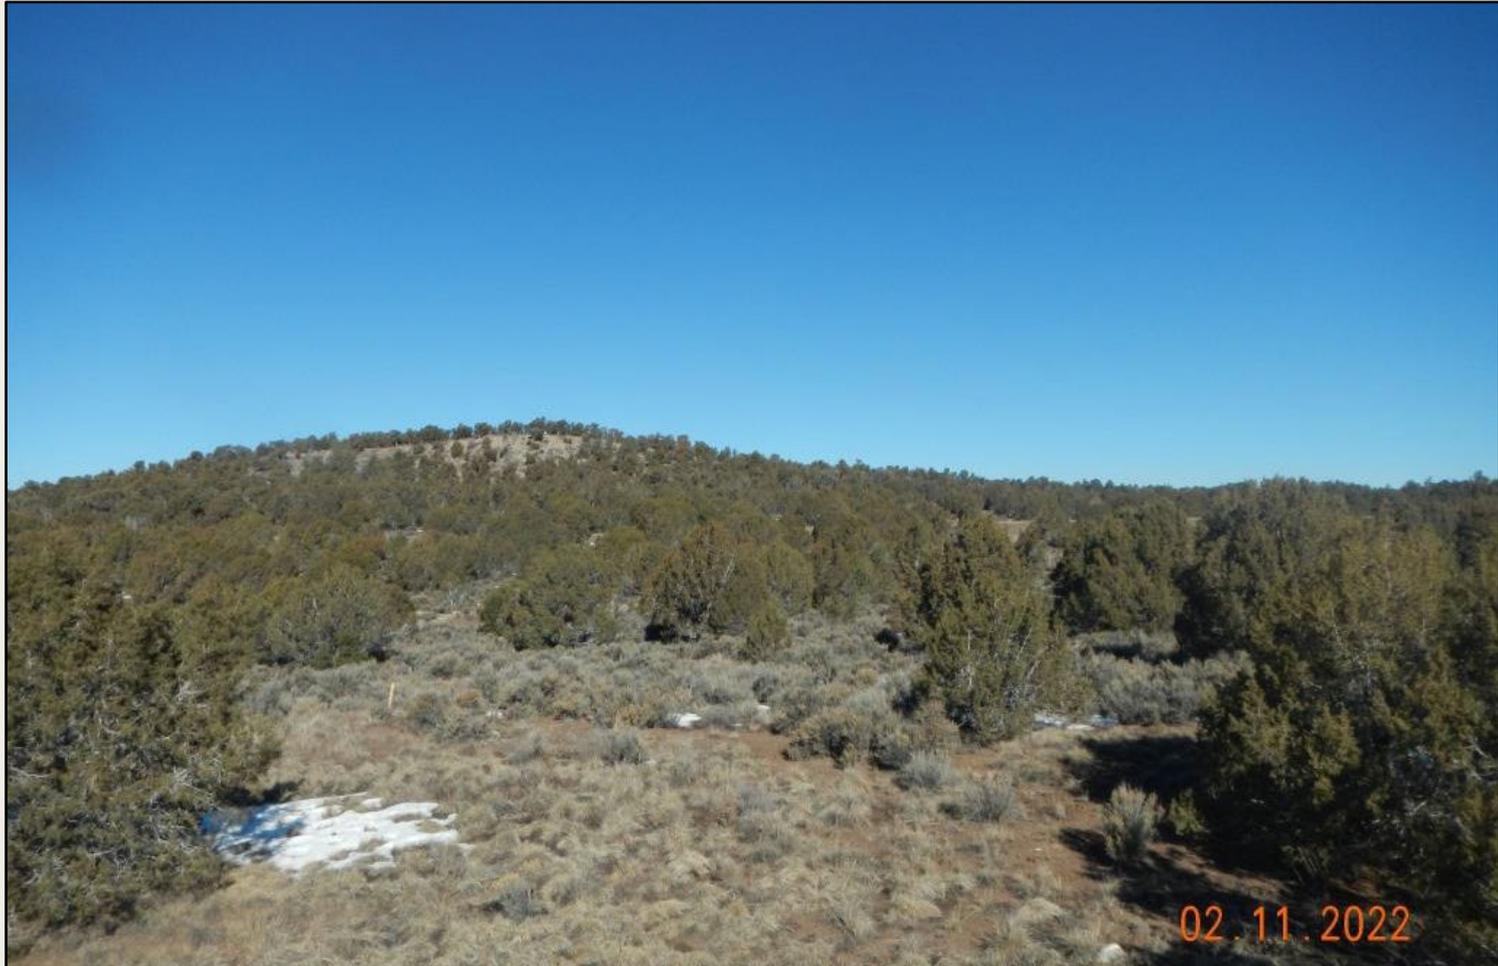
Photo 6. View of reference area comprised of pinyon and juniper/sagebrush shrubland mosaic with Indian ricegrass, squirreltail, blue grama, and snakeweed in the understory.
