# Inspection Photos

API: 017-07778

Operator: INVESTMENT EQUIPMENT LLC

Inspection Date: 2/10/2022

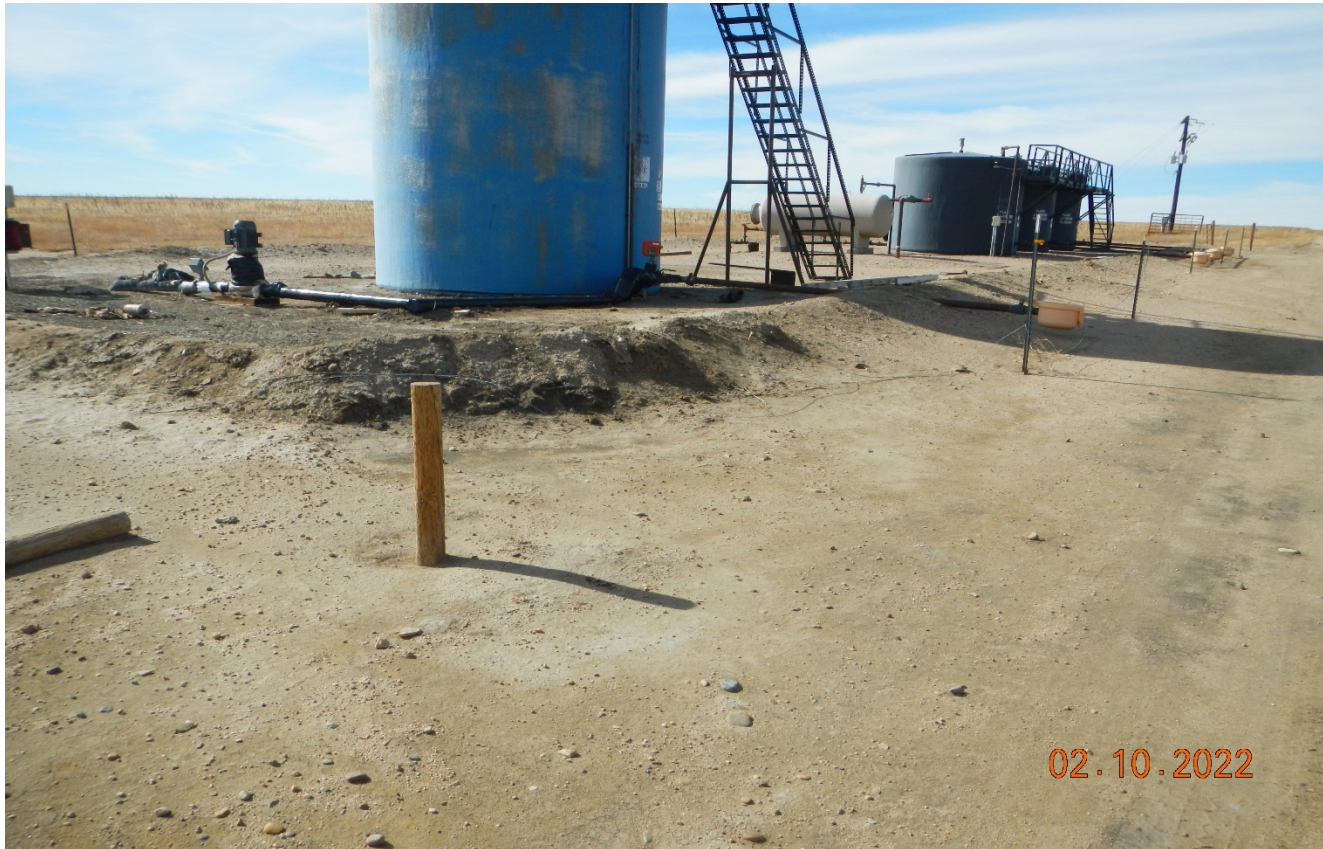
**Photo 1.** Facing toward the associated tank battery located 650 ft. north of the wellsite. The fence around the tank battery is not maintained and the earthen berms are not adequately sized to contain a spill.

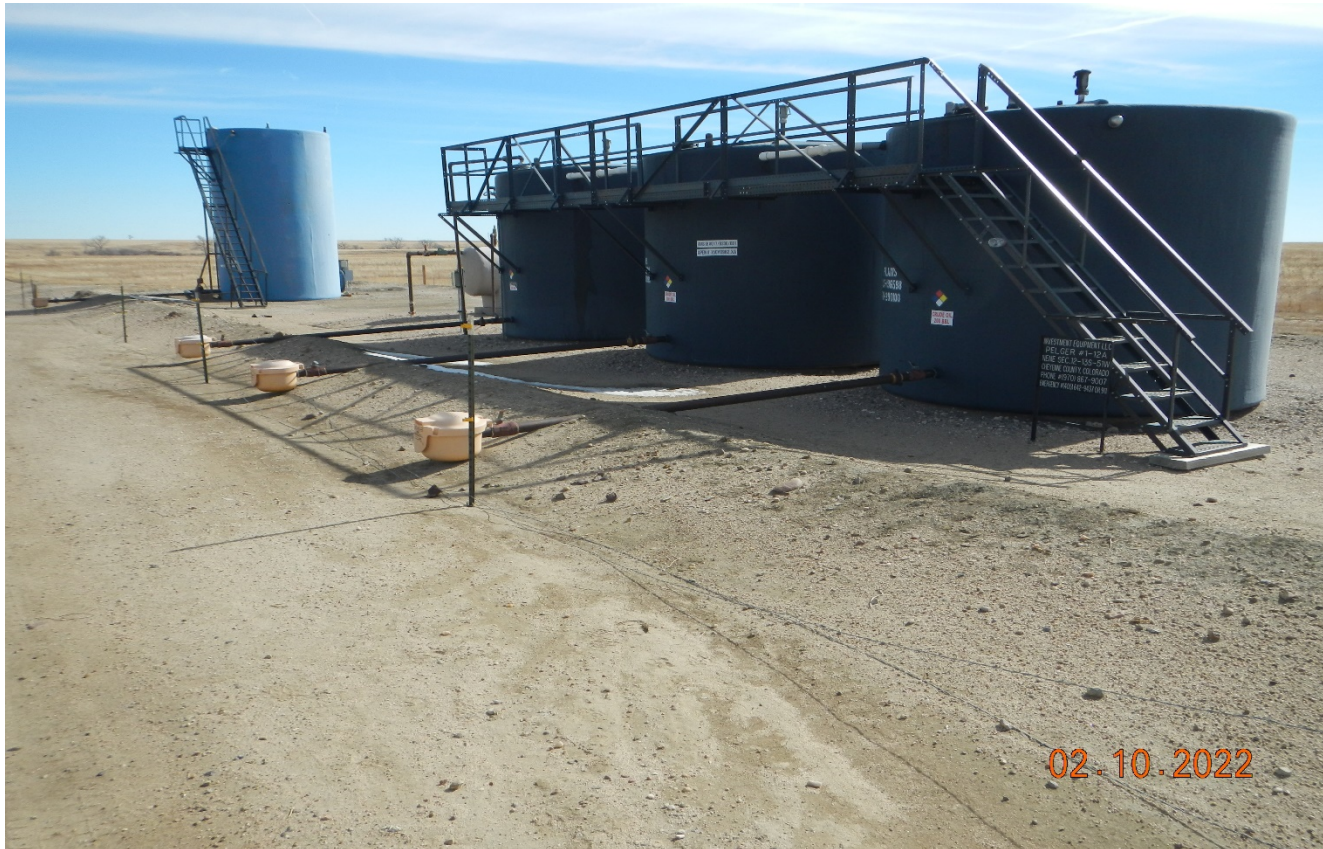
**Photo 2.** Facing toward the associated tank battery located 650 ft. north of the wellsite. The fence around the tank battery is not maintained and the earthen berms are not adequately sized to contain a spill.

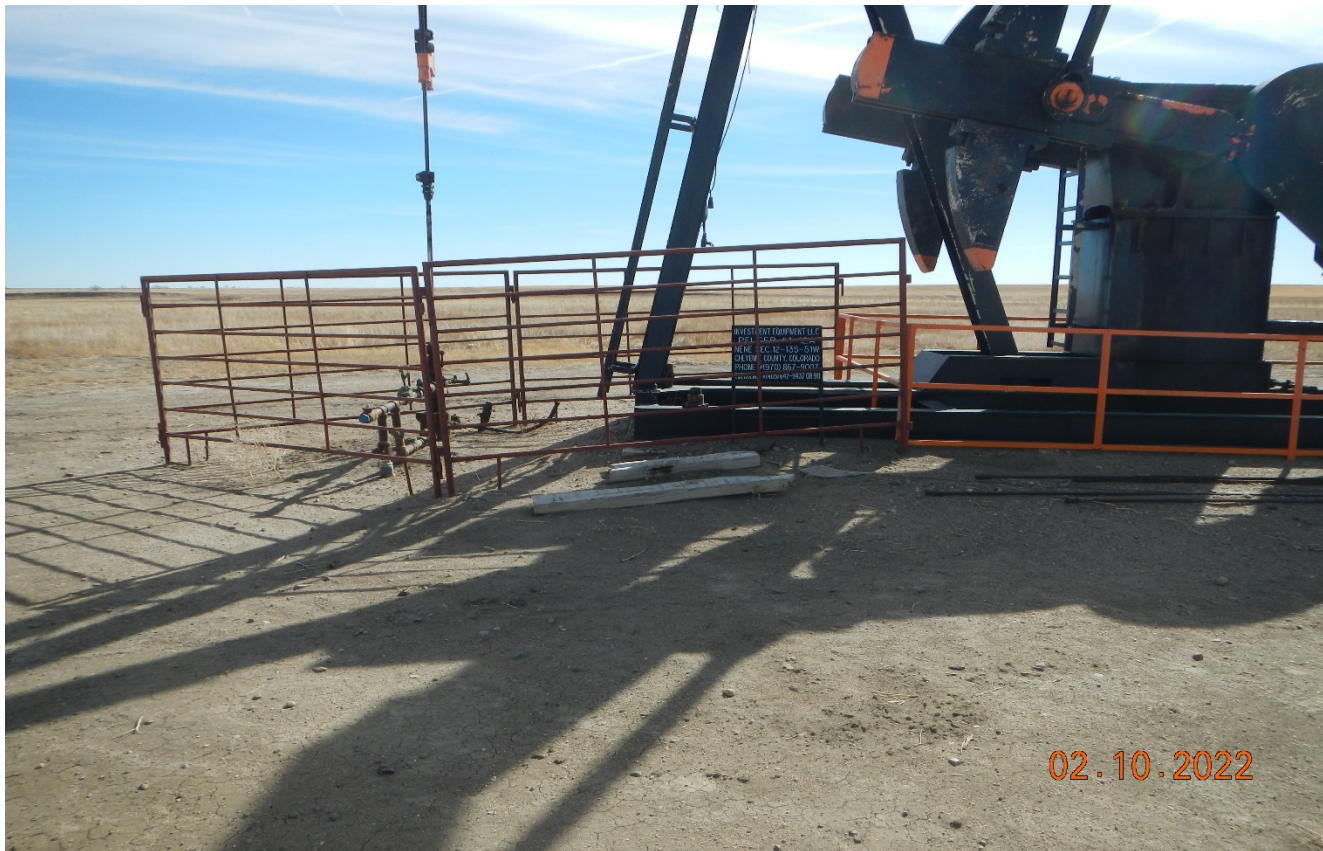
**Photo 3.** Facing toward the well. Sign is posted at the pumpjack.

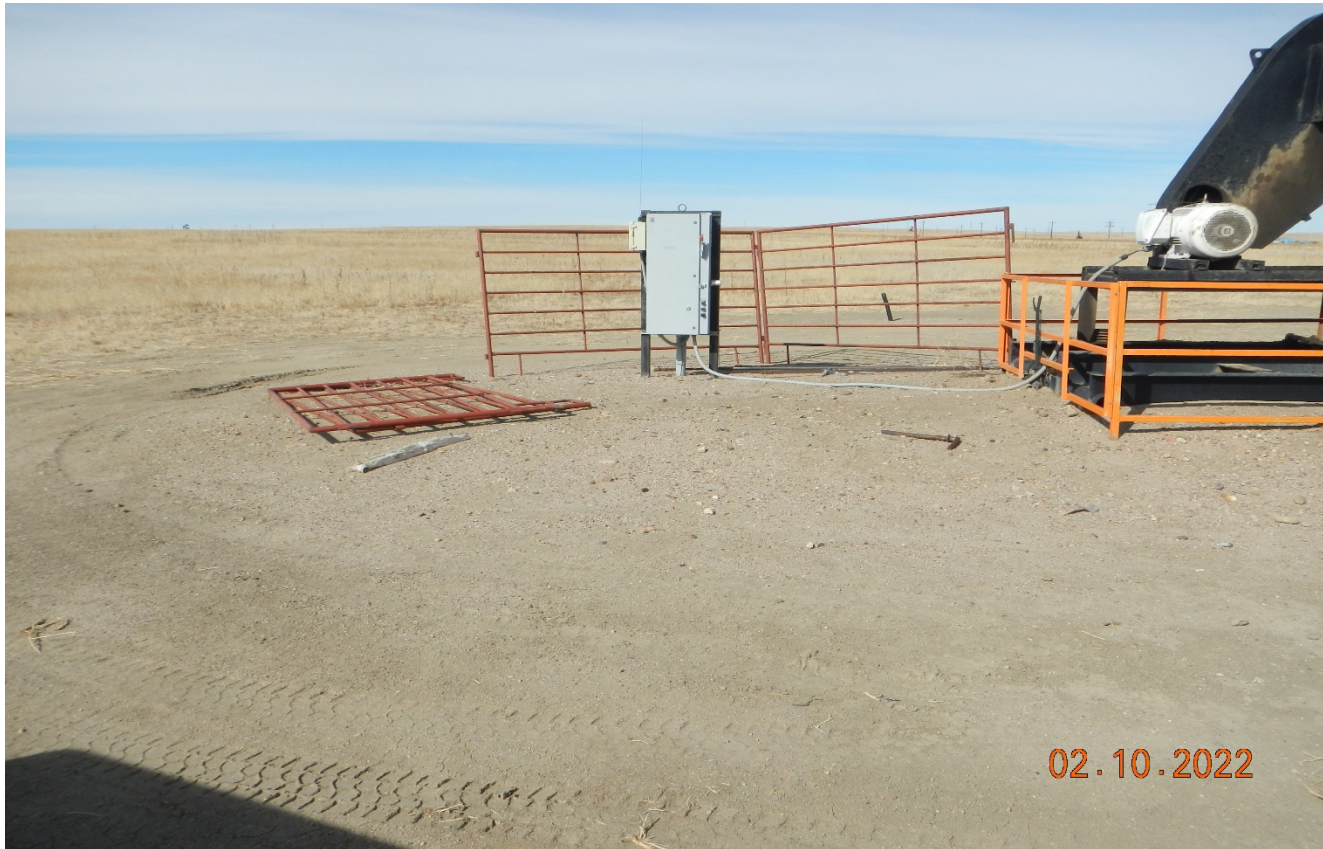
**Photo 4.** There is a panel laying on the ground which needs to be removed or installed.
