# Inspection Photos

API: 017-07209

Operator: CITATION OIL & GAS CORP

Inspection Date: 2/10/2022

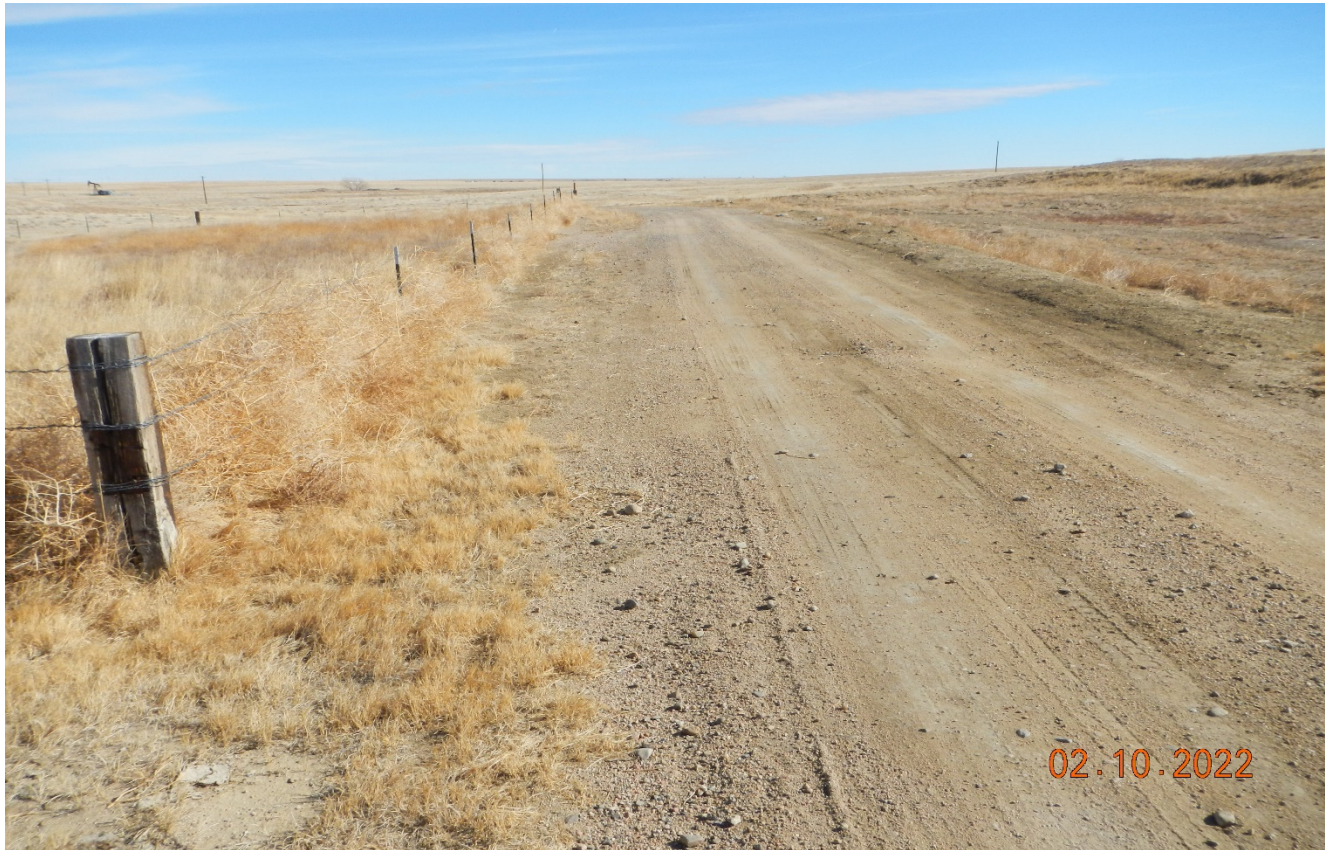
**Photo 1.** Facing northeast at the location. The active road passes through the middle of the location. The area north of the road is fenced.

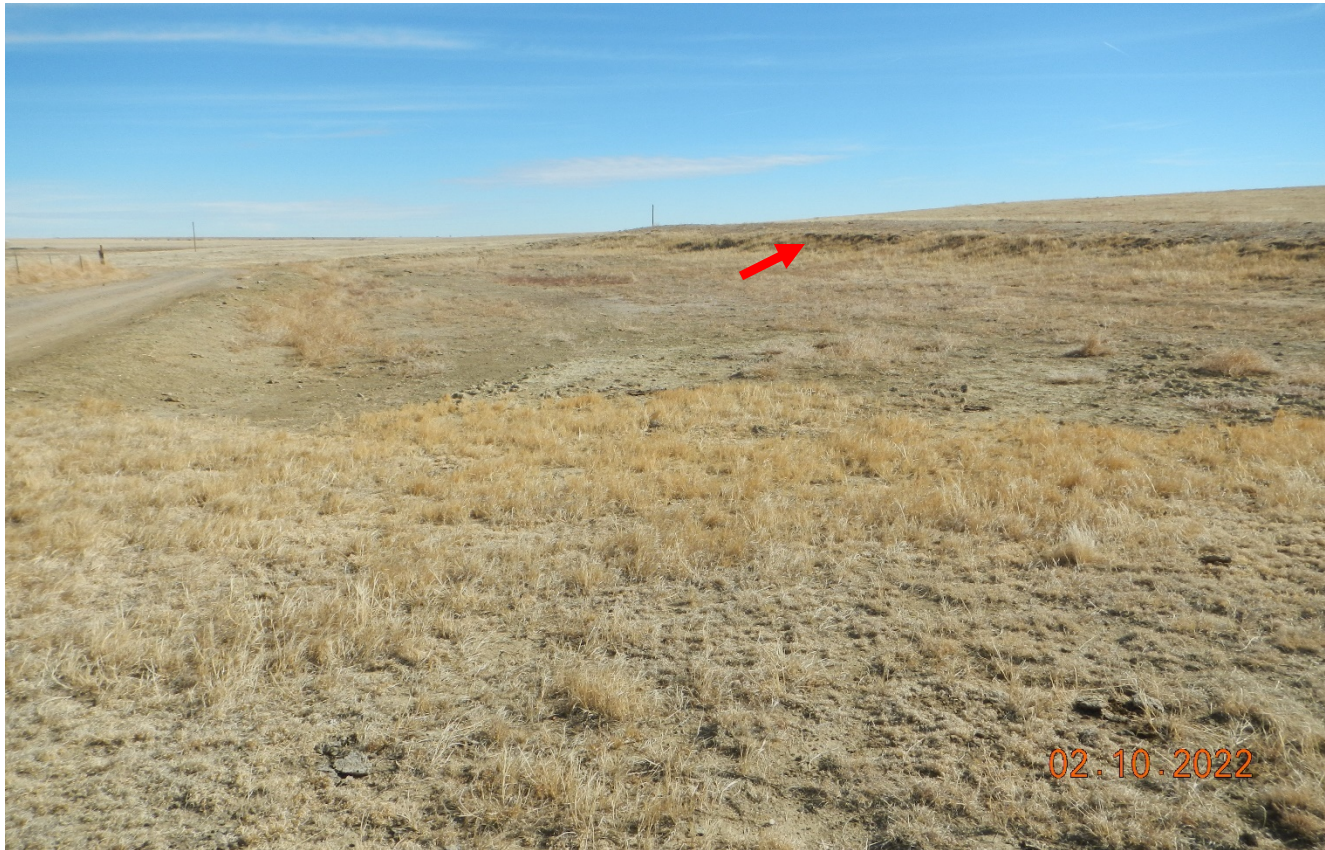
**Photo 2.** Facing east toward the location which has not been recontoured. The cut slope can be seen at red arrow.

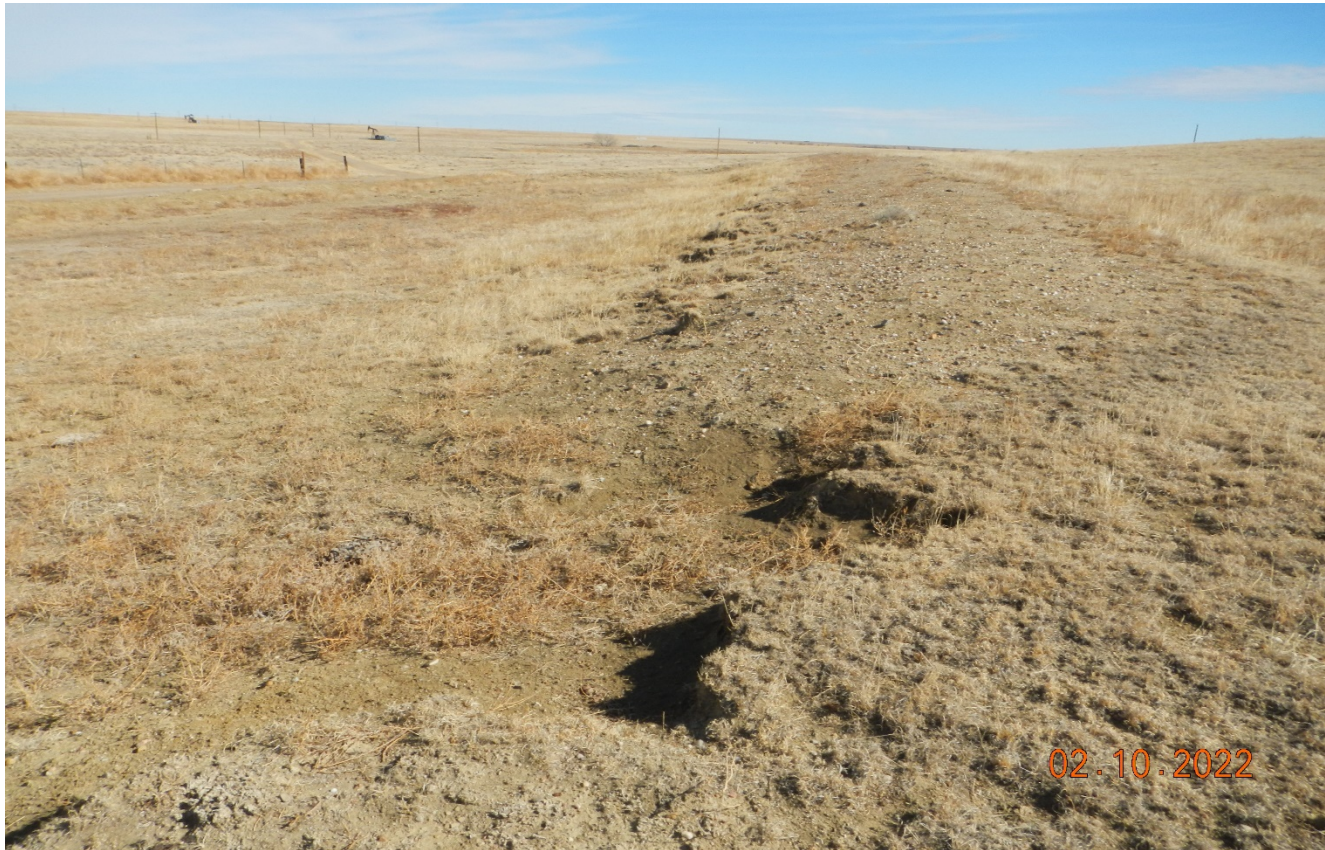
**Photo 3.** Facing northeast along the cut slope.

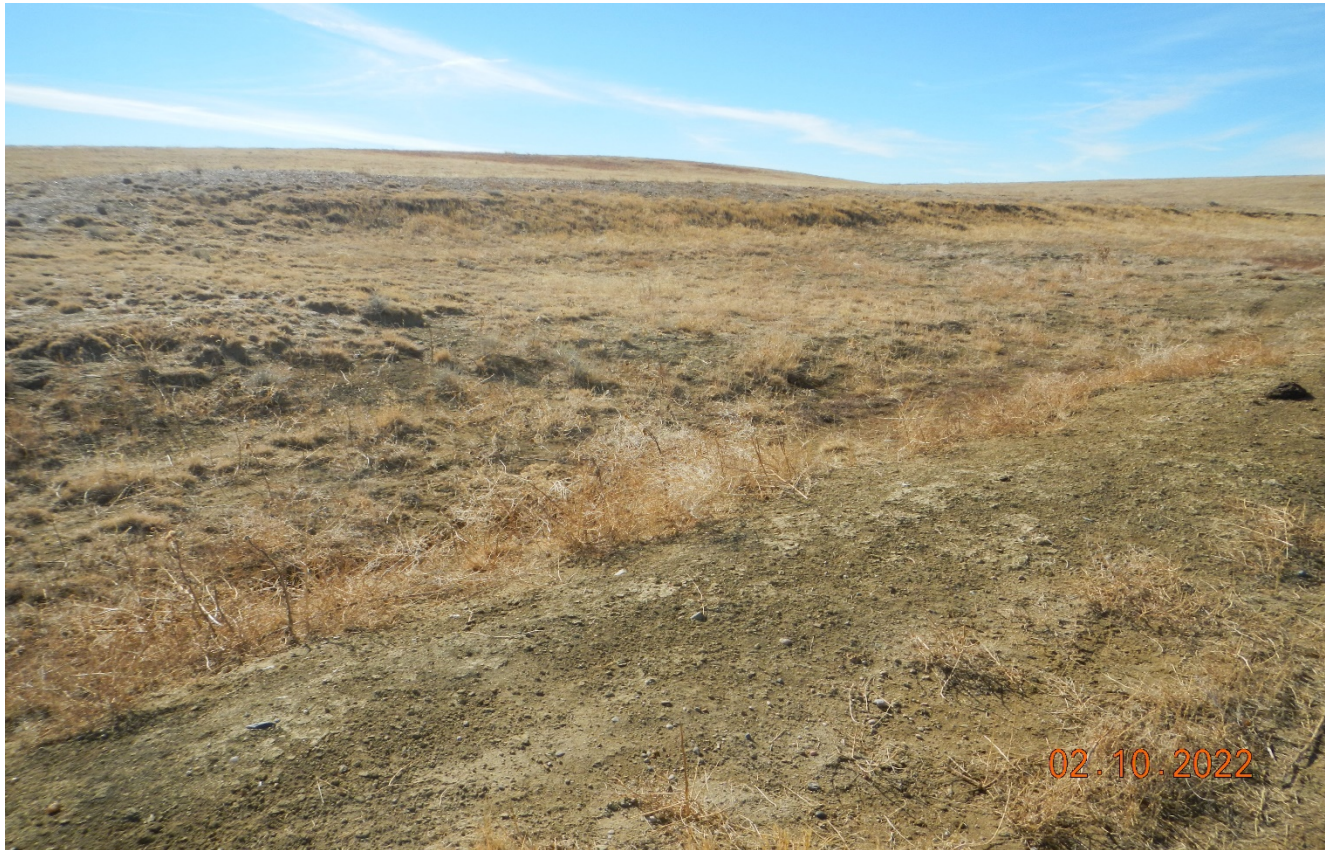
**Photo 4.** Facing southwest toward the location which has not been recontoured.

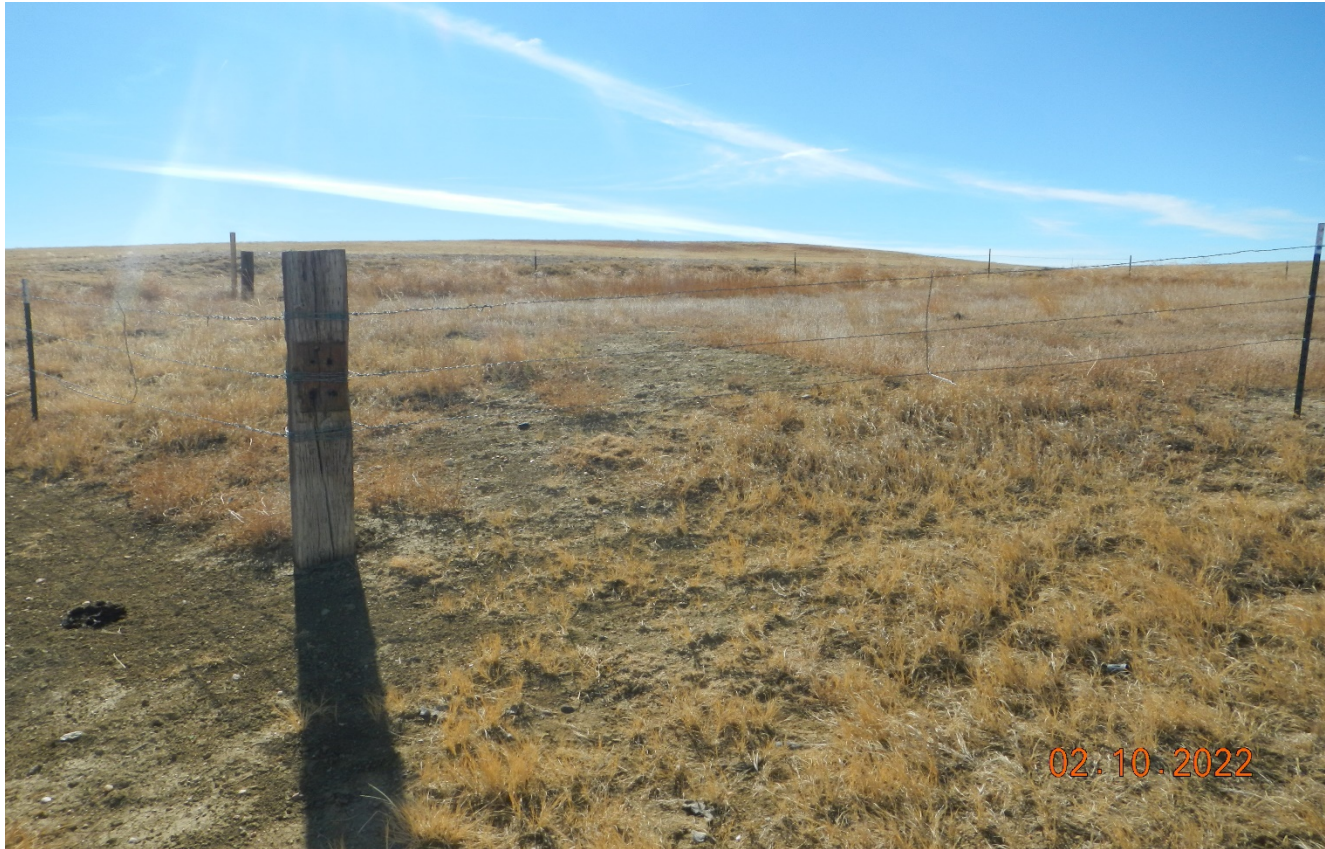
**Photo 5.** Facing southwest toward the fill slope. The fill slope material needs to be pushed back towards the cut slope to match the original contours.

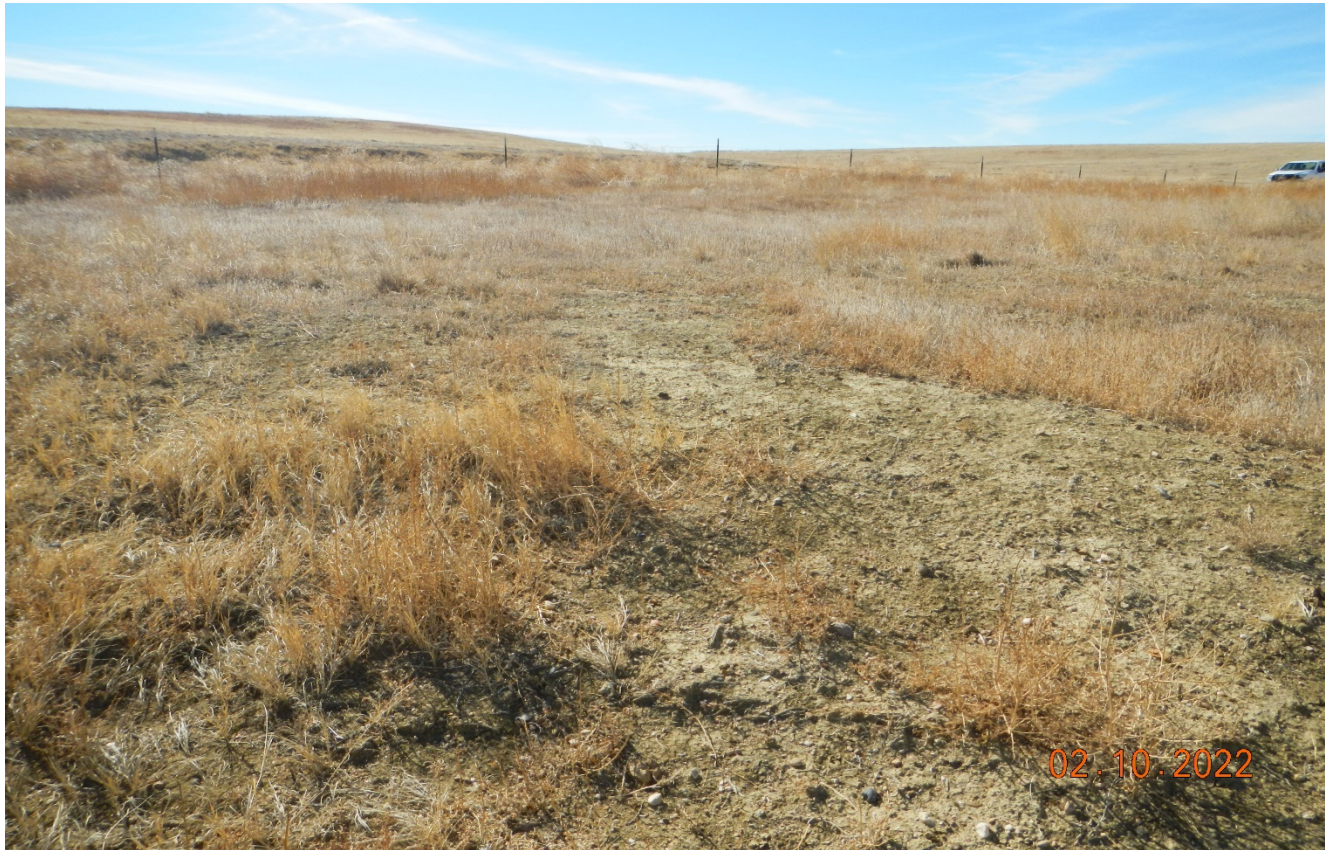
**Photo 6.** Facing southwest inside the fenced area. The vegetation has not established.

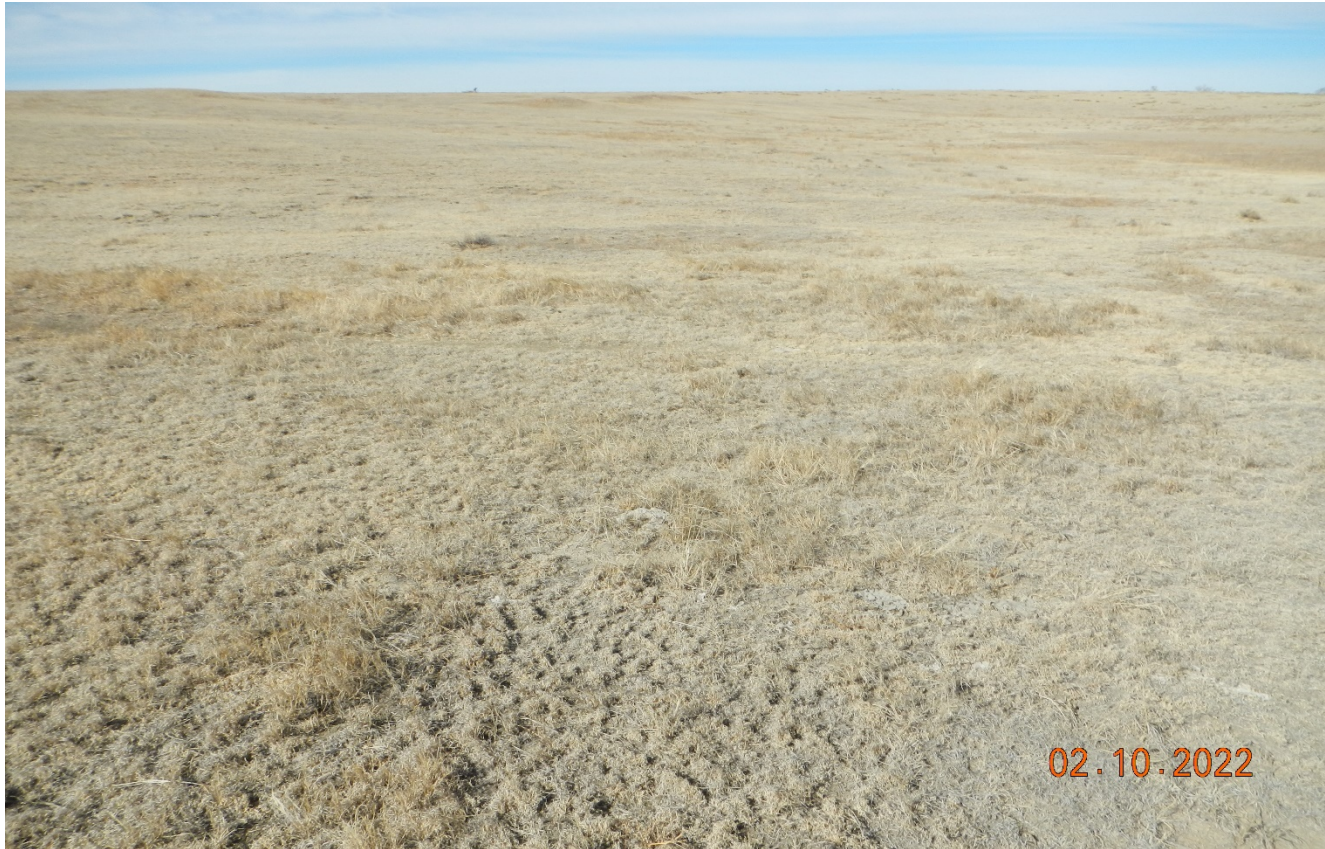
**Photo 7.** Facing northwest toward the surrounding undisturbed reference area which consists of Blue grama grassland.
