Inspection Photos

02/14/2022

Operator: TEP ROCKY MOUNTAIN LLC #96850

Location ID: 335542

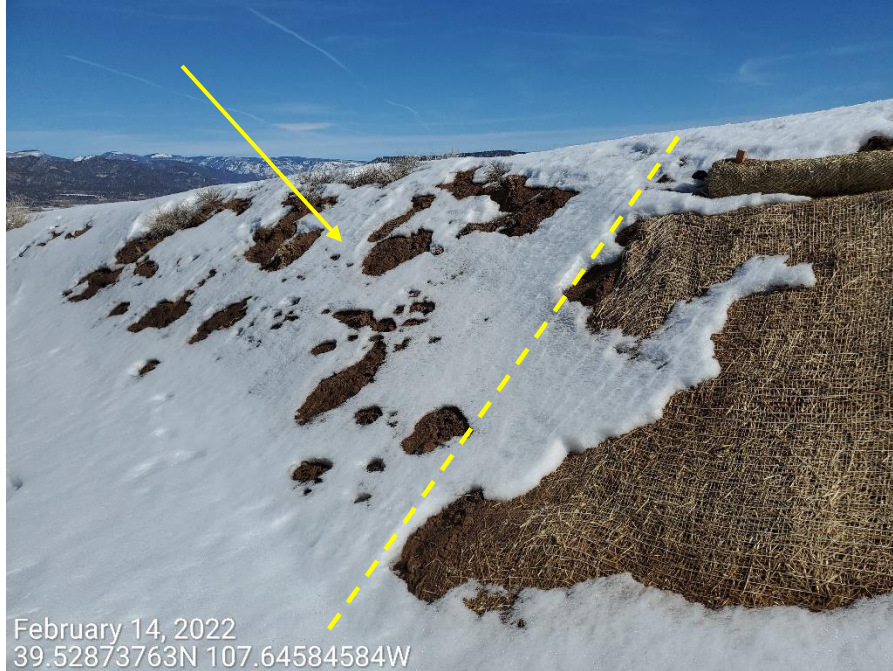
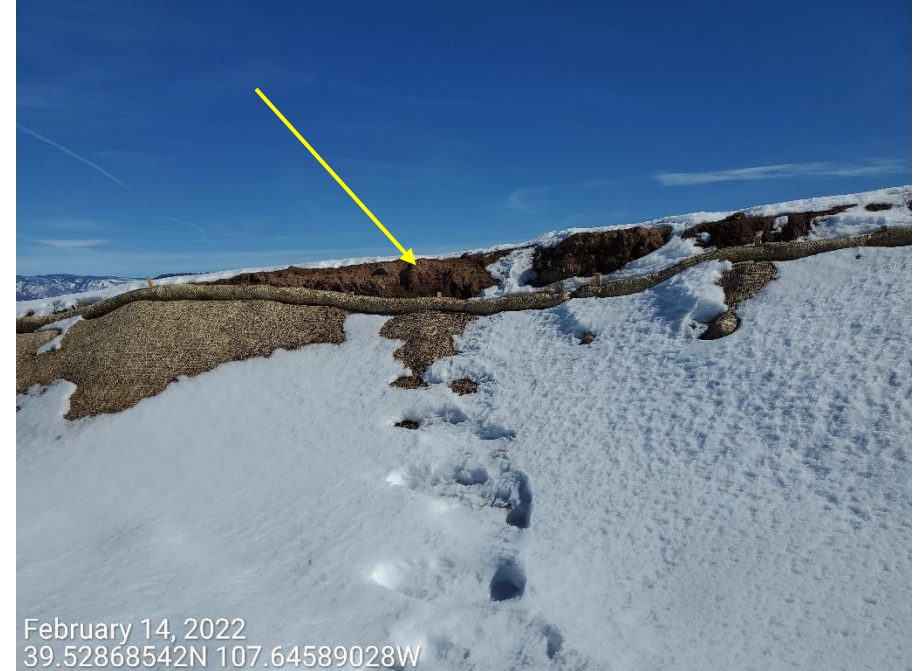
Photo 1: Photos taken from exposed areas of the cutslopes on the Location. Photo left shows Operator appears to have placed erosion blankets on sections of the cut slope, while control measures to protect and stabilize other areas of the cut slope remain missing or insufficient. Photo right shows Operator did not implement control measures to the top of the cut slope, but rather implemented controls to a base of a vertical cut on the slope. This is not considered good engineering practices. Control measures to protect and stabilize slopes of the location remain missing or insufficient.

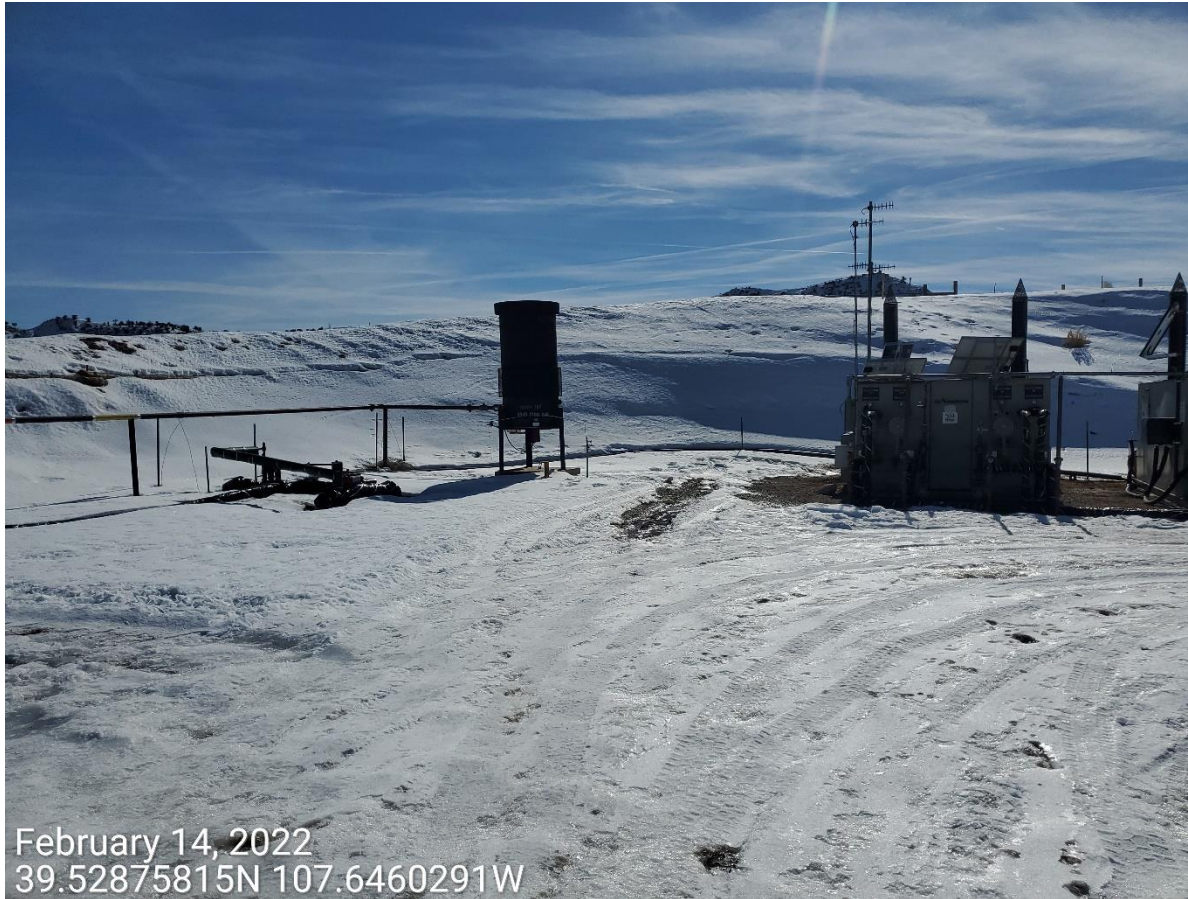
Photo 2: Photo shows majority of cut slopes covered in snow, preventing reclamation specialist from properly assessing stormwater management on the entire location.

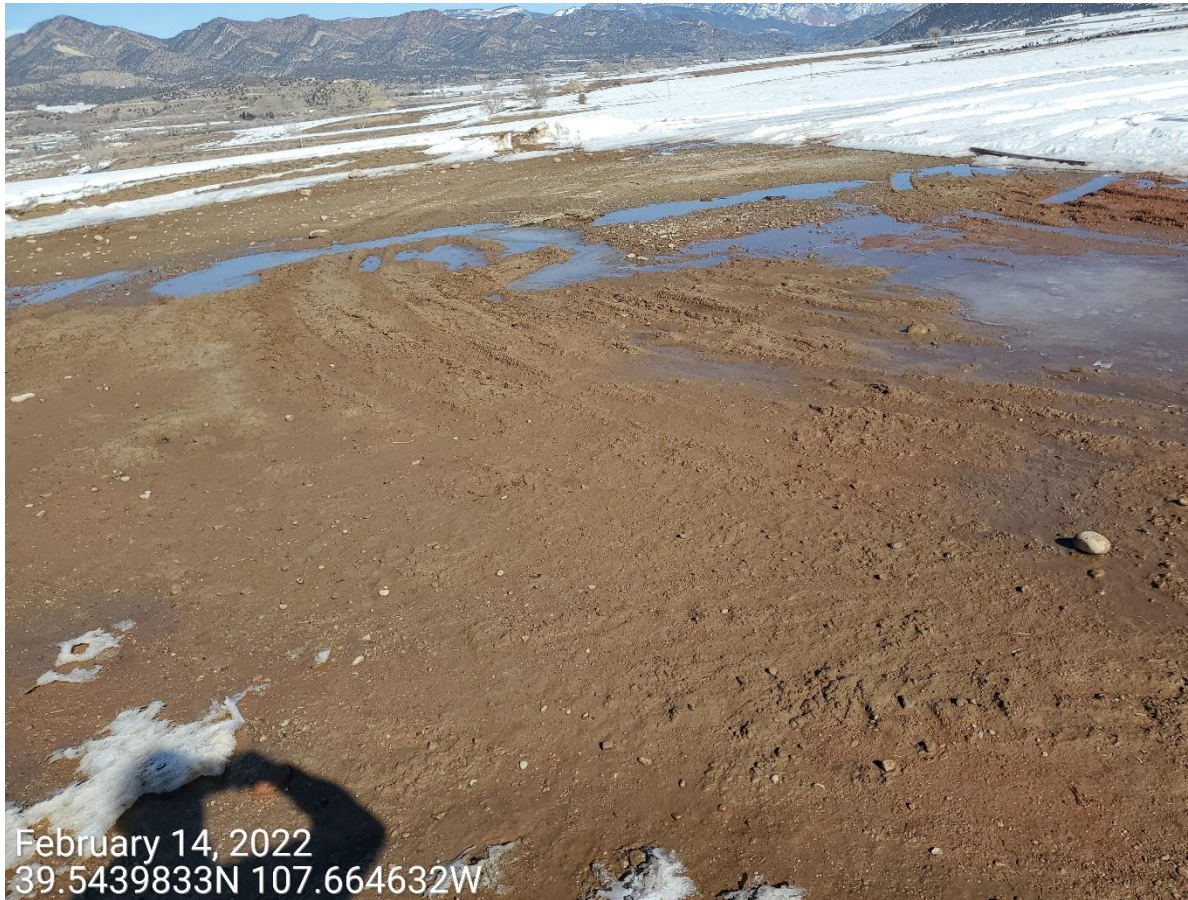
Photo 3: Photo taken from the western production area, facing northeast. Areas of the production pad not covered with snow do not appear to be stabilized, and are at risk of vehicle tracking and sediment transport.

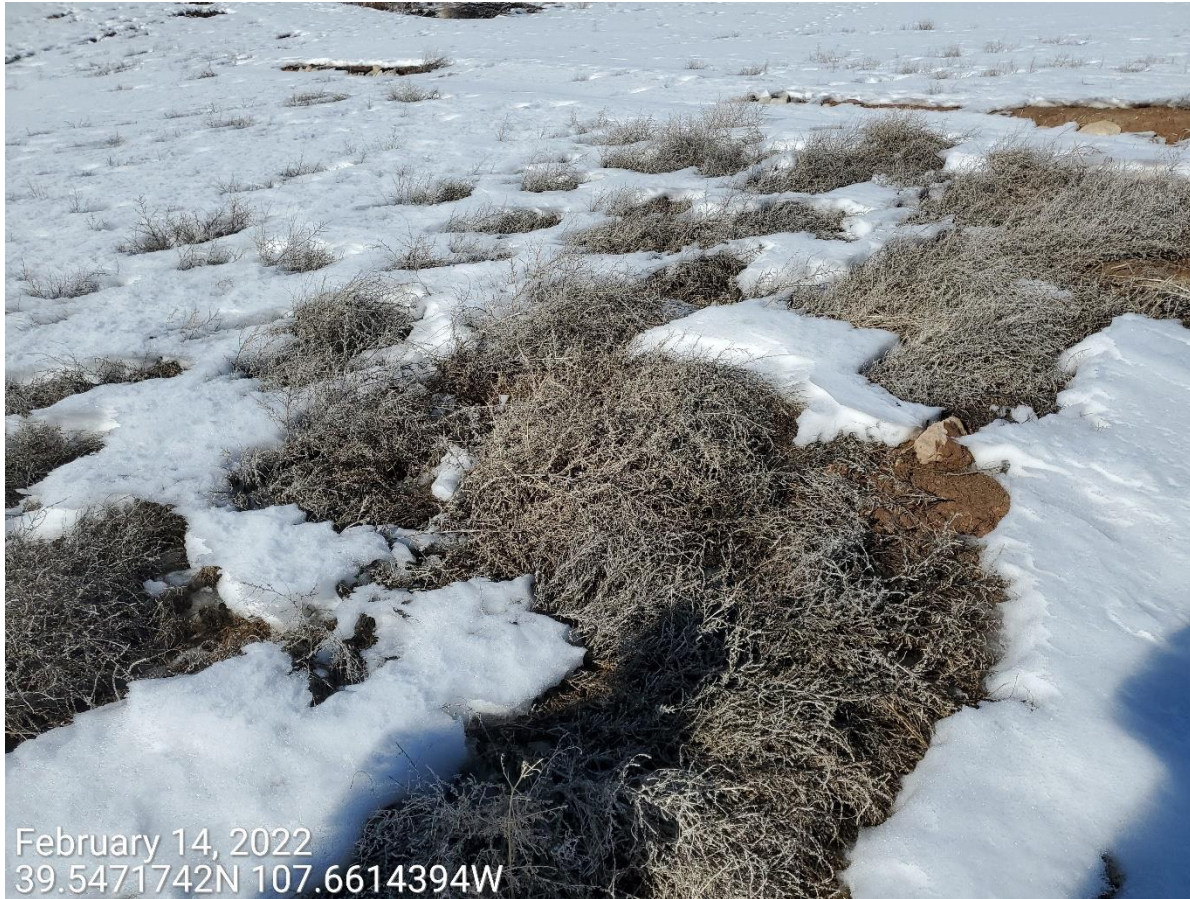
Photo 4: Photo taken from the interim areas of the Location. Previous inspections observed Undesirable Plant Species established on the interim areas. Inspections required Operator to comply with Rule 606 and remove undesirable plant species/weed debris. Photo shows weed debris has not been removed.
