Inspection Photos  
Operator: Arkoma  
API: 067-05373  
Date: 2/15/2022

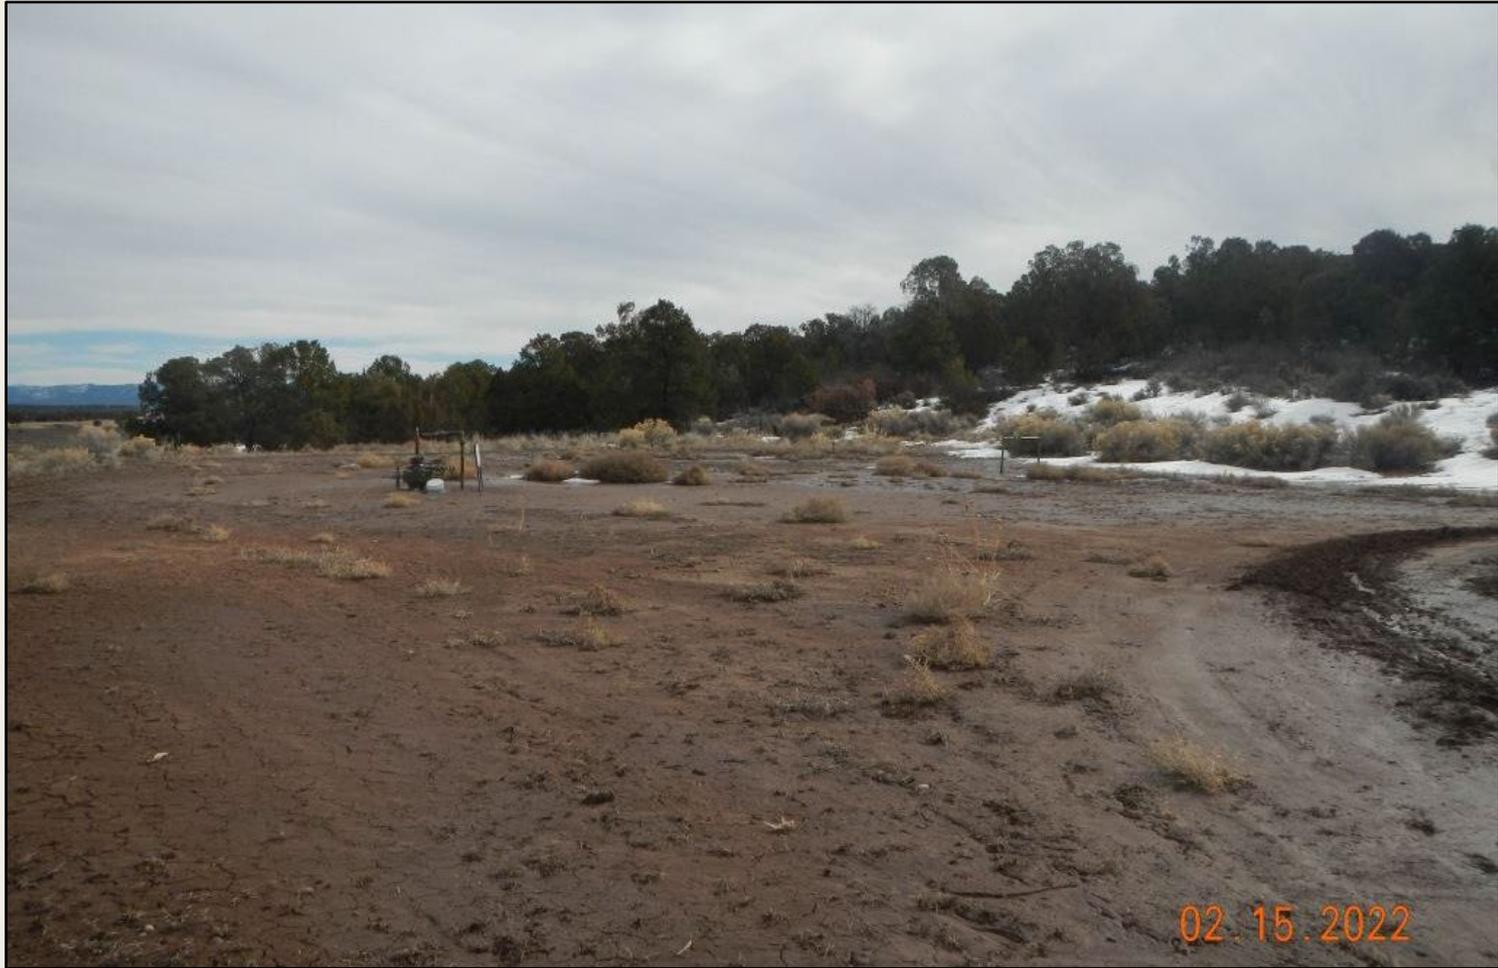
Photo 1. View of project area from the well pad entrance facing center. Well pad surface is not stabilized.

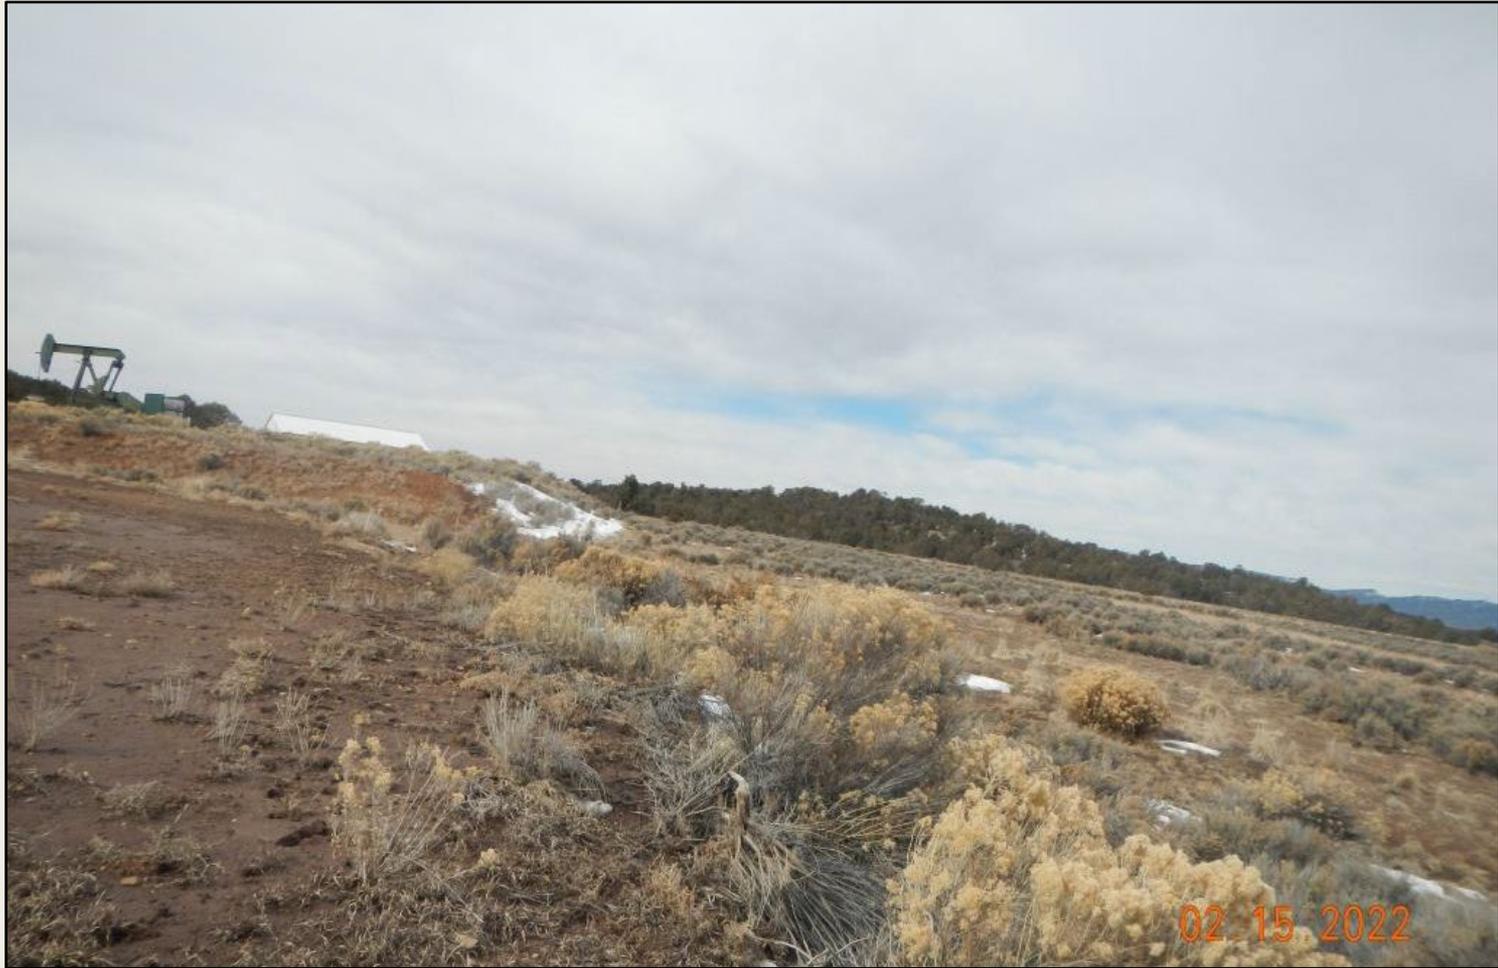
Photo 2. View of the northern project area from the northeastern corner facing westward. Revegetation is progressing with smooth brome, crested wheatgrass, rubber rabbitbrush, and western wheatgrass.

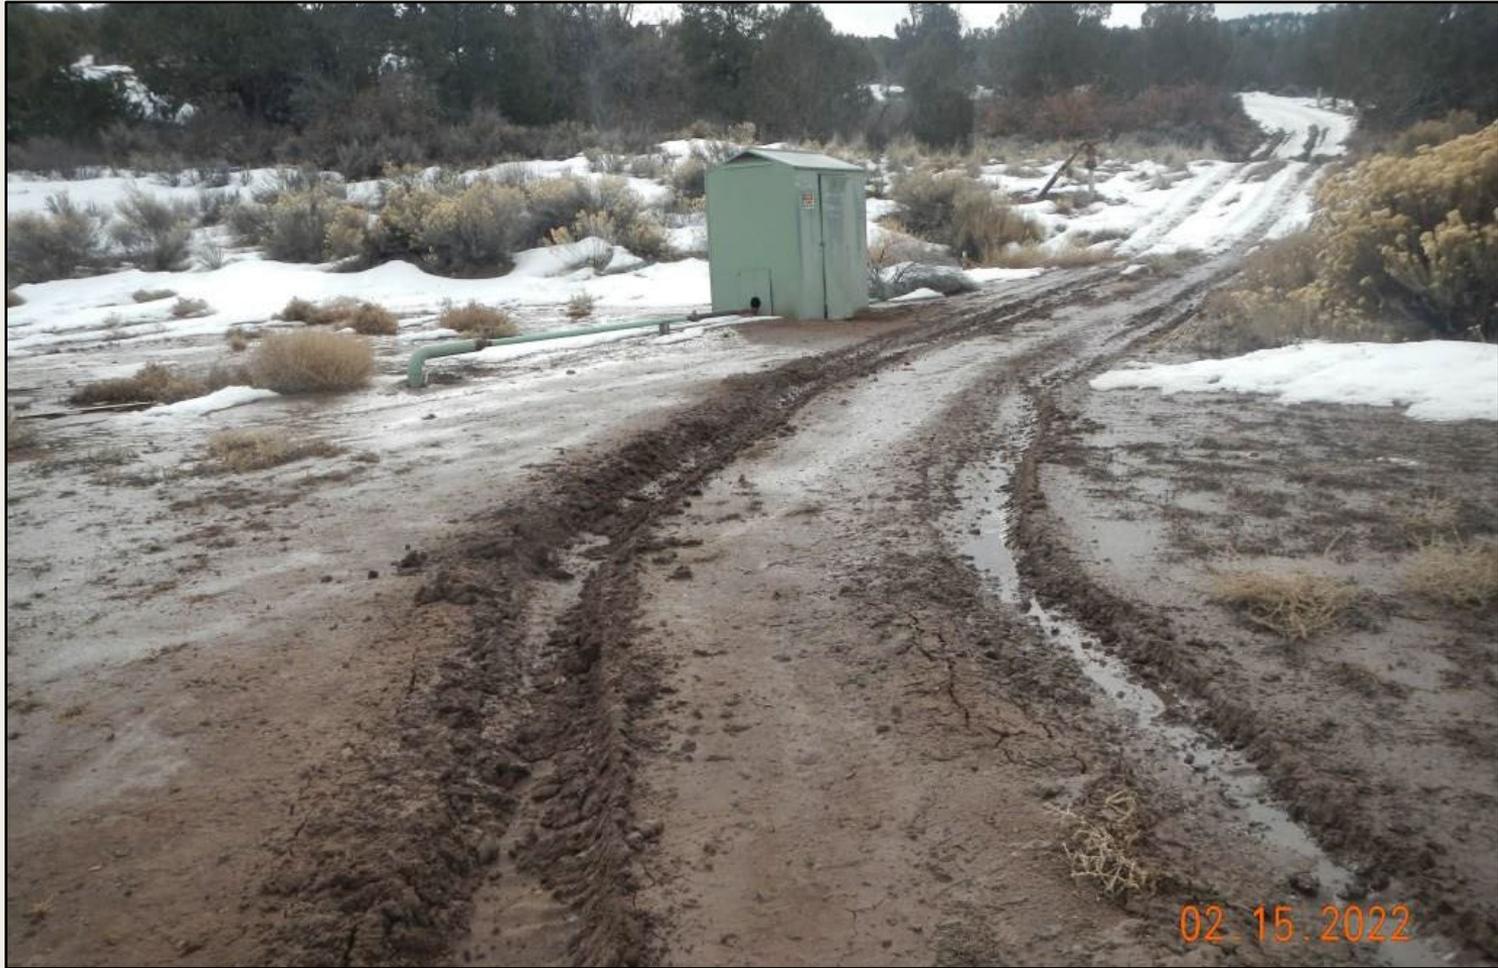
Photo 3. View of rutting up to approx 10-12inches deep on the well pad needing stabilization.

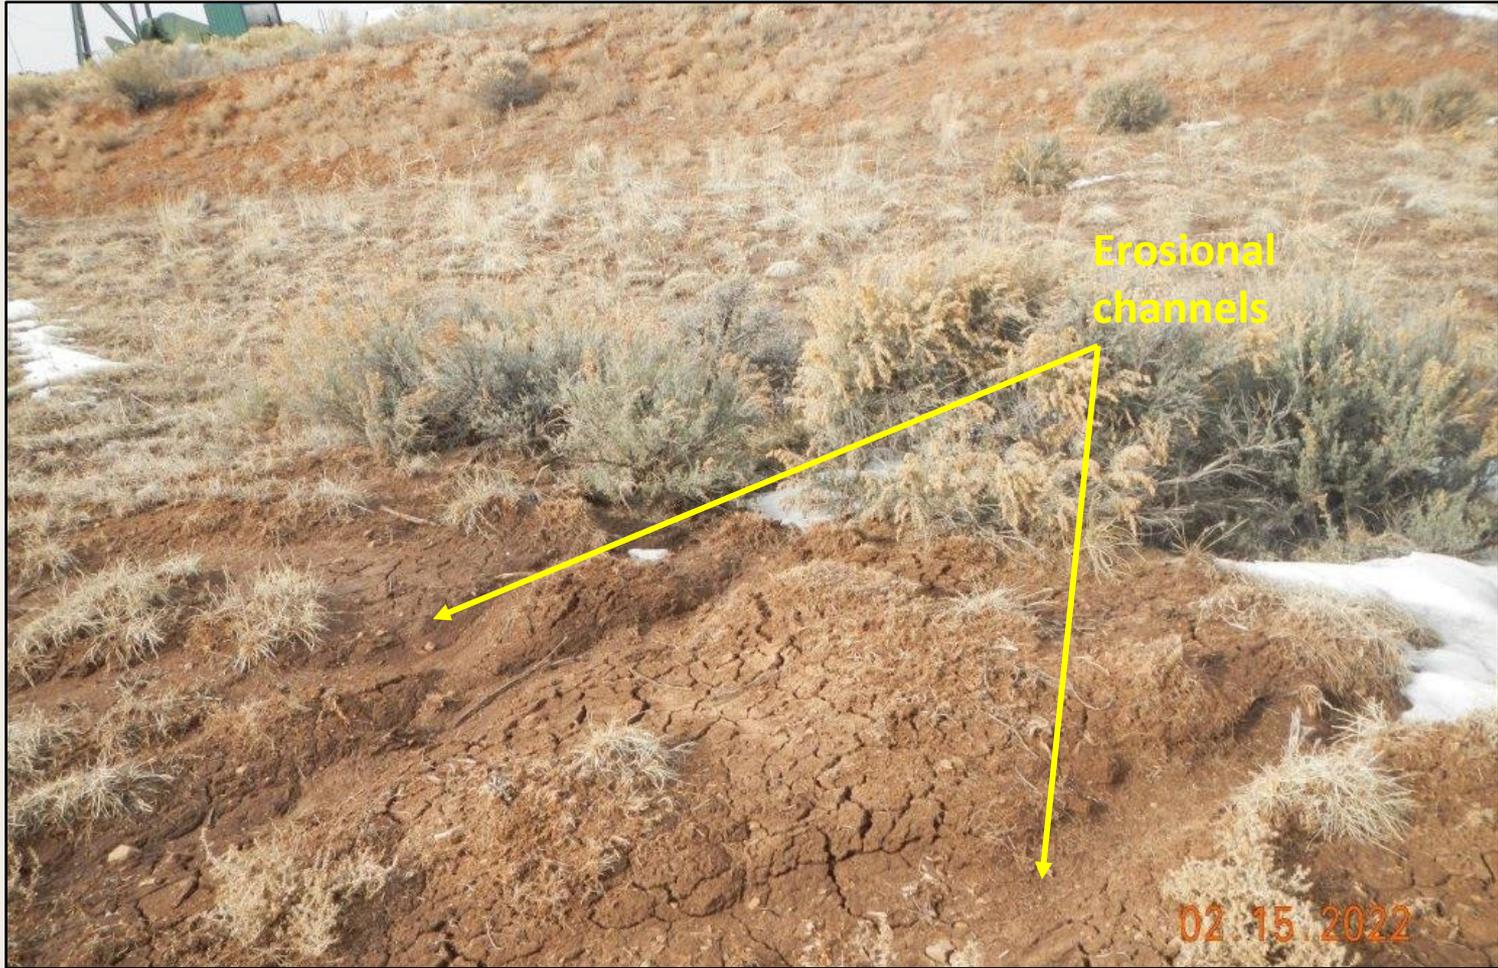
Photo 4. View of erosional channels forming within the northern project area.

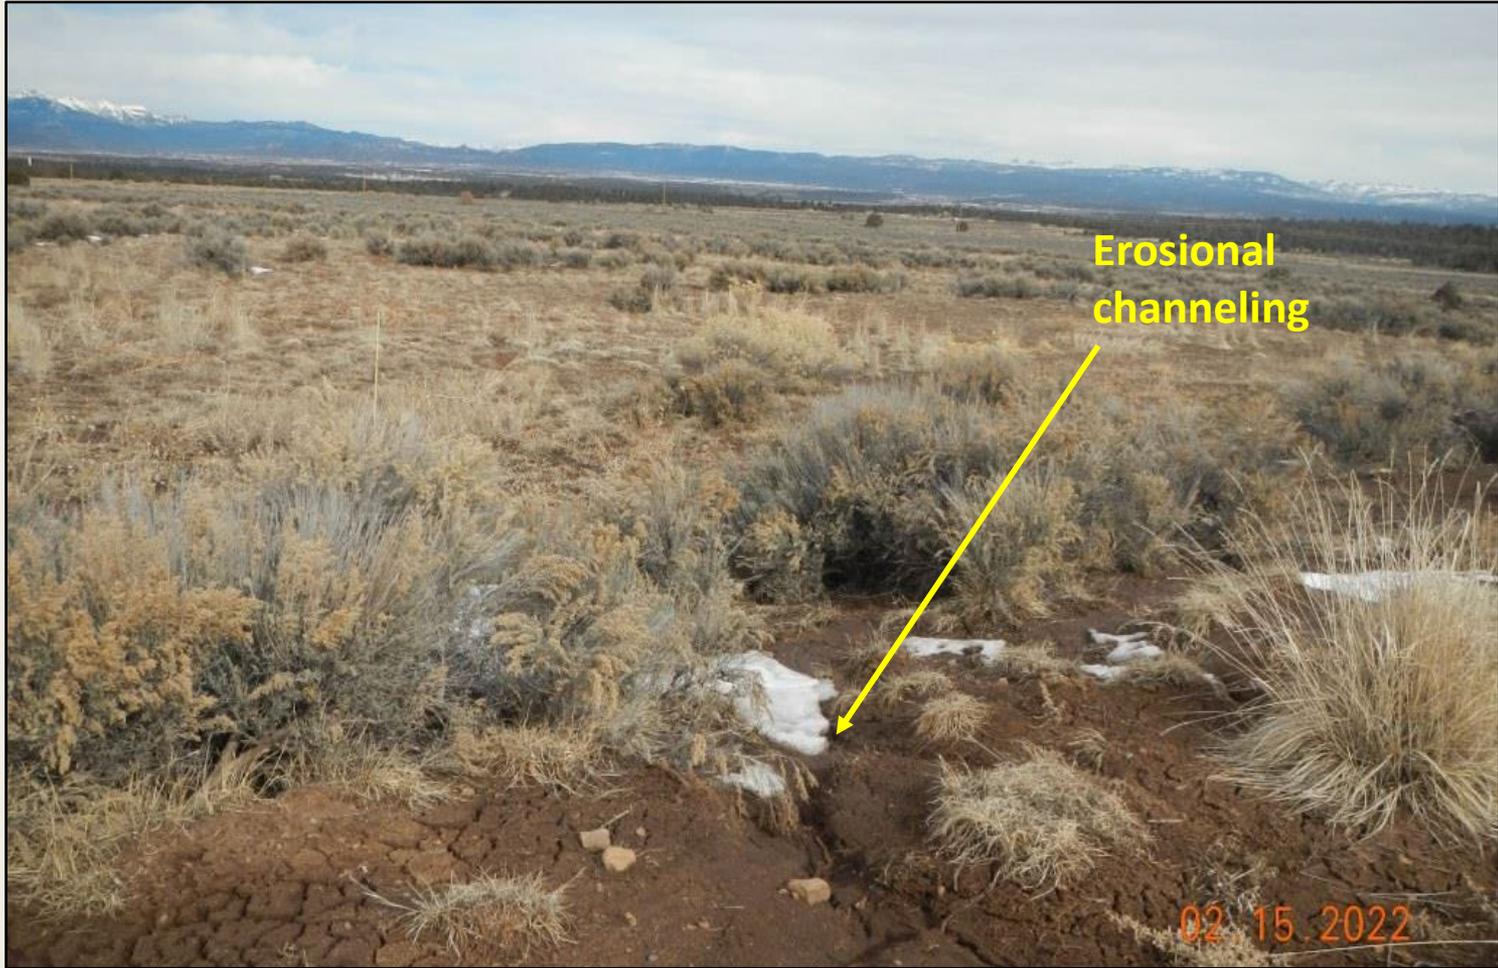
Photo 5. View of additional erosional channeling within the northern project area.

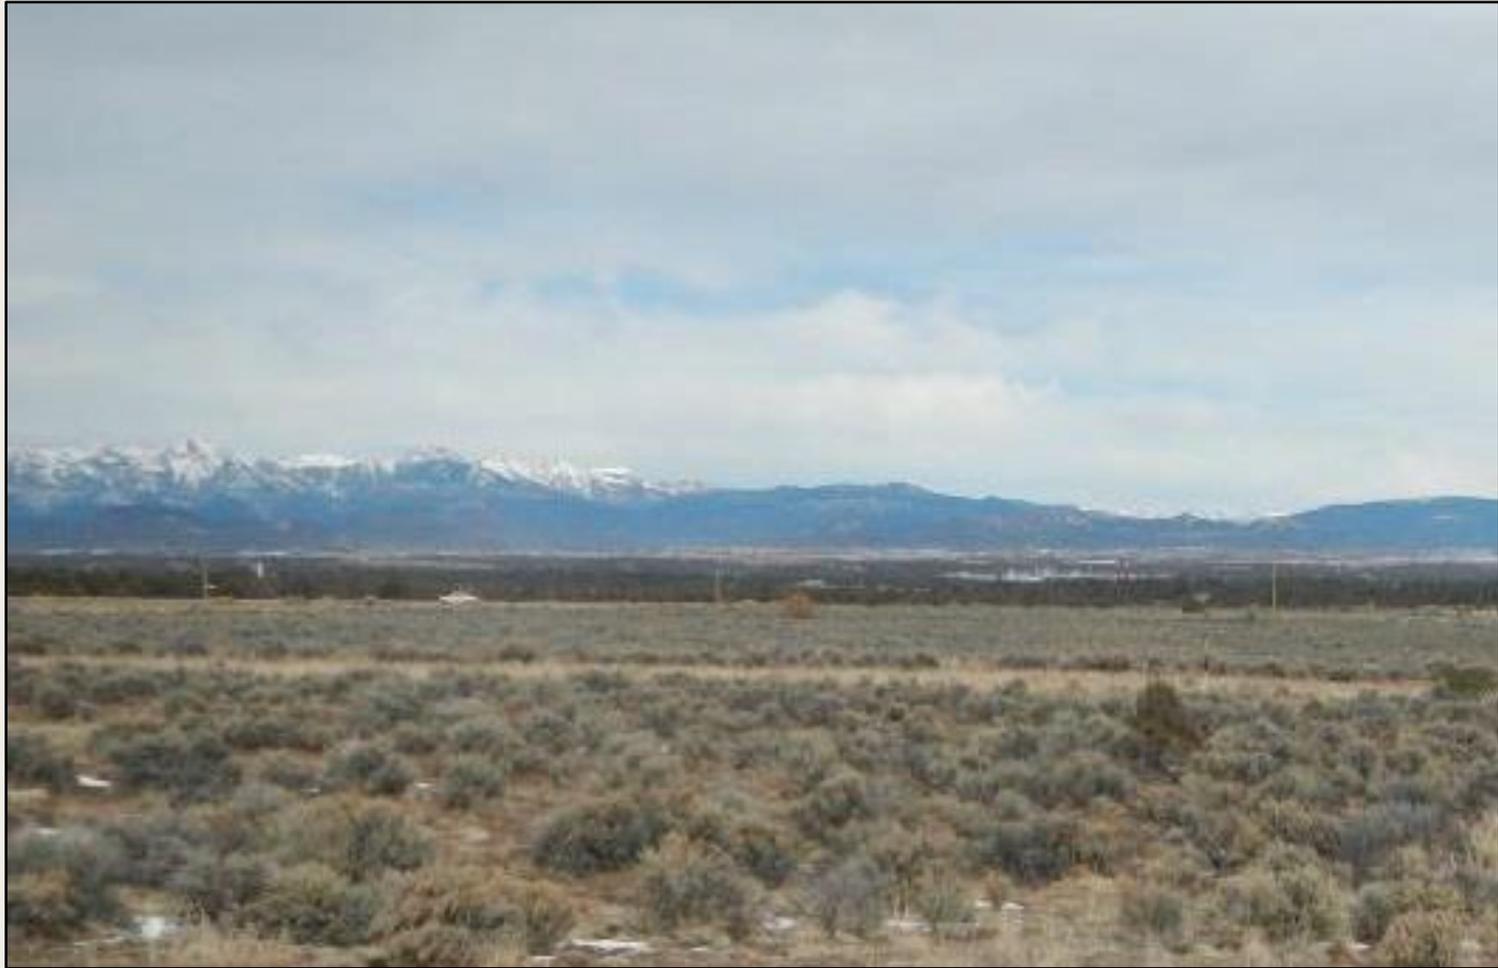
Photo 6. View of reference area comprised of sagebrush shrubland/pinyon juniper woodland mosaic comprised of blue grama, Indian ricegrass, prickly pear, and yucca in the understory.
