Inspection Photos
Operator: Arkoma
API: 067-08193
Date: 2/15/2022

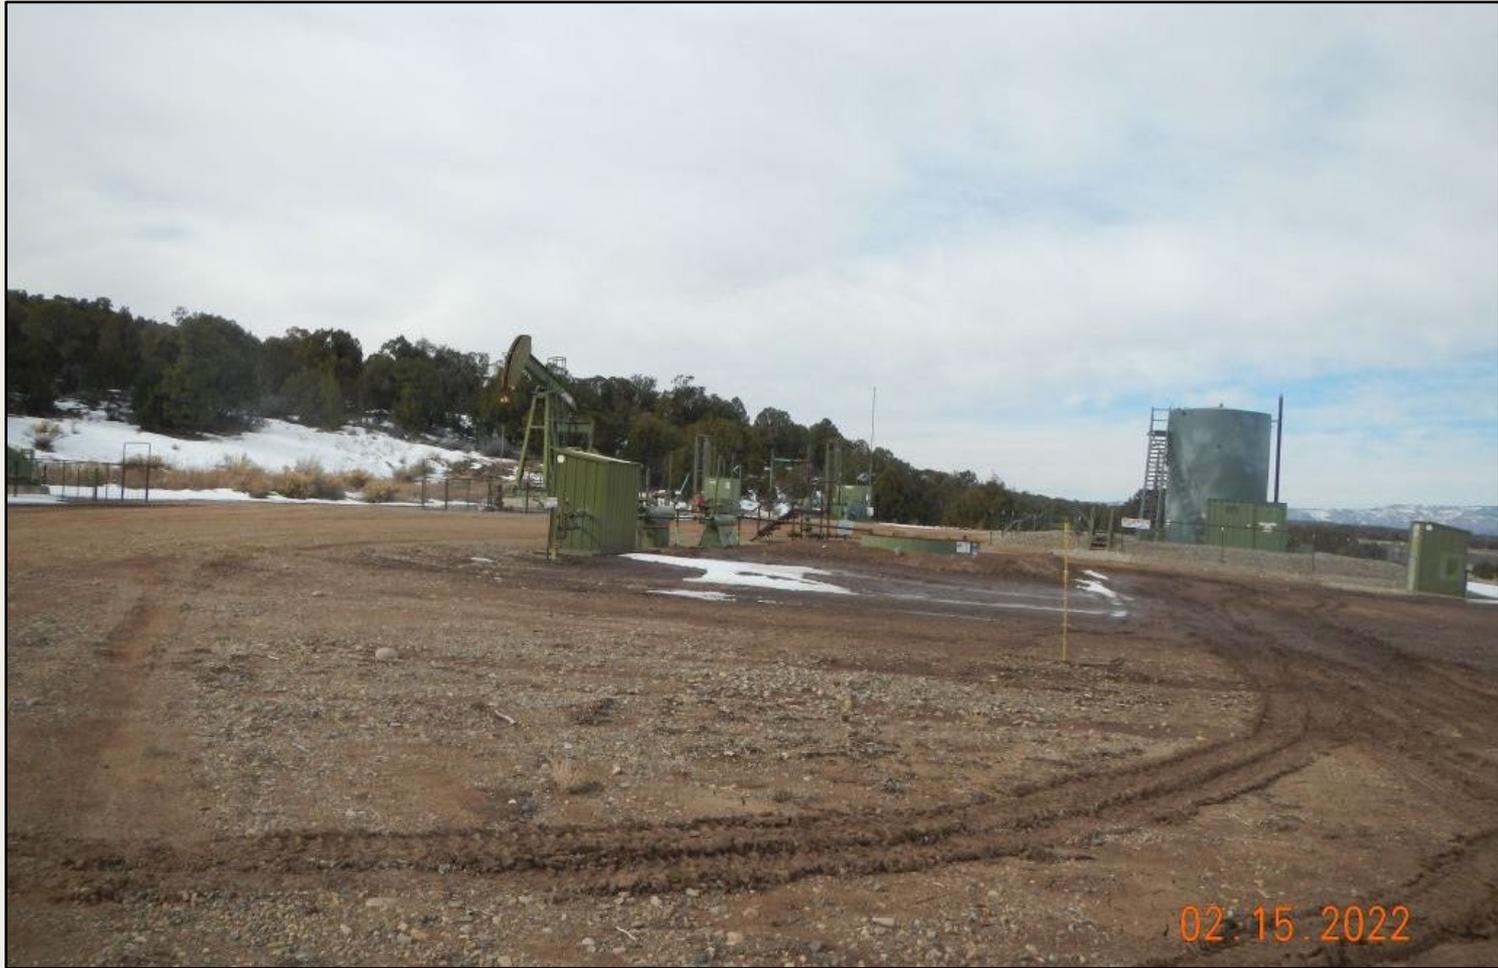
Photo 1. View of project area from the well pad entrance facing center.

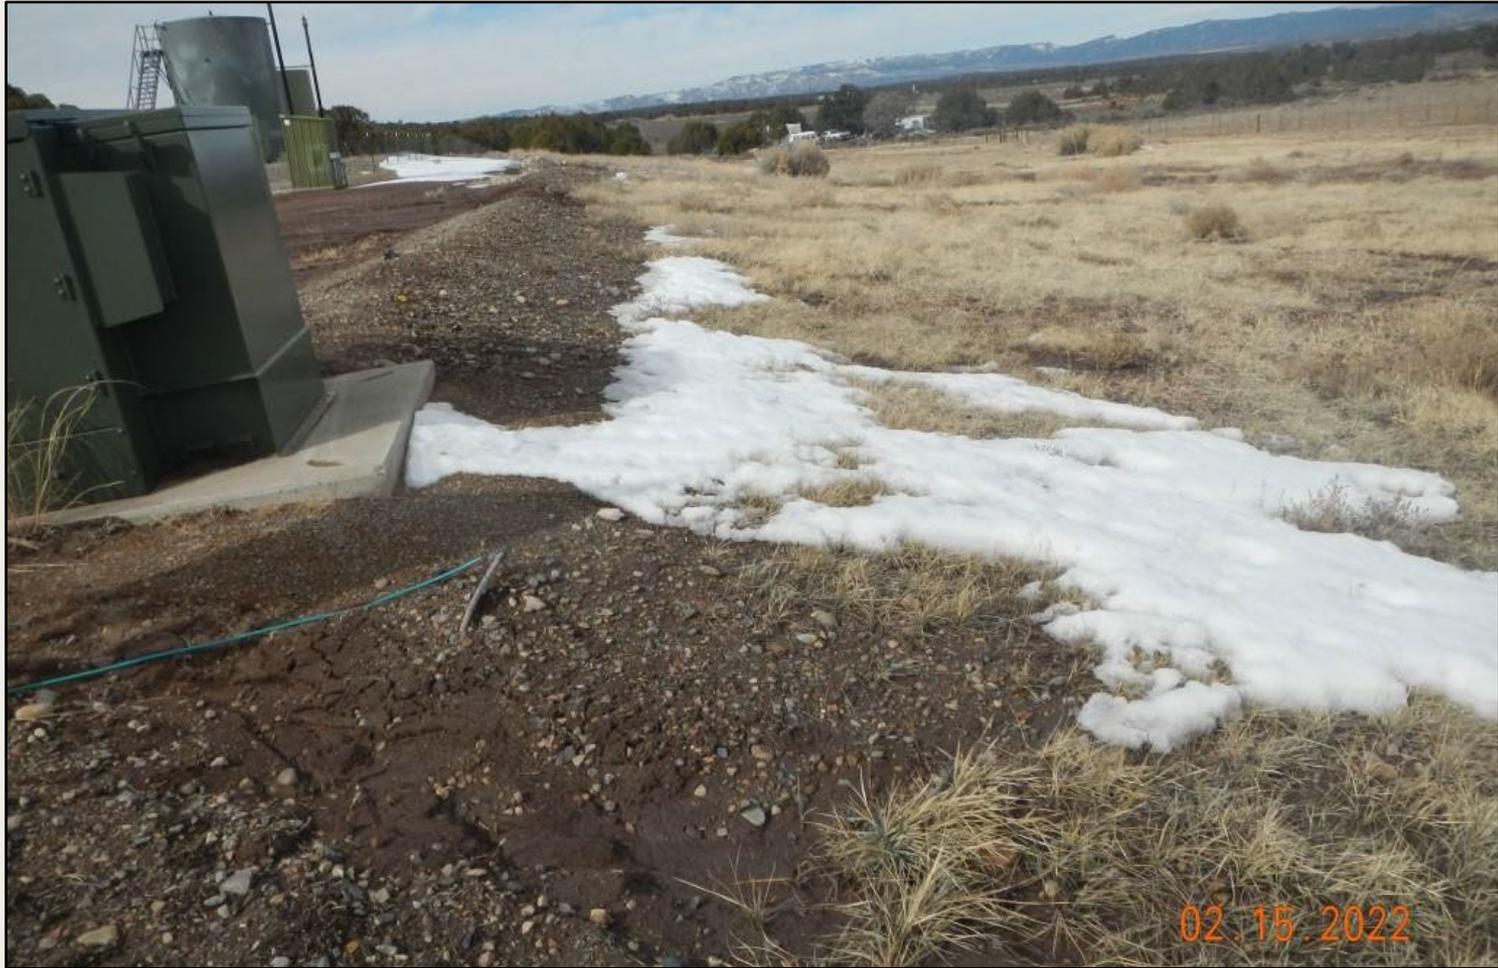
Photo 2. View of the northern project area from the northeastern corner facing westward. Revegetation is progressing with smooth brome, crested wheatgrass, and western wheatgrass.

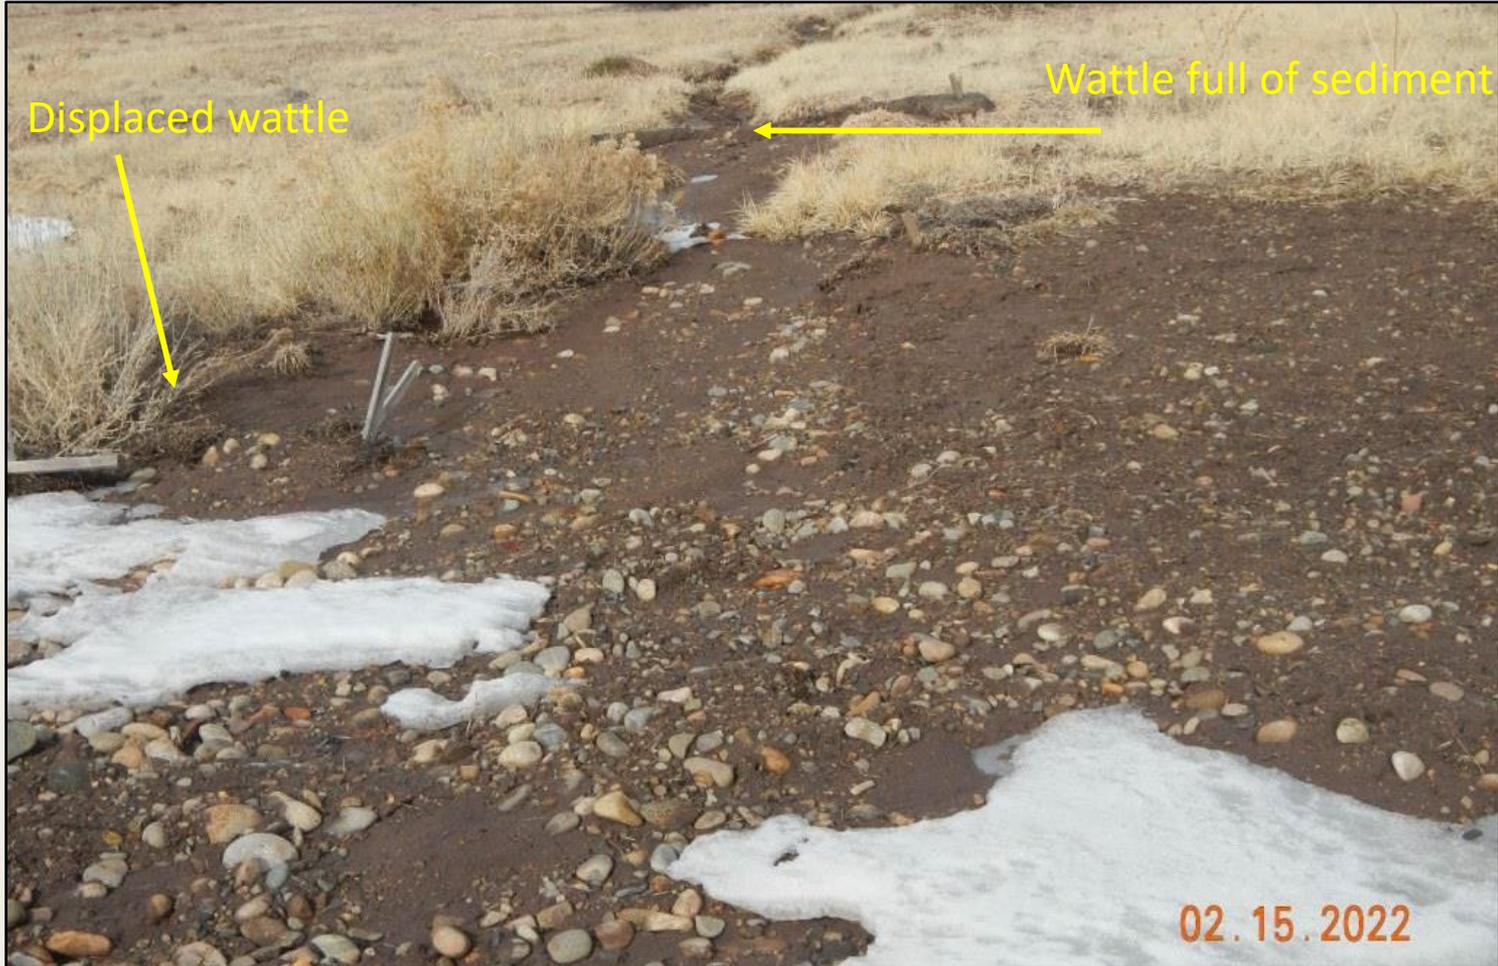
Photo 3. View of stormwater BMPs in the northern project area that need maintenance.

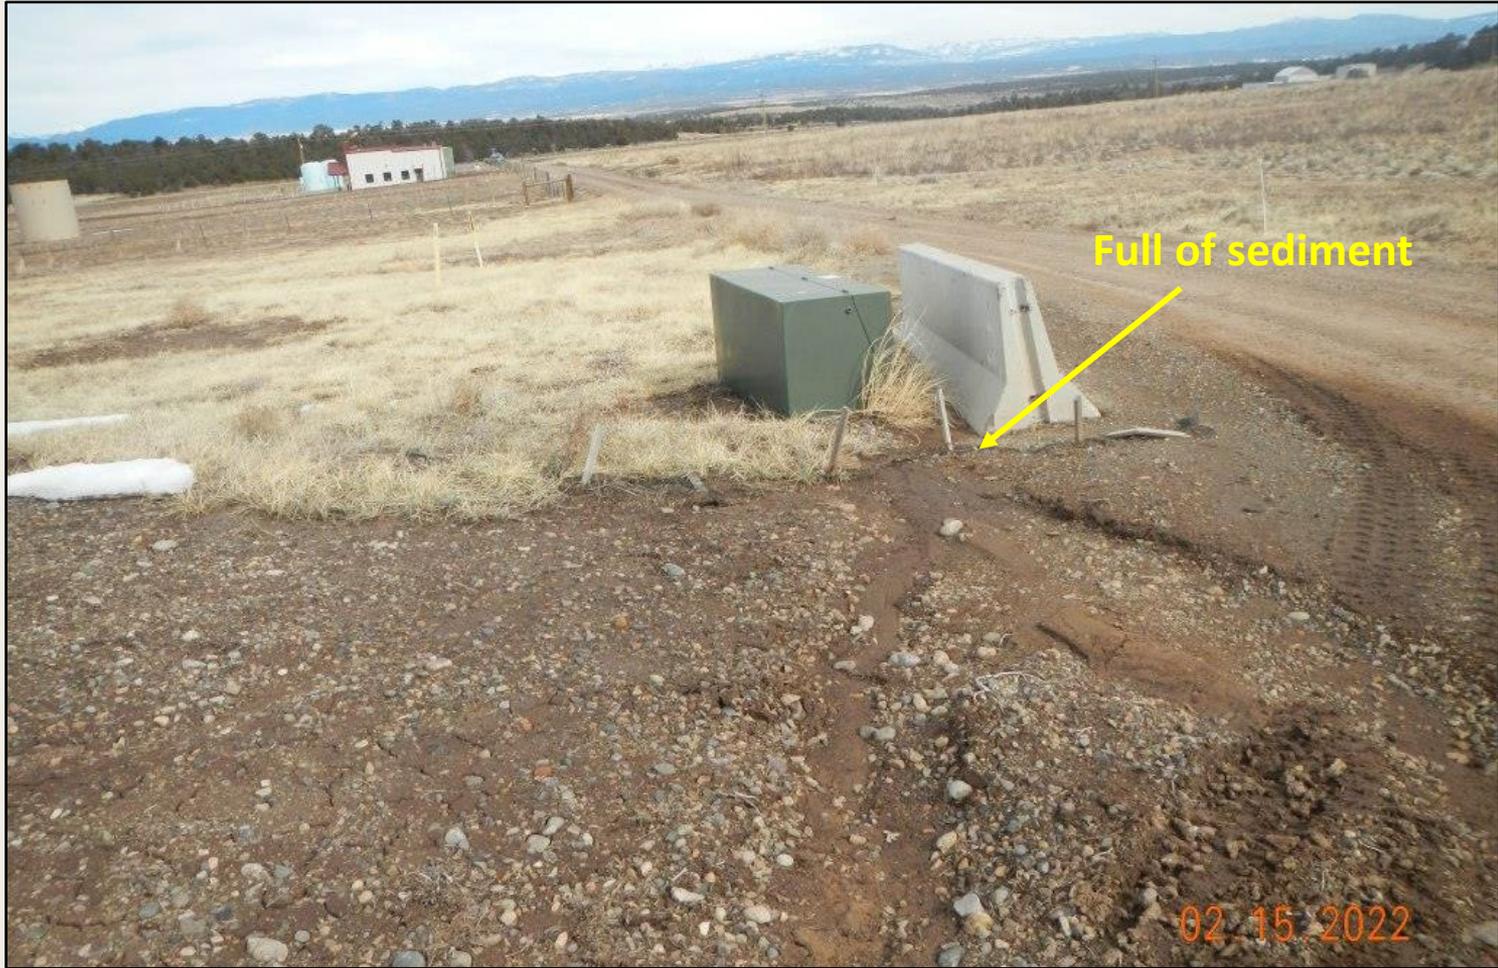
Photo 4. View of wattle at the well pad entrance that is full of sediment and is not an adequate BMP for this location. Maintenance is needed.

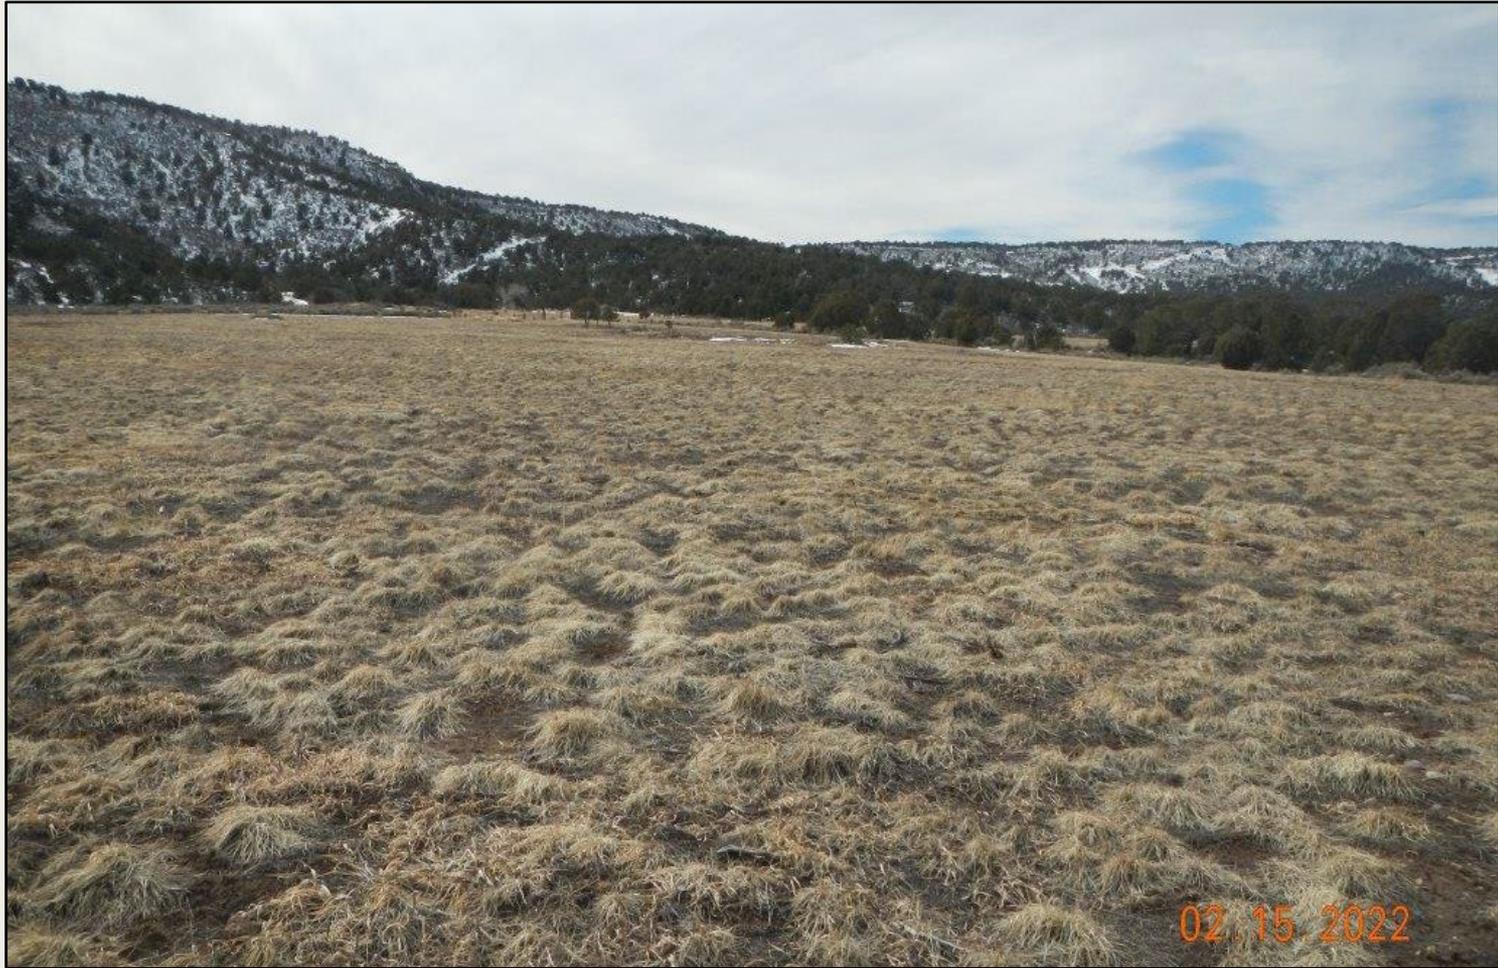
Photo 5. View of reference area comprised of open grass field, largely comprised of grasses such as smooth brome, western wheatgrass, and crested wheatgrass.
