Inspection Photos  
Operator: Arkoma  
API: 067-09139  
Date: 2/15/2022

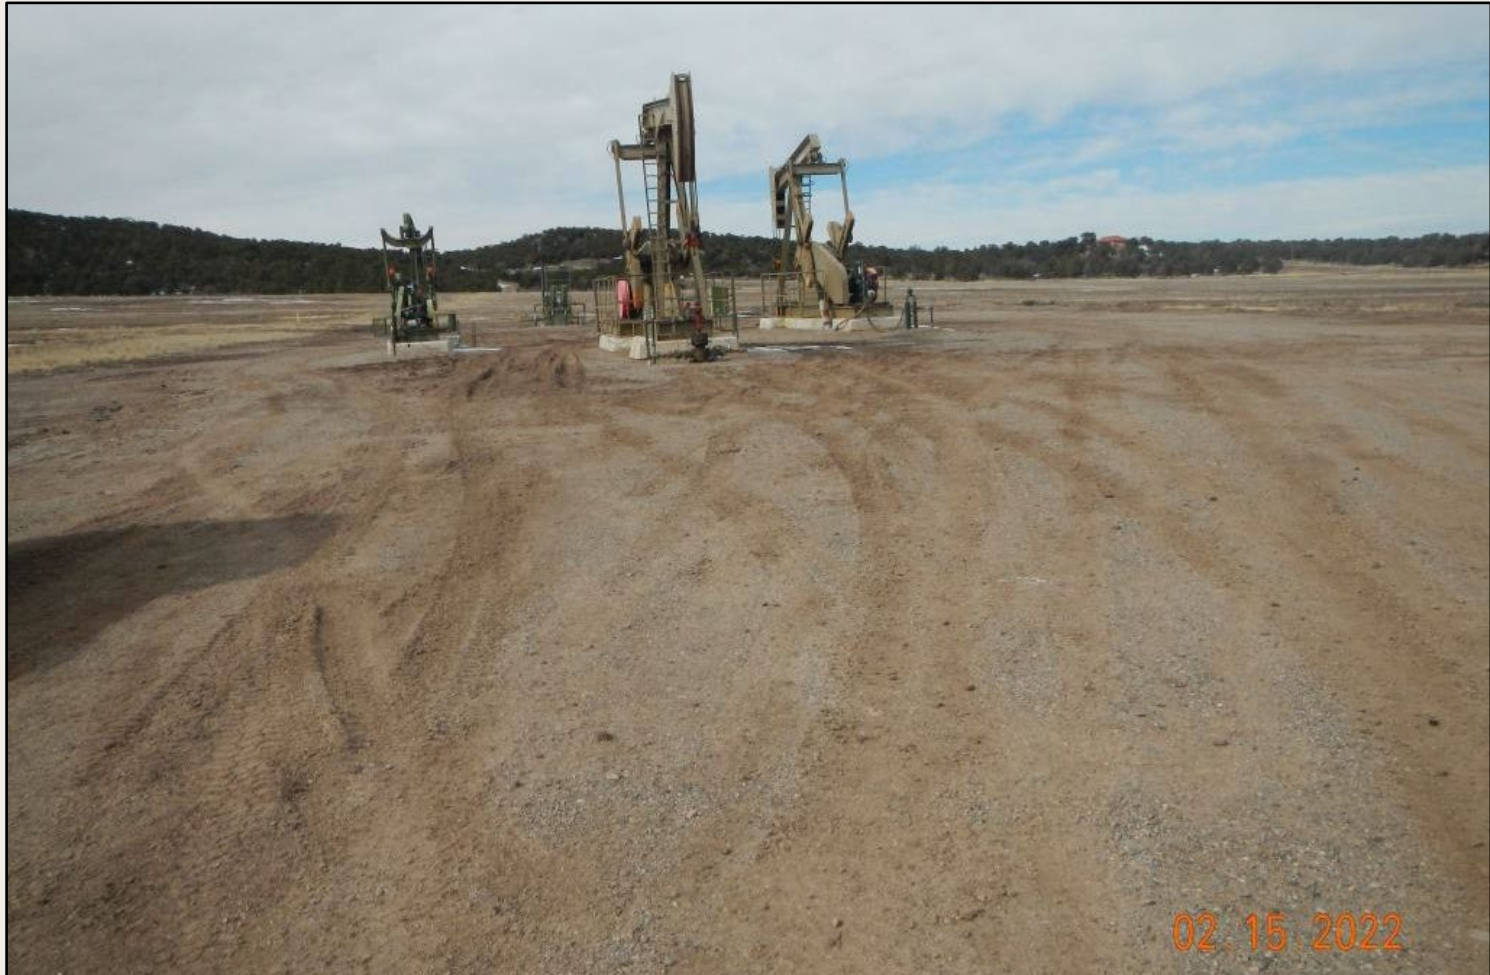
Photo 1. View of project area from the well pad entrance facing center.

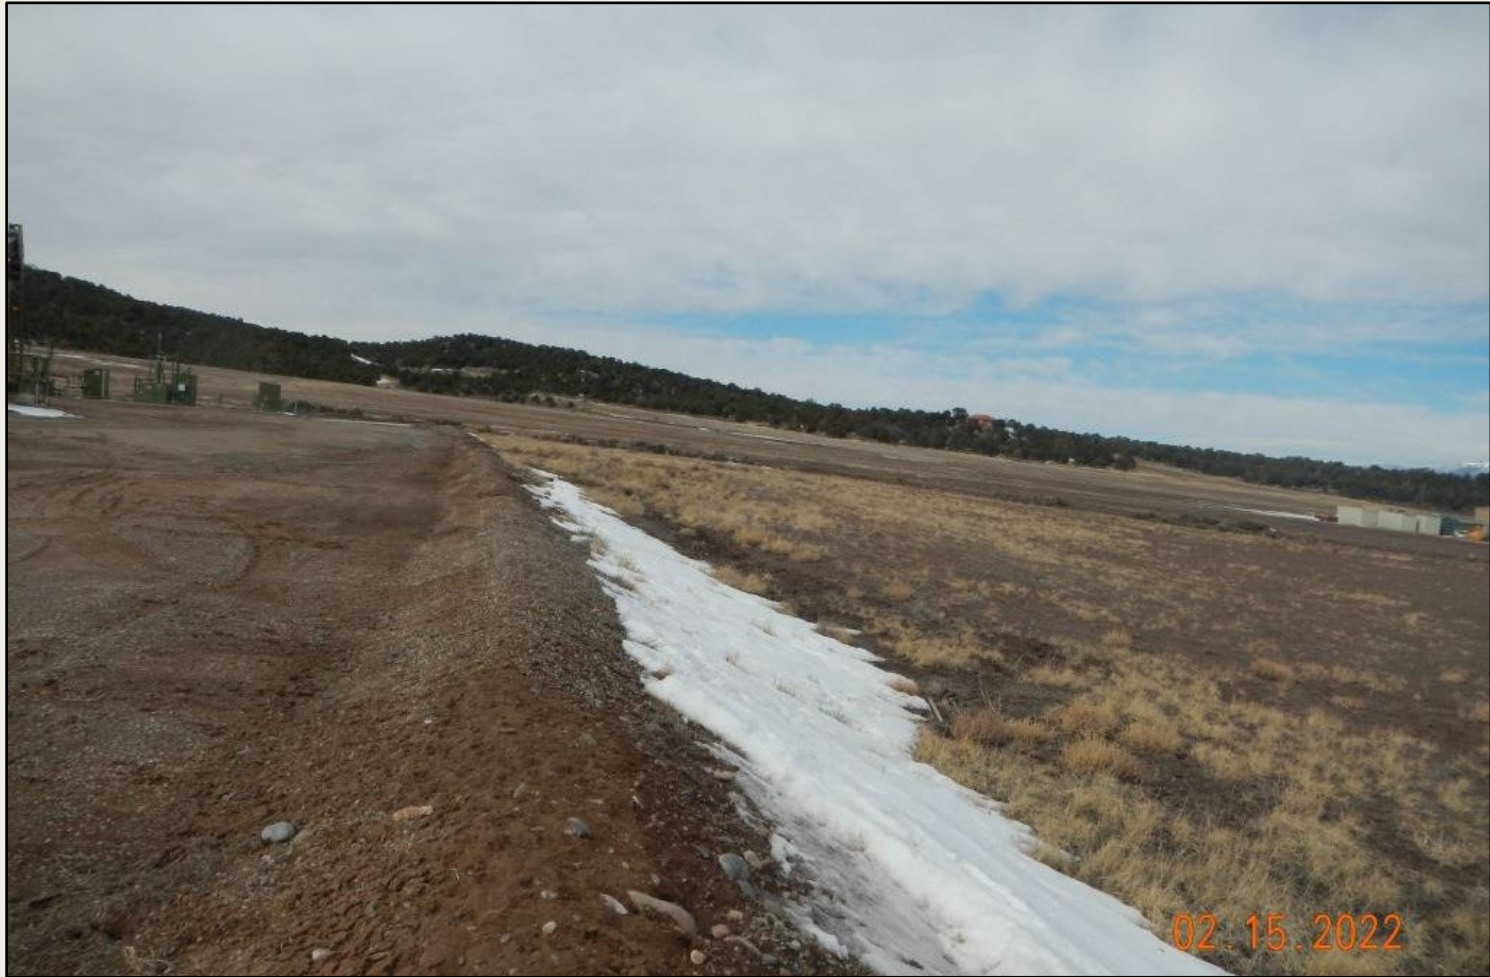
Photo 2. View of the northern project area from the northeastern corner facing westward. Revegetation is progressing with smooth brome, crested wheatgrass, and western wheatgrass.

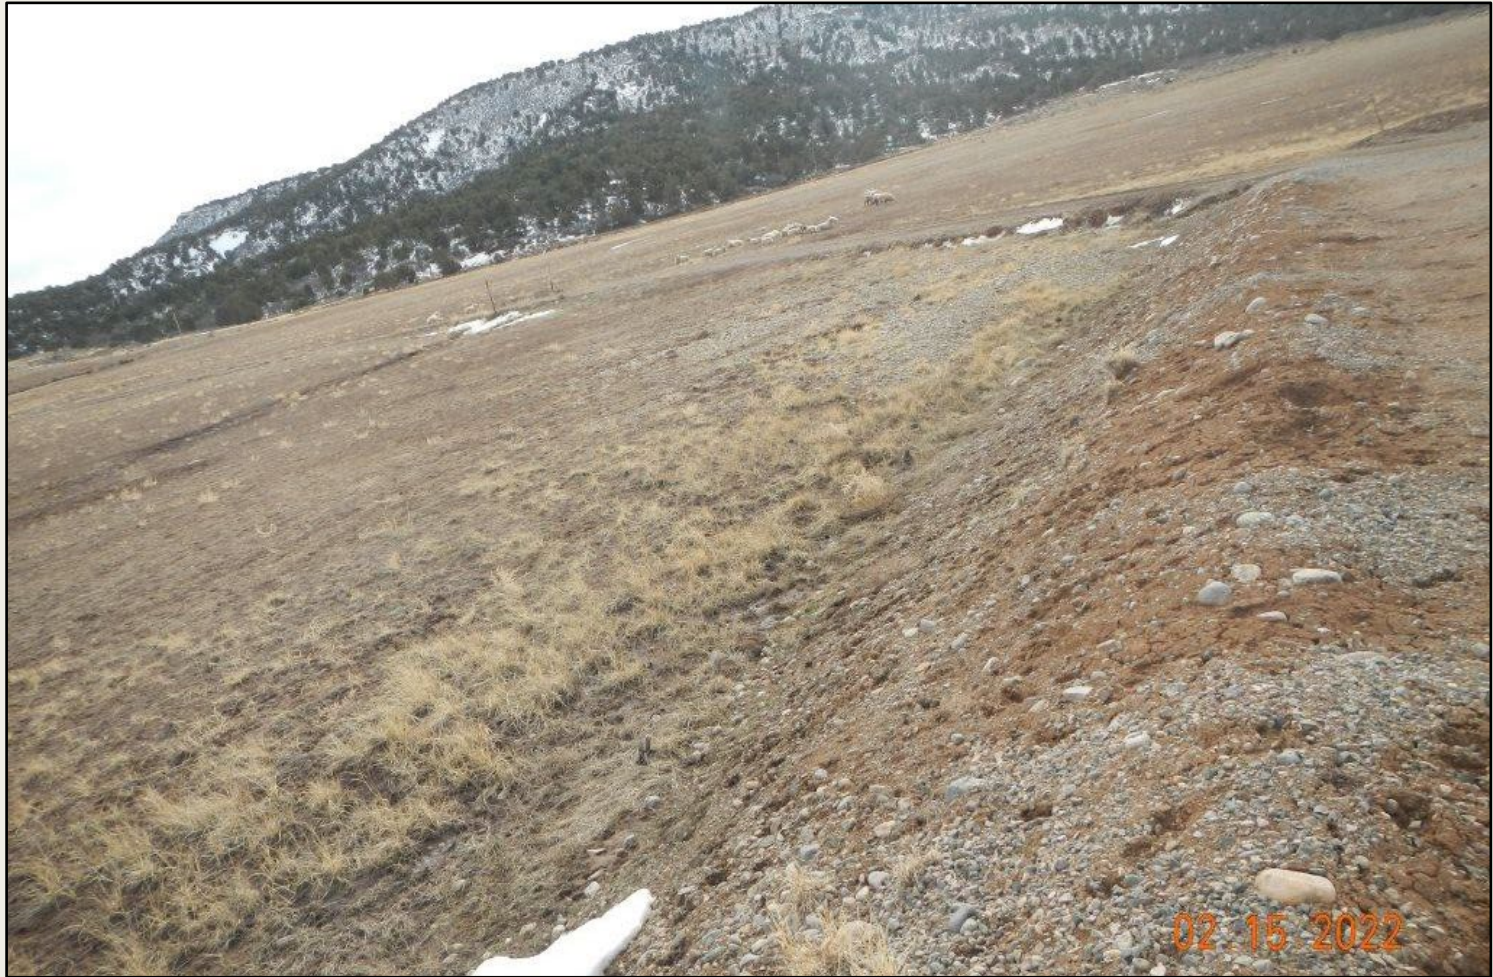
Photo 3. View of the eastern project area from the northeastern corner facing southward.

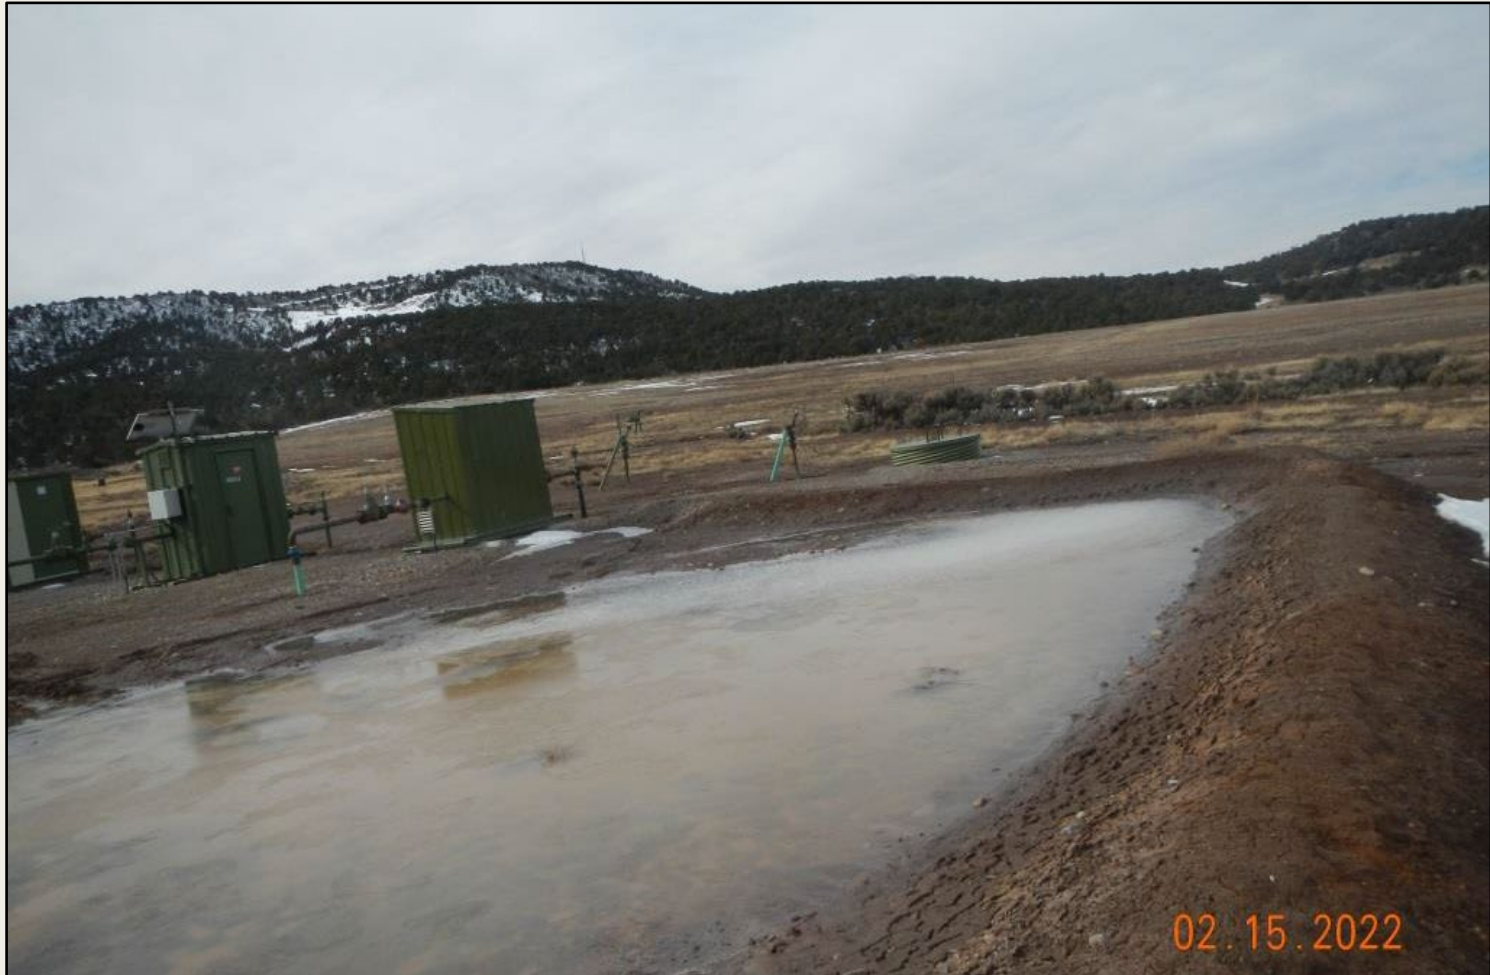
Photo 4. View of ponding observed in the northwestern well pad. A properly armored outlet is needed here.

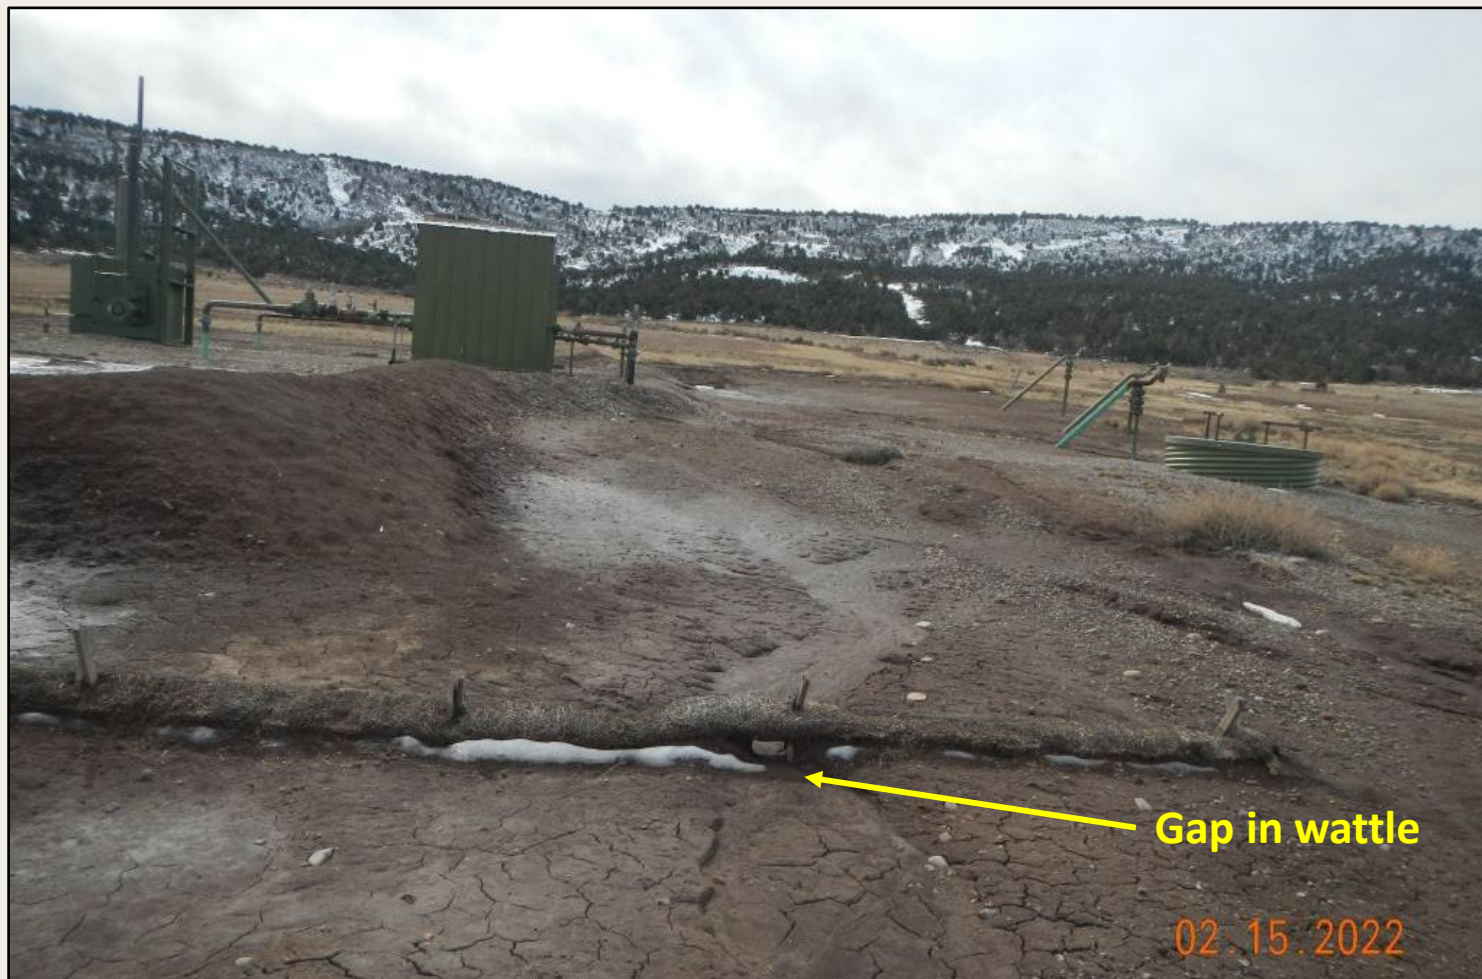
Photo 5. View of bare soils, failed wattles, and erosional channeling occurring within the western project area.

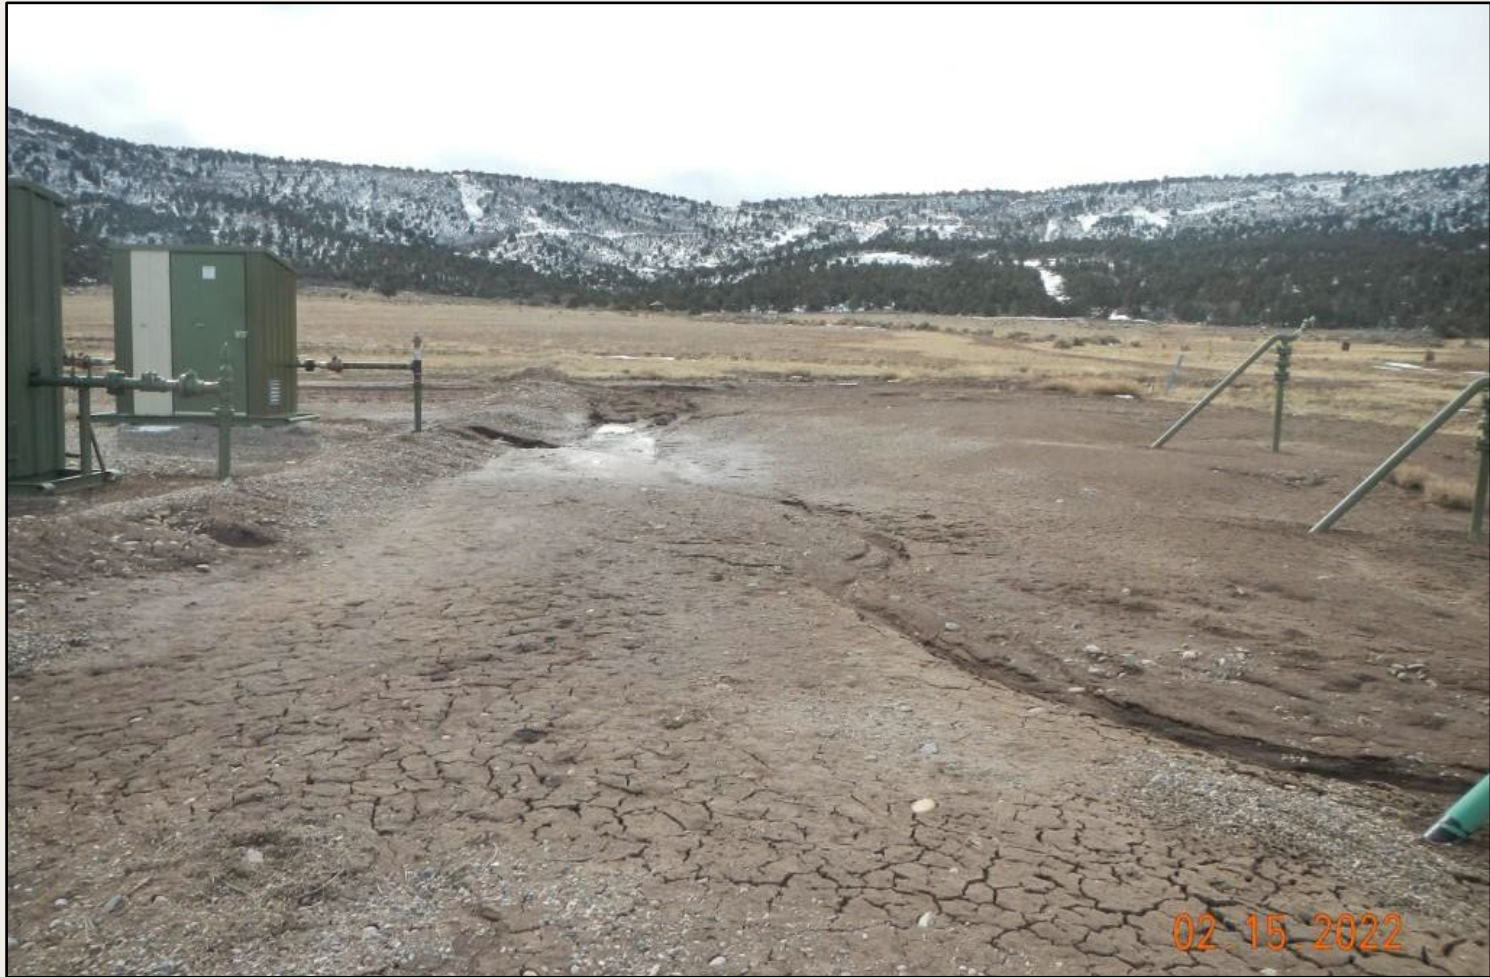
Photo 6. Another view of bare and unstabilized soils and erosional channeling within the western project area.

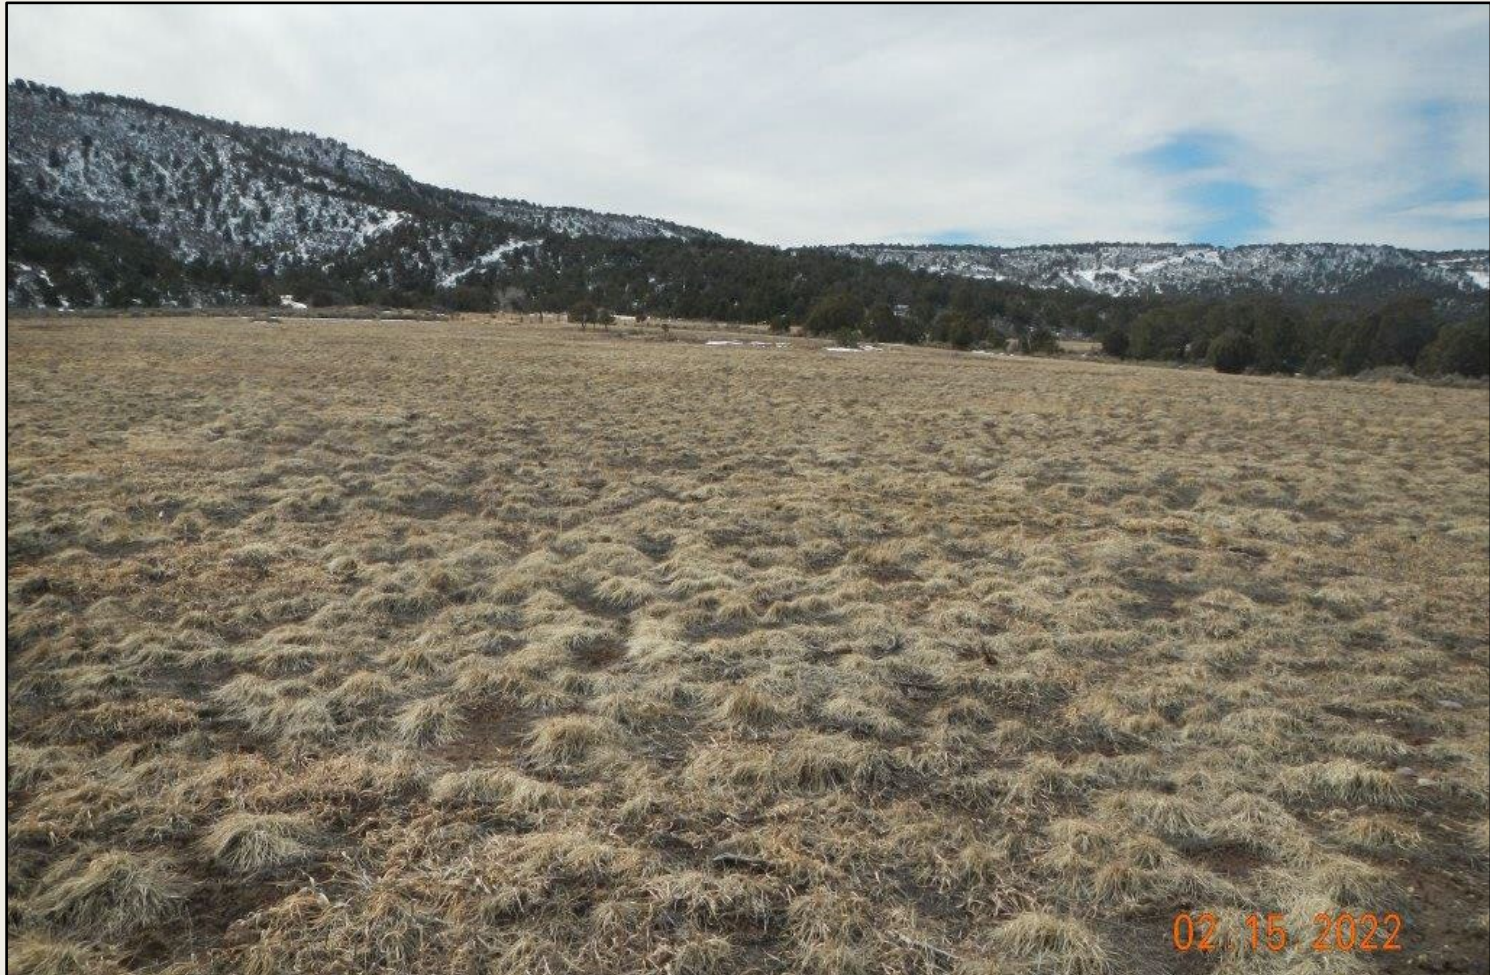
Photo 7. View of reference area comprised of open grass field, largely comprised of grasses such as smooth brome, western wheatgrass, and crested wheatgrass.
