Inspection Photos

Location Name: TEP ROCKY MOUNTAIN LLC FEDERAL-67S96W /11SWNE

Location ID: 334969

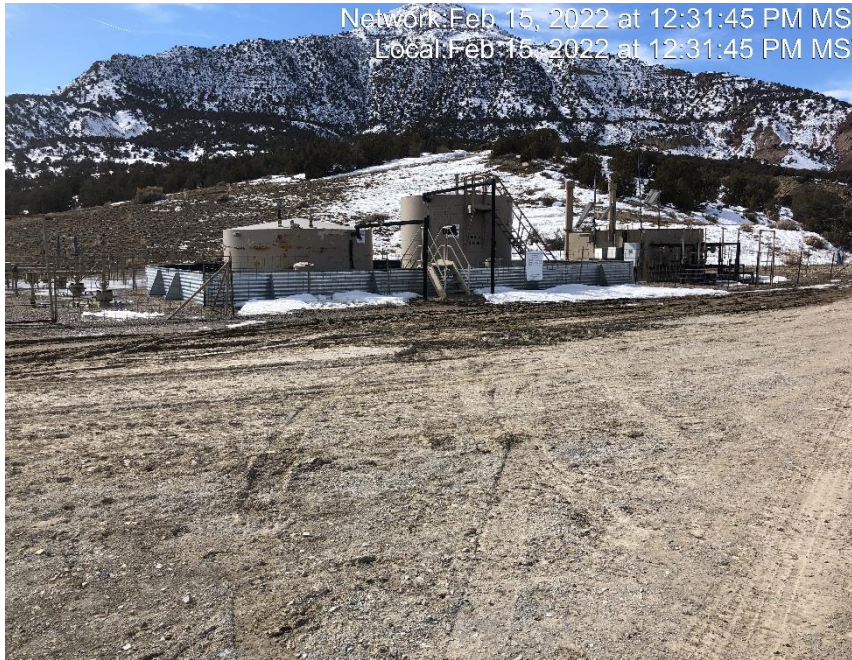
Photo #5962 from entrance to location.

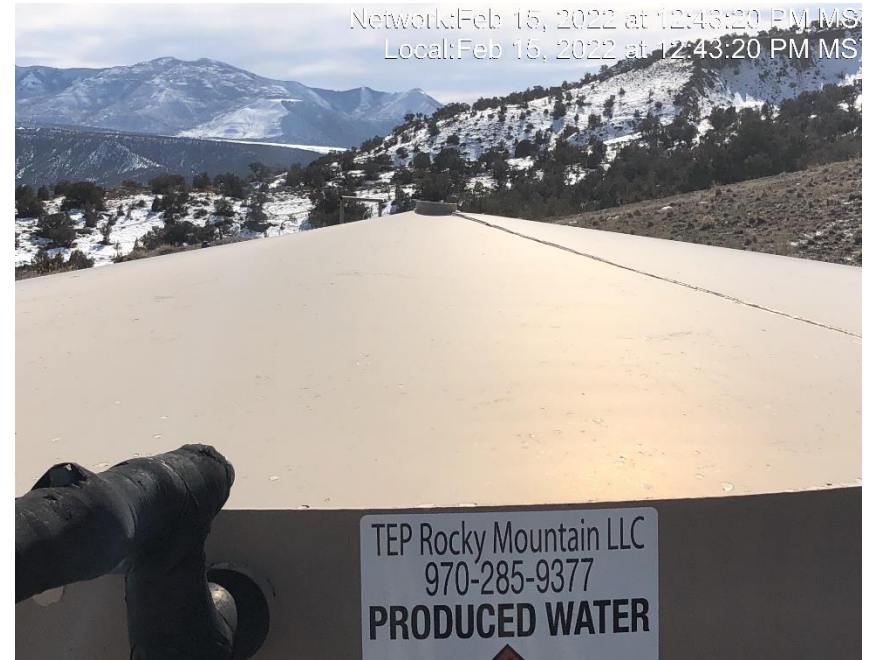
Photo #5965 Vent pipe on tank open ended.

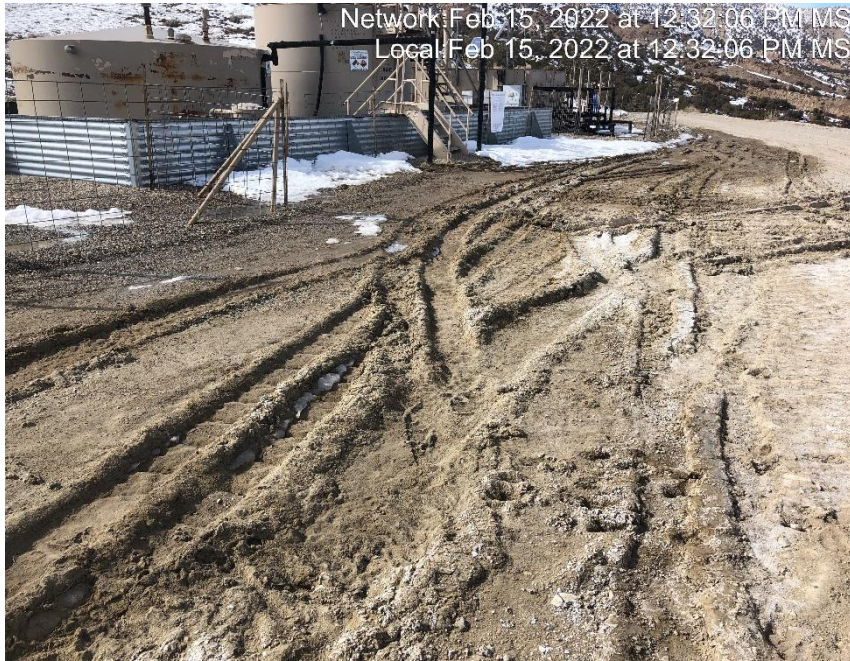
Photo #5963 Location lacks stabilization.

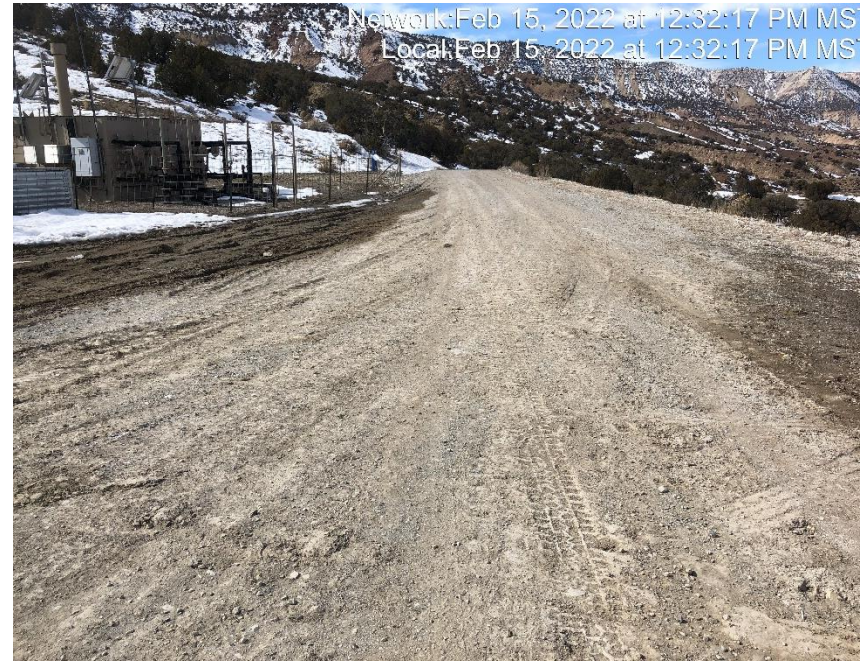
Photo #5964 Insufficient tracking controls.
